# Brudenell Lyndoch and Raglan

Submission to Township of Brudenell, Lyndoch, and Raglan

Roth IAMS Ltd.  
207-1075 North Service Rd W, Oakville ON, L6M 2G2  
[www.rothiams.com](http://www.rothiams.com)  
Project No. 23502

**Facility Condition Assessment Report**  
**Brudenell Fire Hall #4**

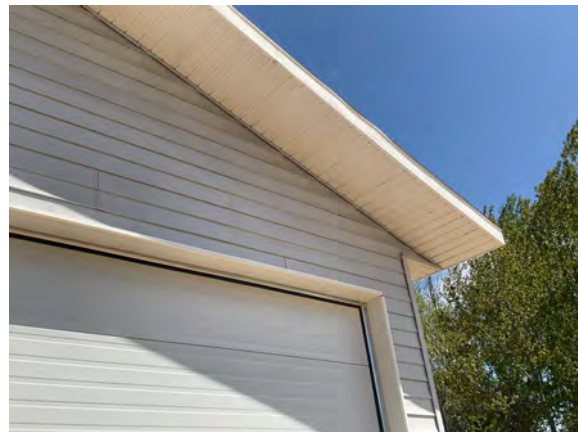
Brudenell Fire Hall #4 - B201008

No significant deficiencies were observed or reported. Replacement is not anticipated in the short term.

Recommendations #1 - Exterior Soffits	
Type	Life Cycle Replacement
Year	2042
Cost	\$8,512.70
