# Brudenell Lyndoch and Raglan

Submission to Township of Brudenell, Lyndoch, and Raglan

Roth IAMS Ltd.  
207-1075 North Service Rd W, Oakville ON, L6M 2G2  
[www.rothiams.com](http://www.rothiams.com)  
Project No. 23502

**Facility Condition Assessment Report**  
**Brudenell Fire Hall #4**

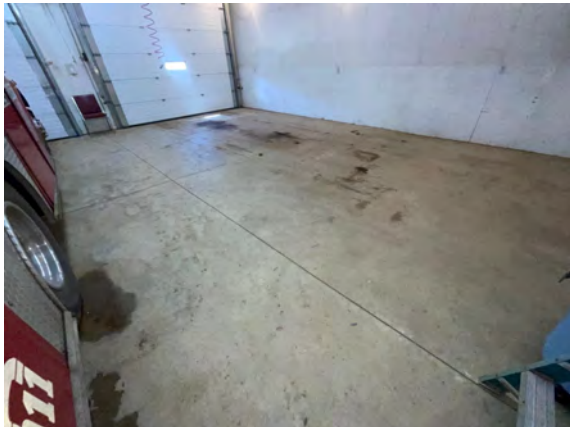
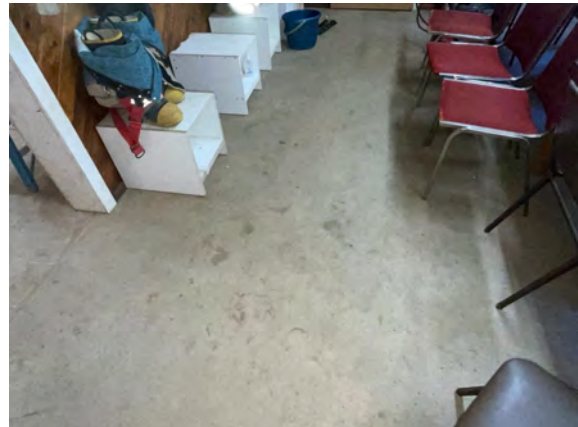
Brudenell Fire Hall #4 - A103001

No major deficiencies were observed or reported. No cracking in concrete was observed.

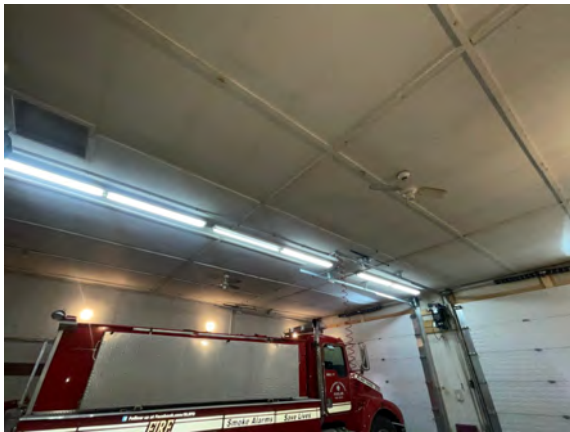
Brudenell Fire Hall #4 - B103001

No significant deficiencies were observed or reported on the exposed structural framing system.

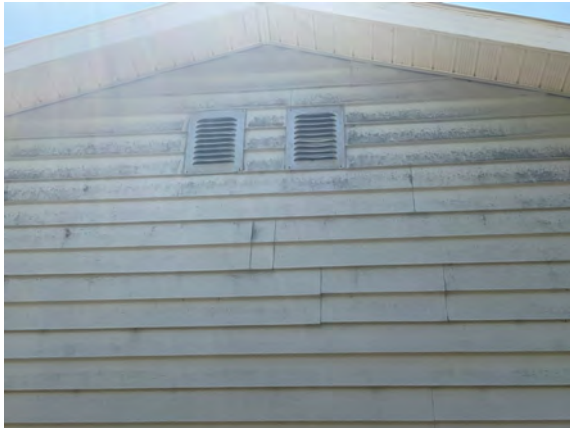
Brudenell Fire Hall #4 - B201005

No significant deficiencies were observed or reported. Replacement is not anticipated in the short term.

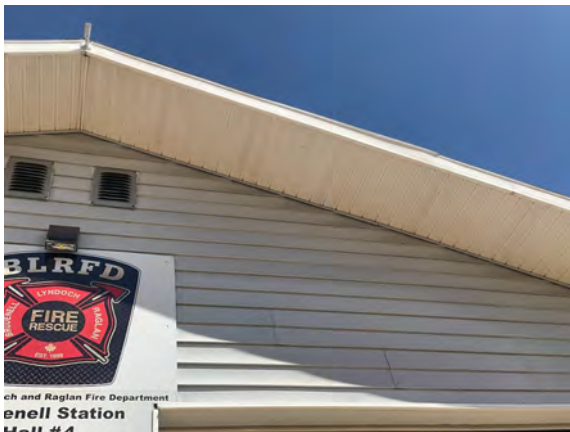
Brudenell Fire Hall #4 - B201008

No significant deficiencies were observed or reported. Replacement is not anticipated in the short term.

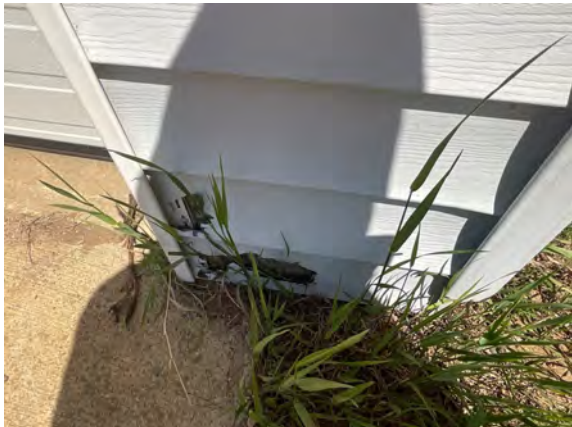
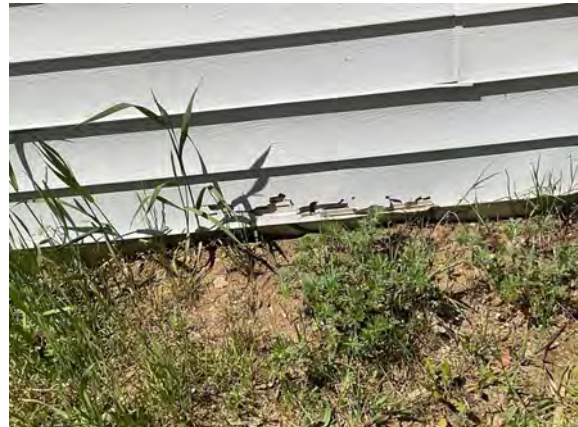
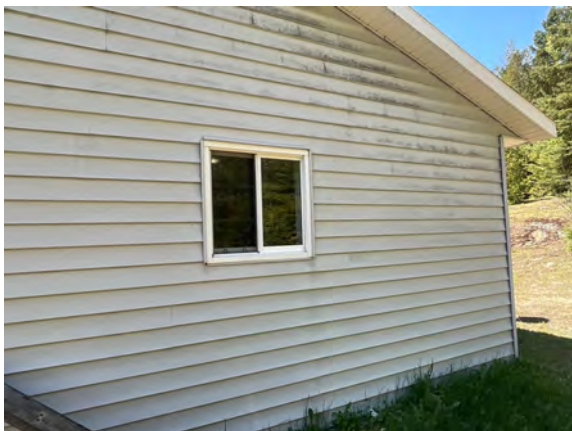
Brudenell Fire Hall #4 - B201025

No significant deficiencies were observed or reported. Some impact damage was observed and should be monitored or repaired. Replacement is not anticipated in the short term.

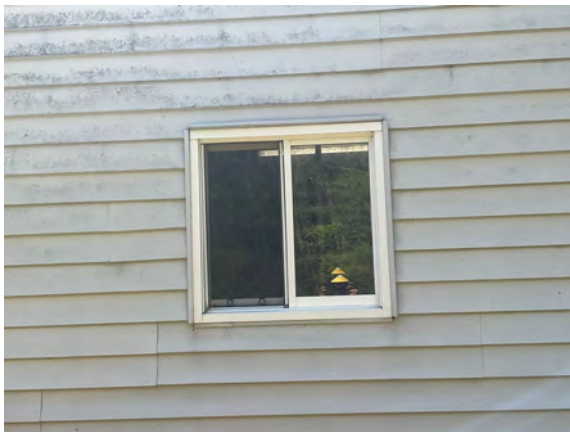
Brudenell Fire Hall #4 - B202001

No significant deficiencies were observed or reported. Replacement is not anticipated in the short term.

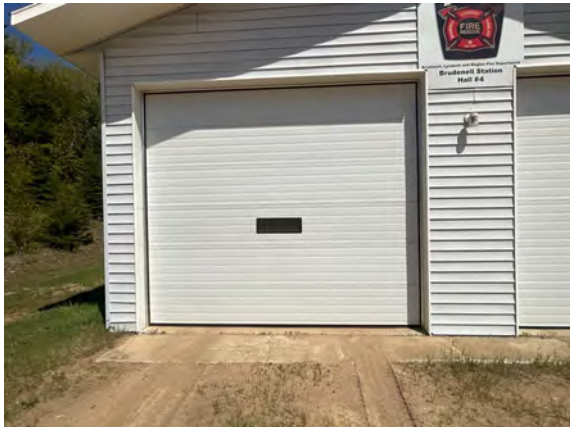
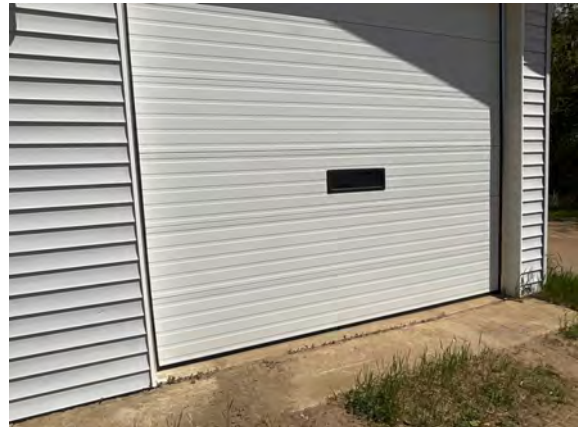
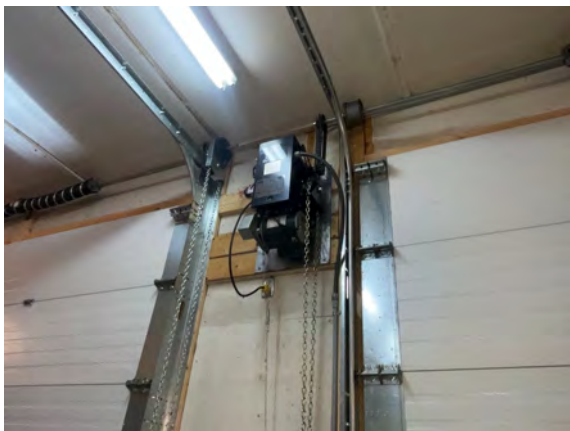
Brudenell Fire Hall #4 - B203022

No significant deficiencies were observed or reported. Replacement is not anticipated in the short term.

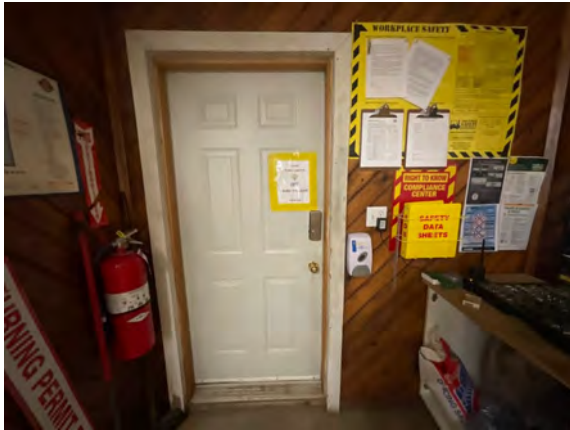
Brudenell Fire Hall #4 - B203023

No significant deficiencies were observed or reported. Lifecycle replacement may be deferred.

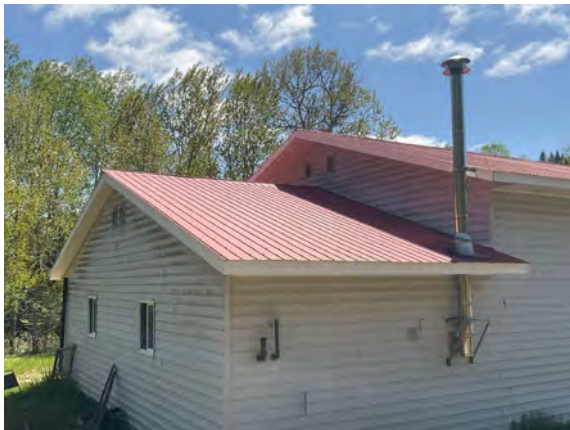
Brudenell Fire Hall #4 - B301028

No significant deficiencies were observed or reported. Replacement is not anticipated in the short term.

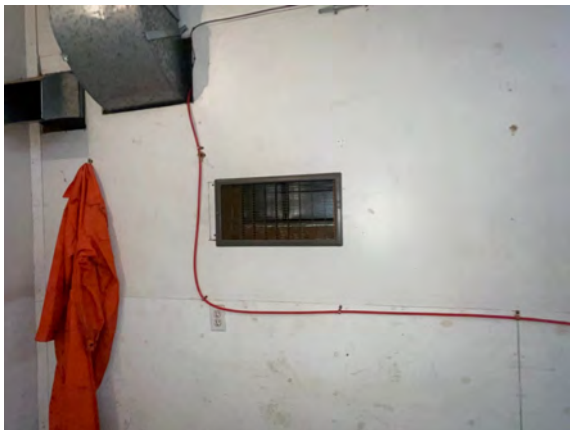
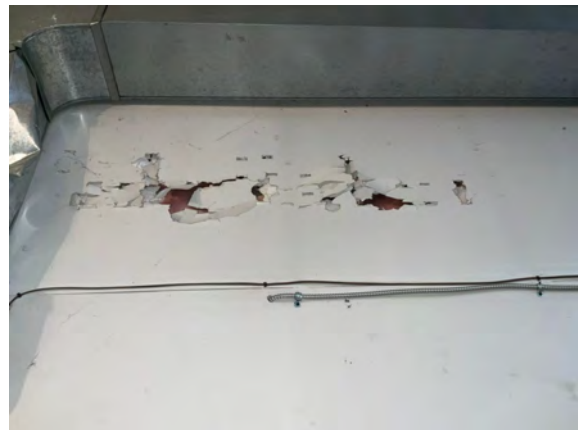
Brudenell Fire Hall #4 - C101001

No significant deficiencies were observed or reported. Some impact damage was observed and should be repaired as part of maintenance. Replacement is not anticipated in the short term.

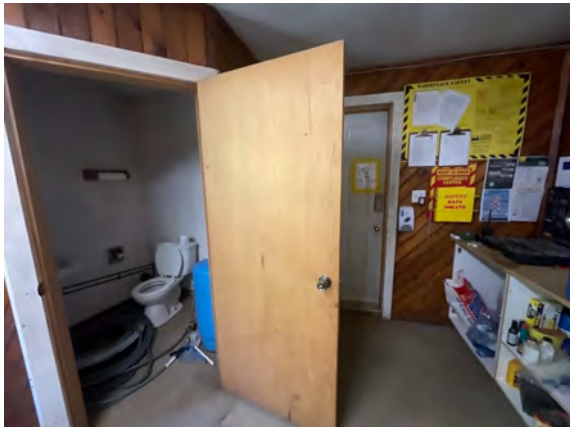
Brudenell Fire Hall #4 - B203024

No significant deficiencies were observed or reported. Replacement is not anticipated in the short term.

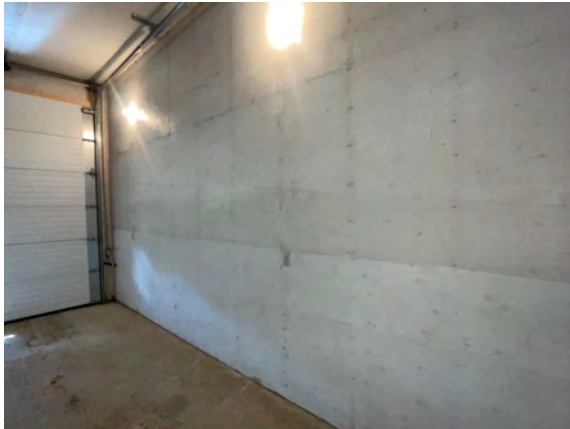
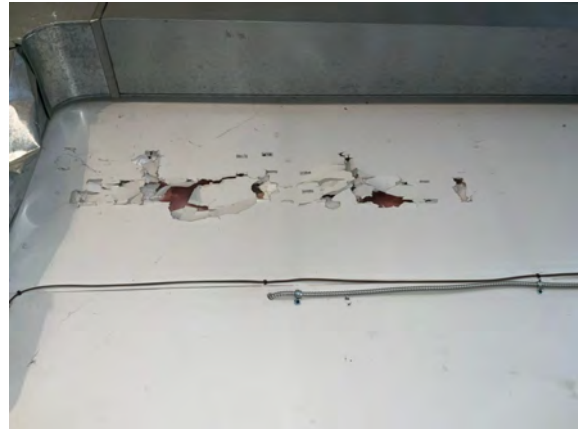
Brudenell Fire Hall #4 - C301005

Deficiencies observed or reported during the assessment include peeling and staining and discoloration, fading, wear, and deterioration. The deterioration is anticipated to progress due to age and ongoing building activities. Replacement is recommended in the short term.

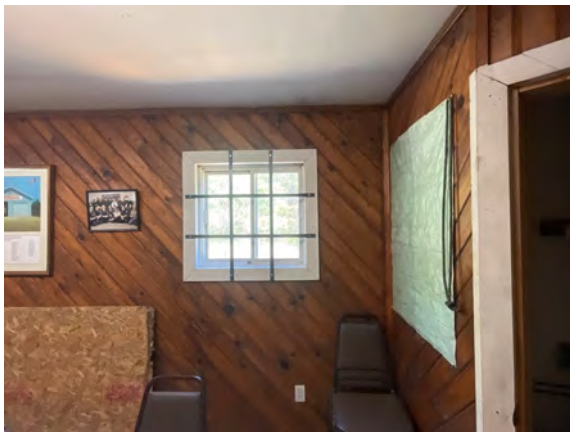
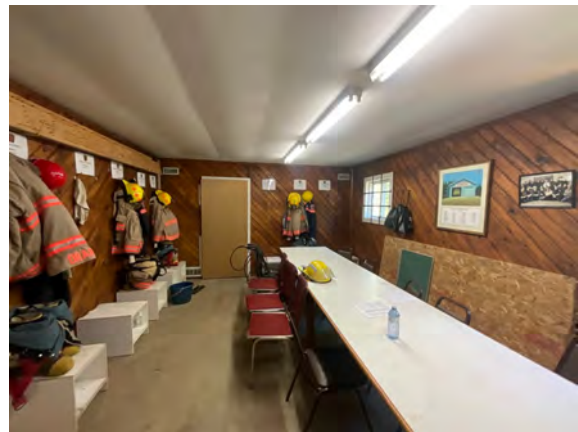
Brudenell Fire Hall #4 - C301022

No significant deficiencies were observed or reported. Lifecycle replacement may be deferred.

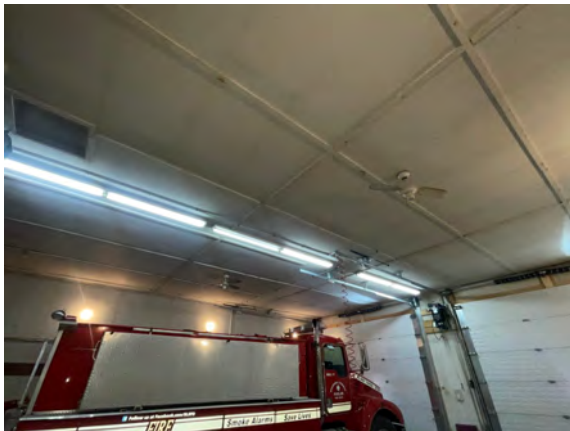
Brudenell Fire Hall #4 - C303006

Deficiencies observed or reported during the assessment include staining and discoloration, fading, wear, and deterioration. The deterioration is anticipated to progress due to age and ongoing building activities. Replacement is recommended in the short term.

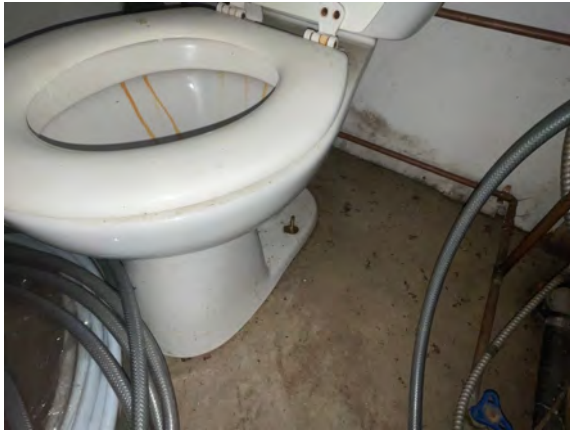
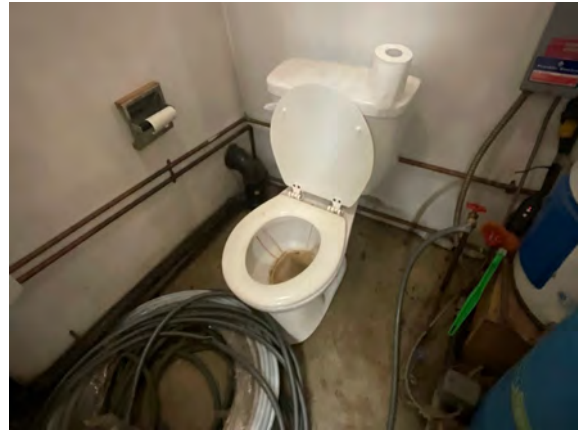
Brudenell Fire Hall #4 - D201001

Deficiencies observed or reported at the time of the assessment include stains. Replacement is recommended in the short term.

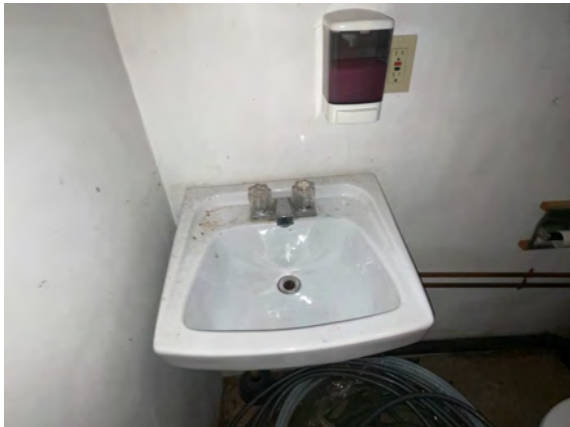
Brudenell Fire Hall #4 - D201003

Deficiencies observed or reported at the time of the assessment include leaking tap-sets. Replacement is recommended in the short term.

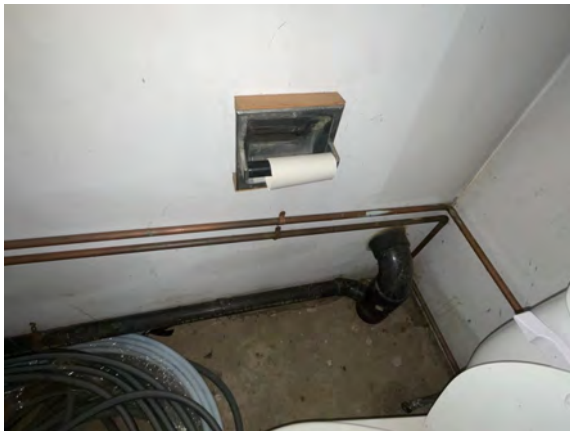
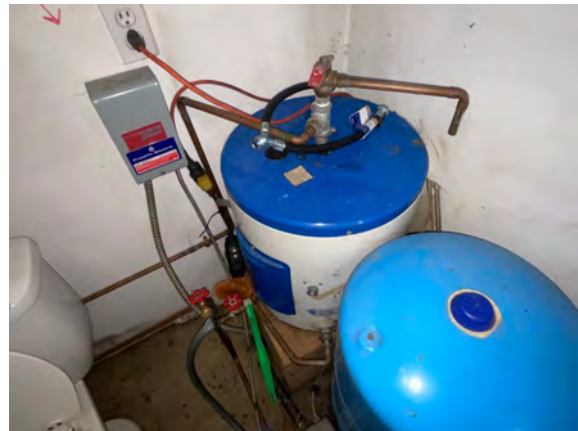
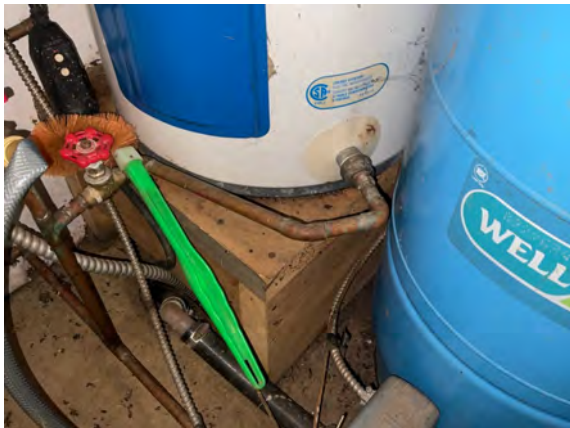
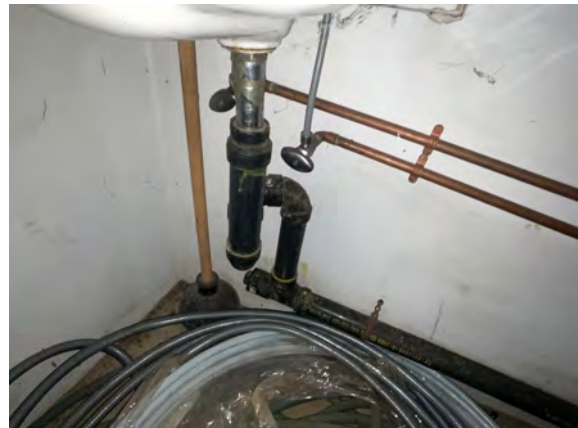
Brudenell Fire Hall #4 - D202001

No significant deficiencies were observed or reported. Replacement is not anticipated in the short term.

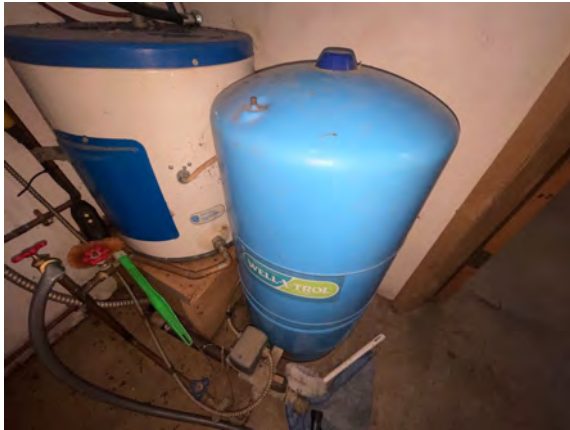
Brudenell Fire Hall #4 - D202021

No significant deficiencies were observed or reported. Lifecycle replacement may be deferred.

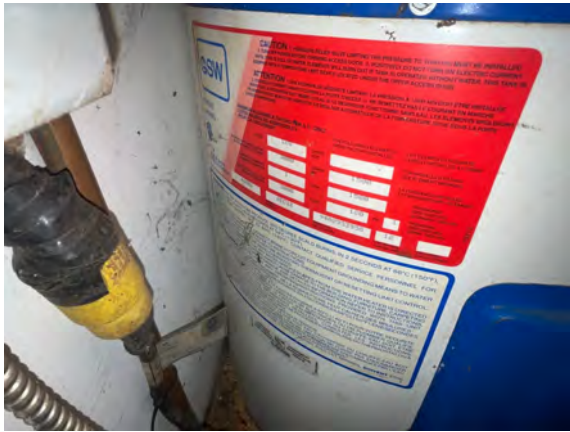
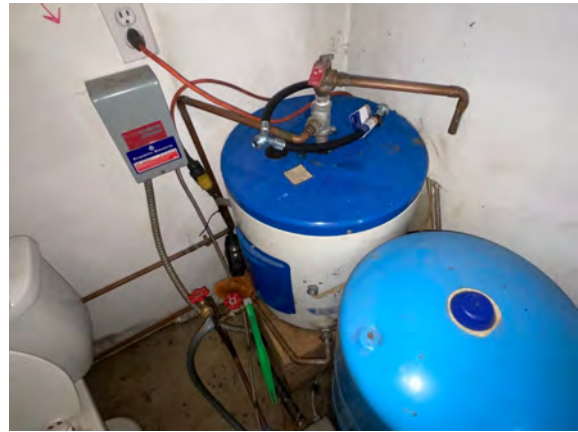
Brudenell Fire Hall #4 - D202034

No significant deficiencies were observed or reported. However the system, based on age, is approaching or is past its expected useful life with performance and reliability likely diminishing over time. Replacement is recommended in the short term.

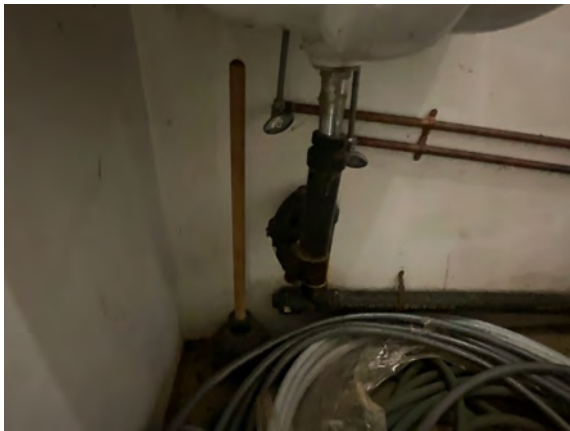
Brudenell Fire Hall #4 - D203001

No significant deficiencies were observed or reported. Replacement is not anticipated in the short term.

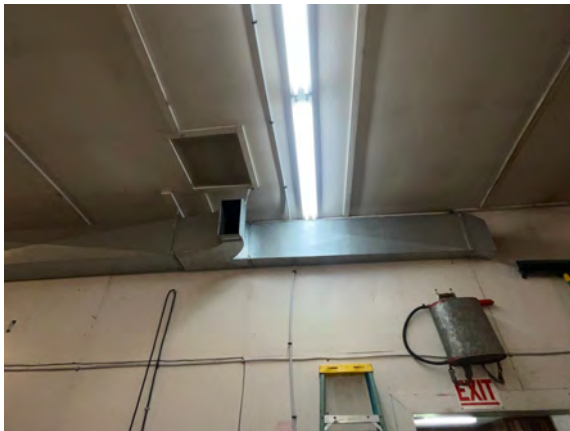
Brudenell Fire Hall #4 - D302003

No significant deficiencies were observed or reported. Replacement is not anticipated in the short term.

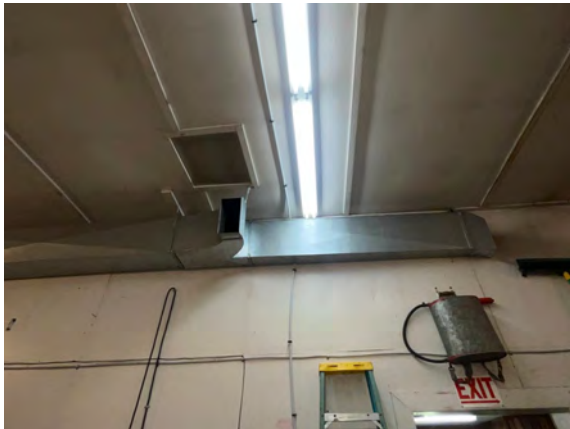
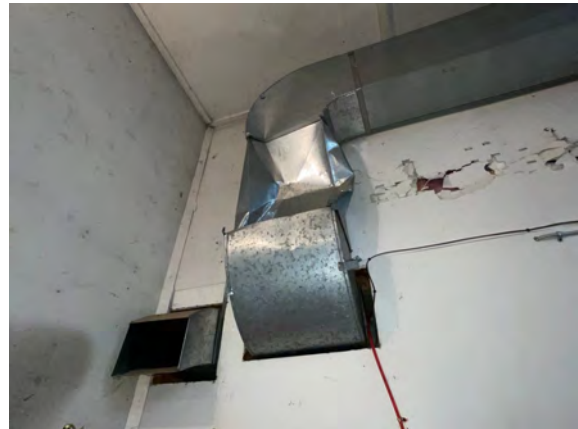
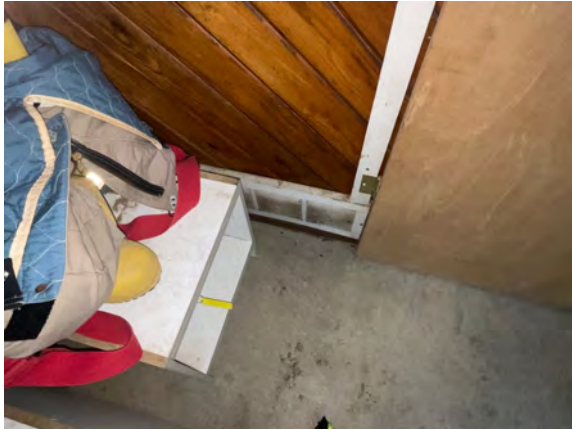
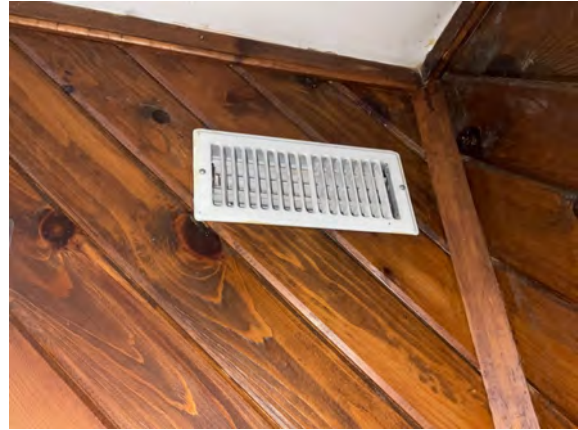
Brudenell Fire Hall #4 - D304001

No significant deficiencies were observed or reported. Replacement is not anticipated in the short term. However minor damage was noted on the duct metal and blocked air filters which need to be addressed in the ongoing maintenance.

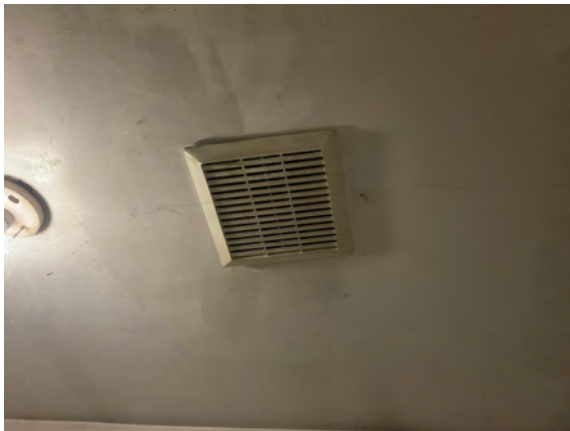
Brudenell Fire Hall #4 - D304031

No significant deficiencies were observed or reported. However, the system, based on age, is approaching or is past its expected useful life with performance and reliability likely diminishing over time. Replacement is recommended in the short term.

Recommendations #1 - Exhaust Fans - Residential	
Type	Life Cycle Replacement
Year	2024
Cost	\$1,565.09

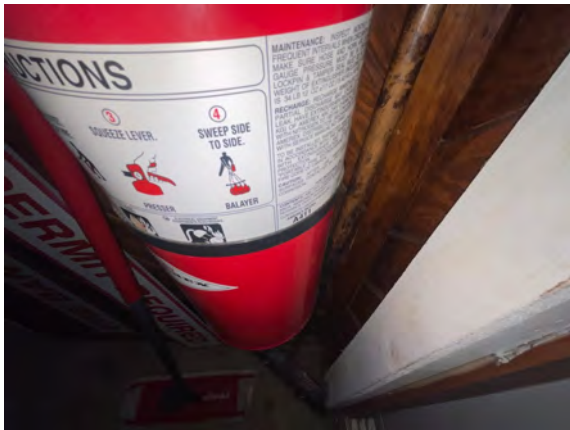
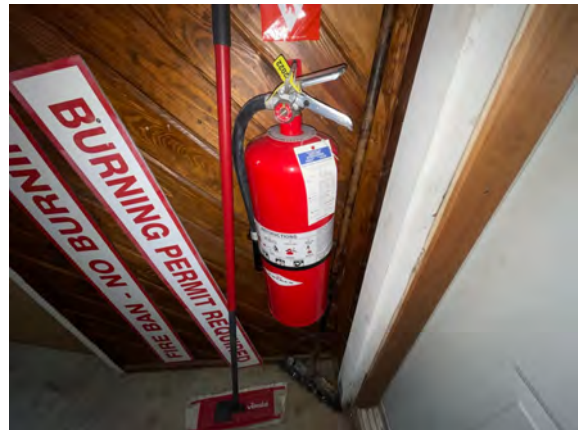
Brudenell Fire Hall #4 - D403002

No significant deficiencies were observed or reported. Replacement is not anticipated in the short term.

Recommendations #1 - Individual Fire Extinguishers	
Type	Life Cycle Replacement
Year	2029
Cost	\$702.25

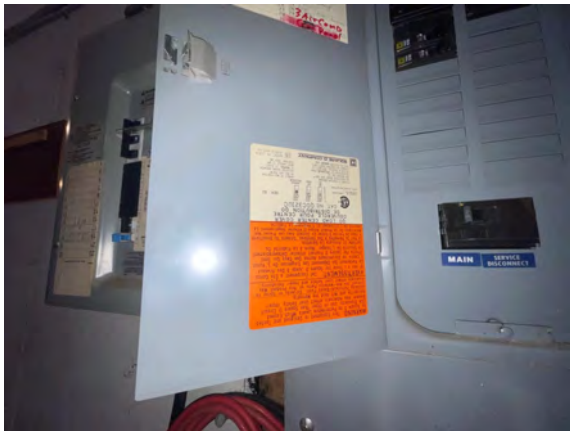
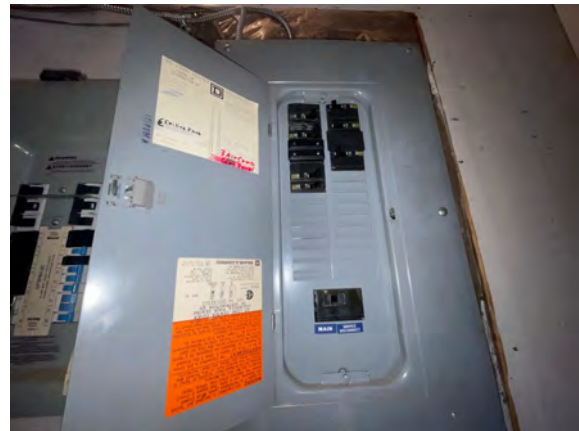
Brudenell Fire Hall #4 - D501003

No significant deficiencies were observed or reported. Replacement is not anticipated in the short term.

Recommendations #1 - Main Service Panels	
Type	Life Cycle Replacement
Year	2032
Cost	\$22,224.22

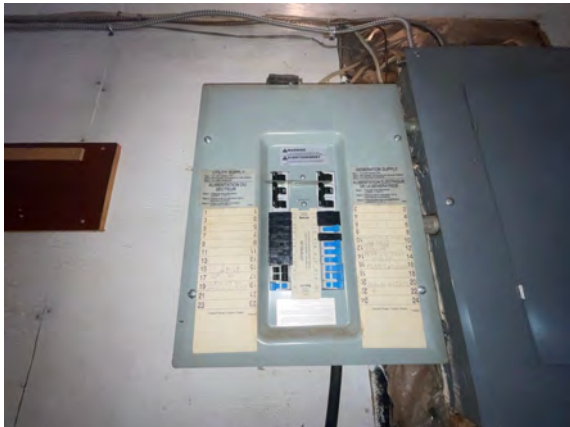
Brudenell Fire Hall #4 - D501025

No significant deficiencies were observed or reported. Replacement is not anticipated in the short term.

<b>Recommendations #1 - Panelboards Residential</b>	
Type	Life Cycle Replacement
Year	2032
Cost	\$2,055.03

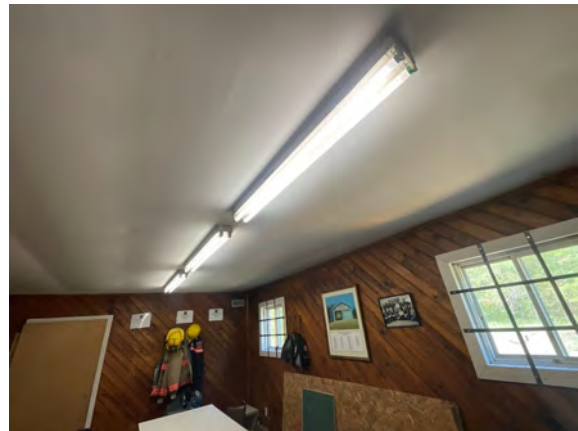
Brudenell Fire Hall #4 - D502002

No significant deficiencies were observed or reported. Some of the lighting was updated over time. However, the lighting is energy inefficient. Replacement or upgrade to LED is recommended in the short term.

Recommendations #1 - Interior Lighting	
Type	Life Cycle Replacement
Year	2027
Cost	\$19,205.64

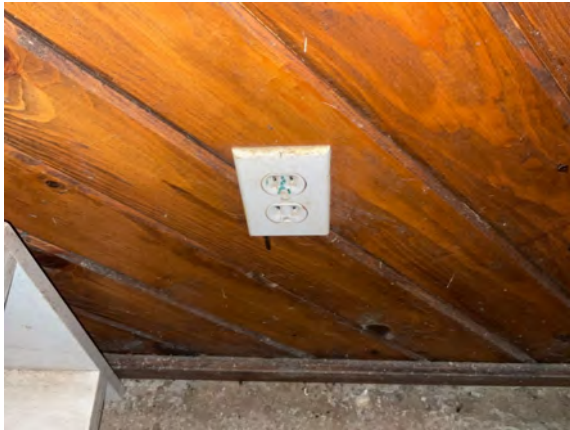
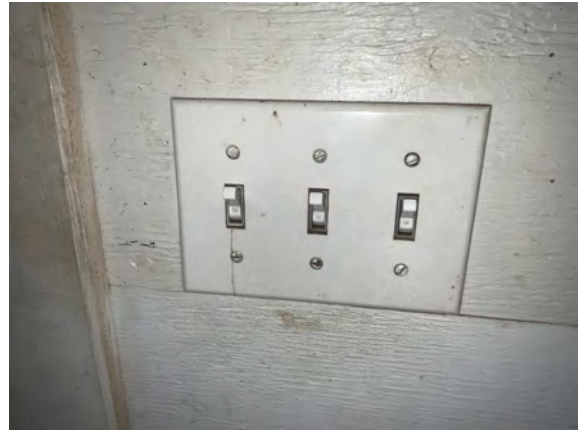
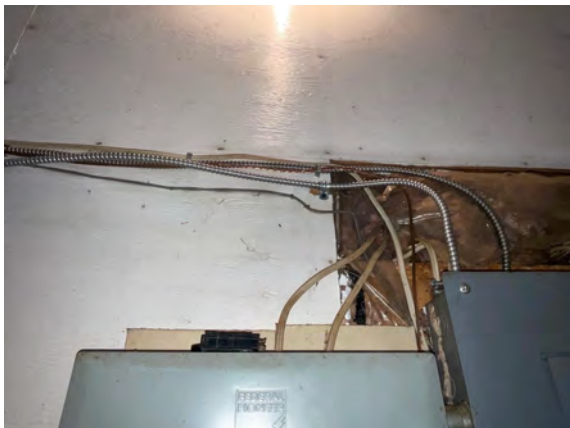
Brudenell Fire Hall #4 - D502001

No significant deficiencies were observed or reported. Replacement is not anticipated in the short term.

<b>Recommendations #1 - Branch Wiring and Devices - Residential</b>	
Type	Life Cycle Replacement
Year	2042
Cost	\$10,974.65

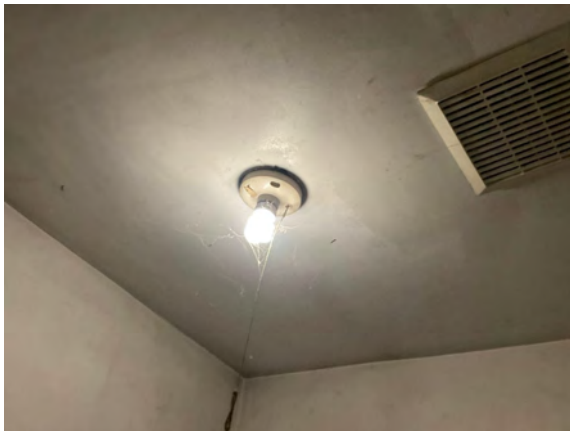
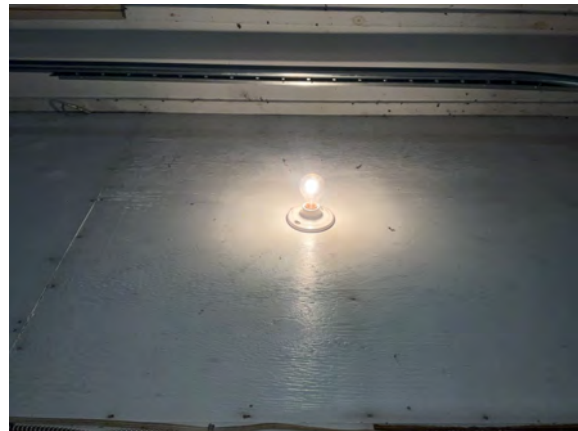
Brudenell Fire Hall #4 - D502002

No significant deficiencies were observed or reported. However, the lighting is energy inefficient. Replacement or upgrade to LED is recommended in the short term /should be considered.

Recommendations #1 - Interior Lighting Residential	
Type	Life Cycle Replacement
Year	2027
Cost	\$6,001.76

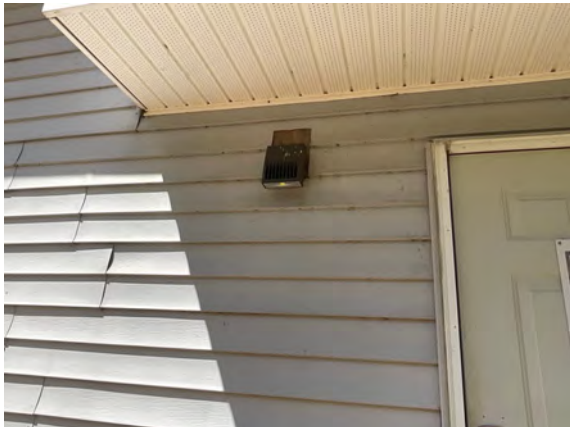
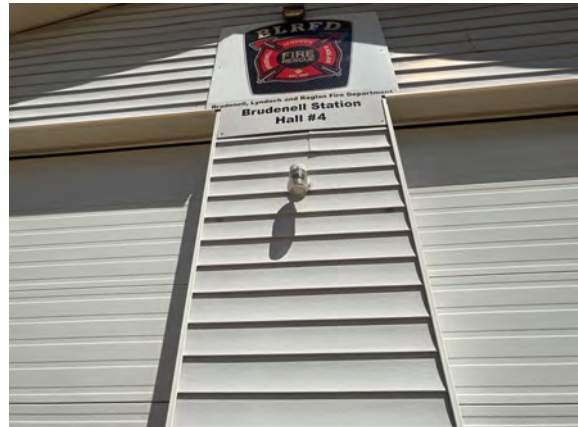
Brudenell Fire Hall #4 - D502041

No significant deficiencies were observed or reported. Replacement is not anticipated in the short term.

Recommendations #1 - Exterior Lighting	
Type	Life Cycle Replacement
Year	2042
Cost	\$1,562.36

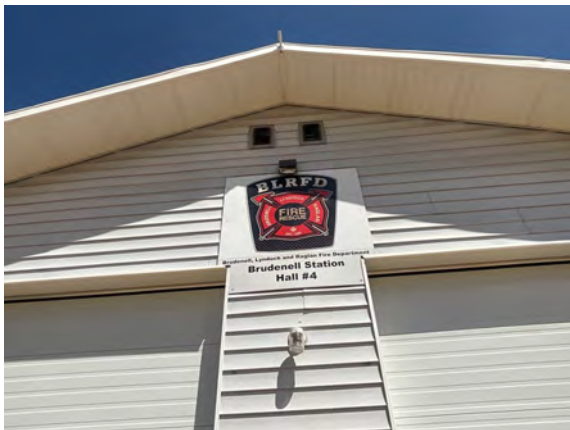
Brudenell Fire Hall #4 - C103021

No significant deficiencies were observed or reported. Replacement is not anticipated in the short term.

<b>Recommendations #1 - Message Sign - Wall-Mounted</b>	
Type	Life Cycle Replacement
Year	2029
Cost	\$2,041.42

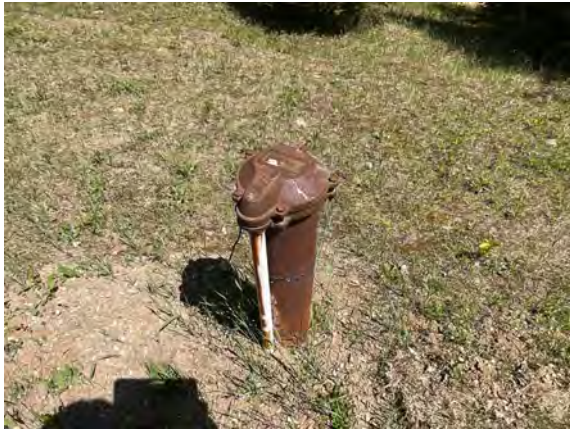
Brudenell Fire Hall #4 - G301001

The well is concealed below ground and cannot be fully assessed via visual means. However, no significant deficiencies were reported. Replacement is not anticipated in the short term. OR Deficiencies observed or reported at the time of the assessment include maintenance issues /poor performance /failure. Replacement is recommended in the short term.

Recommendations #1 - Well Systems	
Type	Life Cycle Replacement
Year	2042
Cost	\$173,887.81

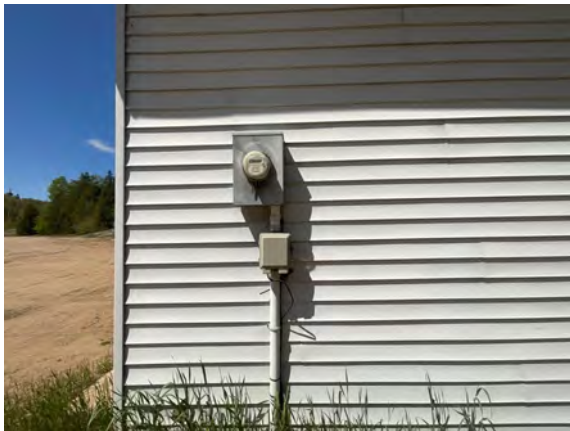
Brudenell Fire Hall #4 - G401010

No significant deficiencies were observed or reported. Replacement is not anticipated in the short term.

Recommendations #1 - Electrical Service Single Phase	
Type	Life Cycle Replacement
Year	2042
Cost	\$22,231.02

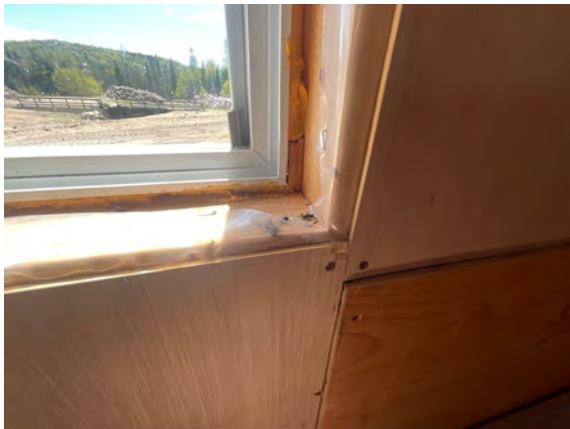
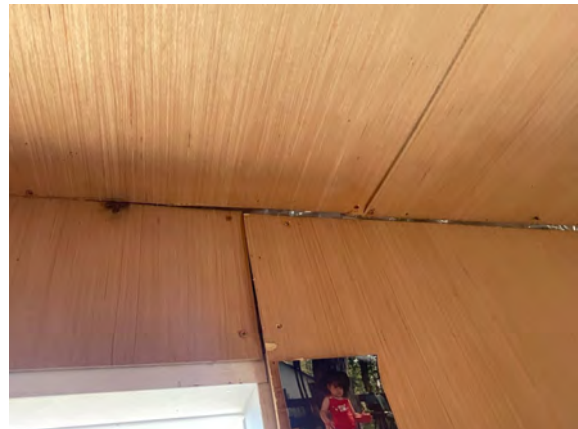
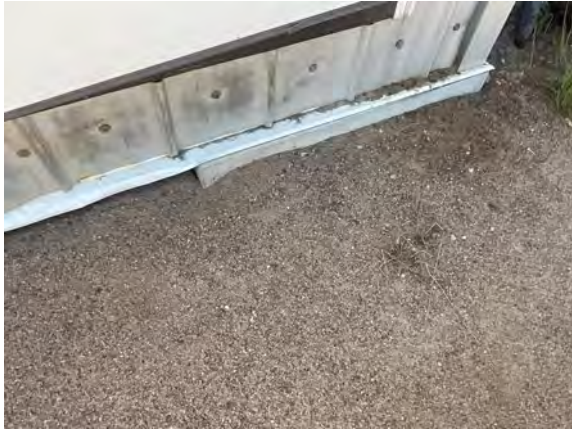
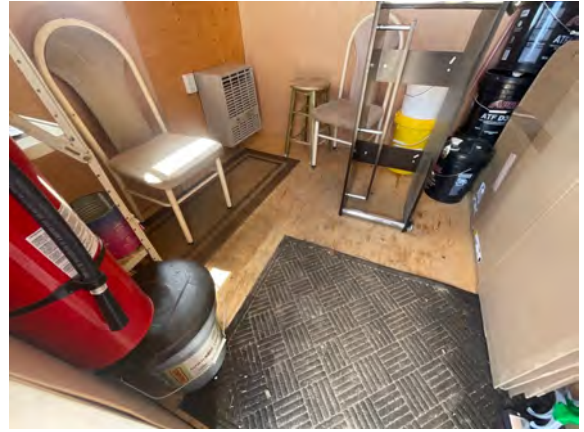
Brudenell Waste Site - B201099

No significant deficiencies were observed or reported. Replacement is not anticipated in the short term.

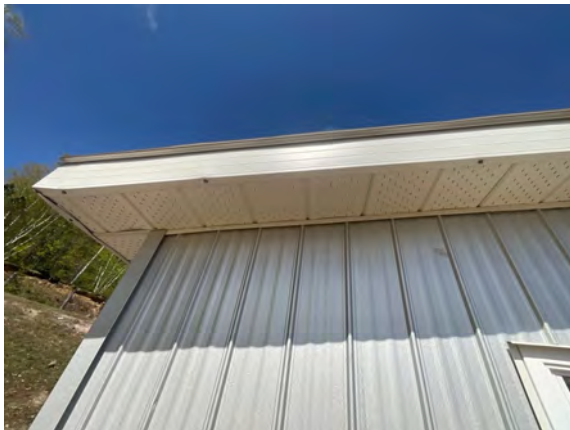
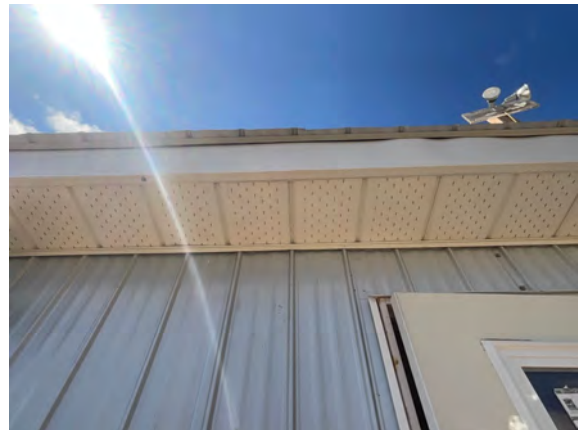
Brudenell Waste Site - B201008

No significant deficiencies were observed or reported. Replacement is not anticipated in the short term.

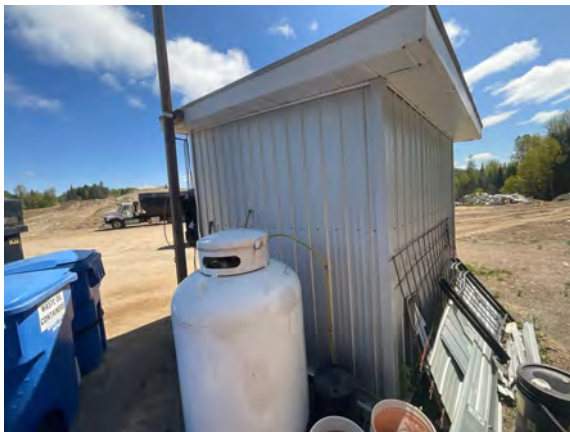
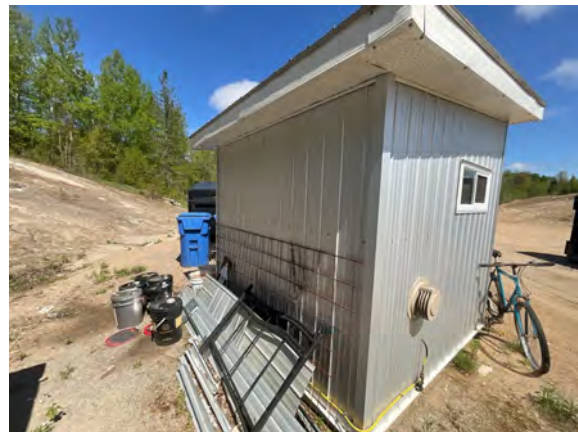
Brudenell Waste Site - B201024

No significant deficiencies were observed or reported. Replacement is not anticipated in the short term.

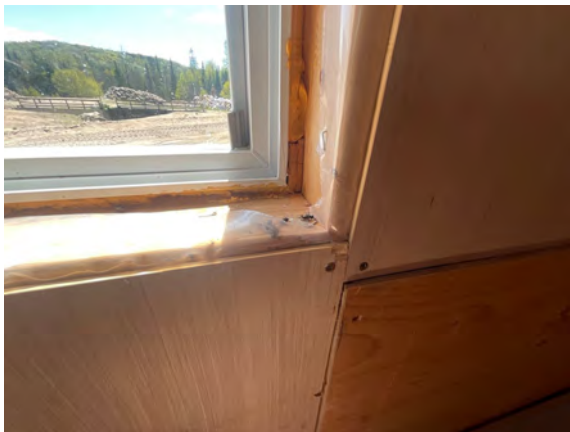
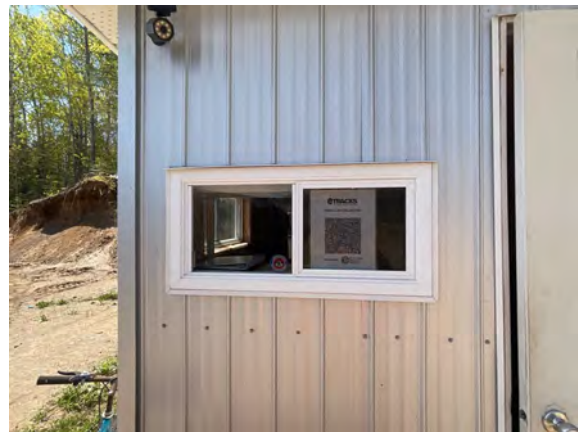
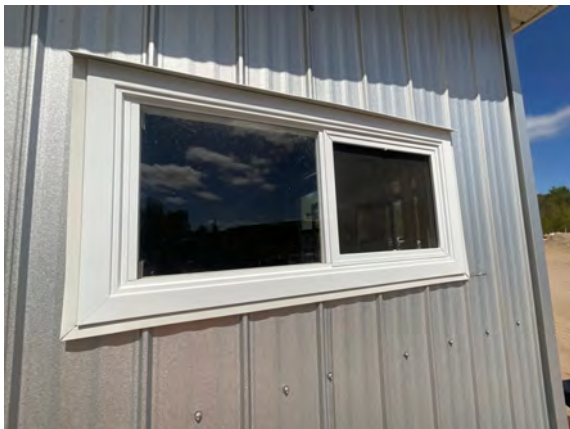
Brudenell Waste Site - B202001

No significant deficiencies were observed or reported. Replacement is not anticipated in the short term.

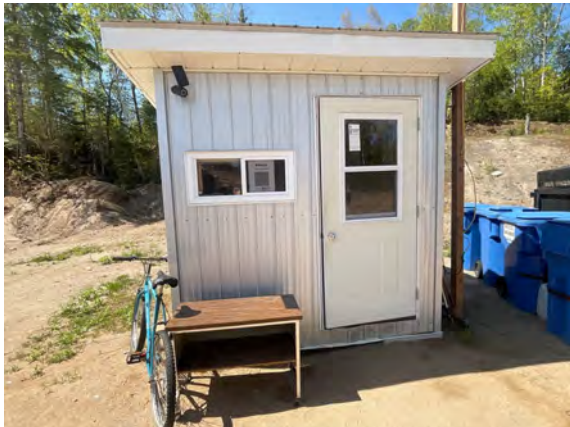
Brudenell Waste Site - C102021

No significant deficiencies were observed or reported. Replacement is not anticipated in the short term.

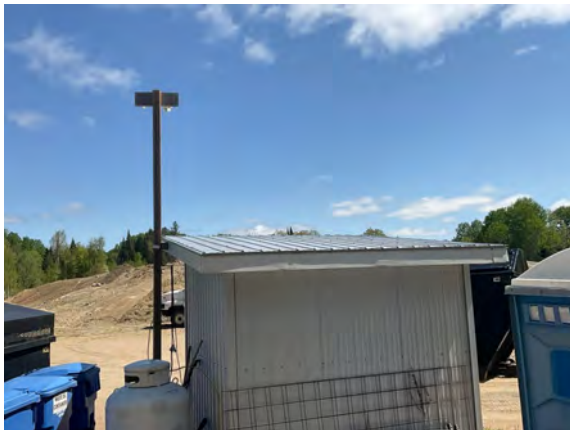
Brudenell Waste Site - B301028

No significant deficiencies were observed or reported. Replacement is not anticipated in the short term.

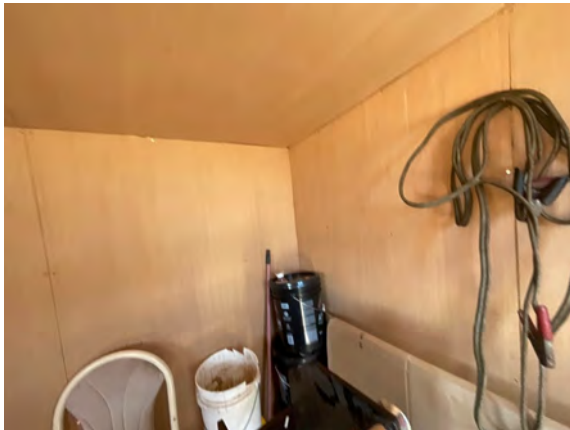
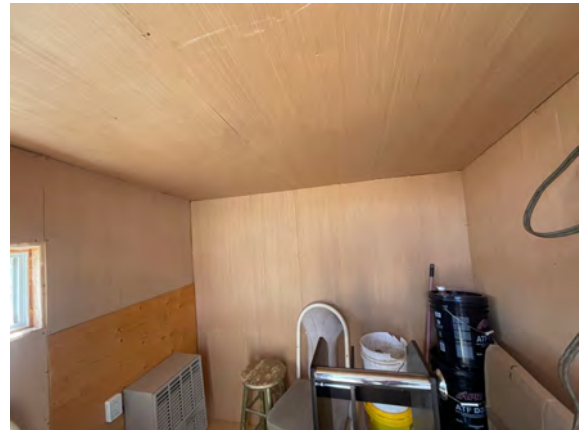
Brudenell Waste Site - C301022

No significant deficiencies were observed or reported. Replacement is not anticipated in the short term.

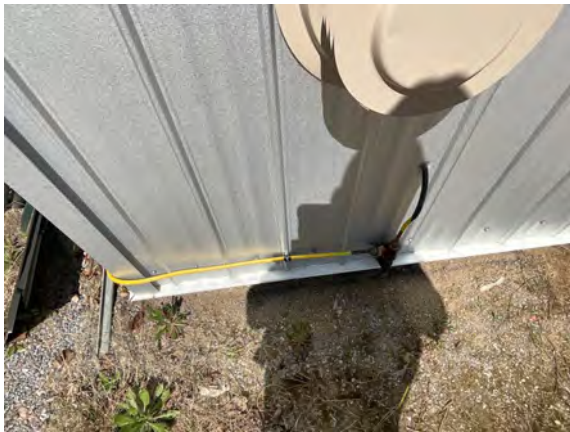
Brudenell Waste Site - D301002

No significant deficiencies were observed or reported. Replacement is not anticipated in the short term.

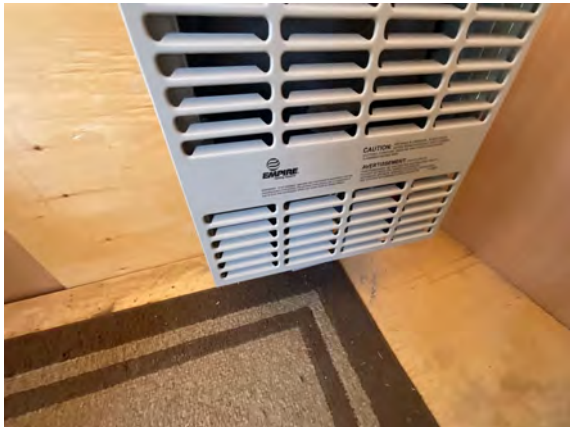
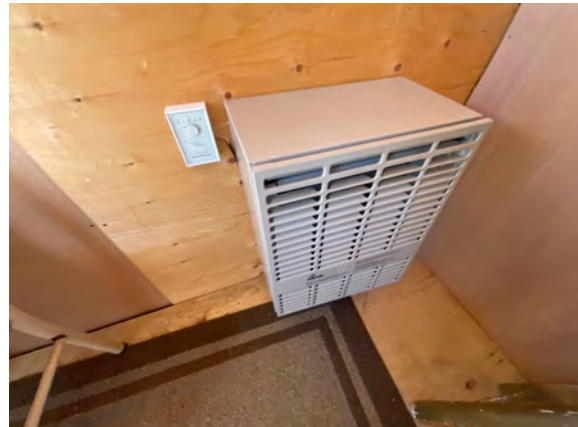
Brudenell Waste Site - D305009

No significant deficiencies were observed or reported. Replacement is not anticipated in the short term.

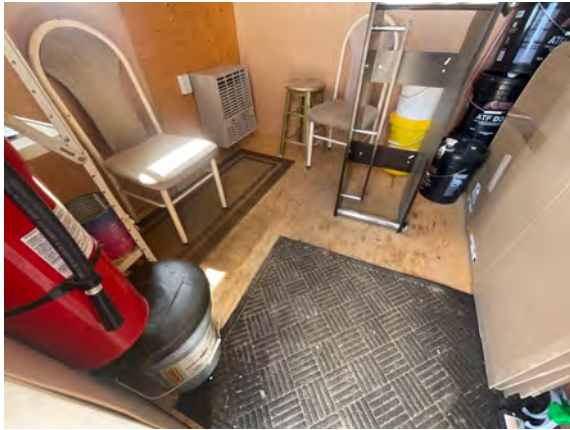
Brudenell Waste Site - D403002

No significant deficiencies were observed or reported. Replacement is not anticipated in the short term.

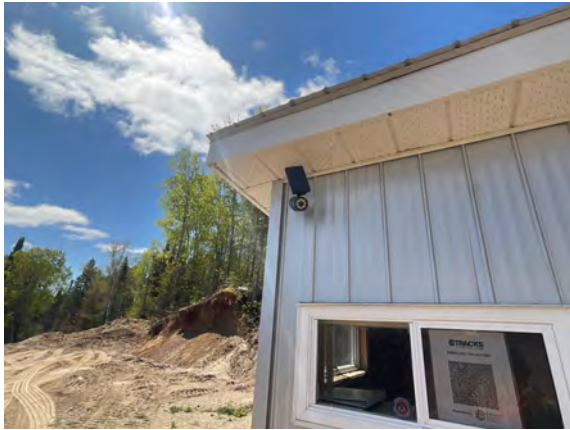
Brudenell Waste Site - G403099

No significant deficiencies were observed or reported. Replacement is not anticipated in the short term.

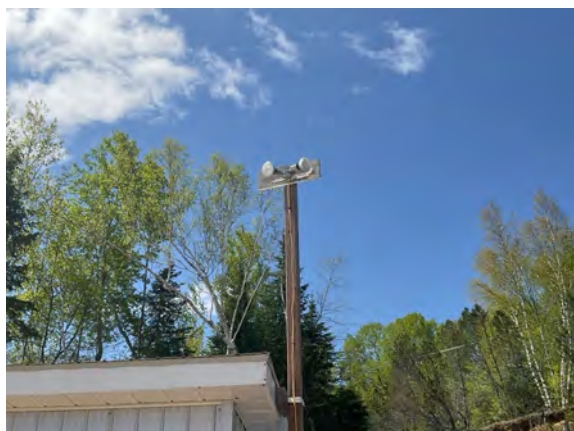
Brudenell Waste Site - D502041

No significant deficiencies were observed or reported. Replacement is not anticipated in the short term.

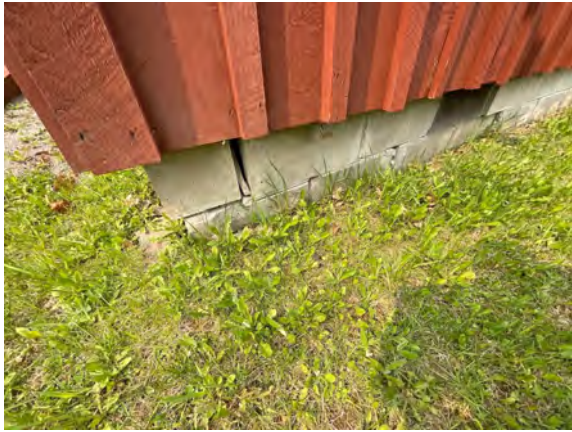
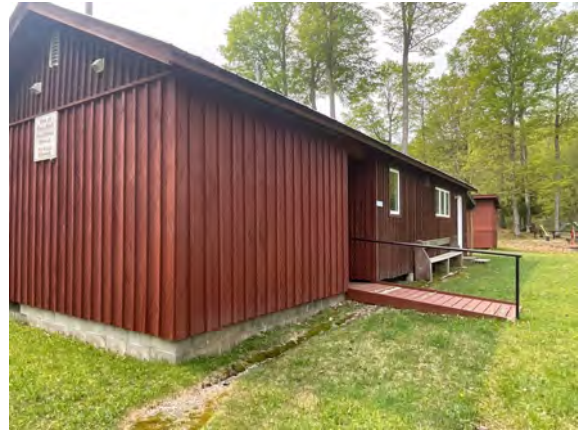
Four Season Park - Canteen - A101001

No significant deficiencies were observed or reported.

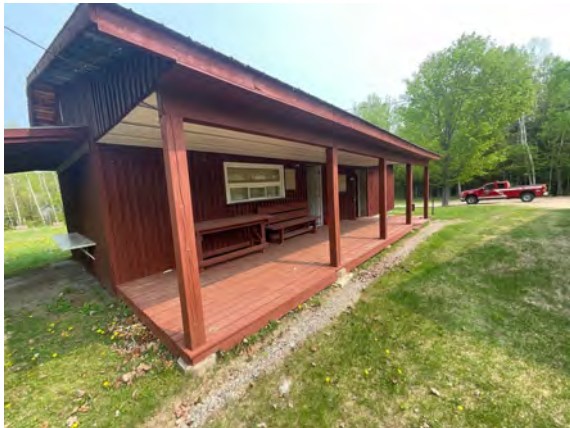
Four Season Park - Canteen - B102004

No significant deficiencies were observed or reported. Replacement is not anticipated in the short term.

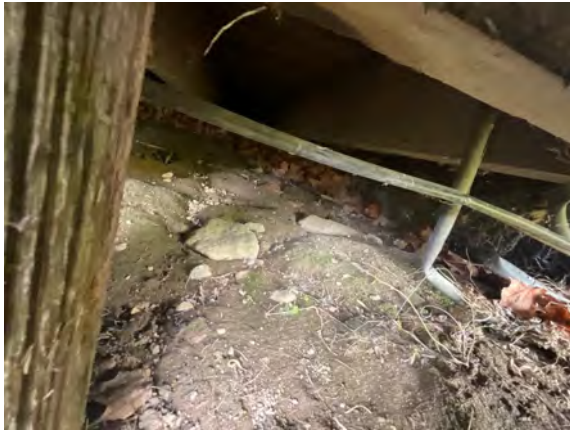
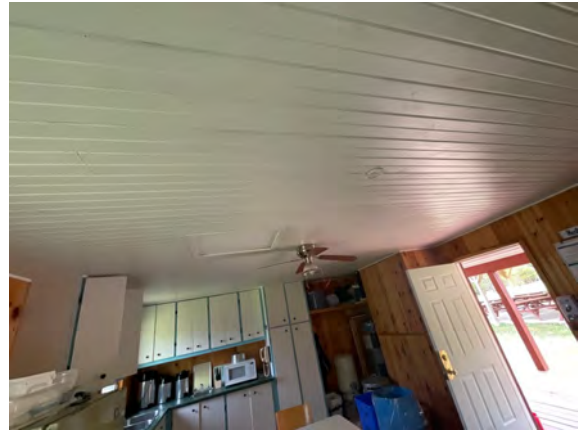
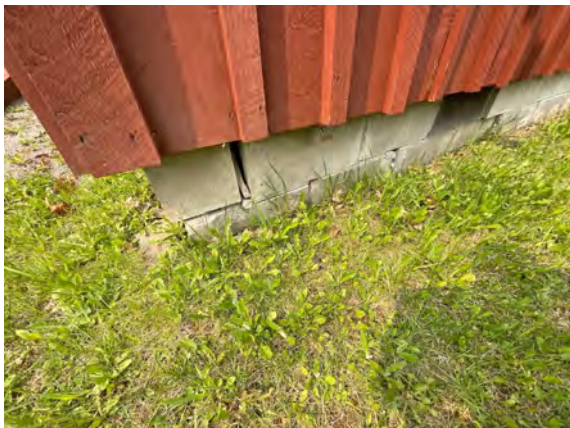
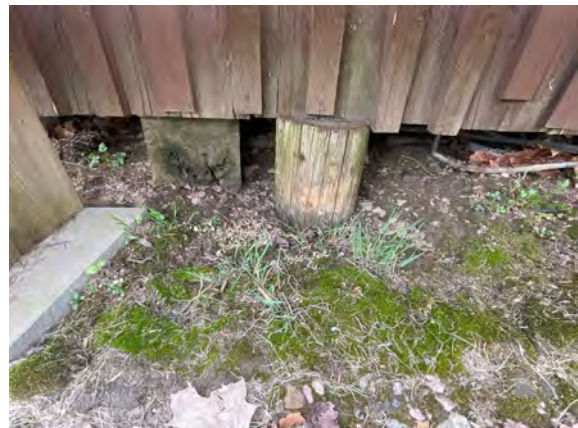
Four Season Park - Canteen - B103001

No significant deficiencies were observed or reported. Replacement is not anticipated in the short term.
