# Brudenell Lyndoch and Raglan

Submission to Township of Brudenell, Lyndoch, and Raglan

Roth IAMS Ltd.  
207-1075 North Service Rd W, Oakville ON, L6M 2G2  
[www.rothiams.com](http://www.rothiams.com)  
Project No. 23502

**Facility Condition Assessment Report**  
**Brudenell Fire Hall #4**

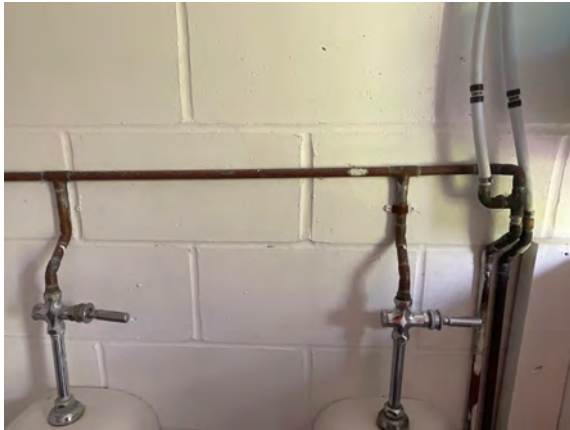
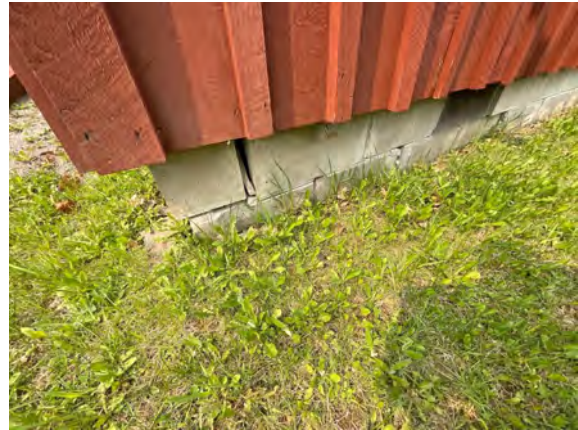
Four Season Park - Canteen - C103021

At the time of the assessment, where accessible in exposed areas for visual review on site, the washroom structural framing system is likely a wood joist floor supported on CMU foundation walls and load bearing CMU walls, supporting a roof deck with roof sheathing.

No significant deficiencies were observed or reported. Replacement is not anticipated in the short term.

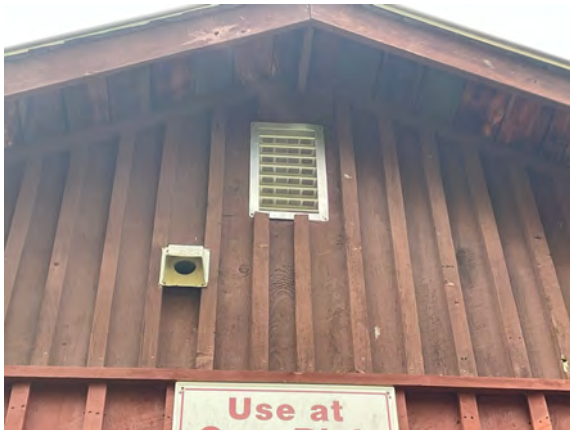
Four Season Park - Canteen - B201005

No significant deficiencies were observed or reported. Replacement is not anticipated in the short term.

Recommendations #1 - Louvers and Screens	
Type	Life Cycle Replacement
Year	2034
Cost	\$1,197.64

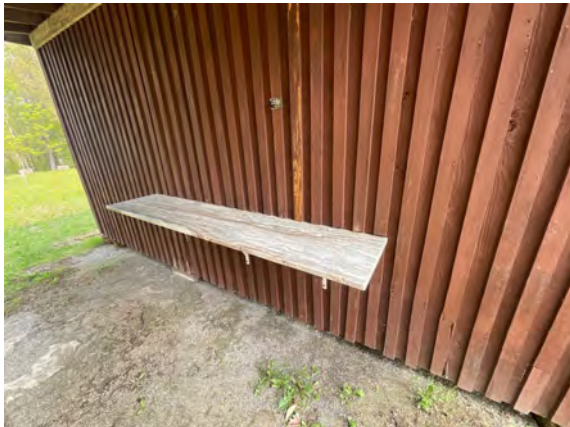
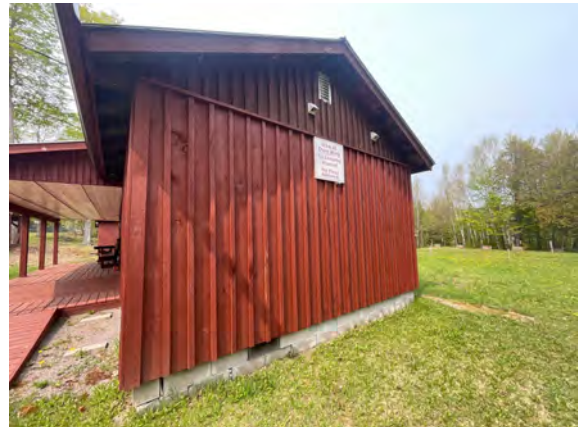
Four Season Park - Canteen - B201010

A stain finish is applied to exterior wall surfaces.

No significant deficiencies were observed or reported. Replacement is not anticipated in the short term.

<b>Recommendations #1 - Exterior Coatings/Paint</b>	
Type	Life Cycle Replacement
Year	2030
Cost	\$6,510.82

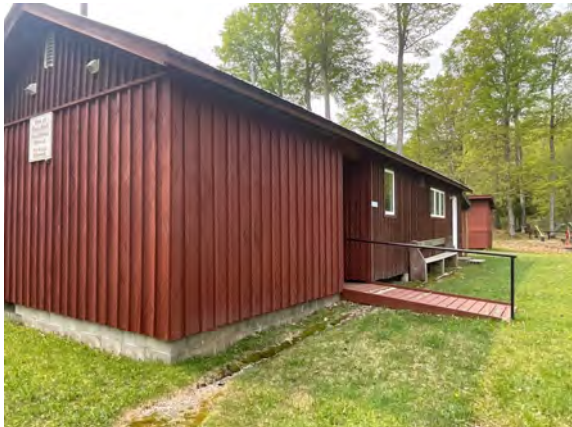
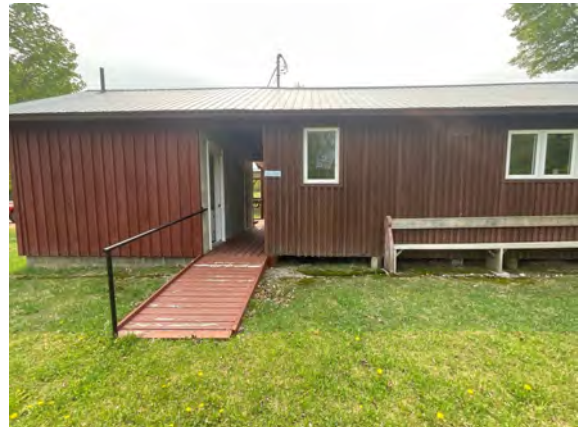
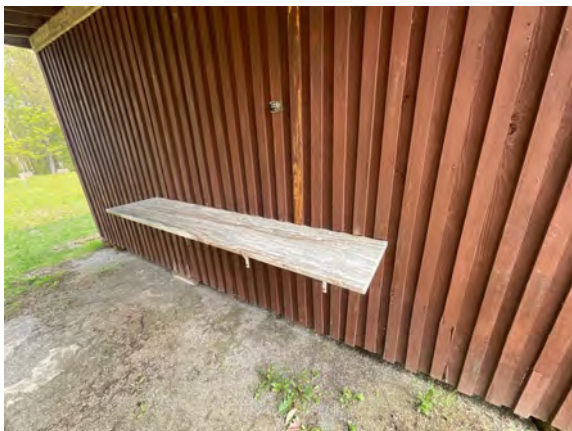
Four Season Park - Canteen - B201026

No significant deficiencies were observed or reported. Minor damage should be repaired as part of maintenance Replacement is not anticipated in the short term.

<b>Recommendations #1 - Wood Siding</b>	
Type	Life Cycle Replacement
Year	2029
Cost	\$35,667.96

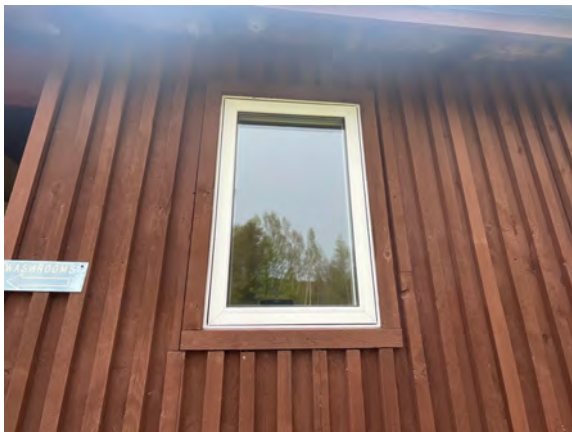
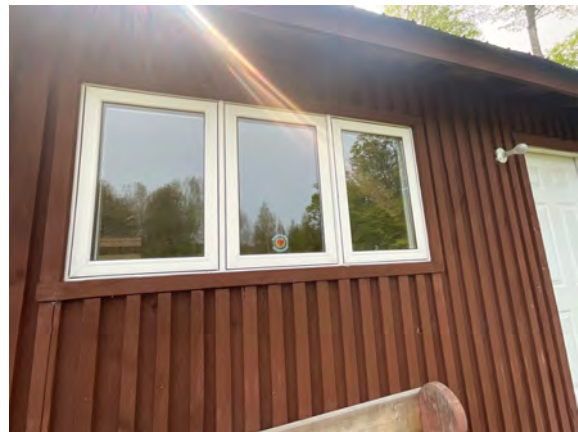
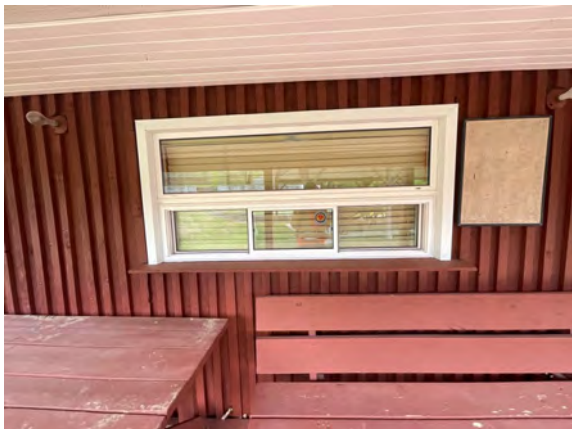
Four Season Park - Canteen - B202001

No significant deficiencies were observed or reported. Lifecycle replacement may be deferred.

<b>Recommendations #1 - Windows</b>	
Type	Life Cycle Replacement
Year	2029
Cost	\$8,165.74

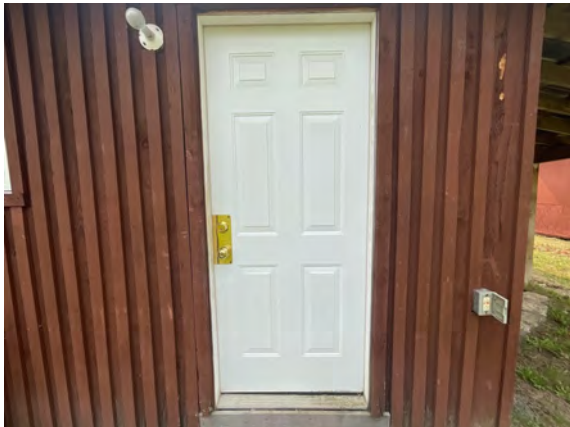
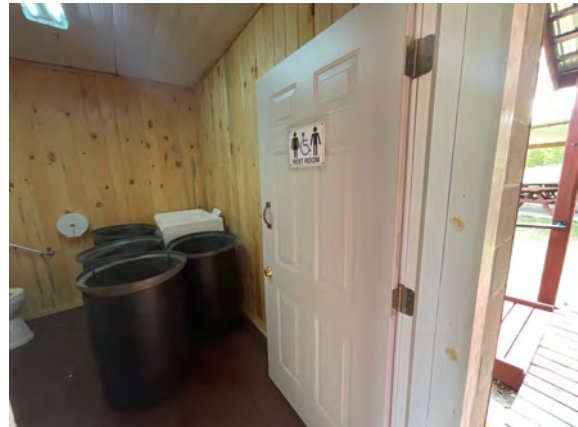
Four Season Park - Canteen - B203023

No significant deficiencies were observed or reported. Replacement is not anticipated in the short term.

<b>Recommendations #1 - Single Door - Wood</b>	
Type	Life Cycle Replacement
Year	2040
Cost	\$18,509.02

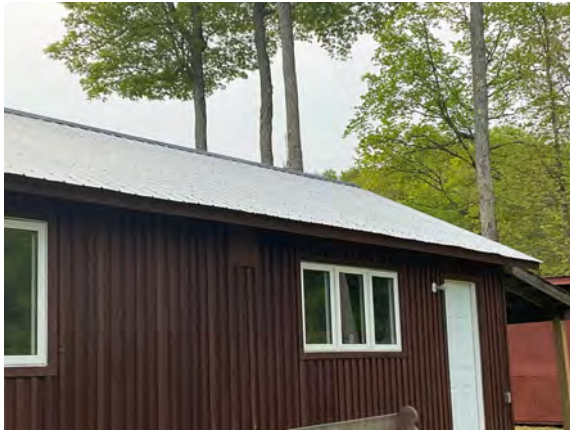
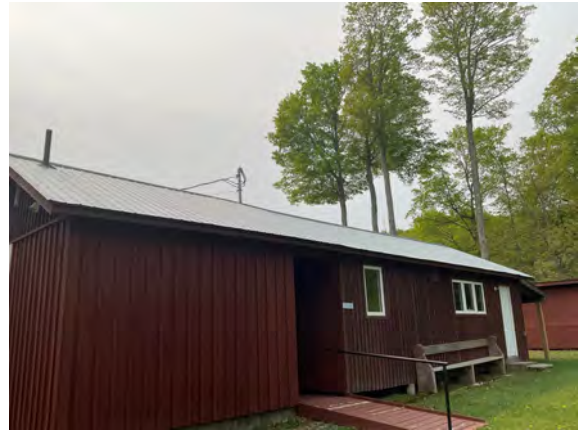
Four Season Park - Canteen - B301028

No significant deficiencies were observed or reported. Lifecycle replacement may be deferred.

Recommendations #1 - Metal Roofing	
Type	Life Cycle Replacement
Year	2029
Cost	\$44,416.19

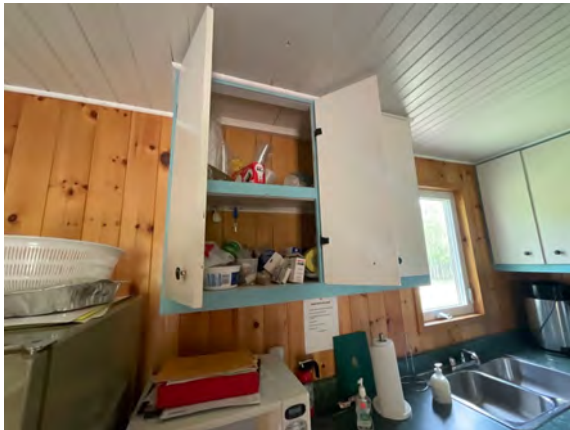
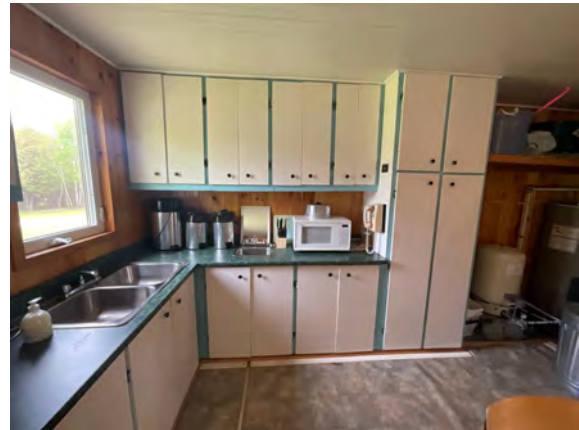
Four Season Park - Canteen - C103011

No significant deficiencies were observed or reported. Lifecycle replacement may be deferred.

Recommendations #1 - Millwork	
Type	Life Cycle Replacement
Year	2029
Cost	\$7,958.88

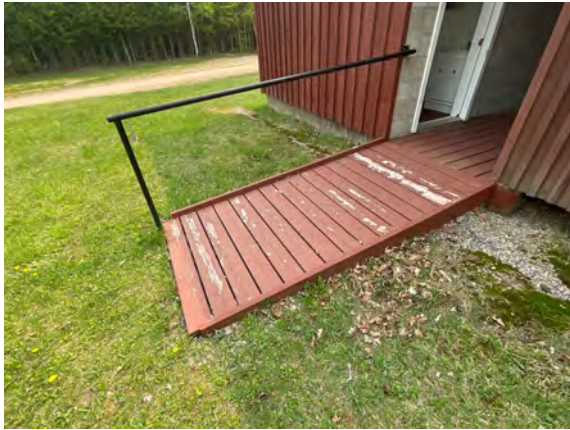
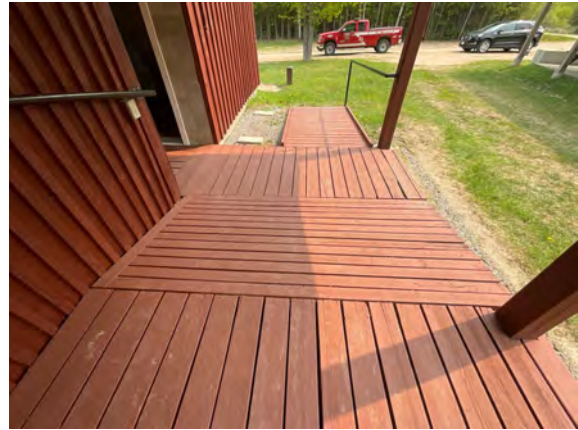
Four Season Park - Canteen - C201004

No significant deficiencies were observed or reported. Replacement is not anticipated in the short term.

Recommendations #1 - Exterior Ramp Construction	
Type	Life Cycle Replacement
Year	2029
Cost	\$4,981.10

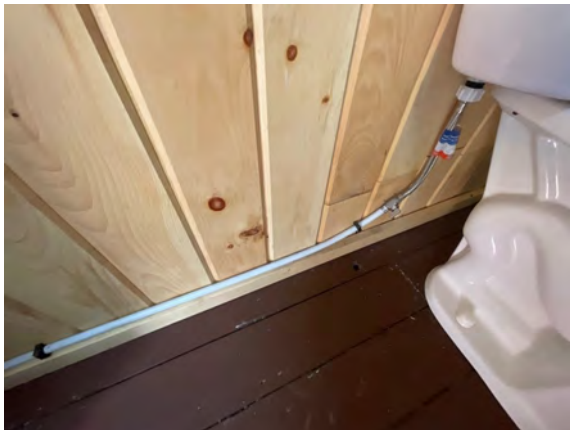
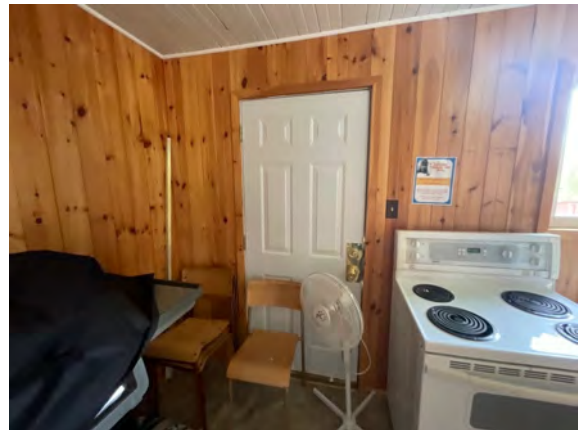
Four Season Park - Canteen - C301022

No significant deficiencies were observed or reported. Replacement is not anticipated in the short term.

Recommendations #1 - Wood Wall Finish	
Type	Life Cycle Replacement
Year	2029
Cost	\$15,732.66

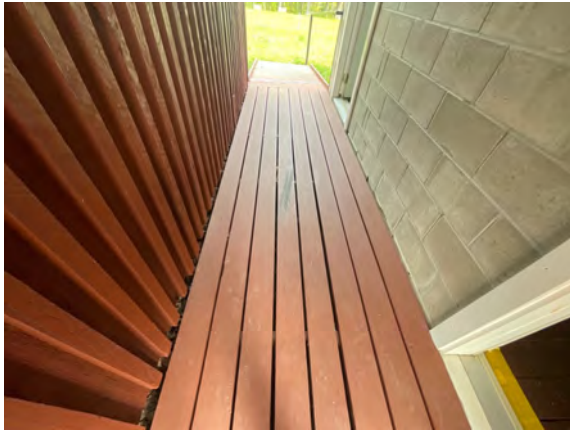
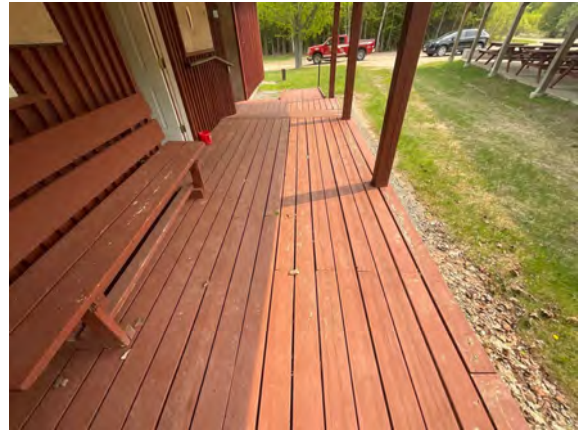
Four Season Park - Canteen - C302003

No significant deficiencies were observed or reported. Lifecycle replacement may be deferred.

<b>Recommendations #1 - Hardwood Floor</b>	
Type	Life Cycle Replacement
Year	2029
Cost	\$8,546.81

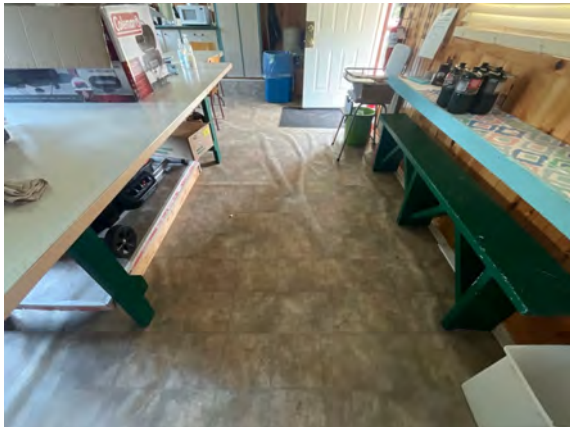
Four Season Park - Canteen - C302022

No significant deficiencies were observed or reported. Lifecycle replacement may be deferred.

<b>Recommendations #1 - Vinyl Tile / Plank Floor</b>	
Type	Life Cycle Replacement
Year	2029
Cost	\$8,623.02

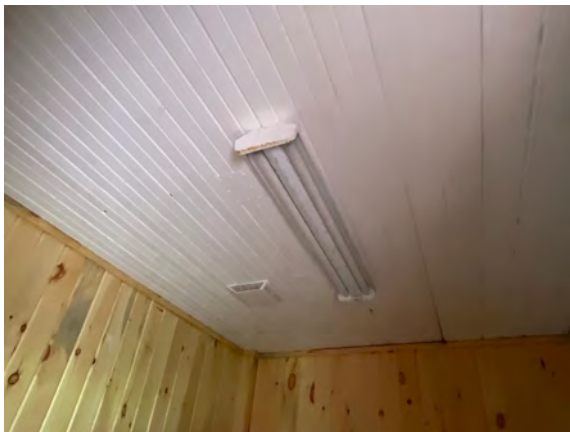
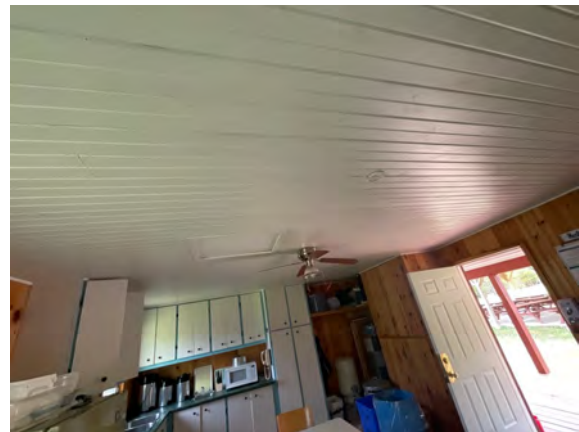
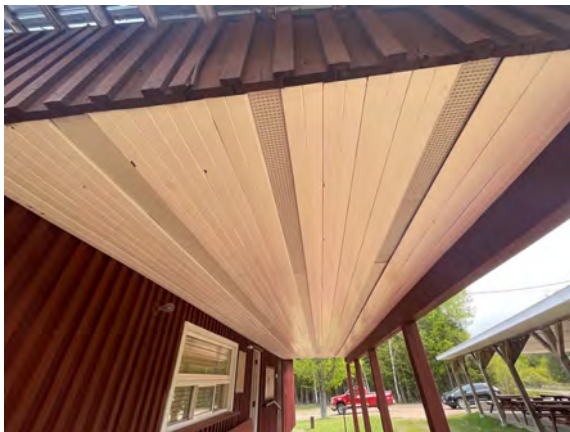
Four Season Park - Canteen - C303099

No significant deficiencies were observed or reported. Replacement is not anticipated in the short term.

<b>Recommendations #1 - Wood Ceiling</b>	
Type	Life Cycle Replacement
Year	2029
Cost	\$13,095.13

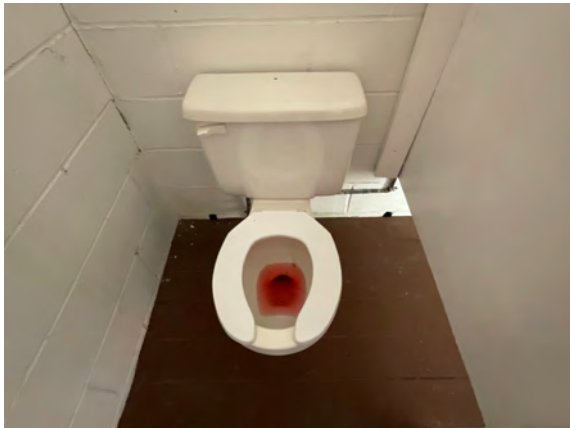
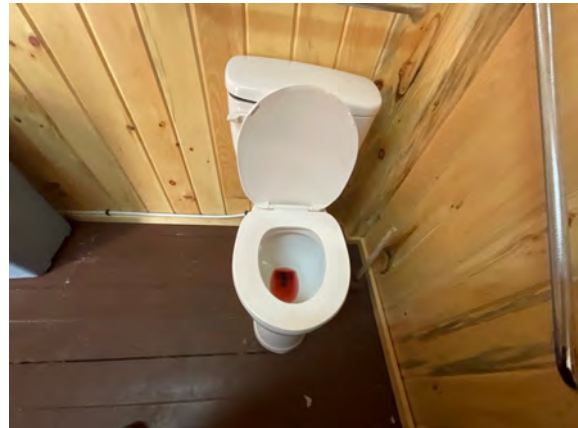
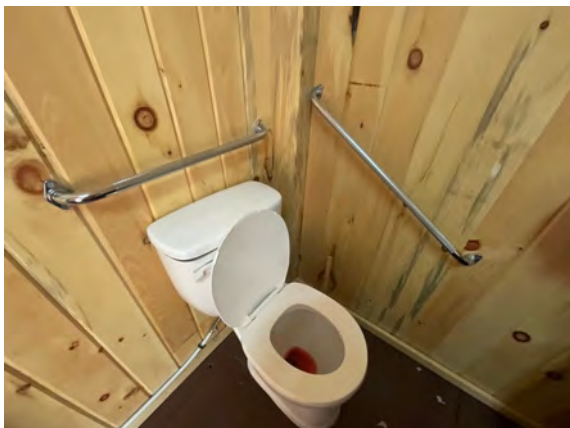
Four Season Park - Canteen - D201003

No significant deficiencies were observed or reported. Lifecycle replacement may be deferred.

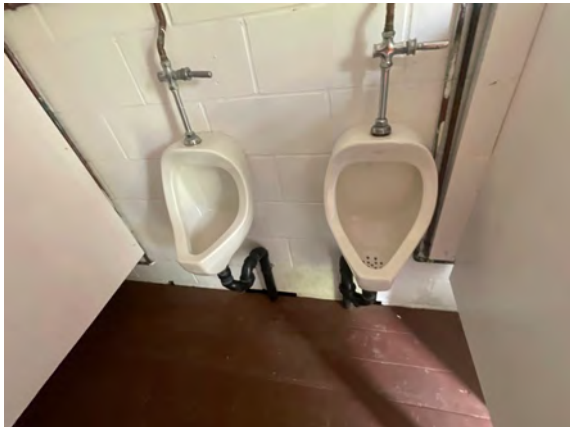
Four Season Park - Canteen - D201002

No significant deficiencies were observed or reported. Lifecycle replacement may be deferred.

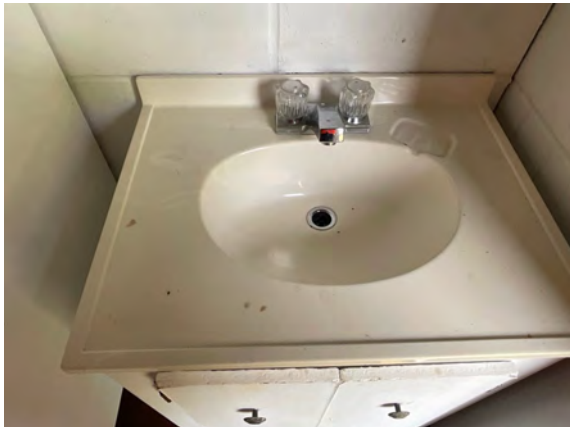
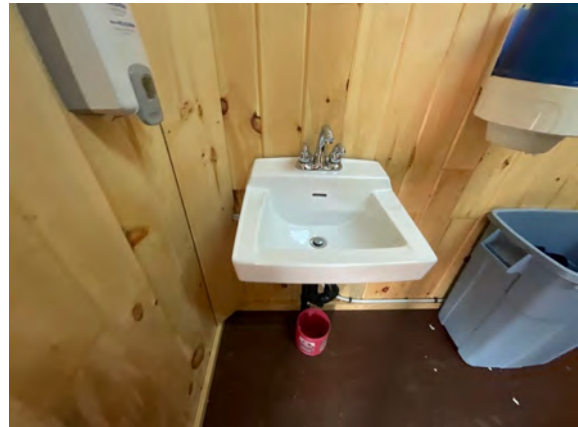
Four Season Park - Canteen - D201001

No significant deficiencies were observed or reported. Lifecycle replacement may be deferred.

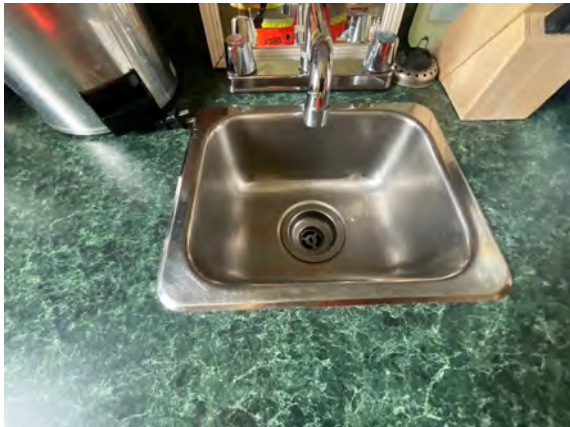
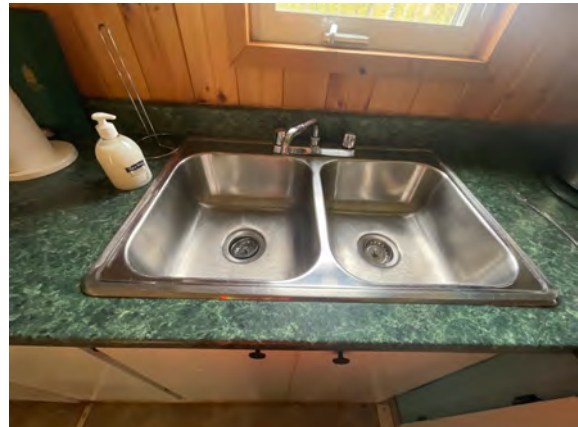
Four Season Park - Canteen - D201004

No significant deficiencies were observed or reported. Lifecycle replacement may be deferred.

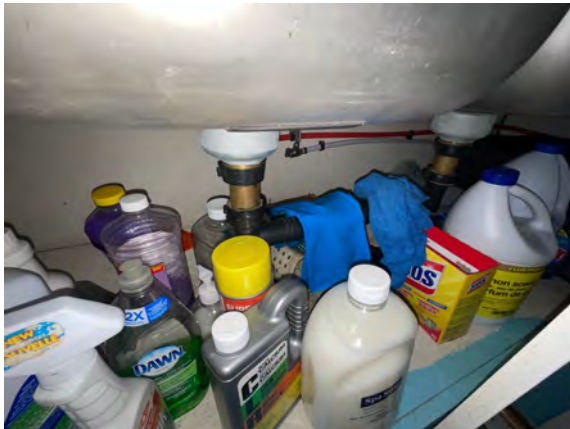
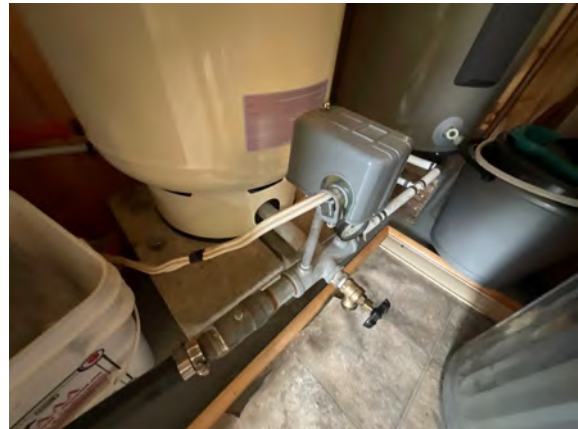
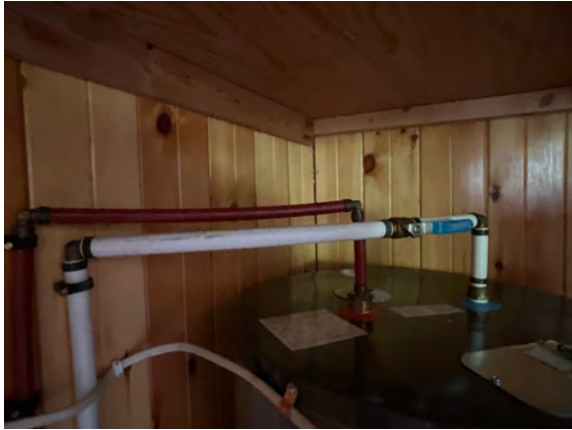
Four Season Park - Canteen - D202001

No significant deficiencies were observed or reported. The system appears to have been updated. Replacement is not anticipated in the short term.

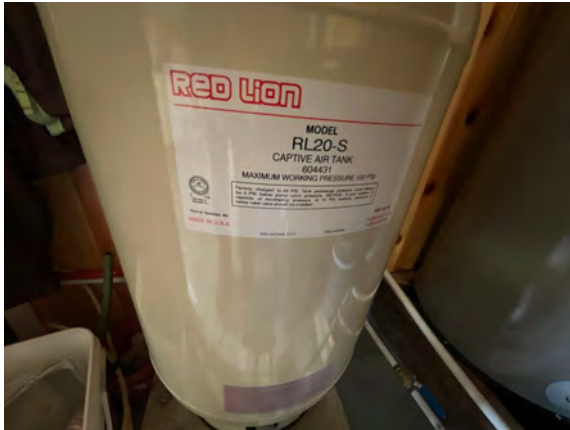
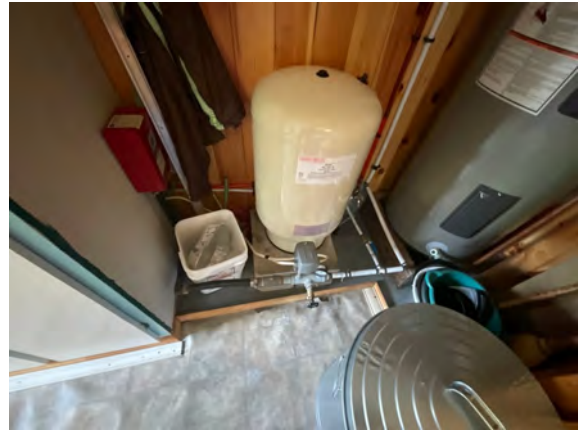
Four Season Park - Canteen - D202008

No significant deficiencies were observed or reported. Replacement is not anticipated in the short term.

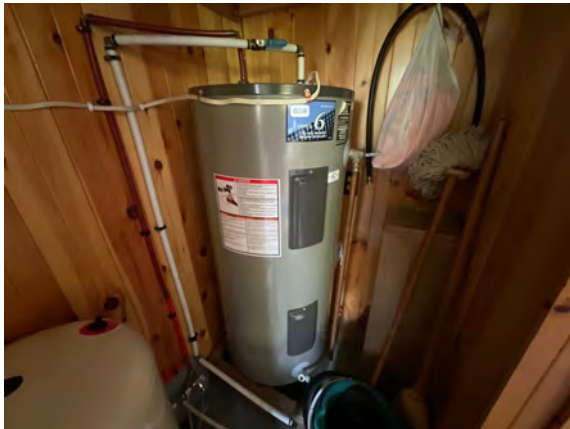
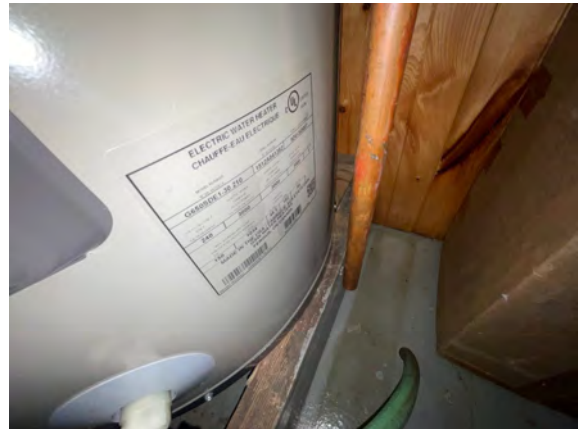
Four Season Park - Canteen - D202034

No significant deficiencies were observed or reported. Replacement is not anticipated in the short term.

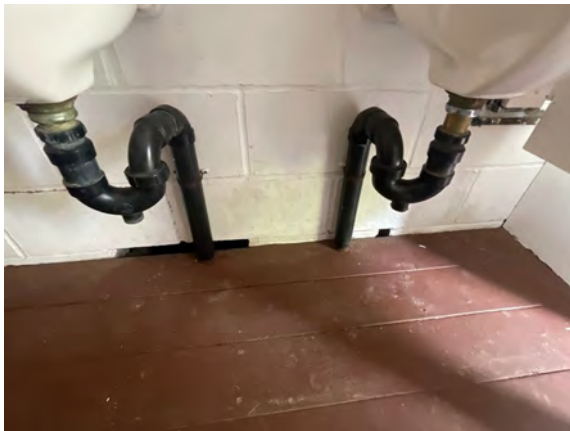
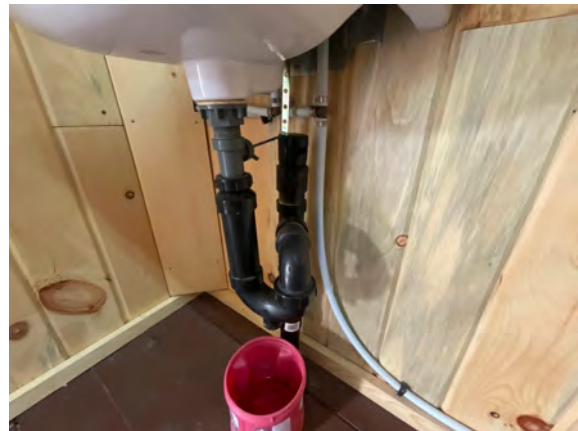
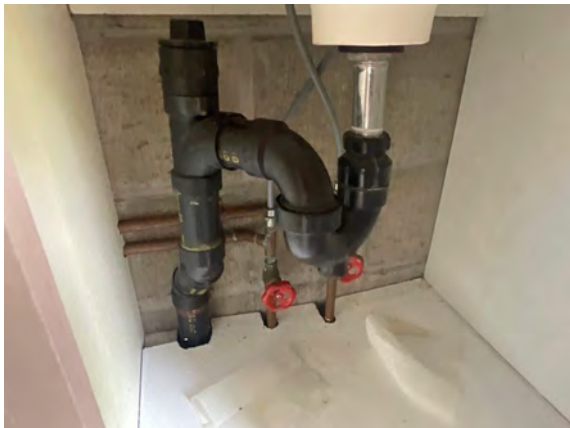
Four Season Park - Canteen - D203001

No significant deficiencies were observed or reported. Replacement is not anticipated in the short term.

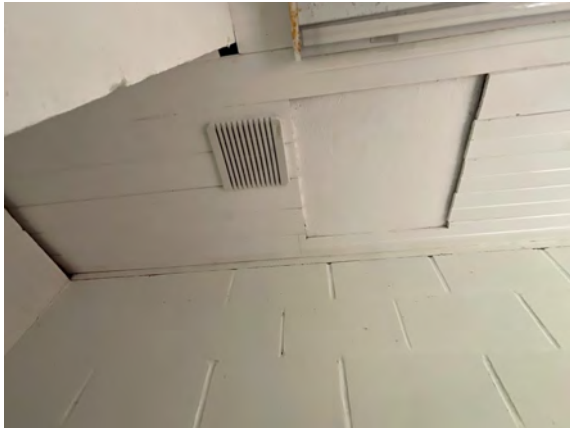
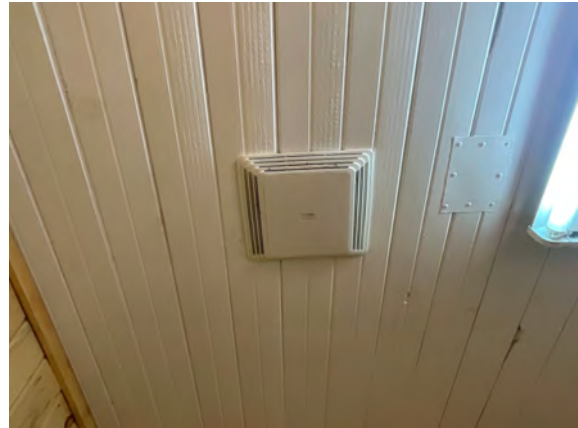
Four Season Park - Canteen - D304031

No significant deficiencies were observed or reported. Replacement is not anticipated in the short term.

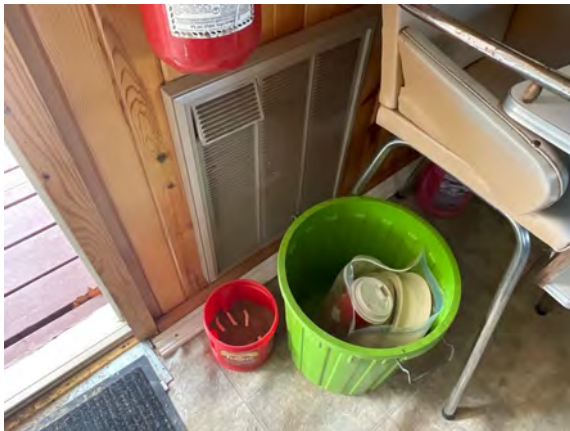
Four Season Park - Canteen - D305008

No significant deficiencies were observed or reported. However the system, based on age, is approaching or is past its expected useful life with performance and reliability likely diminishing over time. Replacement is recommended in the short term.

Recommendations #1 - Force Flow Units (Electric)	
Type	Life Cycle Replacement
Year	2026
Cost	\$781.19

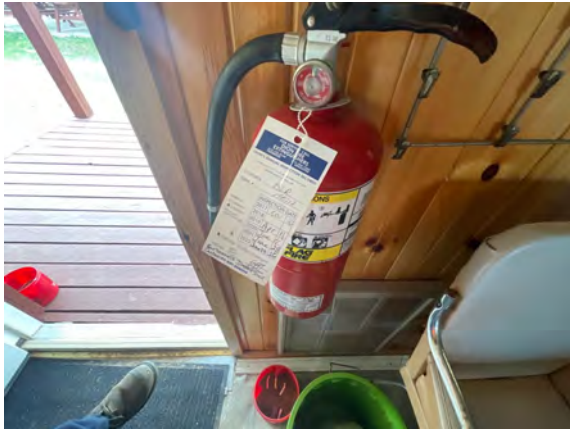
Four Season Park - Canteen - D403001

No significant deficiencies were observed or reported. Replacement is not anticipated in the short term.

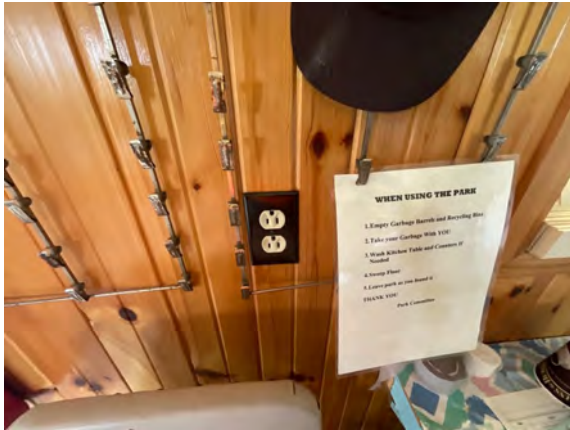
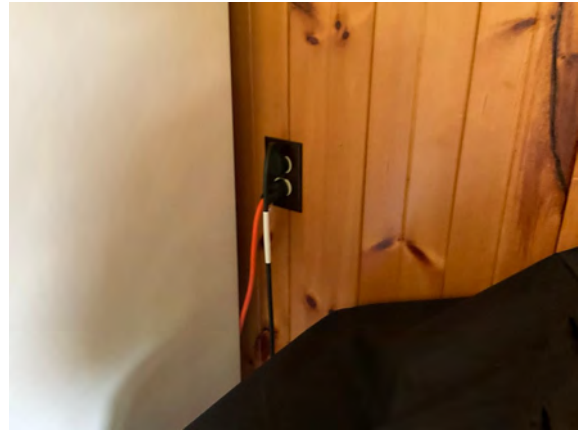
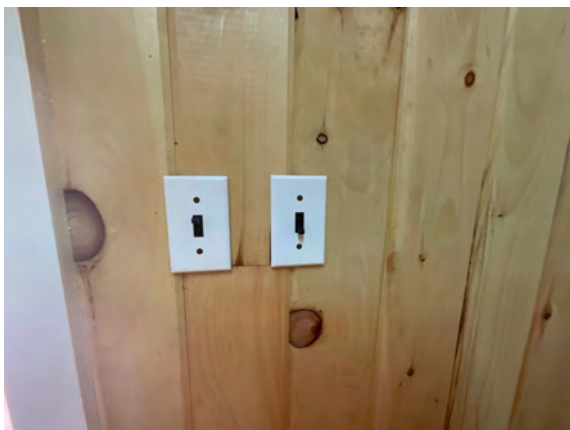
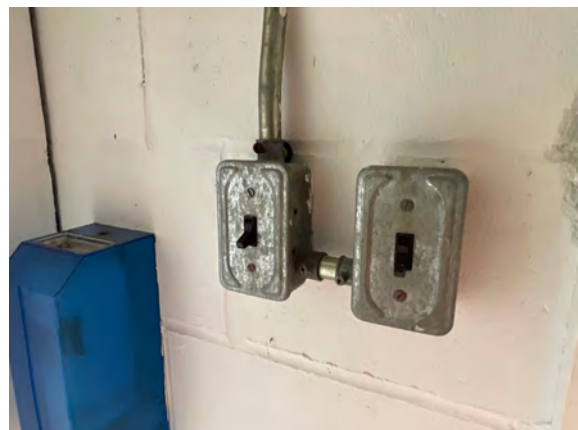
Four Season Park - Canteen - D502001

No significant deficiencies were observed or reported. Replacement is not anticipated in the short term.

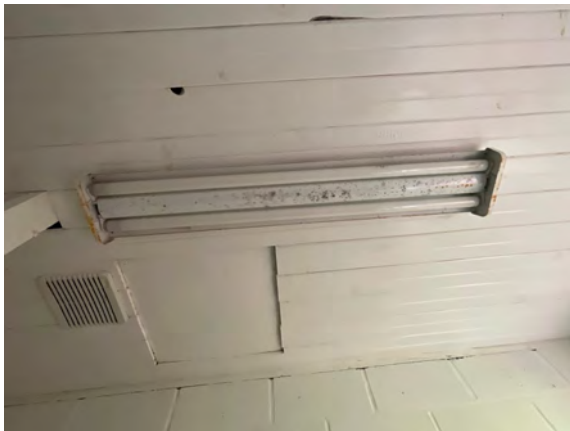
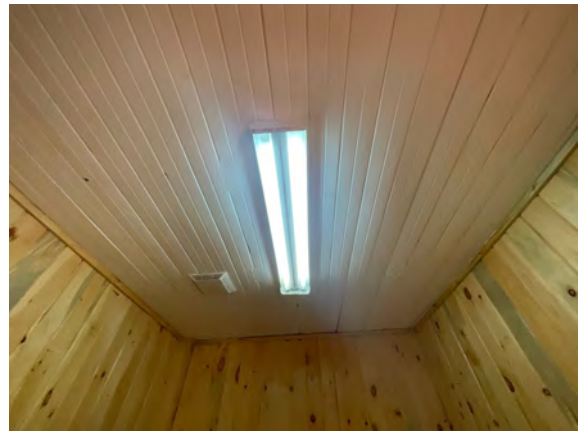
Four Season Park - Canteen - D502002

No significant deficiencies were observed or reported. Some of the lighting was updated over time. However, the lighting is energy inefficient. Replacement or upgrade to LED is recommended in the short term /should be considered.

Recommendations #1 - Interior Lighting	
Type	Life Cycle Replacement
Year	2026
Cost	\$10,365.05

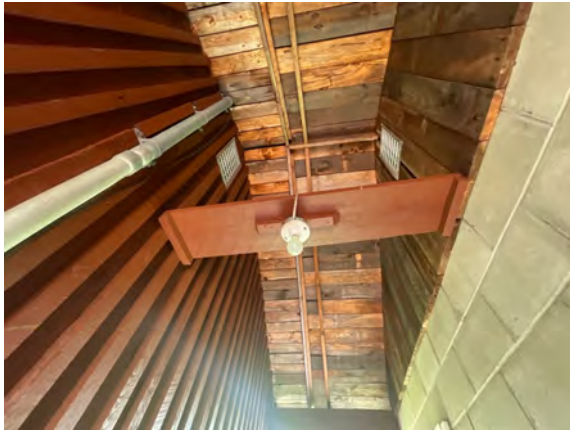
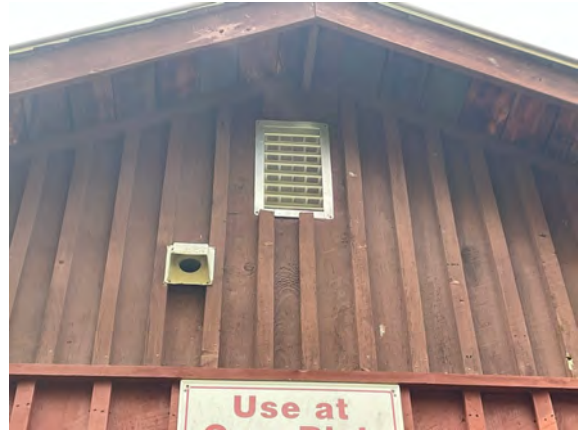
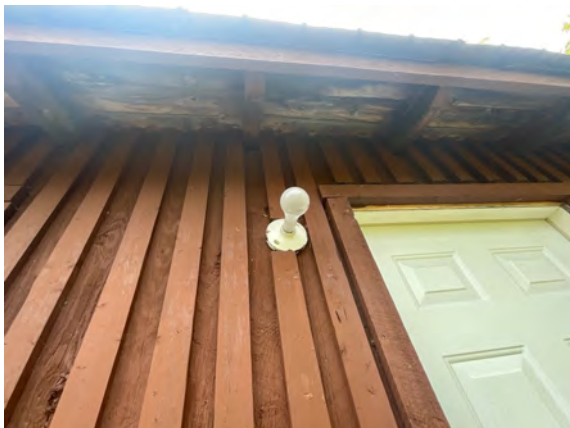
Four Season Park - Canteen - D502041

No significant deficiencies were observed or reported. However, the lighting is energy inefficient. Replacement or upgrade to LED is recommended in the short term /should be considered.

<b>Recommendations #1 - Exterior Lighting</b>	
Type	Life Cycle Replacement
Year	2026
Cost	\$2,343.57

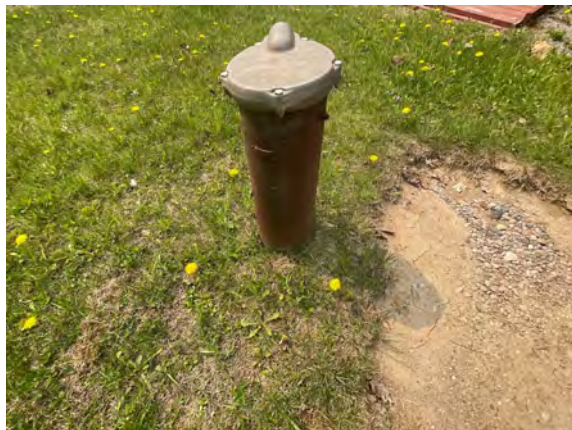
Four Season Park - Canteen - G301001

No significant deficiencies were observed or reported. Replacement is not anticipated in the short term.

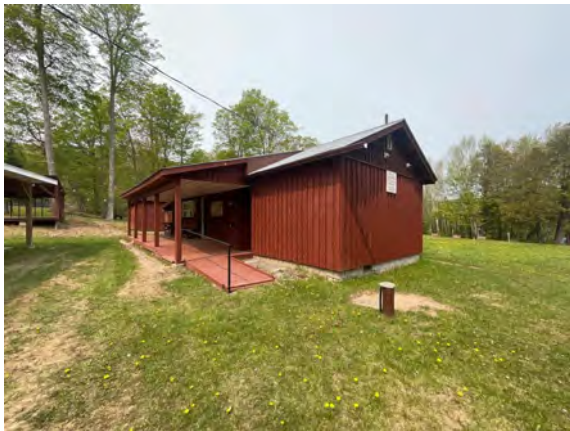
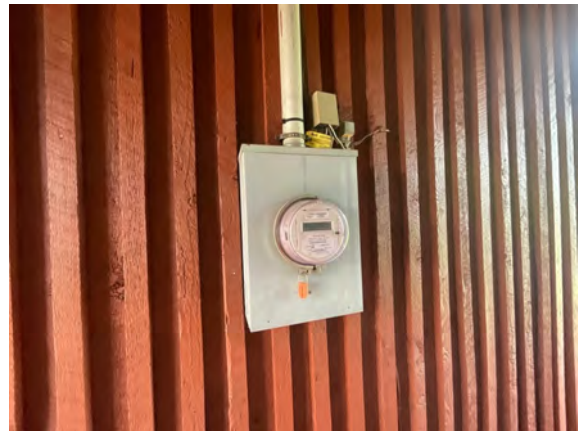
Four Season Park - Canteen - G401010

No significant deficiencies were observed or reported. Replacement is not anticipated in the short term.

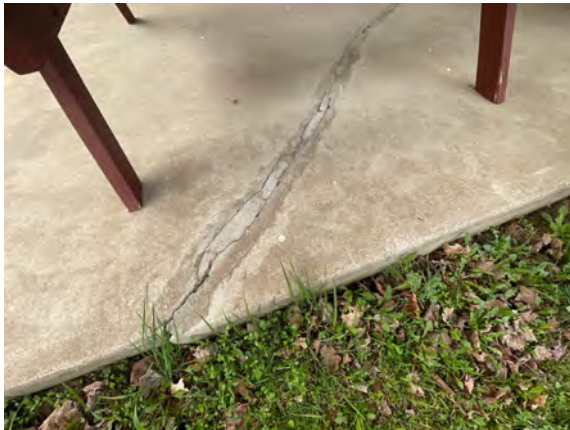
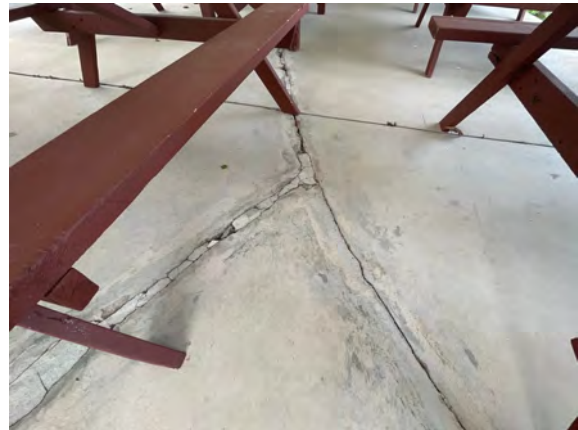
Four Season Park - Pavillion - A103001

Some minor isolated cracking was observed, no significant elevation difference to suggest differential settlement of the concrete slab-on-grade was noted. However, the cracks are recommended to be monitored and should a significant magnitude change be noted, a professional/experienced structural engineer be retained.

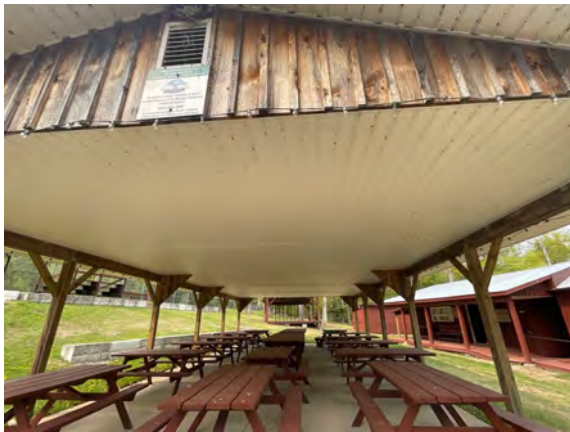
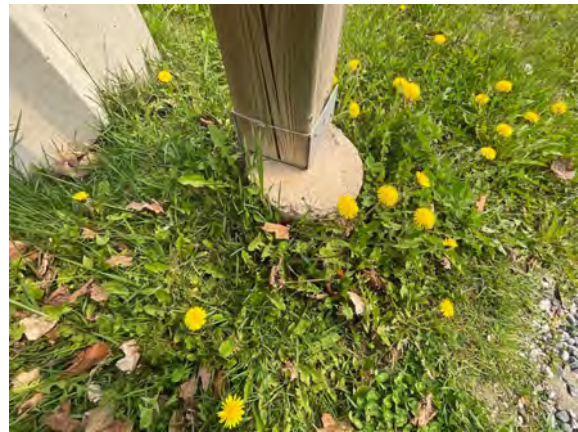
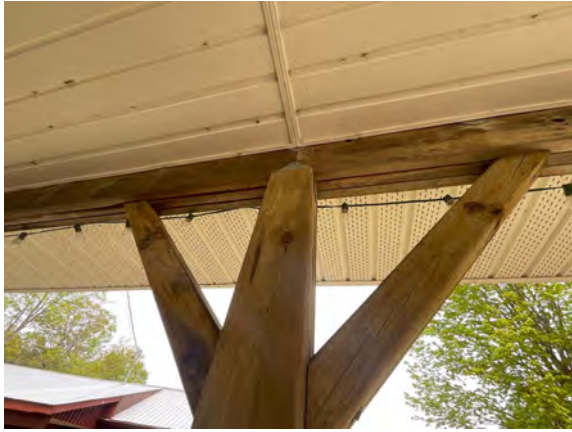
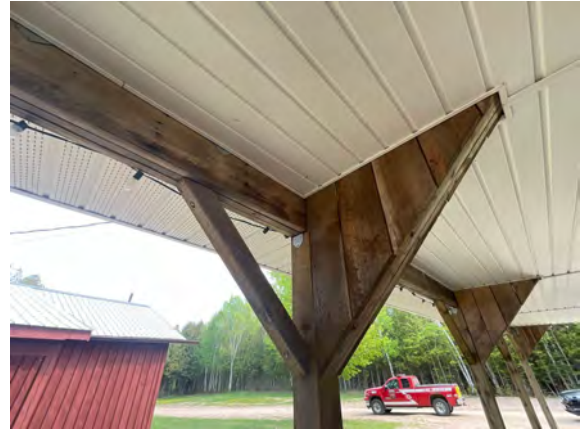
Four Season Park - Pavillion - B102001

No significant deficiencies were observed or reported. Replacement is not anticipated in the short term.

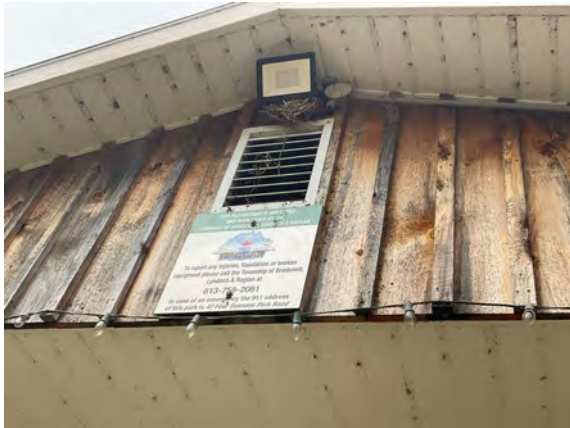
Four Season Park - Pavillion - B201005

No significant deficiencies were observed or reported. Replacement is not anticipated in the short term.

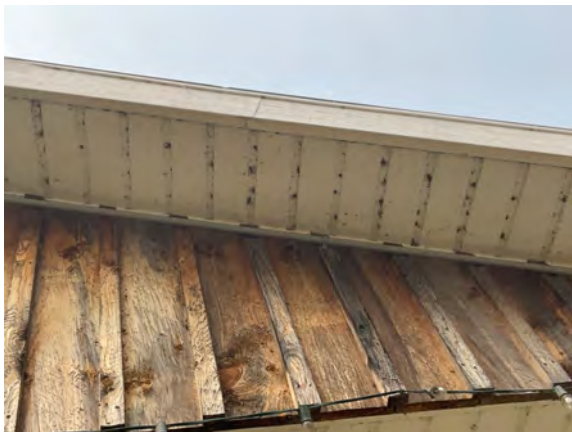
Four Season Park - Pavillion - B201008

No significant deficiencies were observed or reported. Replacement is not anticipated in the short term.

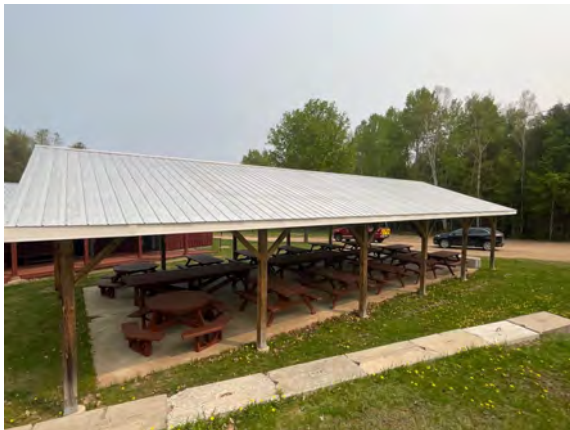
Four Season Park - Pavillion - B301028

No significant deficiencies were observed or reported. Replacement is not anticipated in the short term.

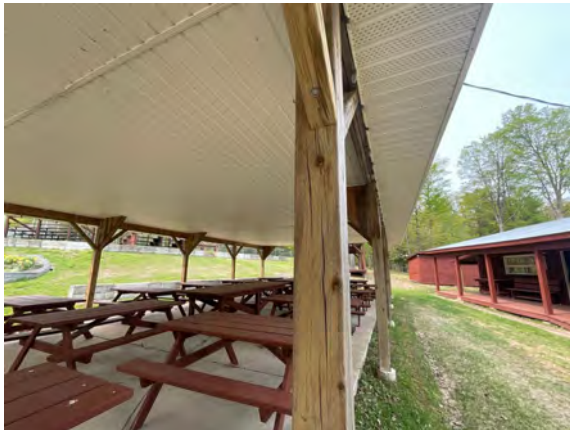
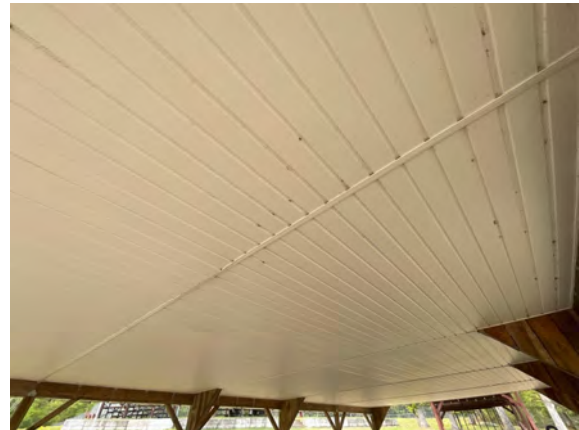
Four Season Park - Pavillion - C303099

No significant deficiencies were observed or reported. Replacement is not anticipated in the short term.

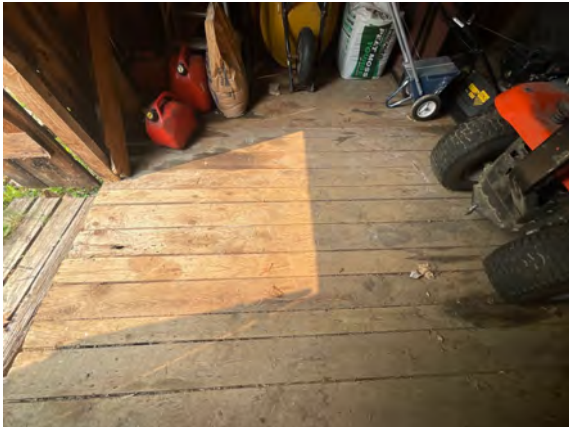
Four Season Park - Storage Building - A103001

No significant deficiencies were observed or reported. Replacement is not anticipated in the short term.

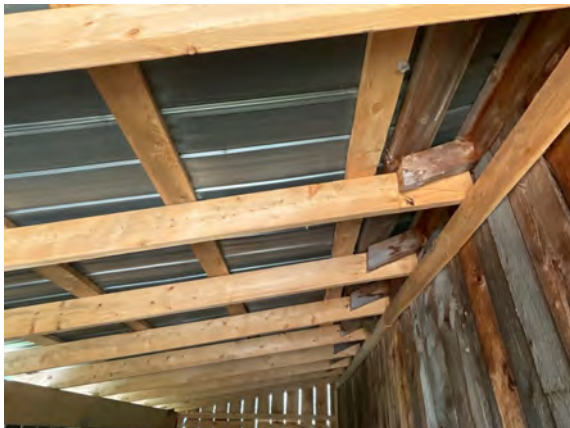
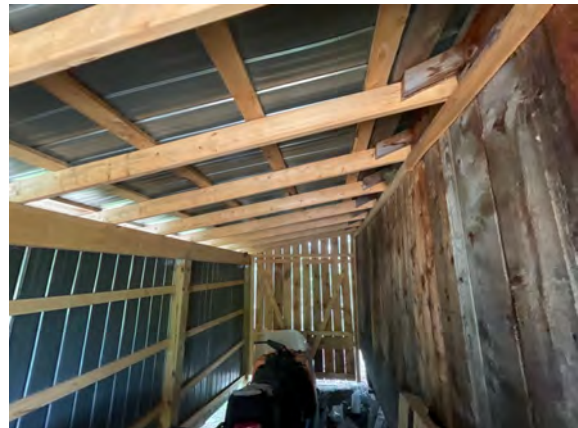
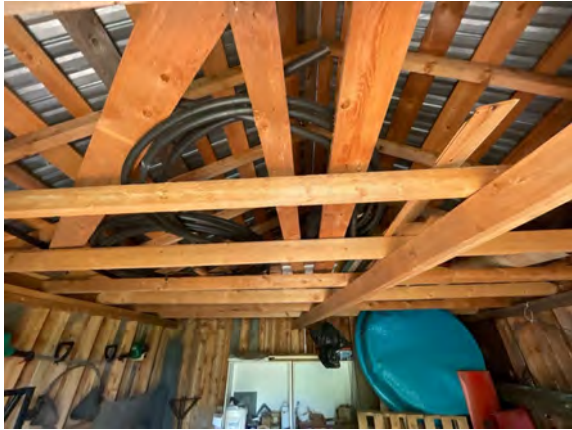
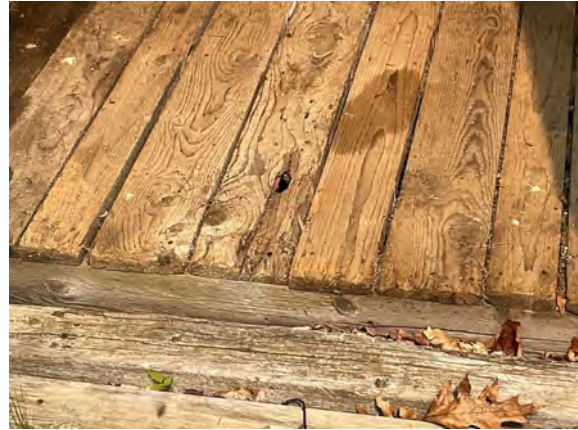
Four Season Park - Storage Building - B103001

No significant deficiencies were observed or reported. However cracks in some concrete footings and deterioration of some wood board footings were observed. Some deterioration of the wood floor was also observed. Repair is recommended. Replacement is not anticipated in the short term.

<b>Recommendations #1 - Structure</b>	
Type	Major Repair
Year	2023
Cost	\$5,800.00

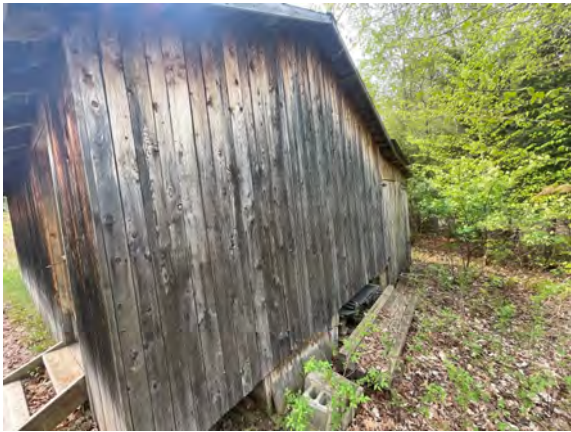
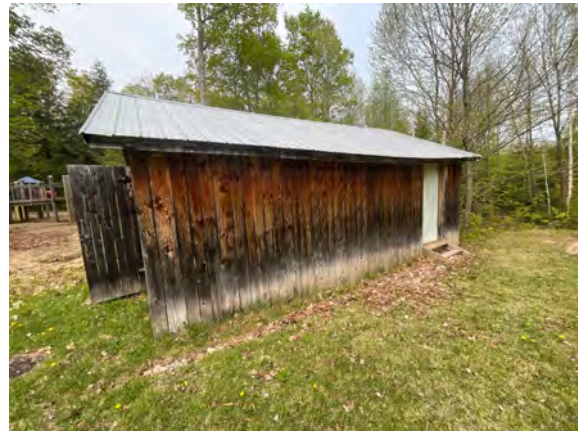
Four Season Park - Storage Building - B201099

Deficiencies observed or reported during the assessment include weathered look and wear, and some wood rot (along the bottoms). The deterioration is anticipated to progress due to age and exposure to the elements. Given the current function of the building as a storage facility, repair is recommended as needed, with the costing including in the repair of the structure. Replacement is not anticipated in the short term.

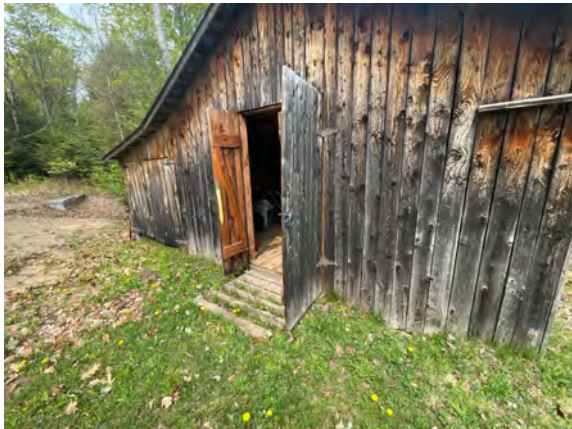
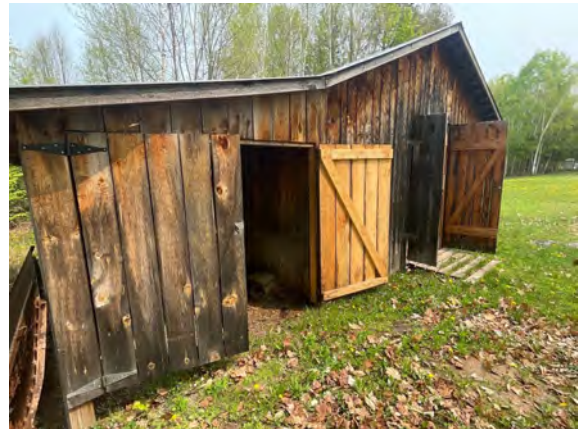
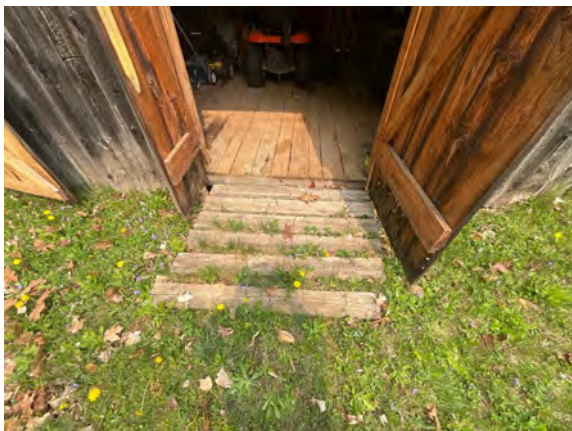
Four Season Park - Storage Building - B203027

No significant deficiencies were observed or reported. Replacement is not anticipated in the short term. It should be noted that the doors will not safeguard against theft of equipment inside.
