# Brudenell Lyndoch and Raglan

Submission to Township of Brudenell, Lyndoch, and Raglan

Roth IAMS Ltd.  
207-1075 North Service Rd W, Oakville ON, L6M 2G2  
[www.rothiams.com](http://www.rothiams.com)  
Project No. 23502

**Facility Condition Assessment Report**  
**Brudenell Fire Hall #4**

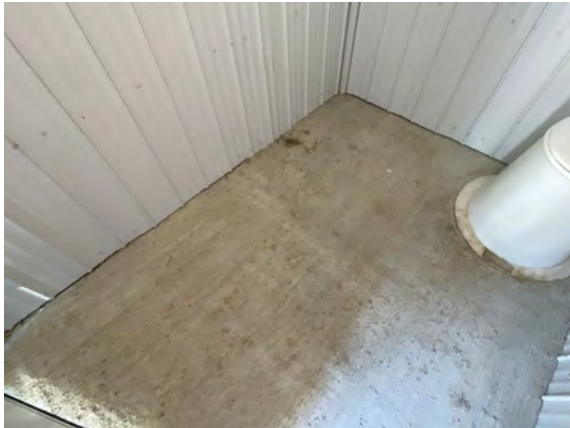
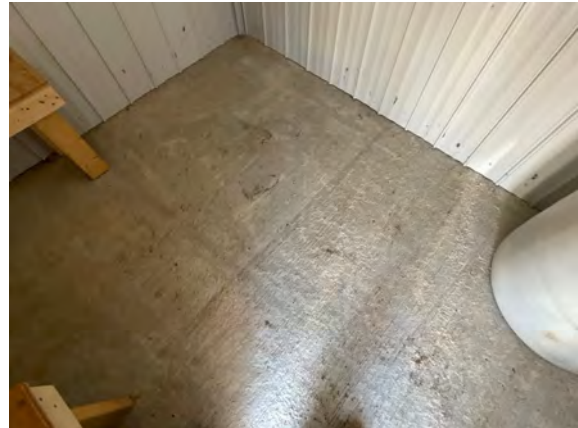
Gorman Lake Beach - A103001

No major deficiencies were observed or reported. No cracking in concrete was observed.

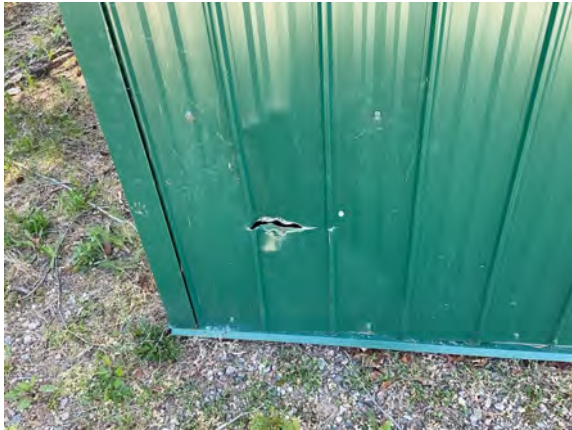
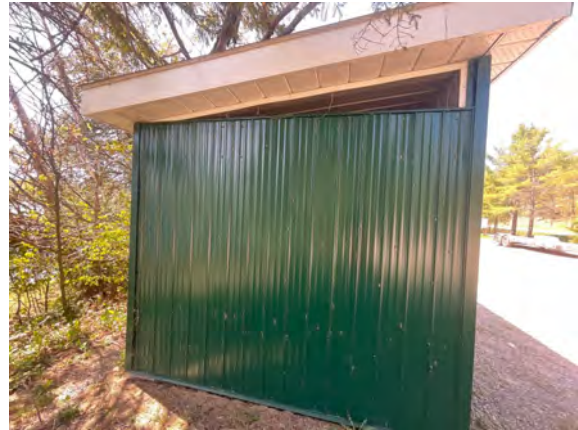
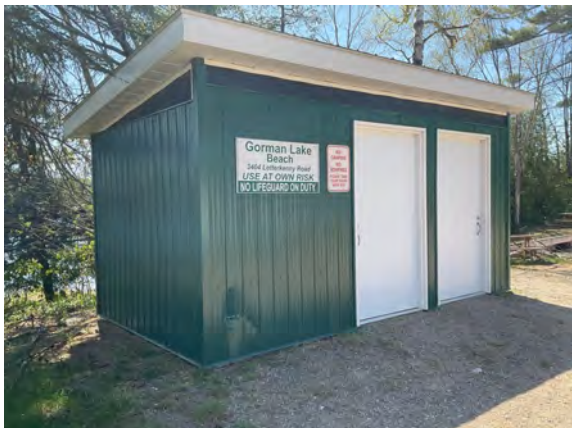
Gorman Lake Beach - B201024

No significant deficiencies were observed or reported. Impact damage on the front exterior wall was observed and should be monitored. Replacement is not anticipated in the short term.

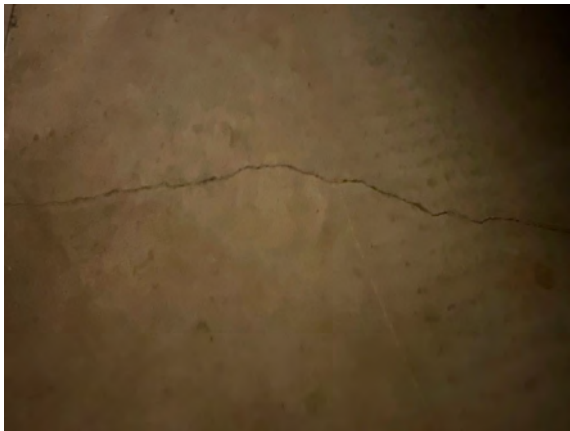
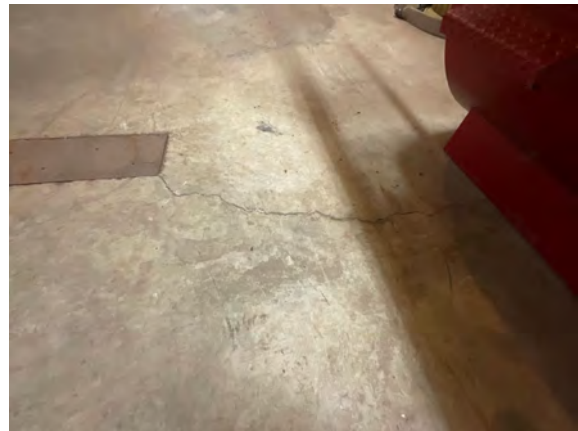
Hardwood Lake Fire Hall #2 - A103001

Some minor isolated cracking was observed, no significant elevation difference to suggest differential settlement of the concrete slab-on-grade was noted. However, the cracks are recommended to be monitored and should a significant magnitude change be noted, a structural engineer should be retained.

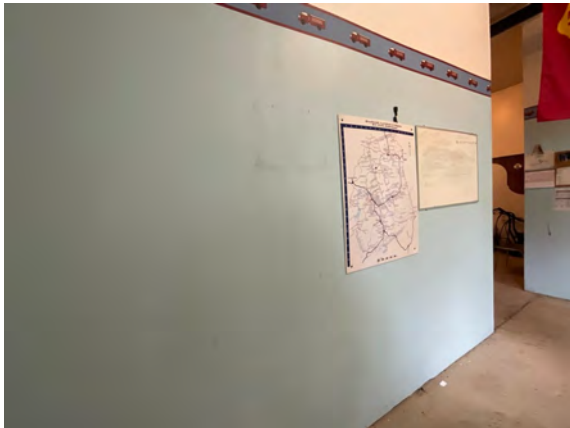
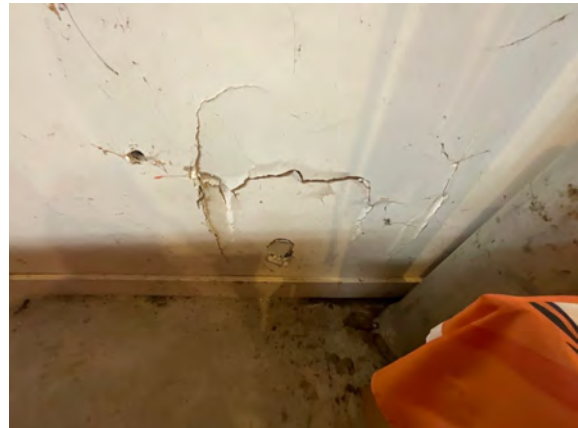
Hardwood Lake Fire Hall #2 - C101001

No significant deficiencies were observed or reported. Some impact damage was observed and should be repaired as part of maintenance. Replacement is not anticipated in the short term.

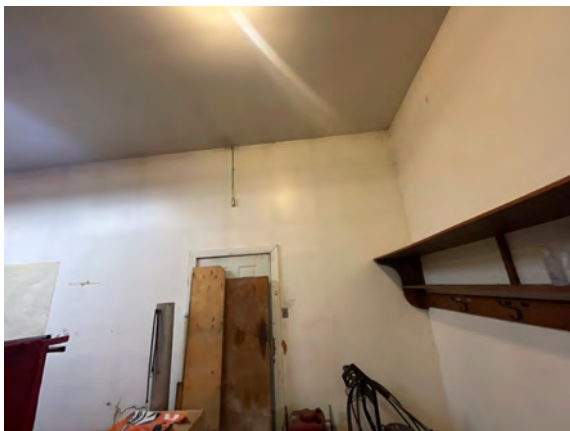
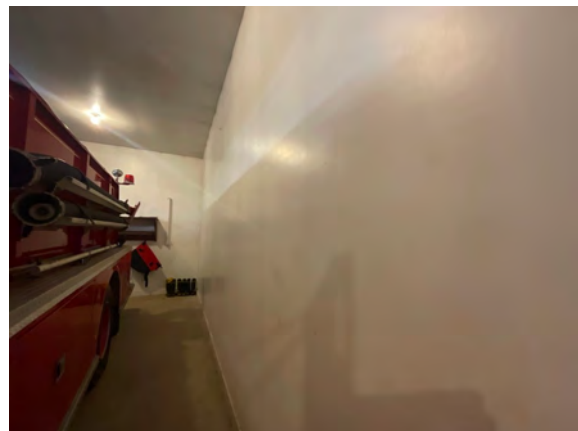
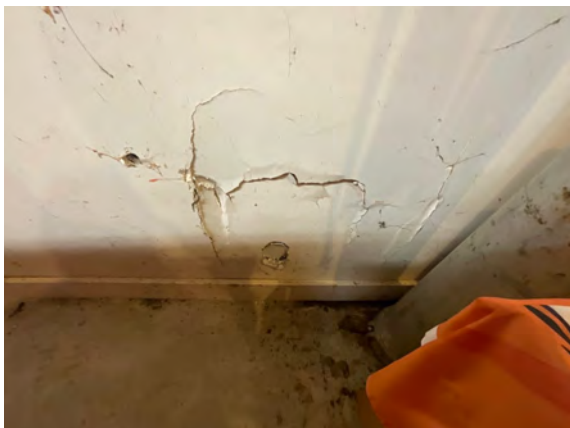
Hardwood Lake Fire Hall #2 - C301005

Deficiencies observed or reported during the assessment include staining, discoloration and fading. The deterioration is anticipated to progress. Replacement is recommended in the short term.

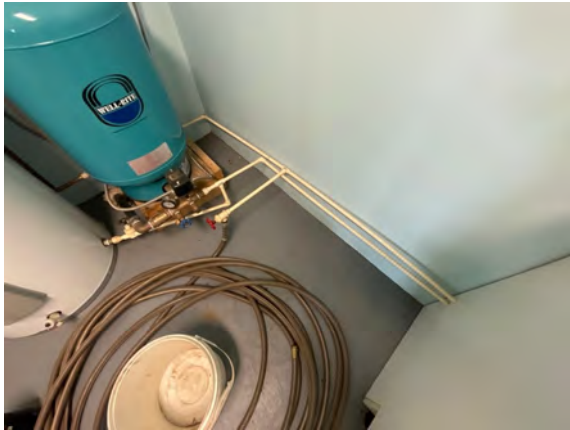
Hardwood Lake Fire Hall #2 - C302007

Deficiencies observed or reported during the assessment include stained and worn sealant. The deterioration is anticipated to progress. Replacement is recommended in the short term.

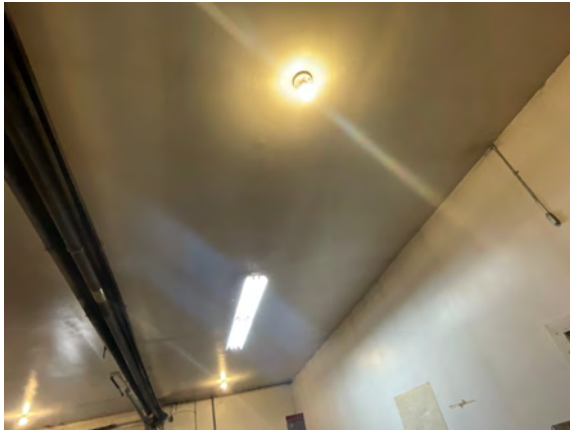
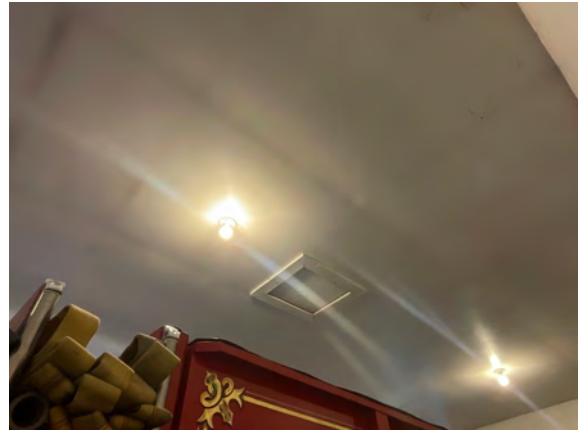
Hardwood Lake Fire Hall #2 - C303006

Deficiencies observed or reported during the assessment include staining, discoloration and fading. The deterioration is anticipated to progress. Replacement is recommended in the short term.

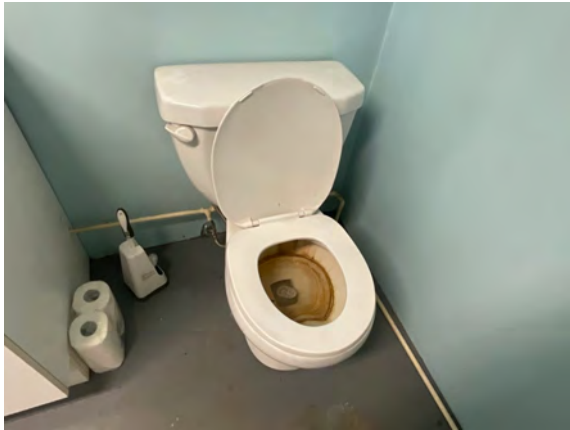
Hardwood Lake Fire Hall #2 - D201001

Deficiencies observed or reported at the time of the assessment include stains. Replacement is recommended in the short term.

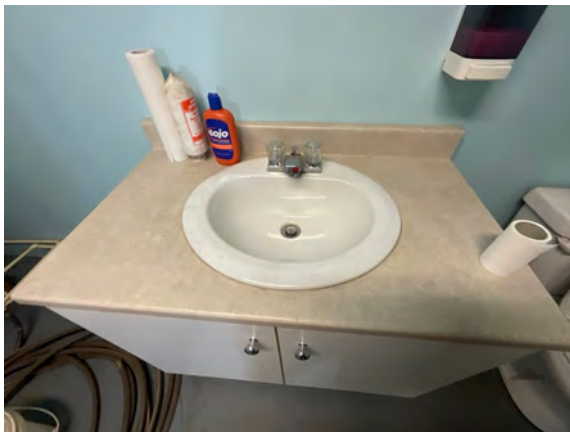
Hardwood Lake Fire Hall #2 - D201003

No significant deficiencies were observed or reported. Replacement is not anticipated in the short term.

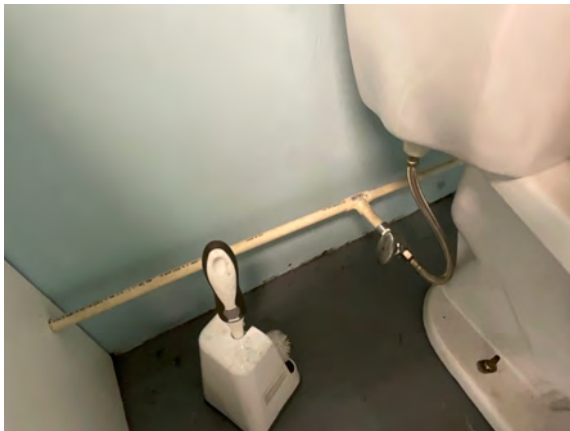
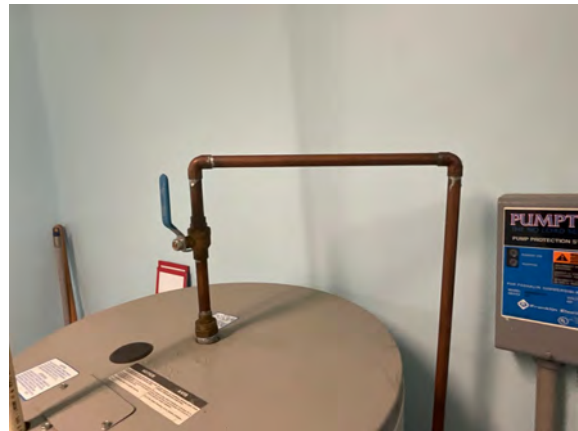
Hardwood Lake Fire Hall #2 - D202001

No significant deficiencies were observed or reported. Replacement is not anticipated in the short term.

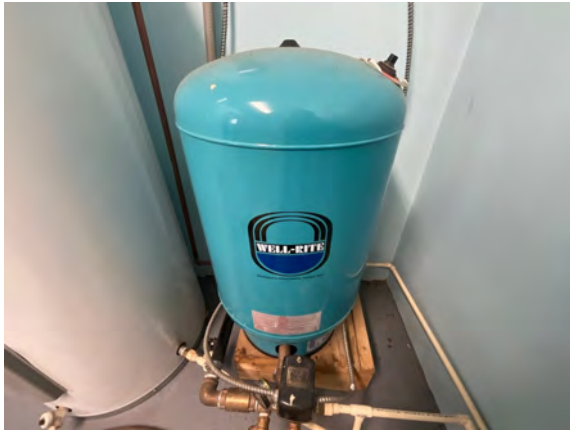
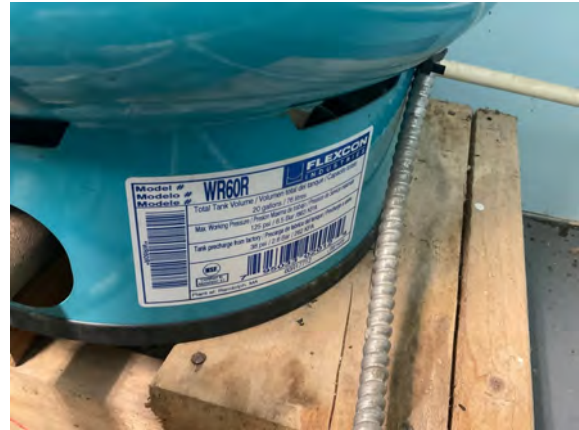
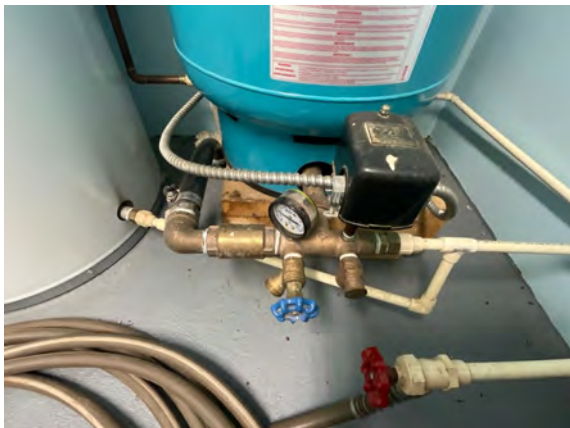
Hardwood Lake Fire Hall #2 - D202021

No significant deficiencies were observed or reported. Lifecycle replacement may be deferred.

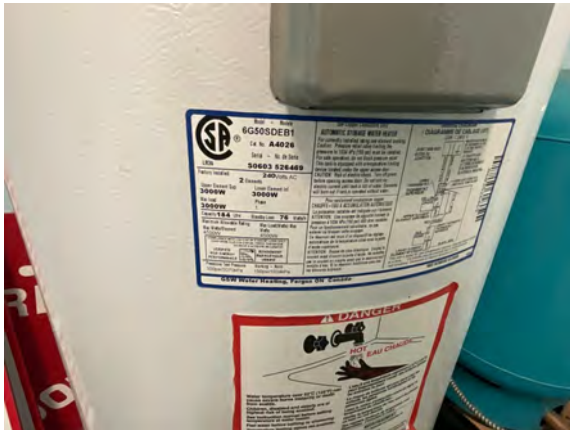
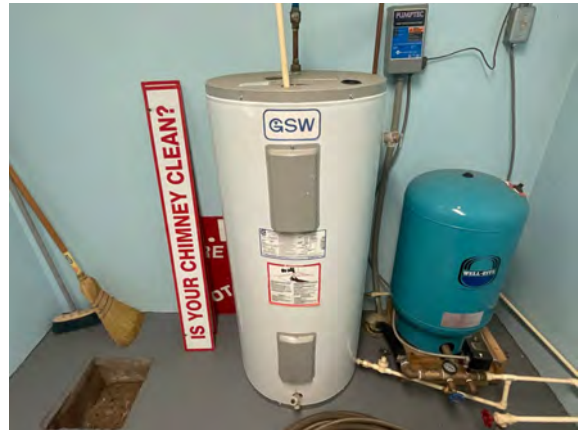
Hardwood Lake Fire Hall #2 - D202034

No significant deficiencies were observed or reported. However the system, based on age, is approaching or is past its expected useful life with performance and reliability likely diminishing over time. Replacement is recommended in the short term.

Recommendations #1 - Domestic Water Heaters - Residential Electric	
Type	Life Cycle Replacement
Year	2024
Cost	\$8,013.24

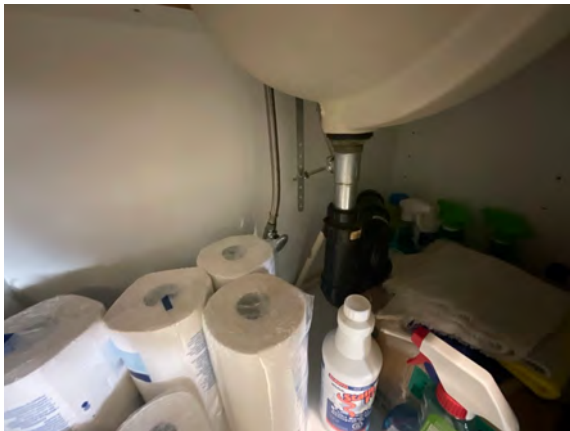
Hardwood Lake Fire Hall #2 - D203001

No significant deficiencies were observed or reported. Replacement is not anticipated in the short term.

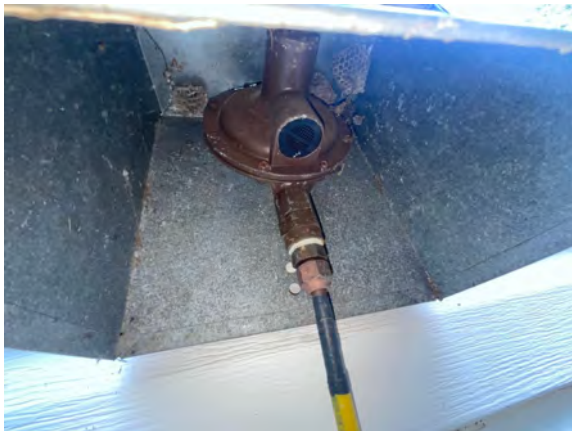
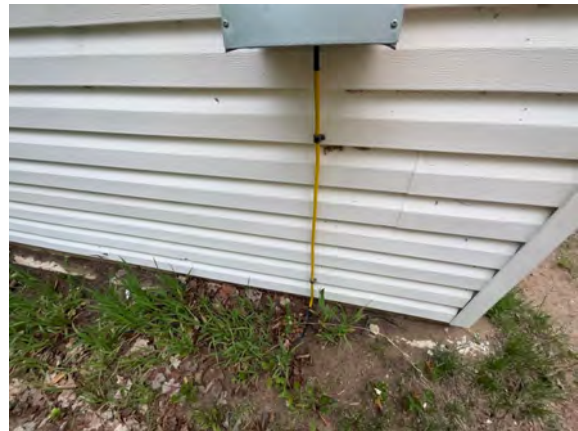
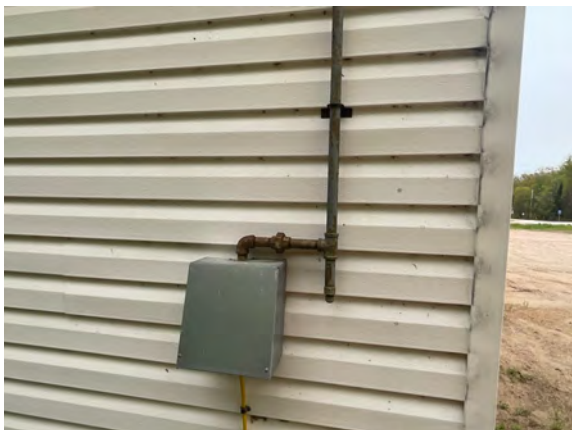
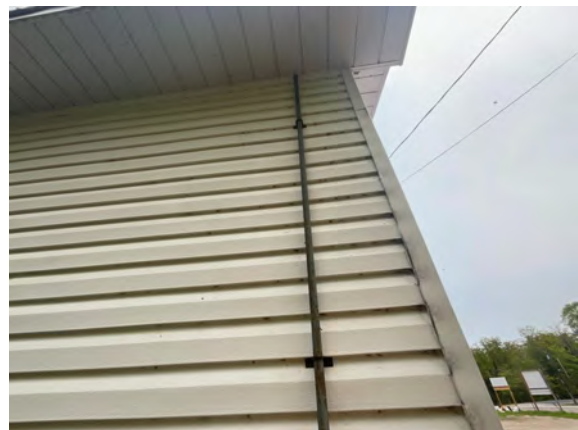
Hardwood Lake Fire Hall #2 - D301002

No significant deficiencies were observed or reported. Replacement is not anticipated in the short term.

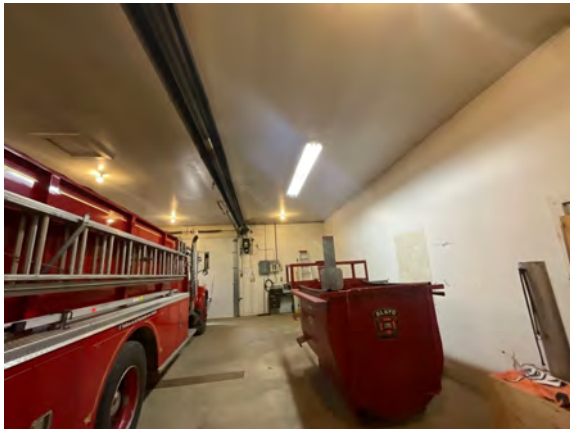
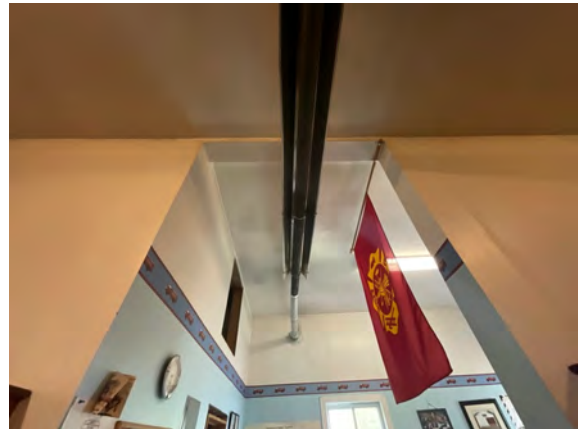
Hardwood Lake Fire Hall #2 - D302032

No significant deficiencies were observed or reported. However, the system, based on age, is approaching or is past its expected useful life with performance and reliability likely diminishing over time. Replacement is recommended in the short term.

<b>Recommendations #1 - Fuel-Fired Radiant Tube Heaters</b>	
Type	Life Cycle Replacement
Year	2026
Cost	\$8,941.40

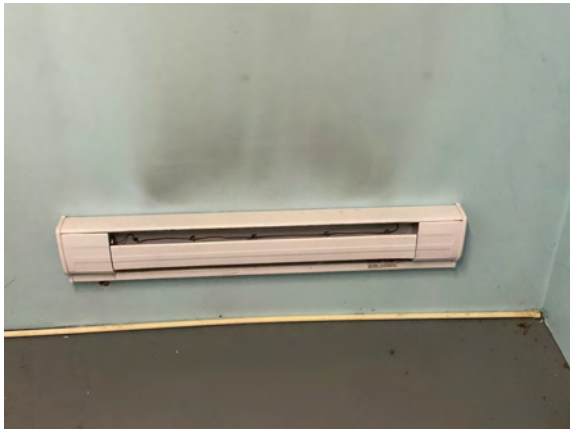
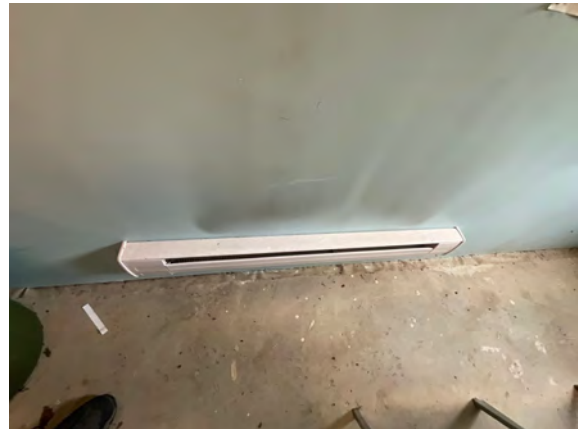
Hardwood Lake Fire Hall #2 - D305010

No significant deficiencies were observed or reported. However, the system, based on age, is approaching or is past its expected useful life with performance and reliability likely diminishing over time. Replacement is recommended in the short term.

Recommendations #1 - Electric Baseboard Heaters	
Type	Life Cycle Replacement
Year	2026
Cost	\$979.88

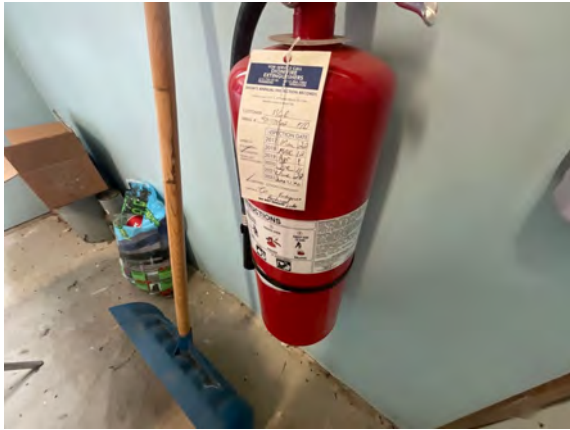
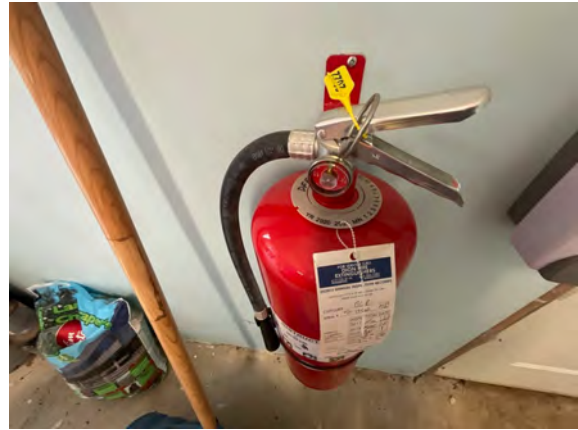
Hardwood Lake Fire Hall #2 - D403002

No significant deficiencies were observed or reported. Replacement is not anticipated in the short term.

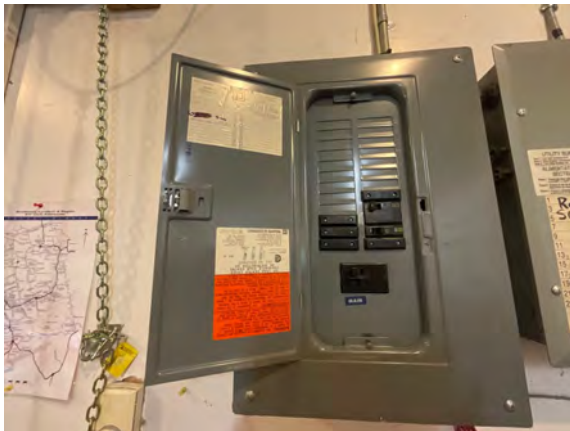
Hardwood Lake Fire Hall #2 - D501003

No significant deficiencies were observed or reported. Replacement is not anticipated in the short term.

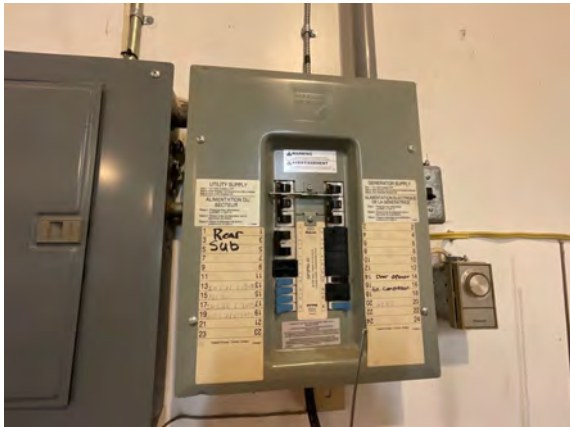
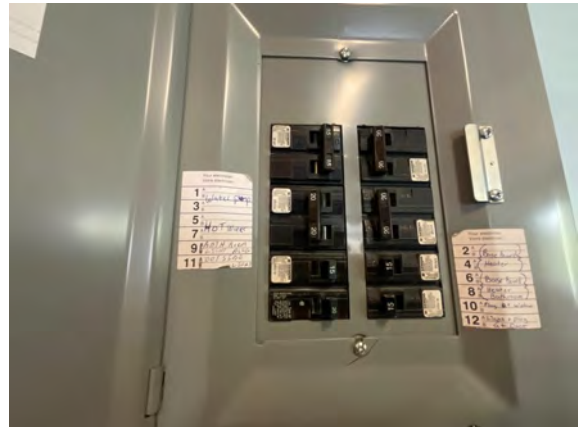
Hardwood Lake Fire Hall #2 - D501025

No significant deficiencies were observed or reported. Replacement is not anticipated in the short term.

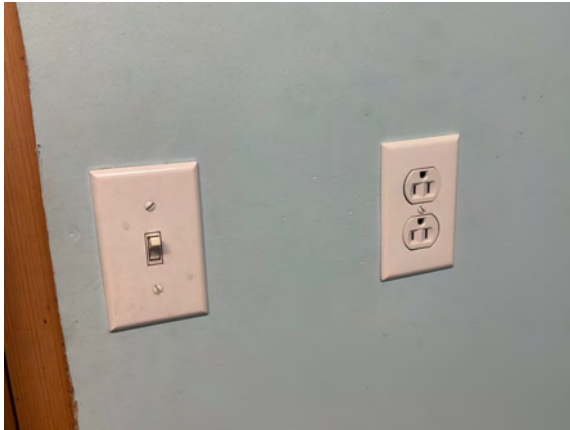
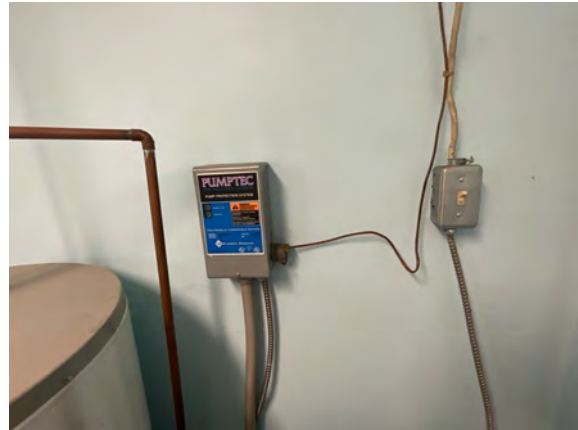
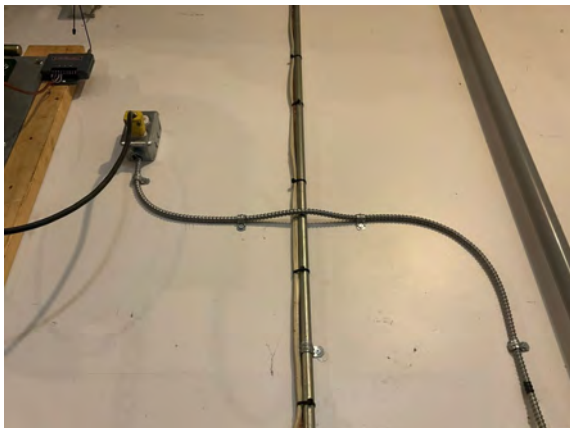
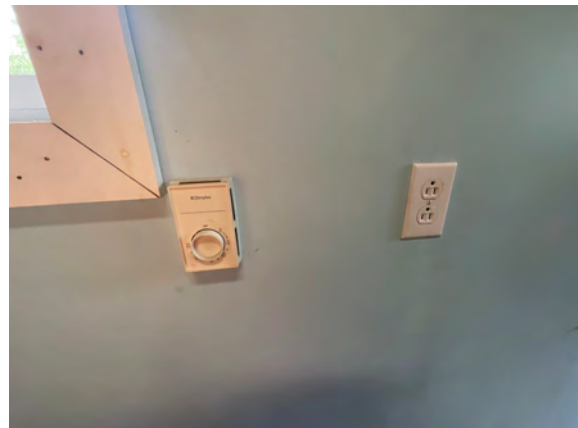
Hardwood Lake Fire Hall #2 - D502001

No significant deficiencies were observed or reported. Replacement is not anticipated in the short term.

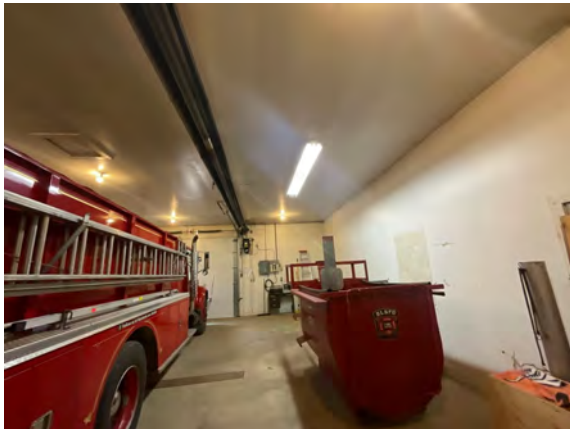
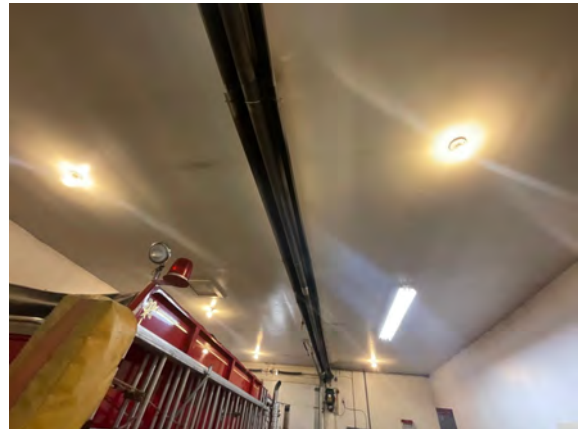
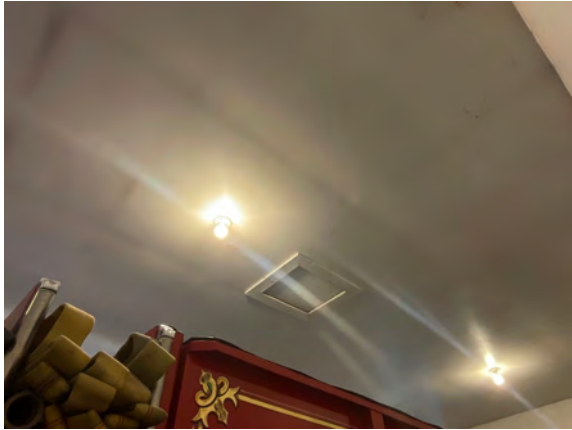
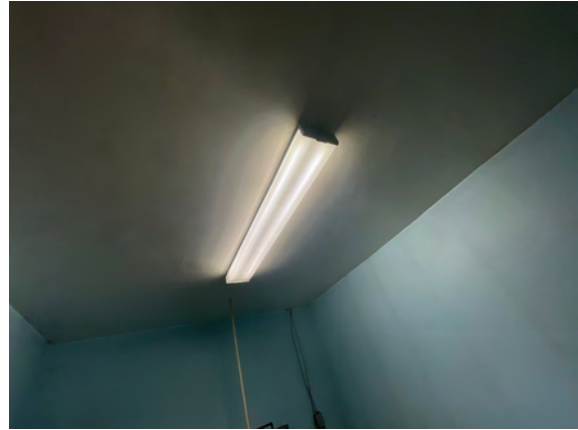
Hardwood Lake Fire Hall #2 - D502002

No significant deficiencies were observed or reported. Some of the lighting was updated over time. However, the lighting is energy inefficient. Replacement or upgrade to LED is recommended in the short term.

<b>Recommendations #1 - Interior Lighting Residential</b>	
Type	Life Cycle Replacement
Year	2027
Cost	\$5,954.13

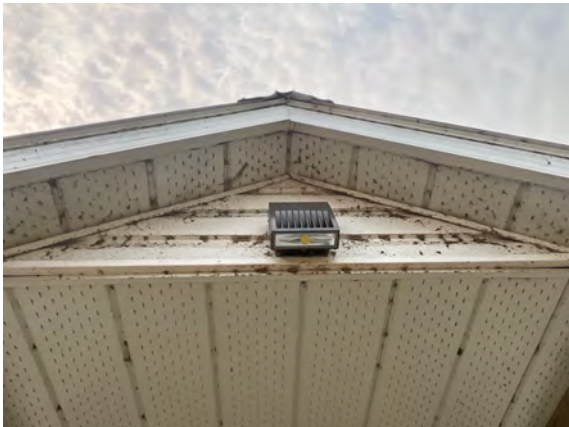
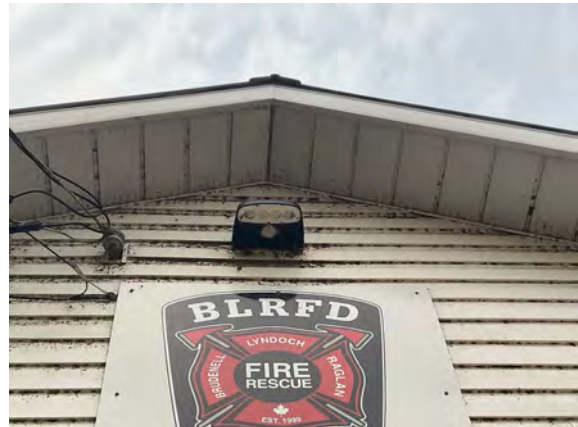
Hardwood Lake Fire Hall #2 - D502041

No significant deficiencies were observed or reported. Replacement is not anticipated in the short term.

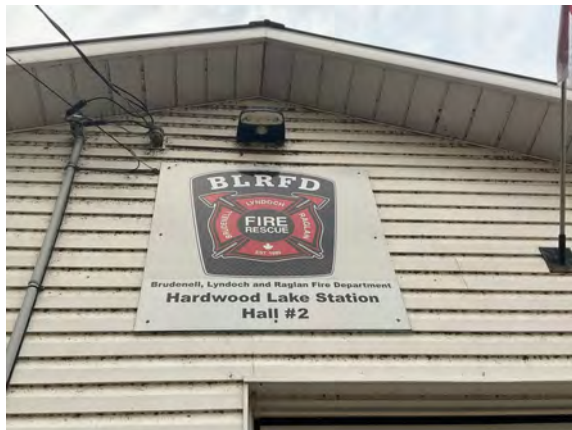
Hardwood Lake Fire Hall #2 - C103021

No significant deficiencies were observed or reported. Replacement is not anticipated in the short term.

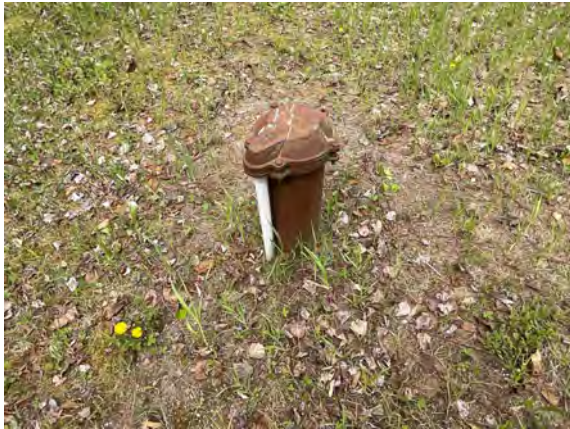
Hardwood Lake Fire Hall #2 - G301001

The well is concealed below ground and cannot be fully assessed via visual means. However, no significant deficiencies were reported. Replacement is not anticipated in the short term. OR Deficiencies observed or reported at the time of the assessment include maintenance issues /poor performance /failure. Replacement is recommended in the short term.

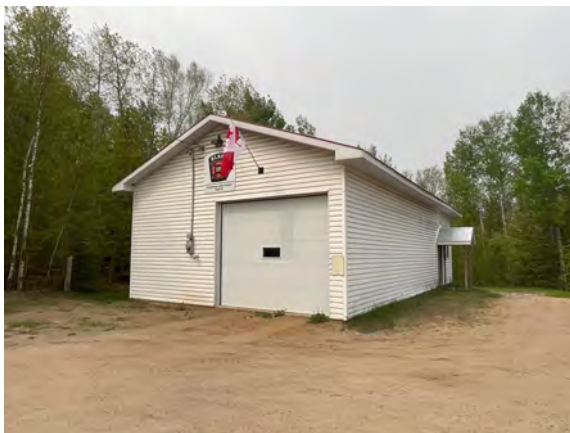
Hardwood Lake Fire Hall #2 - G401010

No significant deficiencies were observed or reported. Replacement is not anticipated in the short term.

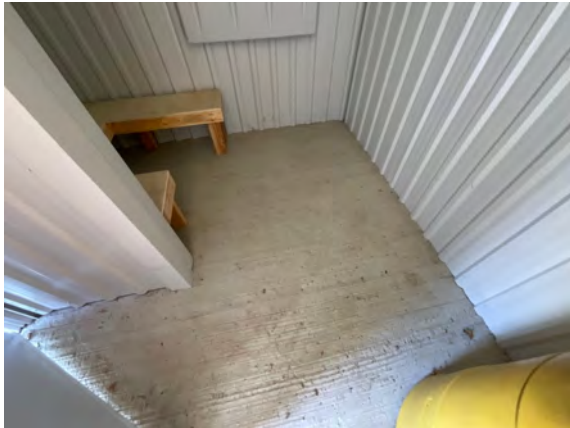
Kauffeldt Lake Beach - A103001

No major deficiencies were observed or reported. No cracking in concrete was observed.

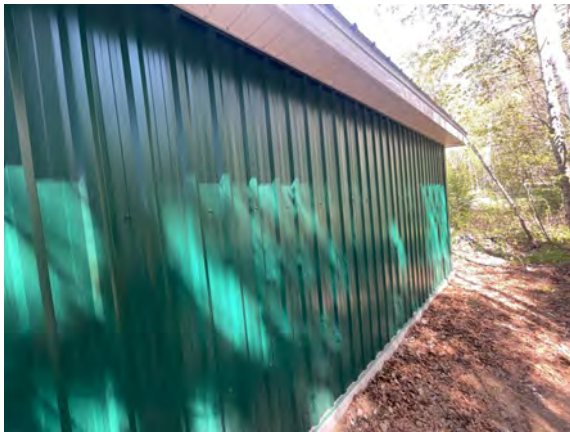
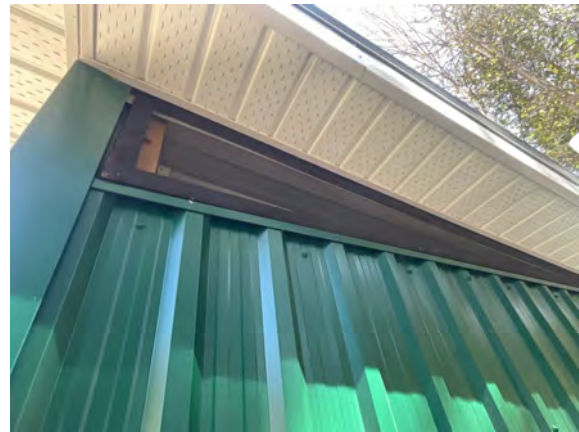
Kauffeldt Lake Beach - B201010

No significant deficiencies were observed or reported. Replacement is not anticipated in the short term.

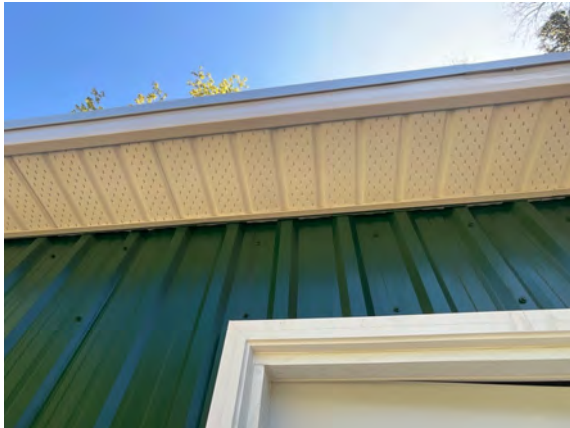
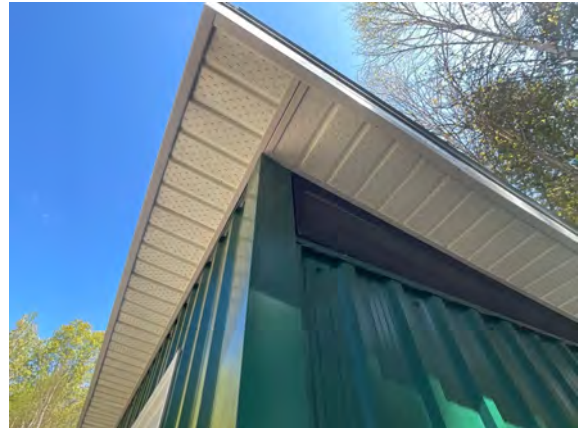
Kauffeldt Lake Beach - B201008

No significant deficiencies were observed or reported. Replacement is not anticipated in the short term.

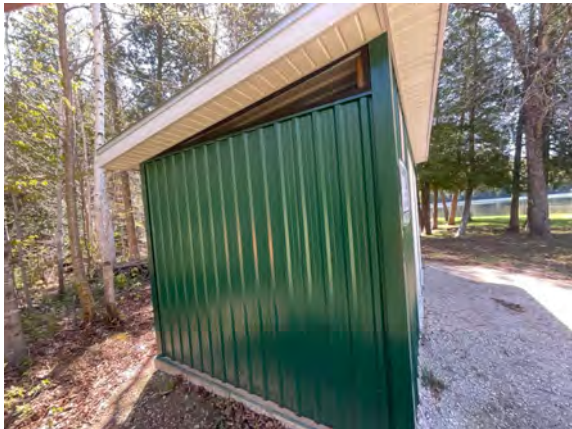
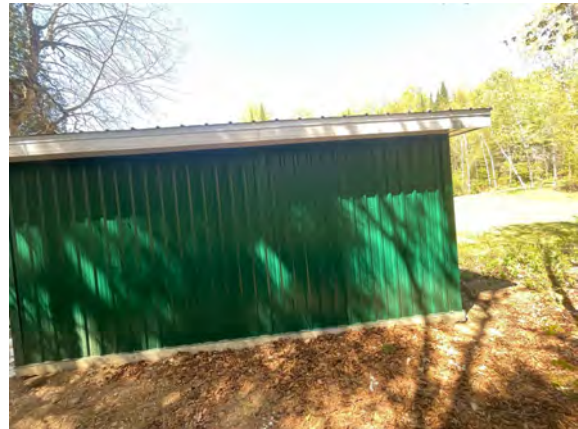
Kauffeldt Lake Beach - B201024

No significant deficiencies were observed or reported. Replacement is not anticipated in the short term.

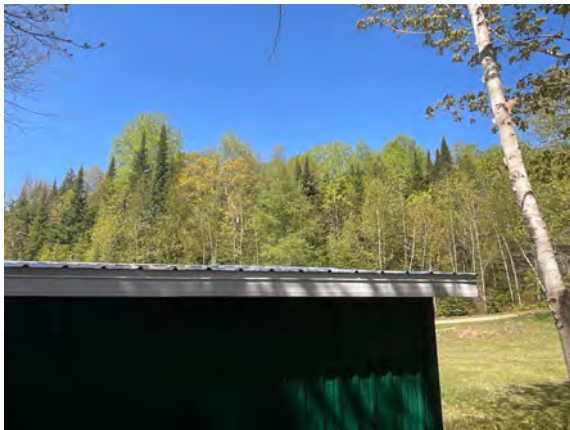
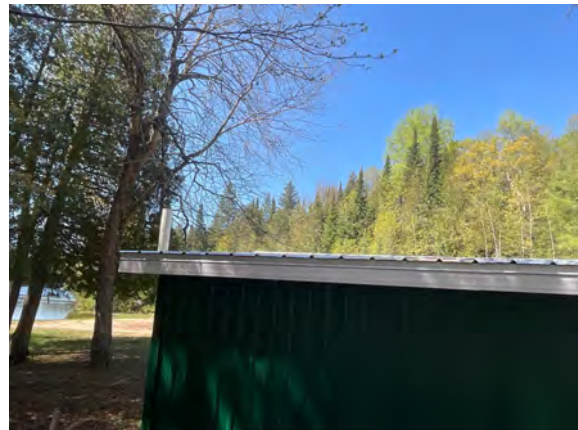
Kauffeldt Lake Beach - B301028

No significant deficiencies were observed or reported. Replacement is not anticipated in the short term.

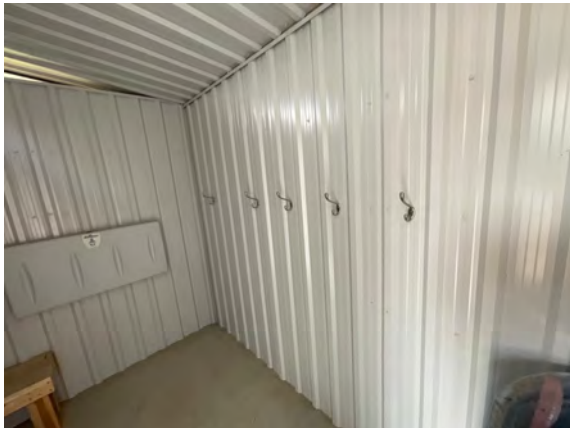
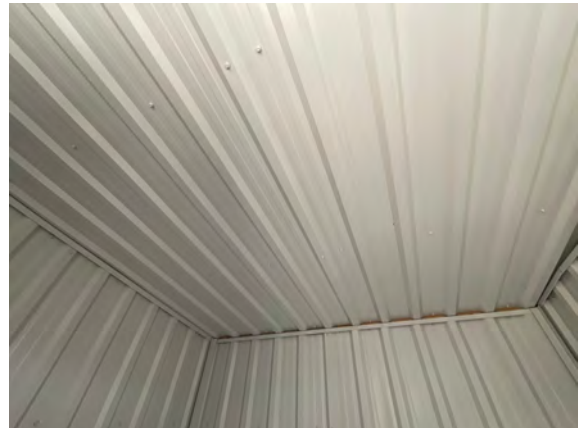
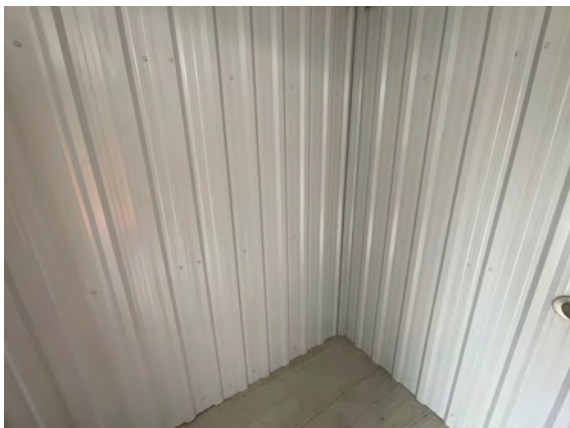
Kauffeldt Lake Beach - C301099

No significant deficiencies were observed or reported. Replacement is not anticipated in the short term.

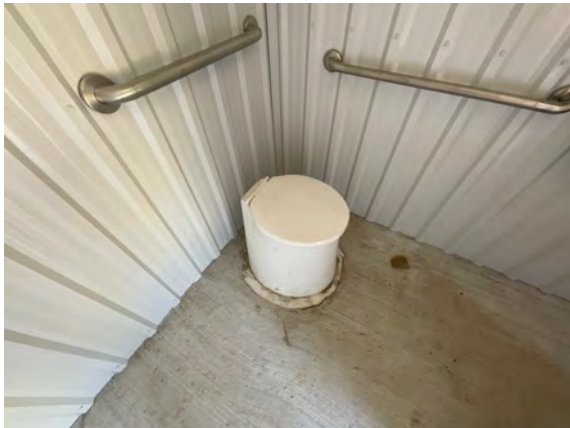
Kauffeldt Lake Beach - D201001

No significant deficiencies were observed or reported. Replacement is not anticipated in the short term.

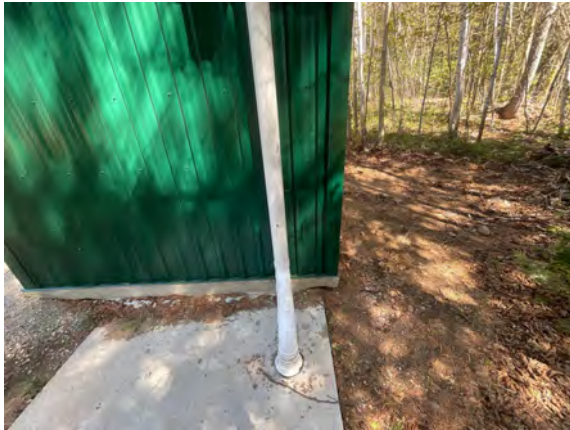
Kauffeldt Lake Beach - D203001

No significant deficiencies were observed or reported. Replacement is not anticipated in the short term.

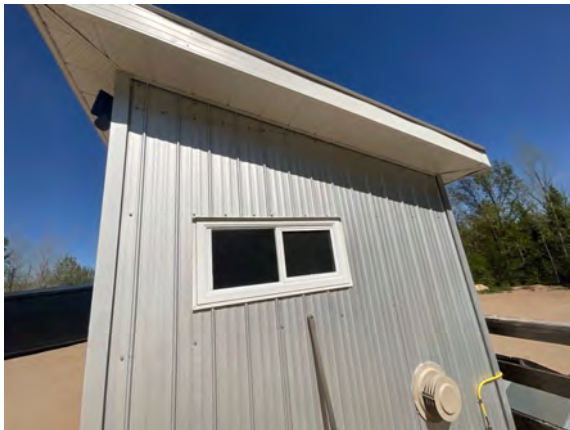
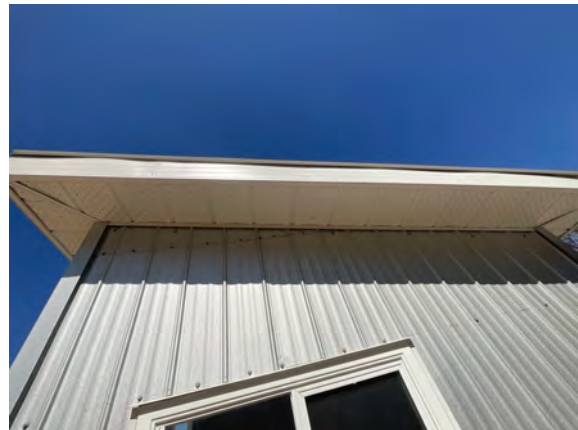
Lyndoch Transfer Station - B201008

No significant deficiencies were observed or reported. Replacement is not anticipated in the short term.

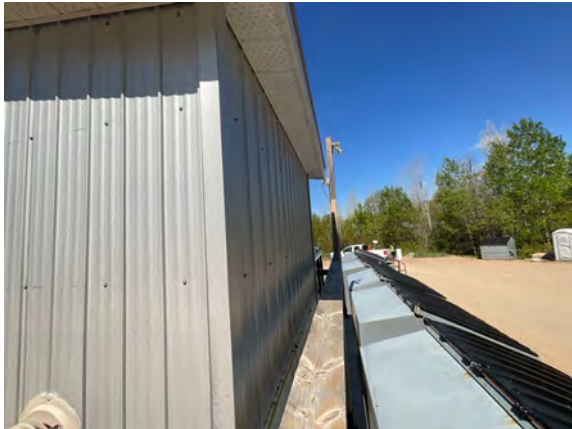
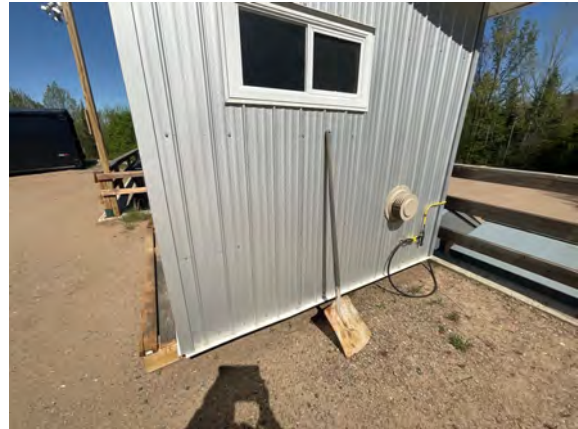
Lyndoch Transfer Station - B201024

No significant deficiencies were observed or reported. Replacement is not anticipated in the short term.

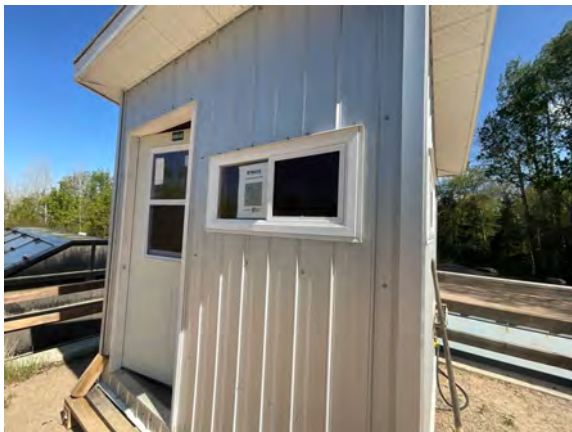
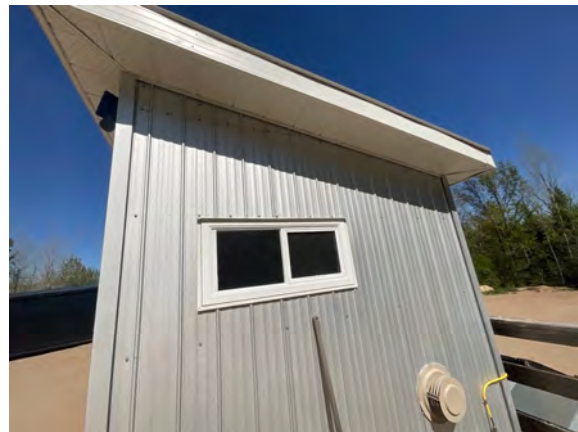
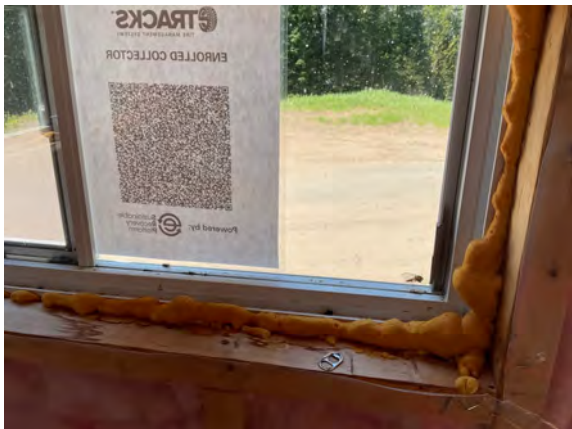
Lyndoch Transfer Station - B202001

No significant deficiencies were observed or reported. Replacement is not anticipated in the short term.

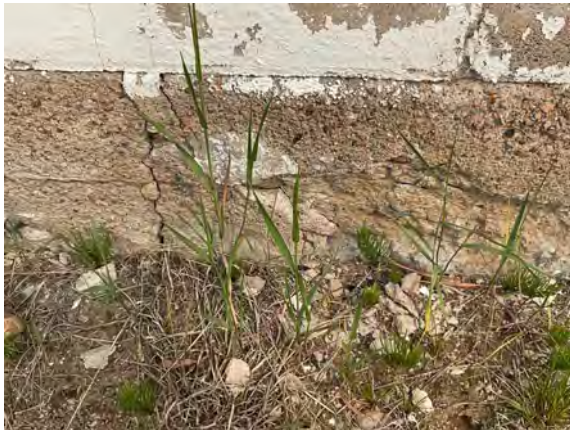
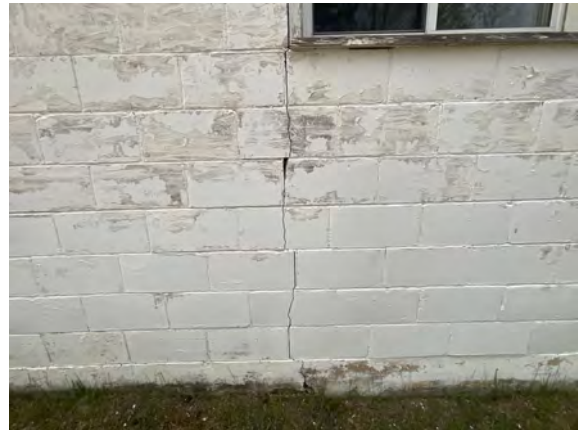
Palmer Fire Hall 1 - A101001

Deficiencies observed include cracks and spalling on the foundation walls. Cracks on exterior wall may suggest the foundation is settling. A study to determine the integrity of the foundation with a repair based on the outcome of the study is recommended.

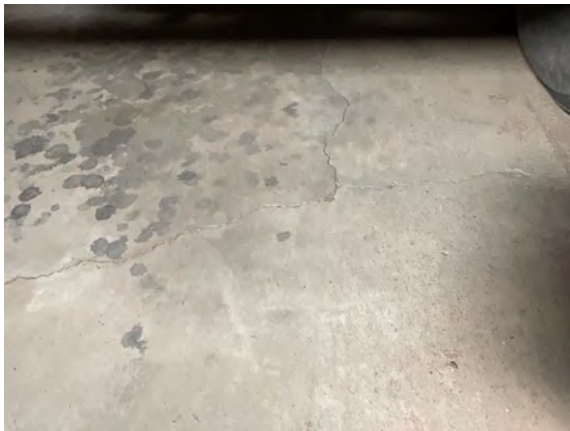
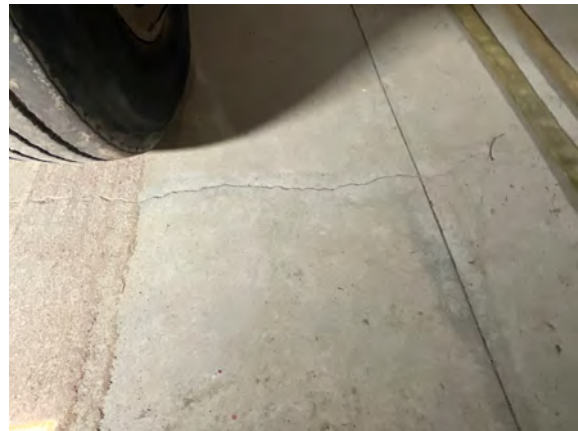
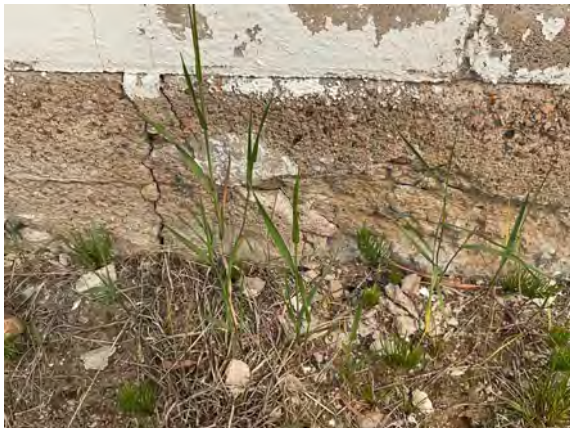
Palmer Fire Hall 1 - A103001

Some minor isolated cracking was observed, no significant elevation difference to suggest differential settlement of the concrete slab-on-grade was noted. The cracks should be monitored and should a significant magnitude change be noted, a structural engineer should be retained.

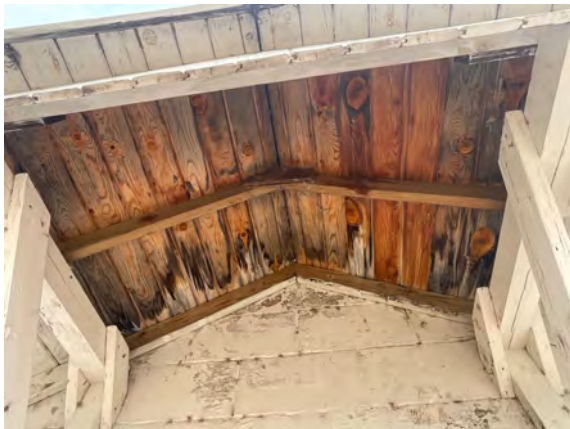
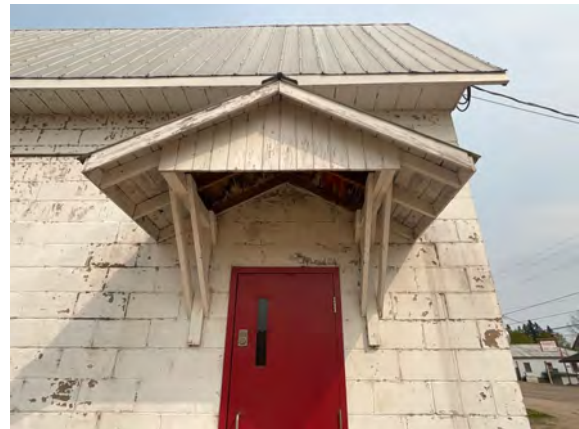
Palmer Fire Hall 1 - B201008

Deficiencies observed during the assessment include wood rot and water stains. Replacement is recommended in the short term.

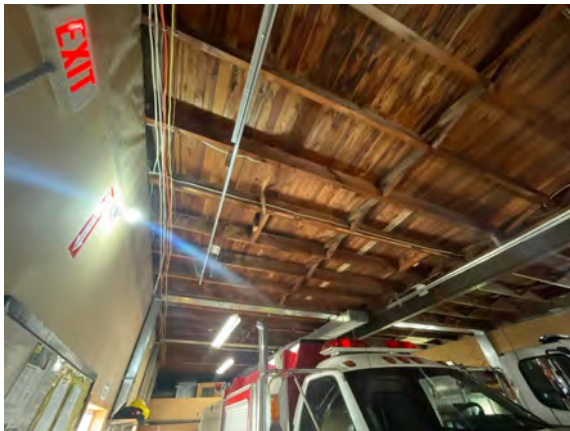
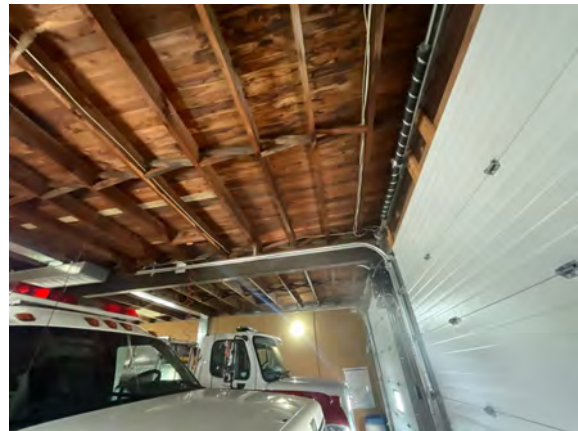
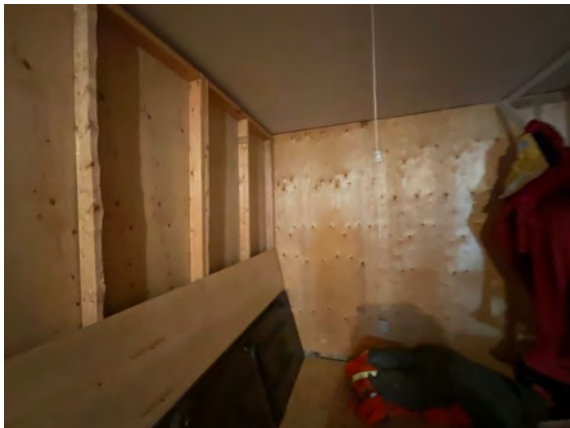
Palmer Fire Hall 1 - B103001

No major deficiencies were observed or reported on the exposed structural framing system. Some wood water stains were observed.

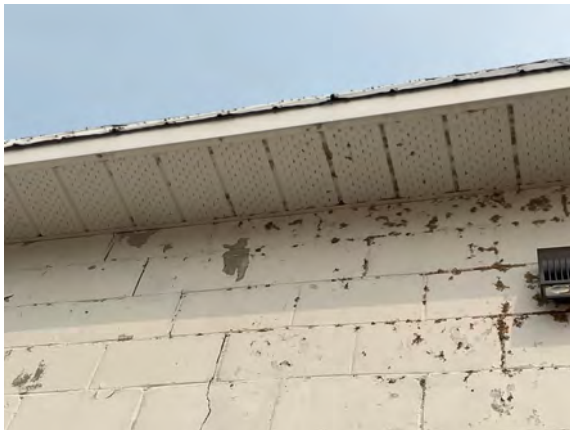
Palmer Fire Hall 1 - B201008

No significant deficiencies were observed or reported. Replacement is not anticipated in the short term.
