# Brudenell Lyndoch and Raglan

Submission to Township of Brudenell, Lyndoch, and Raglan

Roth IAMS Ltd.  
207-1075 North Service Rd W, Oakville ON, L6M 2G2  
[www.rothiams.com](http://www.rothiams.com)  
Project No. 23502

**Facility Condition Assessment Report**  
**Brudenell Fire Hall #4**

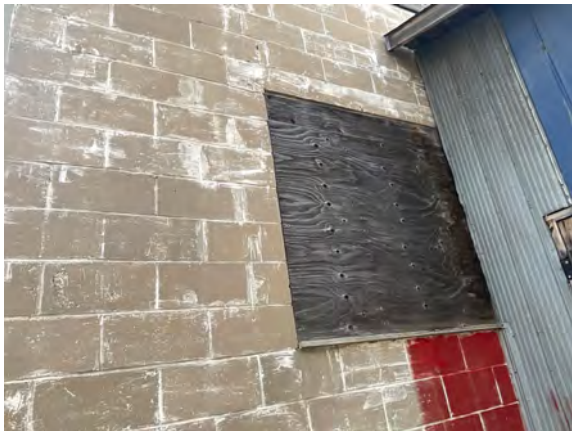
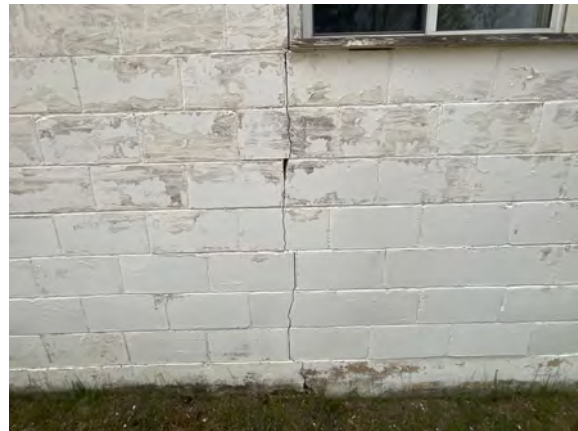
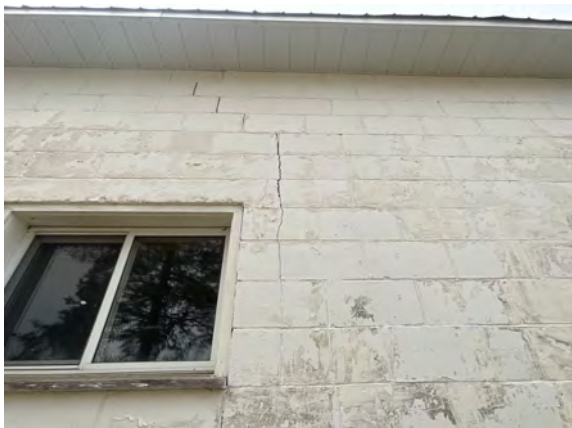
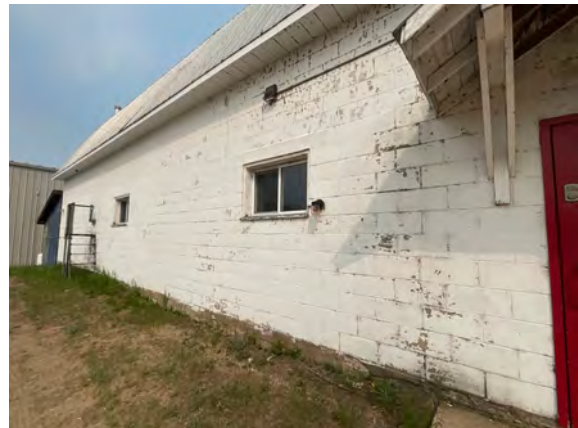
Palmer Fire Hall 1 - B201021

Element Description	
Name	B201010 - Exterior Coatings/Paint - Firehall (Township)
Installation Year	1960
Condition	4 - Poor
Expected Useful Life	10 Years
Remaining Useful Life	0 Years
Renewal Year	2024
Quantity / Unit of Measure	240 / SM
Unit Cost	\$46.00
Difficulty / Regional / Soft Cost / Replacement	1.00 / 1.04688 / 1.30000 / 1.0000
Element Cost	\$15,024.82

Deficiencies observed or reported during the assessment include peeling surfaces, staining, fading, and scuffing. The deterioration is anticipated to progress due to age and exposure to the elements. Replacement is recommended in the short term.

<b>Recommendations #1 - Exterior Coatings/Paint</b>	
Type	Life Cycle Replacement
Year	2024
Cost	\$15,024.82

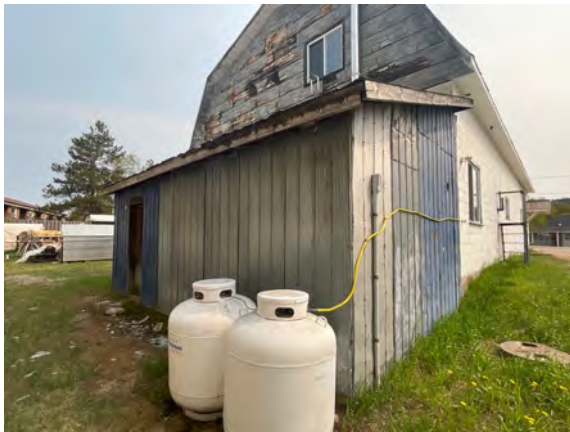
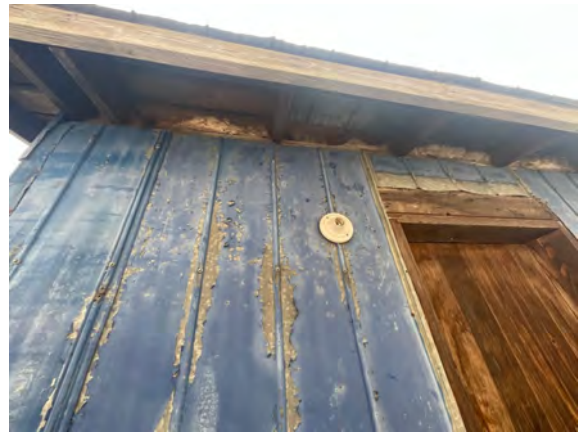
Palmer Fire Hall 1 - B201024

<b>Element Description</b>	
Name	B201024 - Metal Cladding - Firehall (Township)
Installation Year	1960
Condition	4 - Poor
Expected Useful Life	40 Years
Remaining Useful Life	0 Years
Renewal Year	2024
Quantity / Unit of Measure	15 / SM
Unit Cost	\$201.00
Difficulty / Regional / Soft Cost / Replacement	1.00 / 1.04688 / 1.30000 / 1.0000
Element Cost	\$4,103.25

Deficiencies observed or reported during the assessment include corrosion, damage and deformation and peeling paint. The deterioration is anticipated to progress due to age and exposure to the elements. Replacement is recommended in the short term.

<b>Recommendations #1 - Metal Cladding</b>	
Type	Life Cycle Replacement
Year	2024
Cost	\$4,103.25

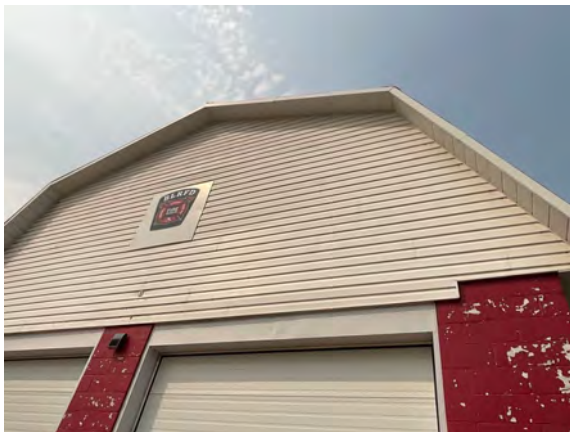
Palmer Fire Hall 1 - B201025

<b>Element Description</b>	
Name	B201025 - Vinyl Siding - Firehall (Township)
Installation Year	1999
Condition	2 - Good
Expected Useful Life	25 Years
Remaining Useful Life	5 Years
Renewal Year	2029
Quantity / Unit of Measure	16 / SM
Unit Cost	\$107.00
Difficulty / Regional / Soft Cost / Replacement	1.00 / 1.04688 / 1.30000 / 1.0000
Element Cost	\$2,329.94

No significant deficiencies were observed or reported. Replacement is not anticipated in the short term.

<b>Recommendations #1 - Vinyl Siding</b>	
Type	Life Cycle Replacement
Year	2029
Cost	\$2,329.94

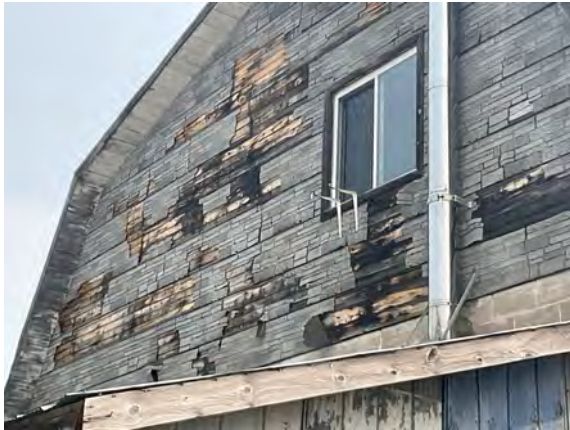
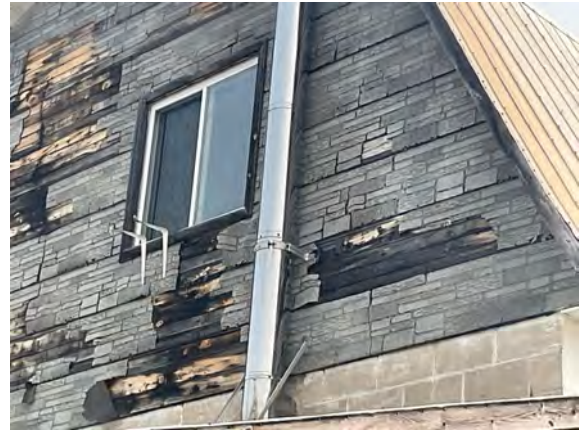
Palmer Fire Hall 1 - B201026

<b>Element Description</b>	
Name	B201026 - Wood Siding - Firehall (Township)
Installation Year	1999
Condition	4 - Poor
Expected Useful Life	30 Years
Remaining Useful Life	0 Year
Renewal Year	2023
Quantity / Unit of Measure	10 / SM
Unit Cost	\$252.00
Difficulty / Regional / Soft Cost / Replacement	1.00 / 1.04688 / 1.30000 / 1.0000
Element Cost	\$3,429.58

Deficiencies observed or reported during the assessment include damaged and missing surfaces, wood rot, loose components. The deterioration is anticipated to progress. Moisture infiltration appears to have occurred. Replacement is recommended in the short term.

<b>Recommendations #1 - Wood Siding</b>	
Type	Life Cycle Replacement
Year	2023
Cost	\$3,429.58

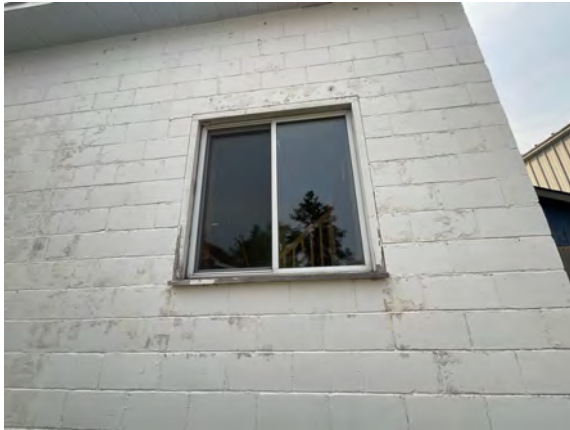
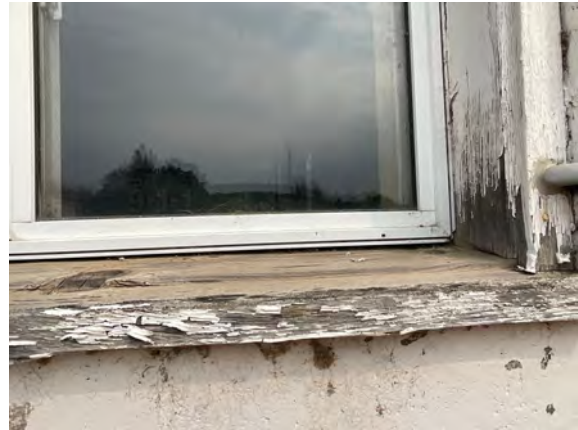
Palmer Fire Hall 1 - B202001

<b>Element Description</b>	
Name	B202001 - Windows - Firehall (Township)
Installation Year	1999
Condition	4 - Poor
Expected Useful Life	35 Years
Remaining Useful Life	0 Years
Renewal Year	2024
Quantity / Unit of Measure	10 / SM
Unit Cost	\$1,200.00
Difficulty / Regional / Soft Cost / Replacement	1.00 / 1.04688 / 1.30000 / 1.0000
Element Cost	\$16,331.33

Deficiencies observed or reported during the assessment include wood rot, air, and water infiltration, and peeling paint. The deterioration is anticipated to progress. Replacement is recommended in the short term.

<b>Recommendations #1 - Windows</b>	
Type	Life Cycle Replacement
Year	2024
Cost	\$16,331.33

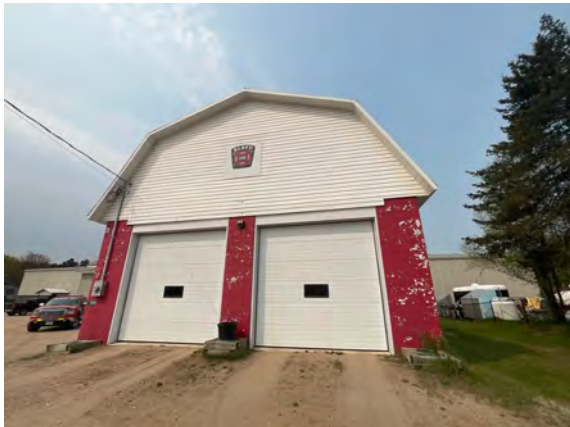
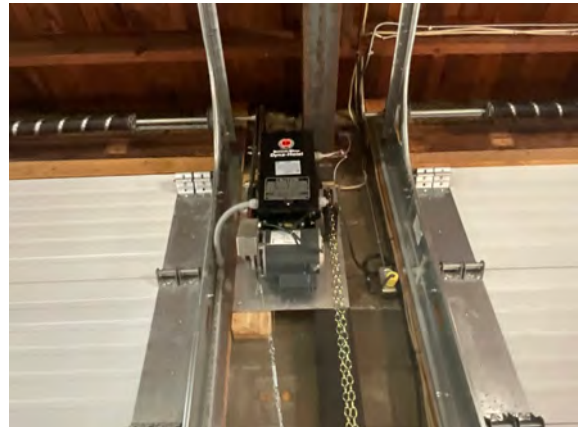
Palmer Fire Hall 1 - B203022

Element Description	
Name	B203022 - Overhead Doors - Industrial - Firehall (Township)
Installation Year	2021
Condition	2 - Good
Expected Useful Life	25 Years
Remaining Useful Life	22 Years
Renewal Year	2046
Quantity / Unit of Measure	2 / Each
Unit Cost	\$15,070.00
Difficulty / Regional / Soft Cost / Replacement	1.00 / 1.04688 / 1.30000 / 1.0000
Element Cost	\$41,018.85

No significant deficiencies were observed or reported. Replacement is not anticipated in the short term.

Recommendations #1 - Overhead Doors - Industrial	
Type	Life Cycle Replacement
Year	2046
Cost	\$41,018.85

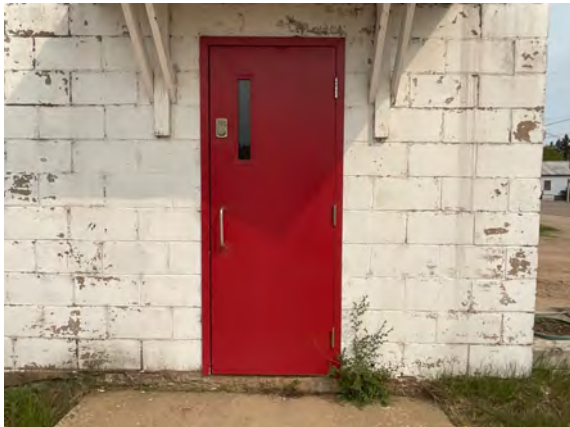
Palmer Fire Hall 1 - B203023

<b>Element Description</b>	
Name	B203023 - Single Door - Hollow Metal - Firehall (Township)
Installation Year	2017
Condition	2 - Good
Expected Useful Life	30 Years
Remaining Useful Life	23 Years
Renewal Year	2047
Quantity / Unit of Measure	1 / Each
Unit Cost	\$4,020.00
Difficulty / Regional / Soft Cost / Replacement	1.00 / 1.04688 / 1.30000 / 1.0000
Element Cost	\$5,470.99

No significant deficiencies were observed or reported. Replacement is not anticipated in the short term.

<b>Recommendations #1 - Single Door - Hollow Metal</b>	
Type	Life Cycle Replacement
Year	2047
Cost	\$5,470.99

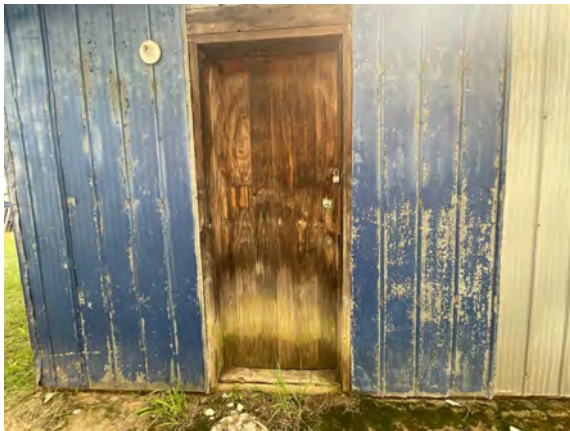
Palmer Fire Hall 1 - B203024

<b>Element Description</b>	
Name	B203024 - Single Door - Wood - Firehall (Township)
Installation Year	1999
Condition	4 - Poor
Expected Useful Life	25 Years
Remaining Useful Life	0 Year
Renewal Year	2023
Quantity / Unit of Measure	1 / Each
Unit Cost	\$3,400.00
Difficulty / Regional / Soft Cost / Replacement	1.00 / 1.04688 / 1.30000 / 1.0000
Element Cost	\$4,627.21

Deficiencies observed or reported during the assessment include damaged surfaces, air or moisture leakage, worn hardware. The deterioration is anticipated to progress Replacement is recommended in the short term.

<b>Recommendations #1 - Single Door - Wood</b>	
Type	Life Cycle Replacement
Year	2023
Cost	\$4,627.21

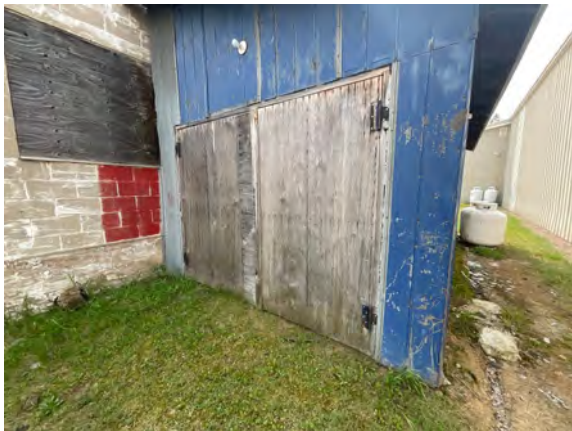
Palmer Fire Hall 1 - C102025

Element Description	
Name	B203027 - Double Door - Wood - Firehall (Township)
Installation Year	1960
Condition	4 - Poor
Expected Useful Life	25 Years
Remaining Useful Life	0 Years
Renewal Year	2024
Quantity / Unit of Measure	1 / Each
Unit Cost	\$6,270.00
Difficulty / Regional / Soft Cost / Replacement	1.00 / 1.04688 / 1.30000 / 1.0000
Element Cost	\$8,533.12

Deficiencies observed or reported during the assessment include delaminated surfaces, air or moisture leakage, worn hardware. The deterioration is anticipated to progress Replacement is recommended in the short term.

Recommendations #1 - Double Door - Wood	
Type	Life Cycle Replacement
Year	2024
Cost	\$8,533.12

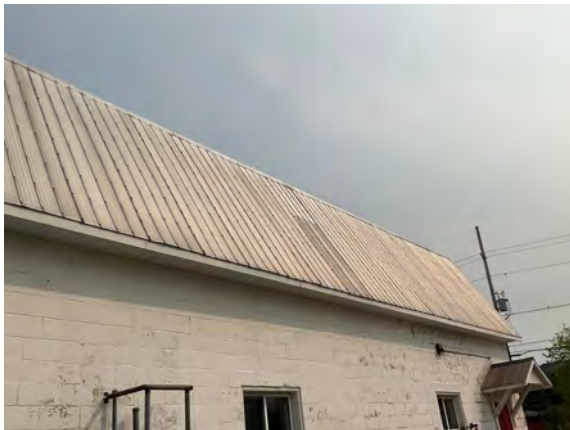
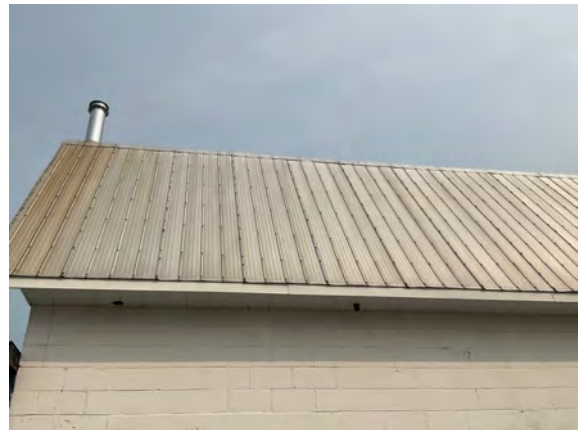
Palmer Fire Hall 1 - B301028

Element Description	
Name	B301028 - Metal Roofing - Firehall (Township)
Installation Year	1999
Condition	2 - Good
Expected Useful Life	40 Years
Remaining Useful Life	15 Years
Renewal Year	2039
Quantity / Unit of Measure	245 / SM
Unit Cost	\$398.00
Difficulty / Regional / Soft Cost / Replacement	1.00 / 1.04688 / 1.30000 / 1.0000
Element Cost	\$132,705.65

No significant deficiencies were observed or reported. Replacement is not anticipated in the short term.

Recommendations #1 - Metal Roofing	
Type	Life Cycle Replacement
Year	2039
Cost	\$132,705.65

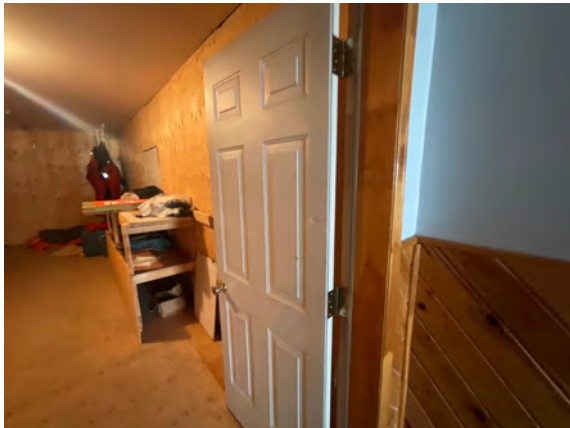
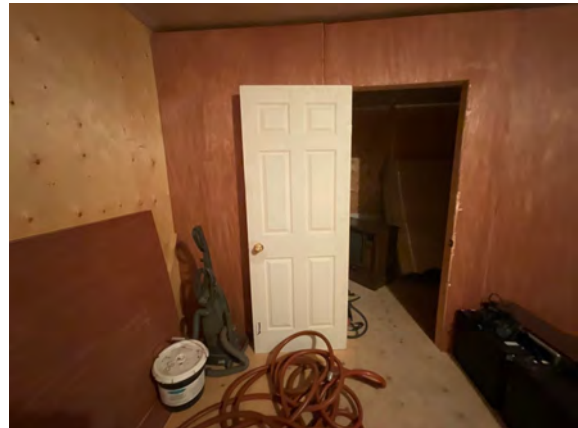
Palmer Fire Hall 1 - C102022

Element Description	
Name	C102022 - Single Door - Wood - Firehall (Township)
Installation Year	1999
Condition	2 - Good
Expected Useful Life	40 Years
Remaining Useful Life	15 Years
Renewal Year	2039
Quantity / Unit of Measure	2 / Each
Unit Cost	\$2,520.00
Difficulty / Regional / Soft Cost / Replacement	1.00 / 1.04688 / 1.30000 / 1.0000
Element Cost	\$6,859.16

No significant deficiencies were observed or reported. Replacement is not anticipated in the short term.

Recommendations #1 - Single Door - Wood	
Type	Life Cycle Replacement
Year	2039
Cost	\$6,859.16

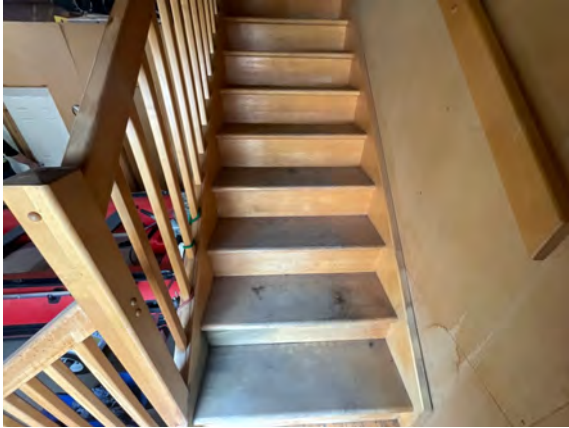
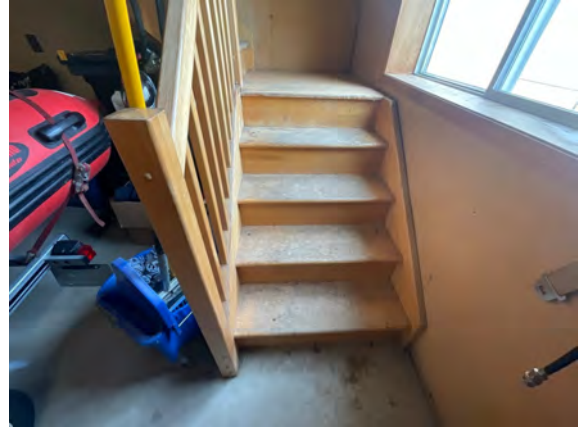
Palmer Fire Hall 1 - C201001

Element Description	
Name	C201001 - Interior Stair Construction - Firehall (Township)
Installation Year	1999
Condition	2 - Good
Expected Useful Life	75 Years
Remaining Useful Life	50 Years
Renewal Year	2074
Quantity / Unit of Measure	14 / Per Riser
Unit Cost	\$1,140.00
Difficulty / Regional / Soft Cost / Replacement	1.00 / 1.04688 / 1.30000 / 1.0000
Element Cost	\$21,720.67

No significant deficiencies were observed or reported. Replacement is not anticipated in the short term.

Recommendations #1 - Interior Stair Construction	
Type	Life Cycle Replacement
Year	2074
Cost	\$21,720.67

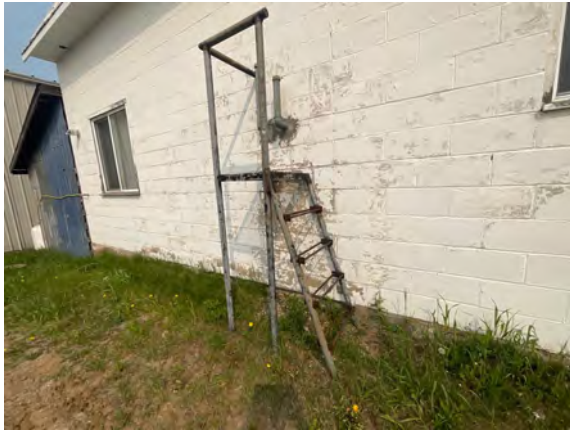
Palmer Fire Hall 1 - C201002

<b>Element Description</b>	
Name	C201002 - Exterior Stair Construction - Firehall (Township)
Installation Year	1999
Condition	4 - Poor
Expected Useful Life	40 Years
Remaining Useful Life	0 Years
Renewal Year	2024
Quantity / Unit of Measure	4 / Per Riser
Unit Cost	\$1,260.00
Difficulty / Regional / Soft Cost / Replacement	1.00 / 1.04688 / 1.30000 / 1.0000
Element Cost	\$6,859.16

Deficiencies observed or reported during the assessment include corrosion, wear, and inadequate guards. The deterioration is anticipated to progress. Replacement is recommended in the short term.

<b>Recommendations #1 - Exterior Stair Construction</b>	
Type	Life Cycle Replacement
Year	2024
Cost	\$6,859.16

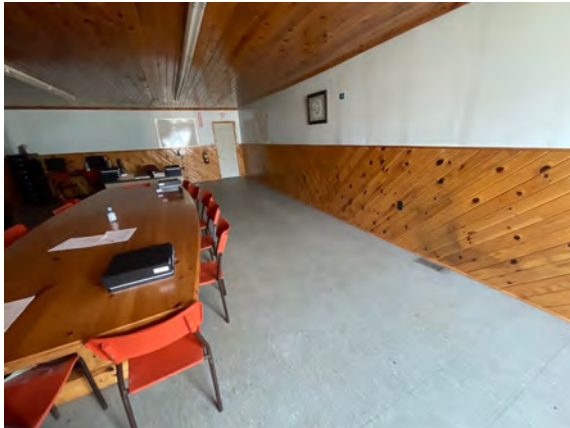
Palmer Fire Hall 1 - C301005

Element Description	
Name	C301005 - Paint Wall Covering - Firehall (Township)
Installation Year	2000
Condition	2 - Good
Expected Useful Life	10 Years
Remaining Useful Life	5 Years
Renewal Year	2029
Quantity / Unit of Measure	70 / SM Building
Unit Cost	\$53.00
Difficulty / Regional / Soft Cost / Replacement	1.00 / 1.04688 / 1.30000 / 1.0000
Element Cost	\$5,049.10

No significant deficiencies were observed or reported. Lifecycle replacement may be deferred.

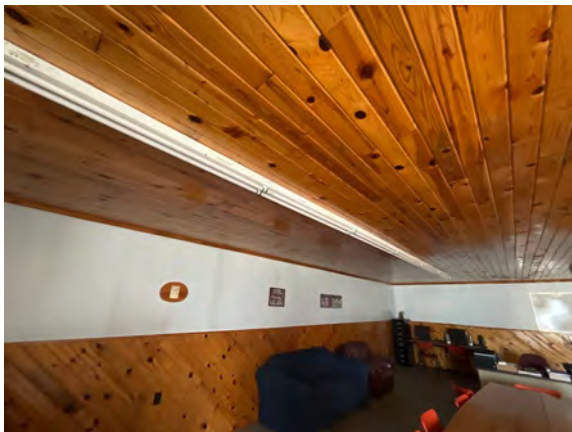
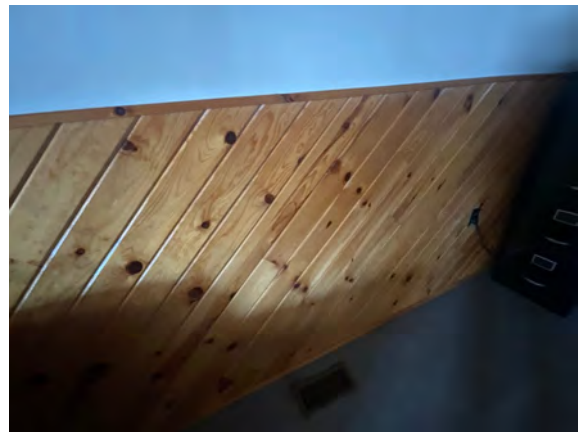
Palmer Fire Hall 1 - C301022

No significant deficiencies were observed or reported. Lifecycle replacement may be deferred.

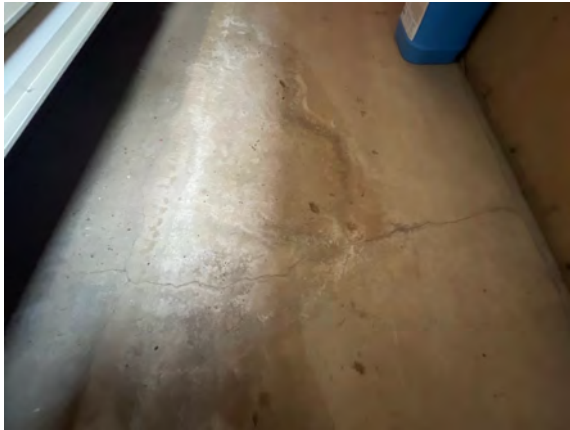
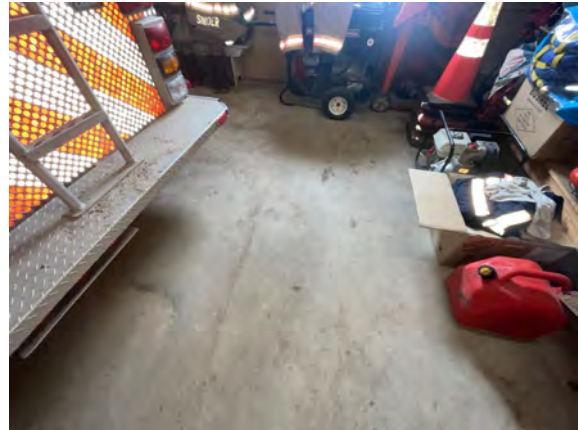
Palmer Fire Hall 1 - C302007

Deficiencies observed or reported during the assessment include stained and worn sealant. The deterioration is anticipated to progress. Replacement is recommended in the short term.

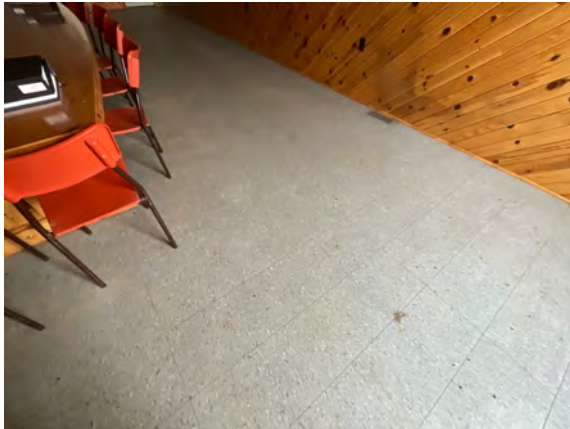
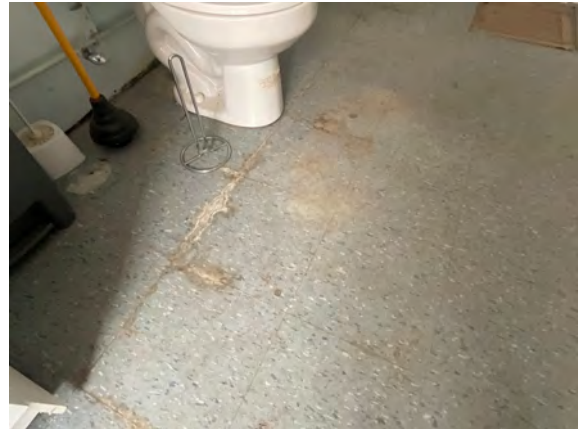
Palmer Fire Hall 1 - C302023

Deficiencies observed or reported during the assessment include damaged and worn surfaces, and stains. The deterioration is anticipated to progress due to age and ongoing building activities. Replacement is recommended in the short term.

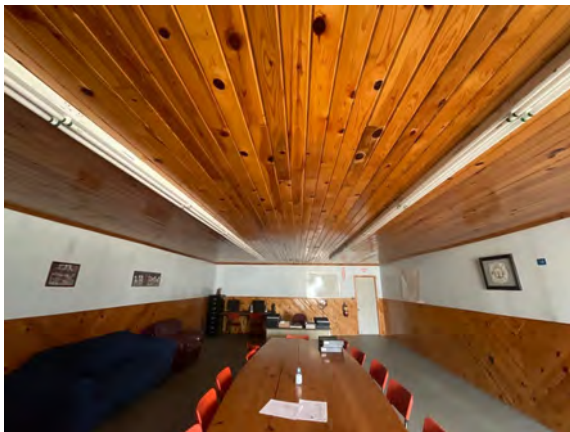
Palmer Fire Hall 1 - C303005

No significant deficiencies were observed or reported. Replacement is not anticipated in the short term.

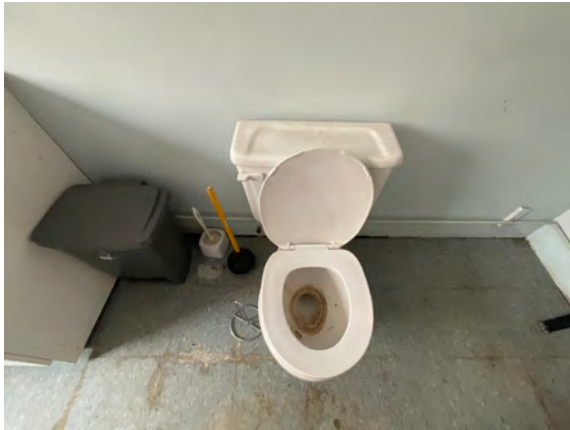
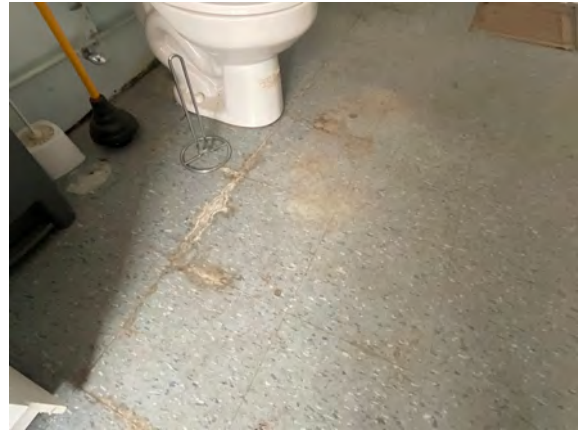
Palmer Fire Hall 1 - D201001

Deficiencies observed or reported at the time of the assessment include stains. Replacement is recommended in the short term.

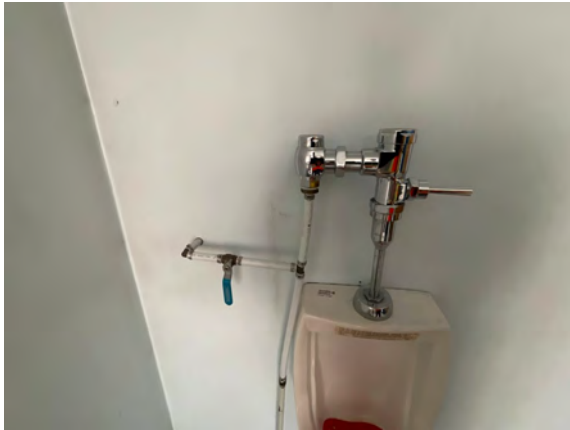
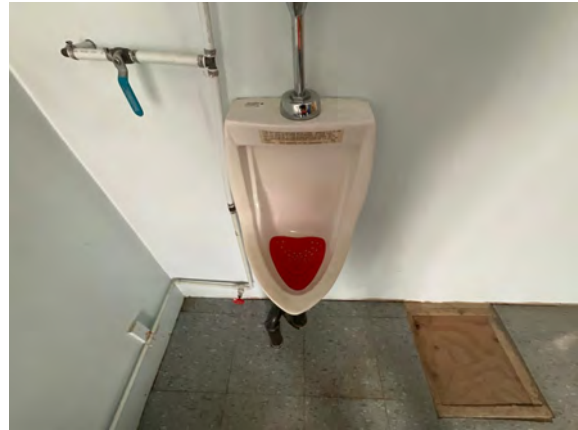
Palmer Fire Hall 1 - D201002

No significant deficiencies were observed or reported. The flush valve appears to have been replaced recently. Replacement is not anticipated in the short term.

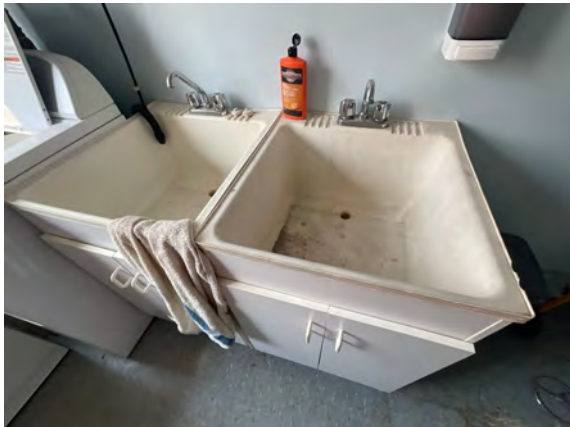
Palmer Fire Hall 1 - D201016

No significant deficiencies were observed or reported. Replacement is not anticipated in the short term.

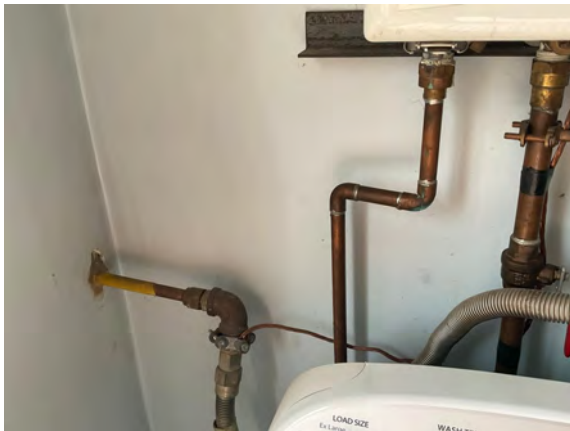
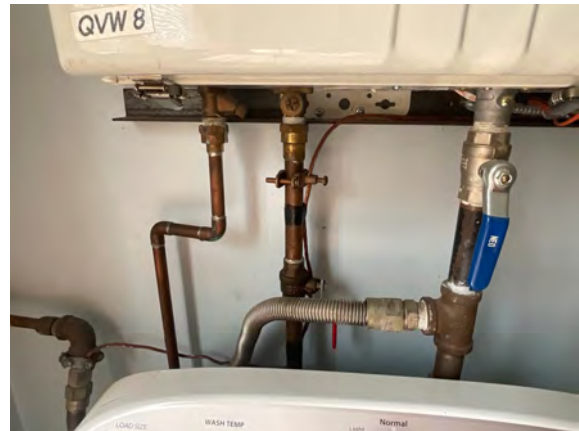
Palmer Fire Hall 1 - D202001

No significant deficiencies were observed or reported. Replacement is not anticipated in the short term.

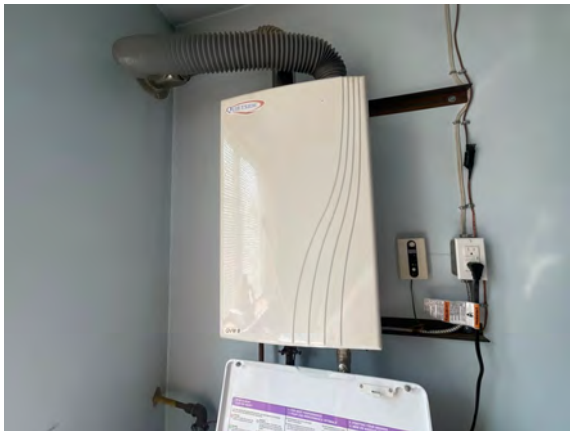
Palmer Fire Hall 1 - D202034

No significant deficiencies were observed or reported. Replacement is not anticipated in the short term.

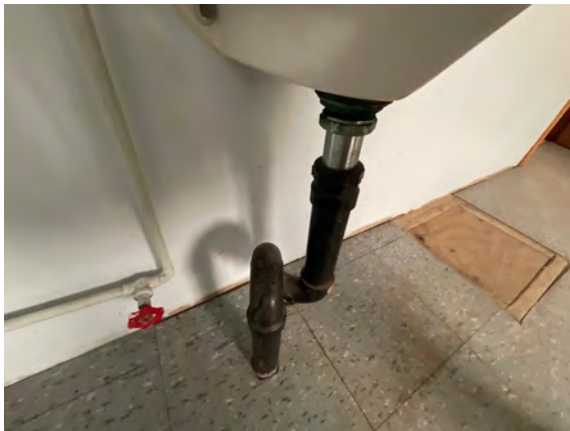
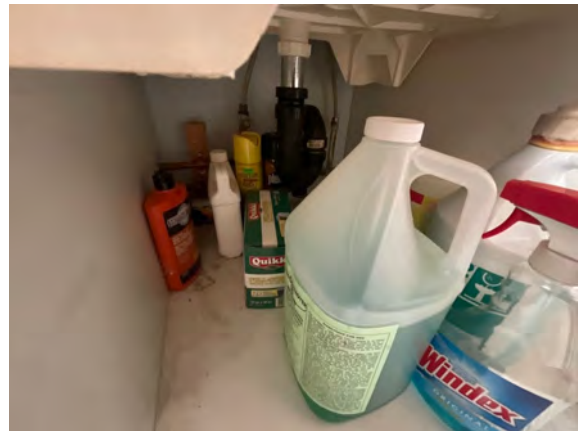
Palmer Fire Hall 1 - D203001

No significant deficiencies were observed or reported. Replacement is not anticipated in the short term.

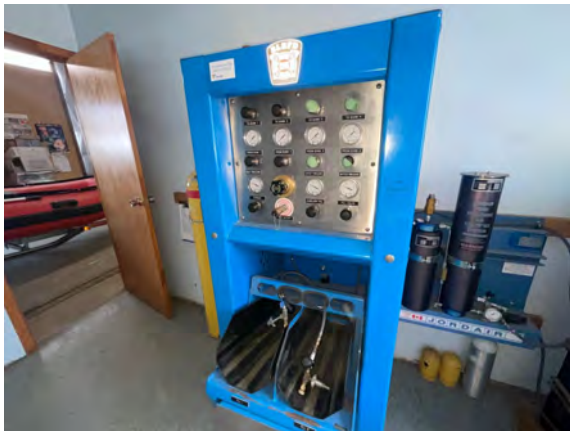
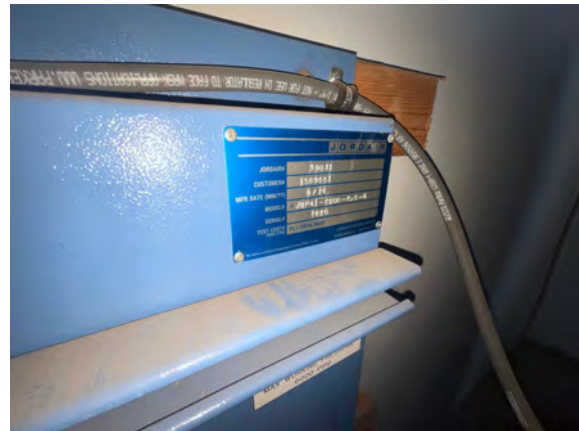
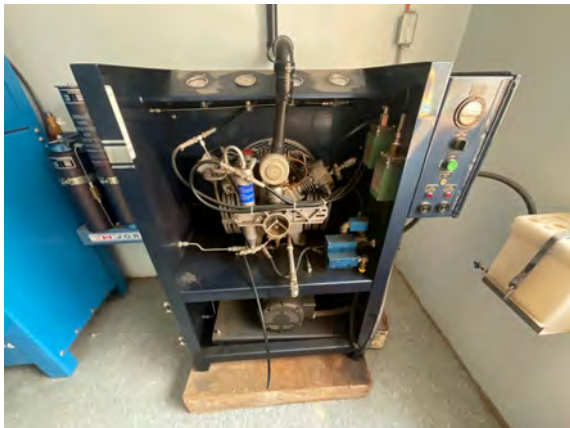
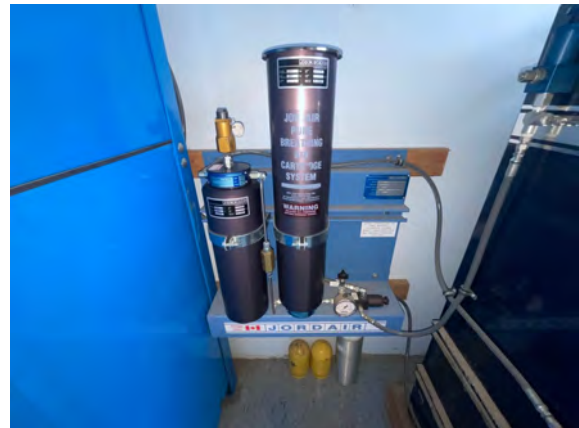
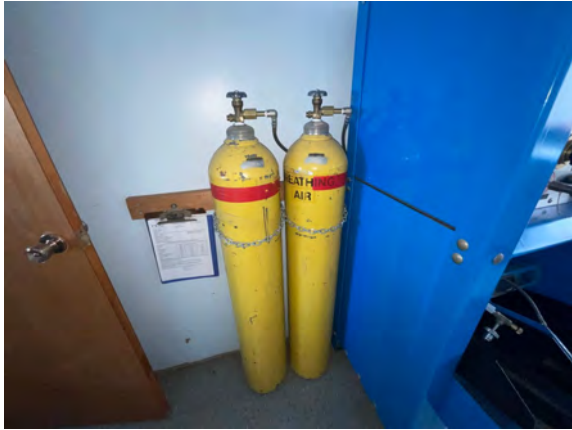
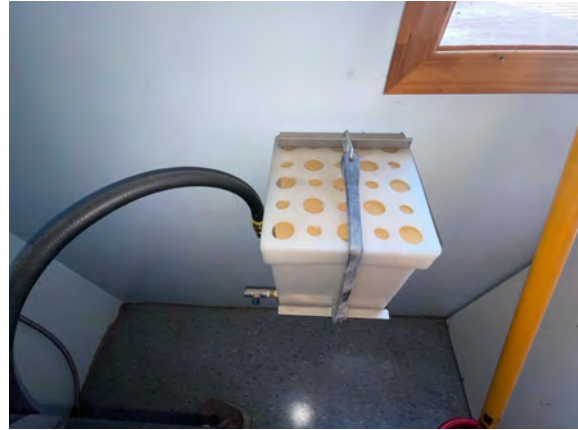
Palmer Fire Hall 1 - D209006

No significant deficiencies were observed or reported. Replacement is not anticipated in the short term.

<b>Recommendations #1 - Air Compressors and Air Dryers</b>	
Type	Life Cycle Replacement
Year	2031
Cost	\$11,976.31

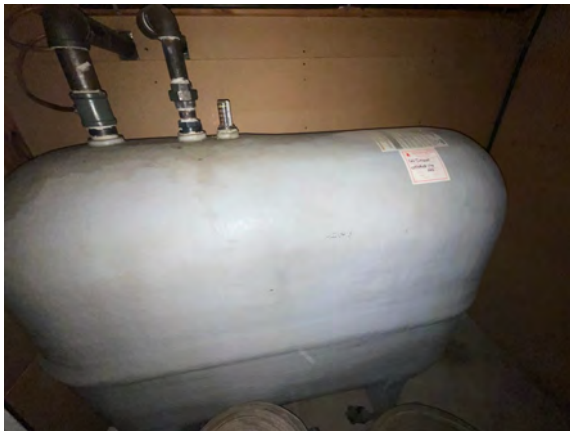
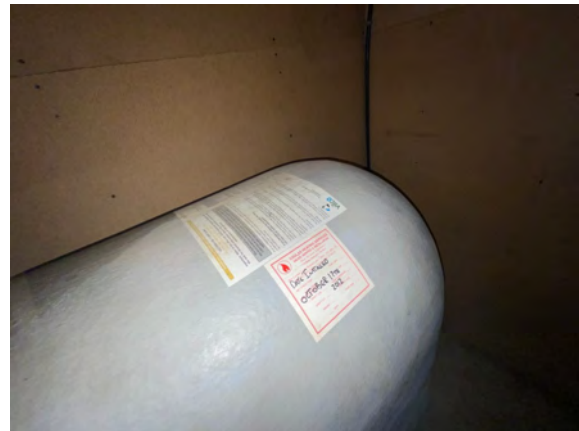
Palmer Fire Hall 1 - D301012

No significant deficiencies were observed or reported. Replacement is not anticipated in the short term.

Recommendations #1 - Fuel Supply Storage Tanks (Interior)	
Type	Life Cycle Replacement
Year	2052
Cost	\$17,090.73

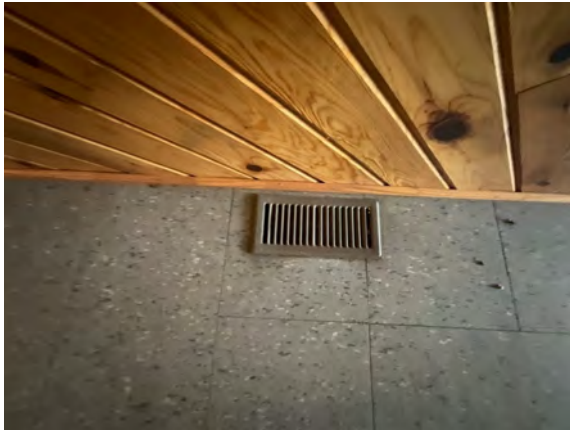
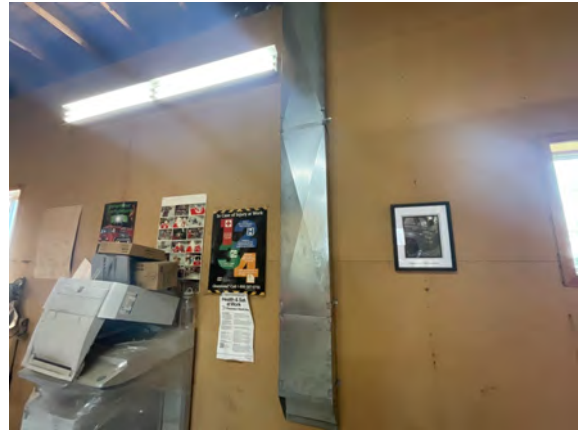
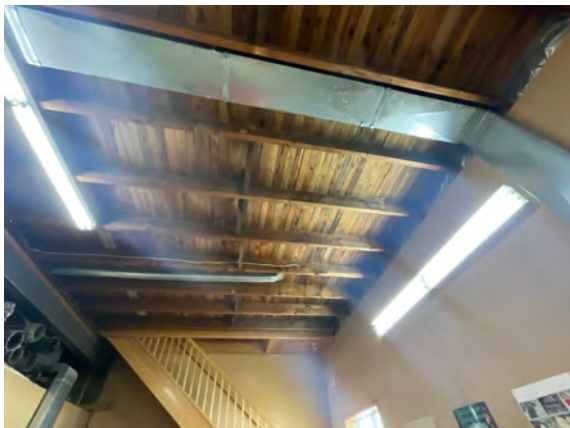
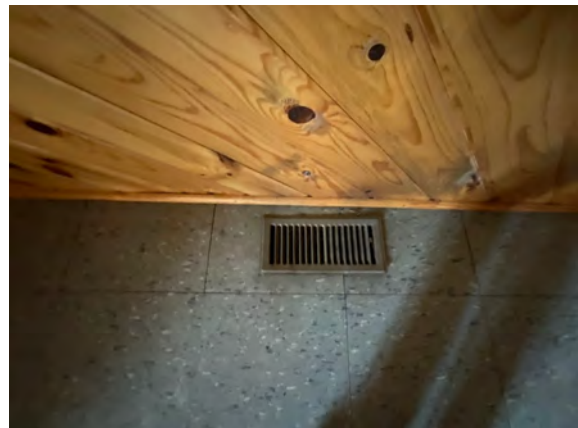
Palmer Fire Hall 1 - D304001

No significant deficiencies were observed or reported. Replacement is not anticipated in the short term.

<b>Recommendations #1 - Air Distribution Systems</b>	
Type	Life Cycle Replacement
Year	2050
Cost	\$49,418.60

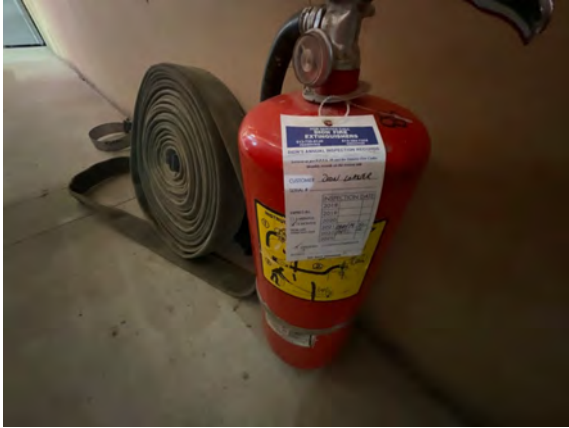
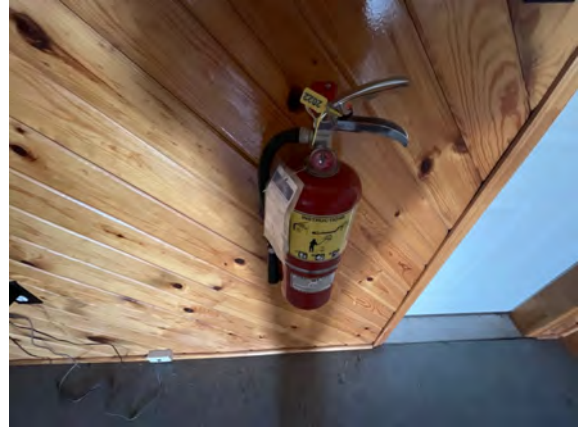
Palmer Fire Hall 1 - D403002

No significant deficiencies were observed or reported. Replacement is not anticipated in the short term.

Recommendations #1 - Individual Fire Extinguishers	
Type	Life Cycle Replacement
Year	2029
Cost	\$702.25

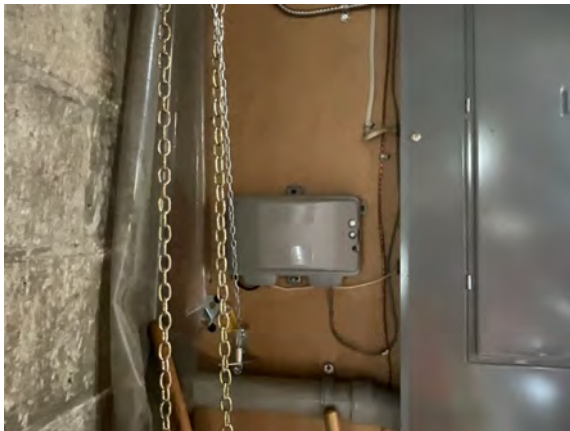
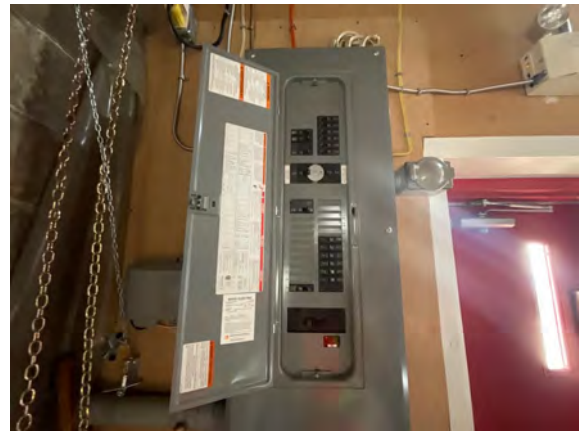
Palmer Fire Hall 1 - D501003

No significant deficiencies were observed or reported. Replacement is not anticipated in the short term.

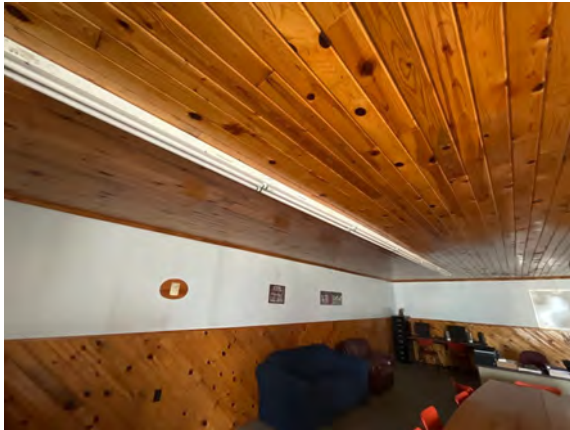
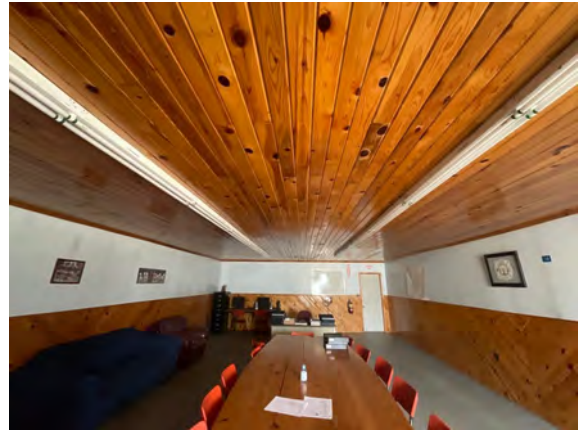
Palmer Fire Hall 1 - D502002

No significant deficiencies were observed or reported. However the lighting is energy inefficient. Replacement with upgrade to LED is recommended.

Recommendations #1 - Interior Lighting	
Type	Life Cycle Replacement
Year	2026
Cost	\$10,364.95

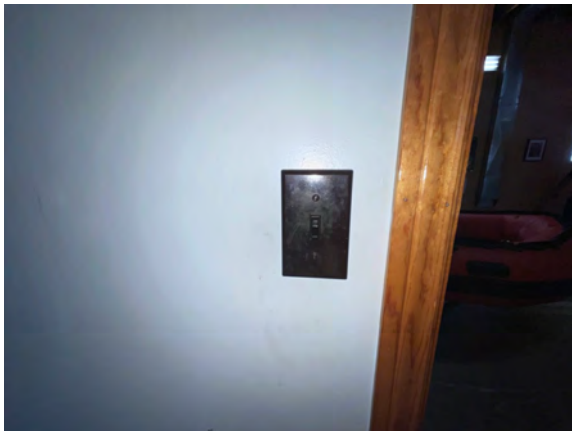
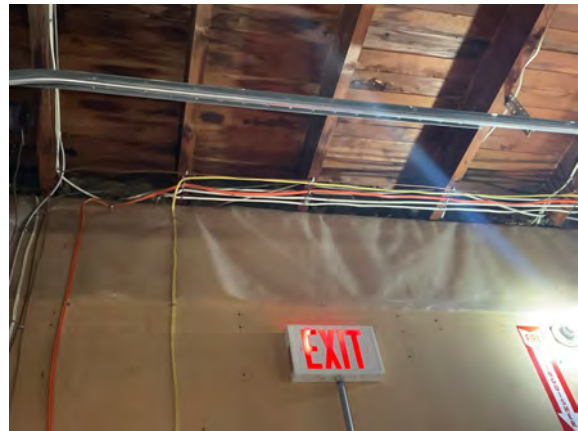
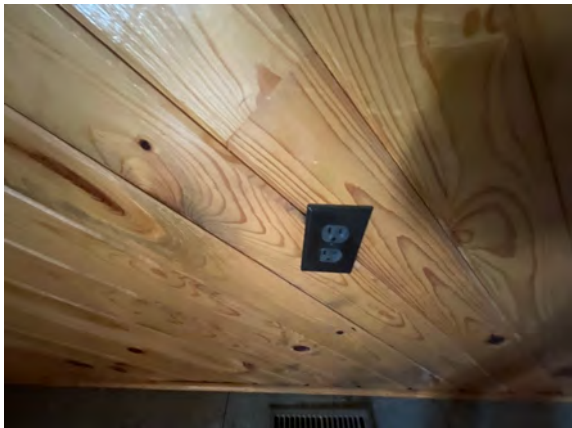
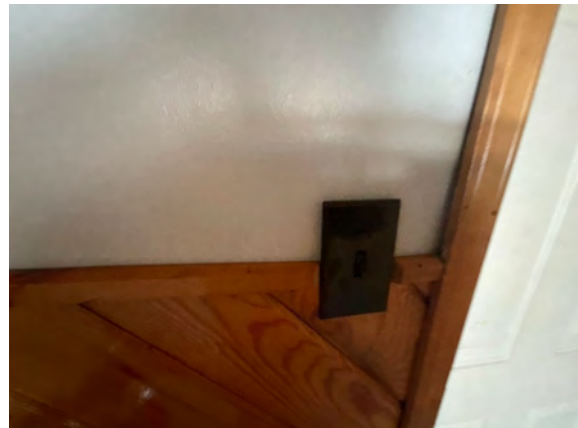
Palmer Fire Hall 1 - D502001

No significant deficiencies were observed or reported. some of the wiring appears to have been updated over time. Replacement is not anticipated in the short term.

<b>Recommendations #1 - Branch Wiring and Devices - Residential</b>	
Type	Life Cycle Replacement
Year	2049
Cost	\$17,768.48

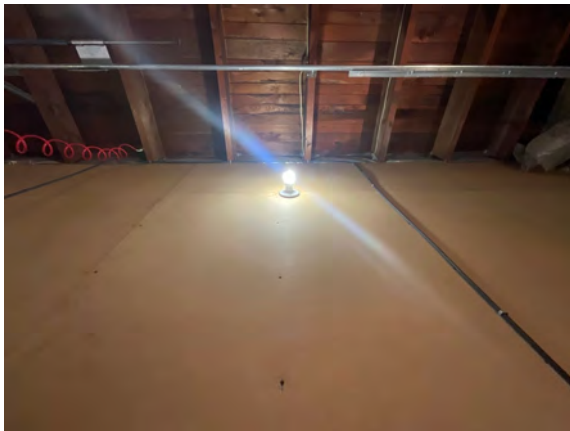
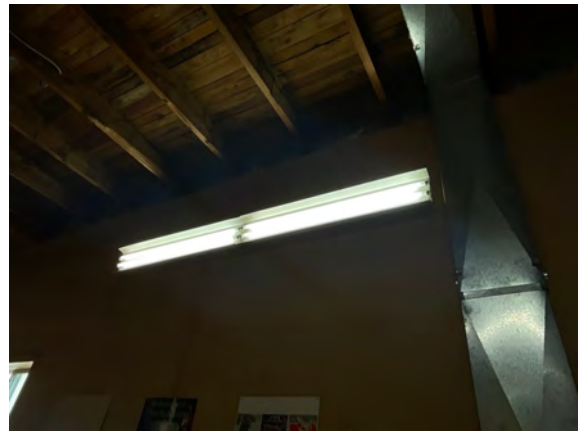
Palmer Fire Hall 1 - D502002

No significant deficiencies were observed or reported. Replacement is not anticipated in the short term. Upgrade to LED should be considered.

Recommendations #1 - Interior Lighting	
Type	Life Cycle Replacement
Year	2034
Cost	\$9,717.14

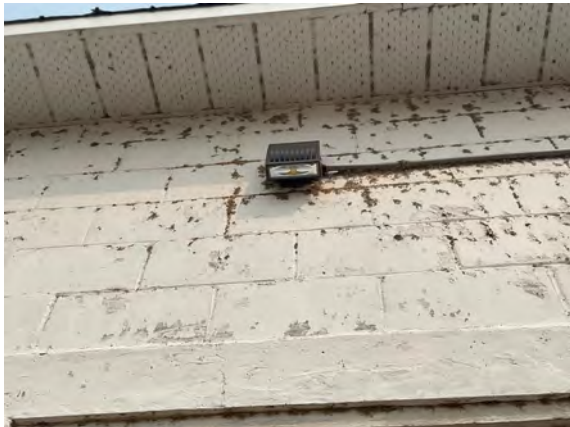
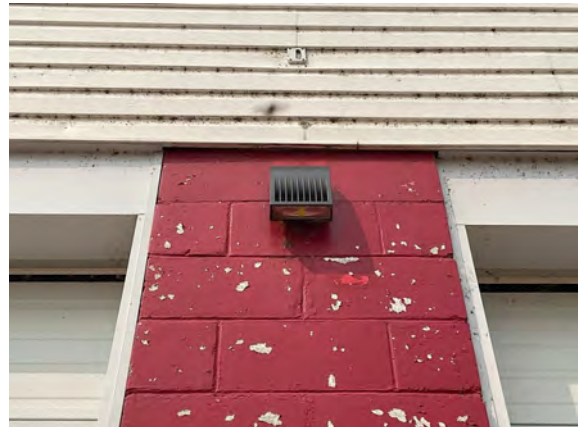
Palmer Fire Hall 1 - D502041

No significant deficiencies were observed or reported. Replacement is not anticipated in the short term.

<b>Recommendations #1 - Exterior Lighting</b>	
Type	Life Cycle Replacement
Year	2042
Cost	\$1,562.36

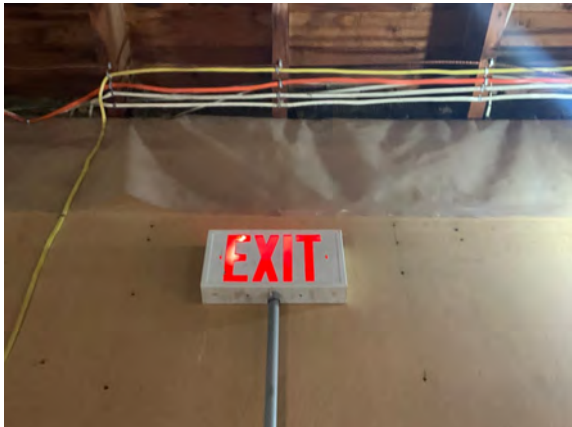
Palmer Fire Hall 1 - D502051

No significant deficiencies were observed or reported. Upgrade to pictogram exit signs should be considered.

Recommendations #1 - Exit Lighting	
Type	Life Cycle Replacement
Year	2034
Cost	\$1,110.53

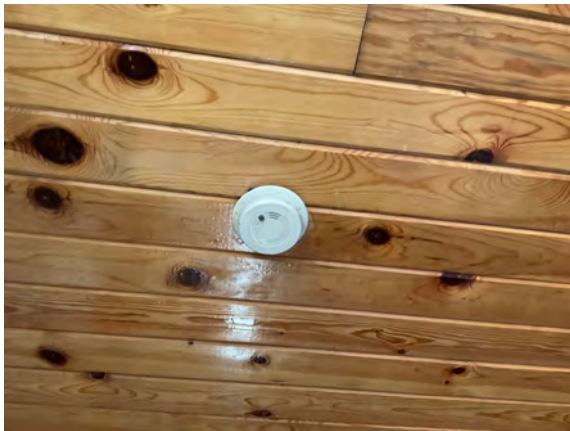
Palmer Fire Hall 1 - D503015

No significant deficiencies were observed or reported. However, the system is approaching or is past the manufacturer's expiry date with reliability likely diminishing over time. Replacement is recommended in the short term.

Recommendations #1 - Independent CO and Smoke Alarms	
Type	Life Cycle Replacement
Year	2024
Cost	\$313.02

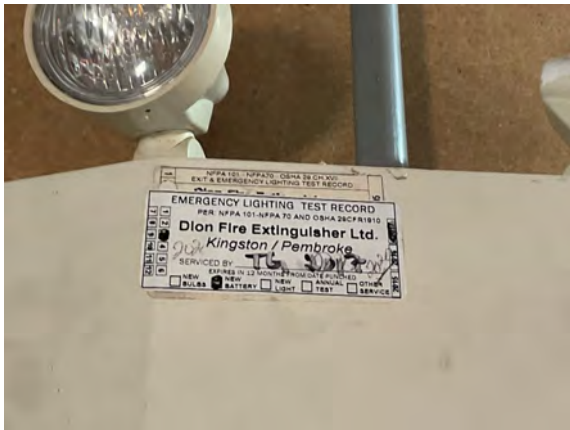
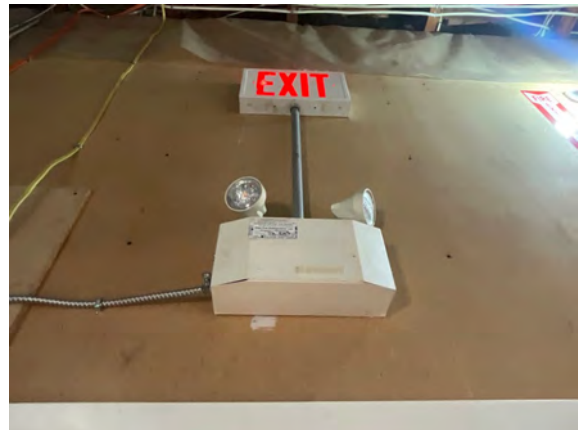
Palmer Fire Hall 1 - D509021

No significant deficiencies were observed or reported. Lifecycle replacement may be deferred. Upgrade to LED should be considered.

Recommendations #1 - Emergency Lighting - Battery Pack Units (EBUs)	
Type	Life Cycle Replacement
Year	2029
Cost	\$936.33

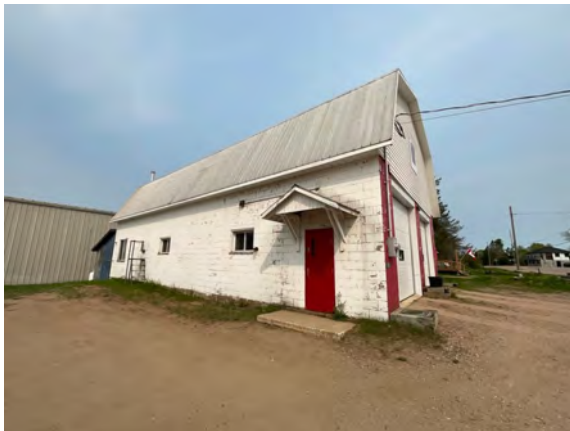
Palmer Fire Hall 1 - G401010

No significant deficiencies were observed or reported. Replacement is not anticipated in the short term.

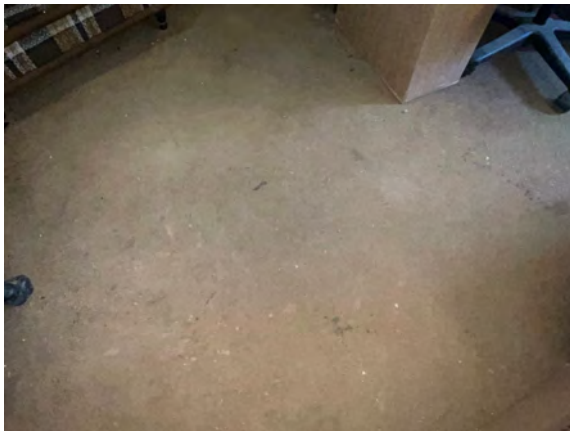
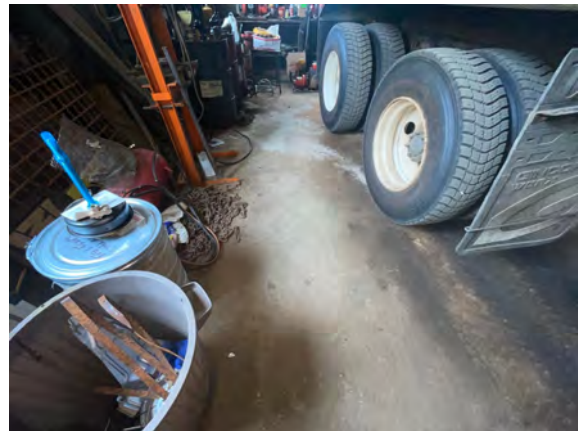
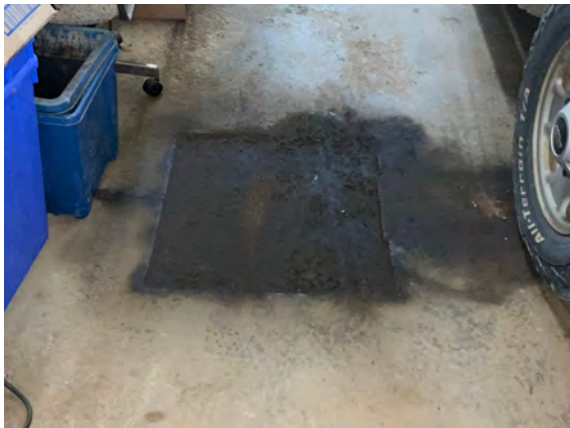
Palmer Public Works Garage - A103001

Some minor isolated cracking was observed, but no significant elevation difference to suggest differential settlement of the concrete slab-on-grade was noted.
