# Brudenell Lyndoch and Raglan

Submission to Township of Brudenell, Lyndoch, and Raglan

Roth IAMS Ltd.  
207-1075 North Service Rd W, Oakville ON, L6M 2G2  
[www.rothiams.com](http://www.rothiams.com)  
Project No. 23502

**Facility Condition Assessment Report**  
**Brudenell Fire Hall #4**

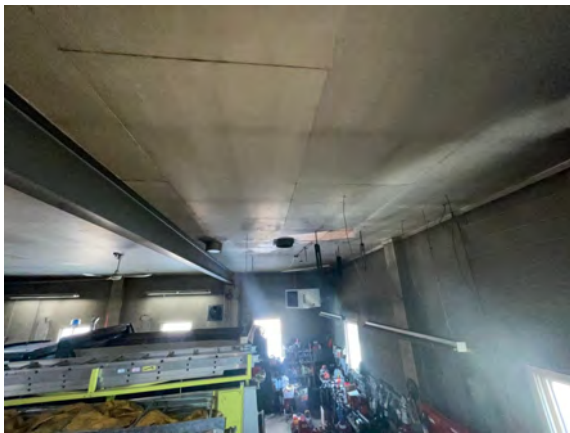
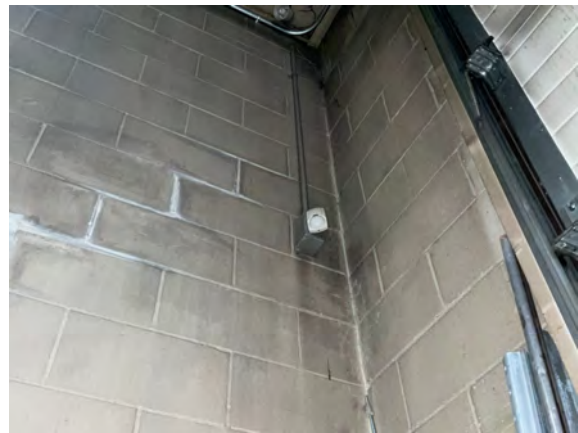
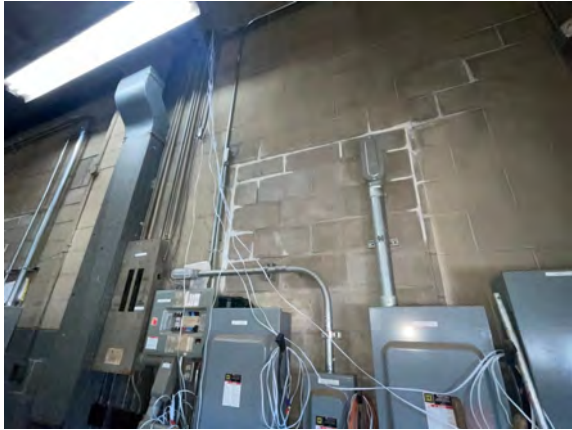
Palmer Public Works Garage - B103001

No significant deficiencies were observed or reported. Isolated mortar repair appears to have been completed recently. Replacement is not anticipated in the short term.

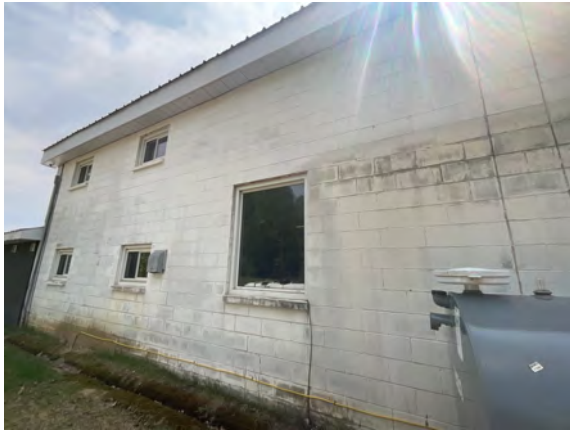
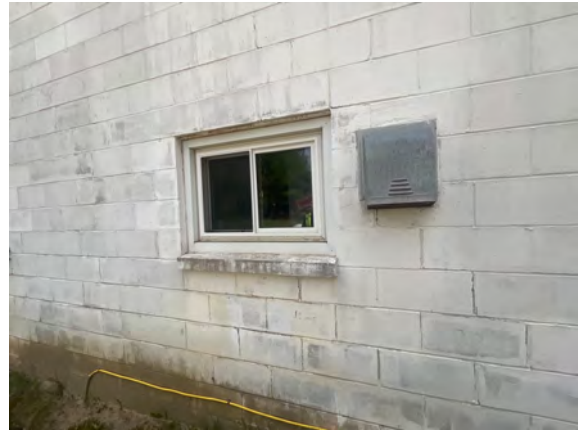
Palmer Public Works Garage - B201010

Deficiencies observed or reported during the assessment include fading and patching. The deterioration is anticipated to progress due to age and exposure to the elements and may lead to deterioration of underlying surfaces. Replacement is recommended in the short term.

<b>Recommendations #1 - Exterior Coatings/Paint</b>	
Type	Life Cycle Replacement
Year	2024
Cost	\$20,033.10

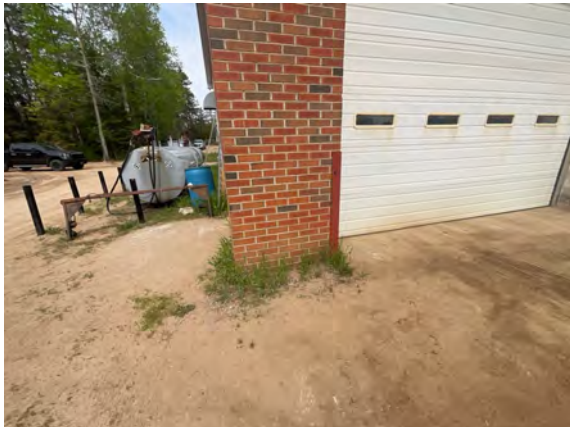
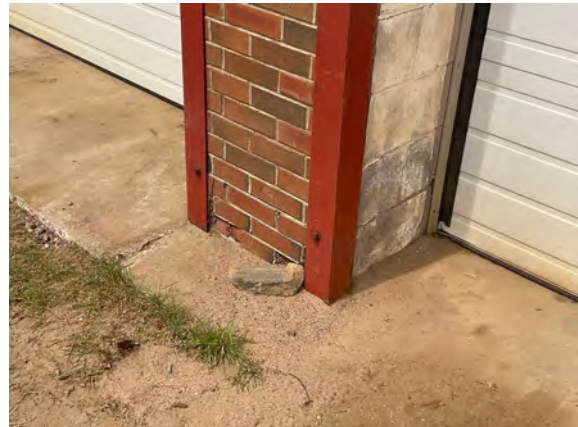
Palmer Public Works Garage - B201021

No significant deficiencies were observed or reported. Replacement is not anticipated in the short term. However, minor spalling was noted which should be repaired as a part of ongoing maintenance.

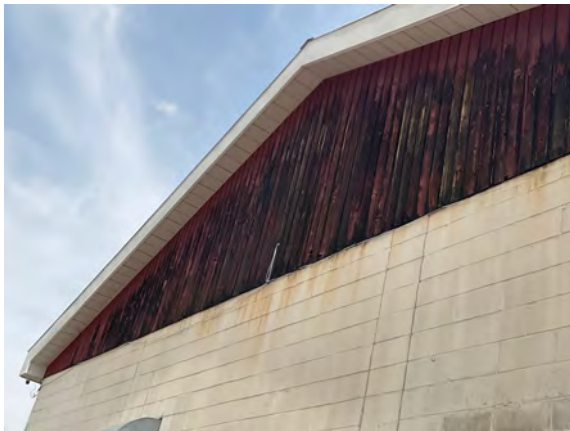
Palmer Public Works Garage - B201026

Deficiencies observed or reported during the assessment include damaged surfaces, delamination, deformation, loose connections, loose components, staining, fading, and gaps in material coverage. The deterioration is anticipated to progress due to age and exposure to the elements and may lead to moisture infiltration, and a weakening of integrity. Replacement is recommended in the short term.

<b>Recommendations #1 - Wood Siding</b>	
Type	Life Cycle Replacement
Year	2026
Cost	\$2,057.75

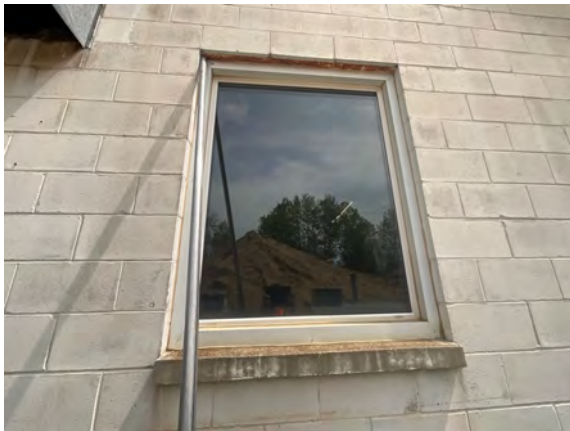
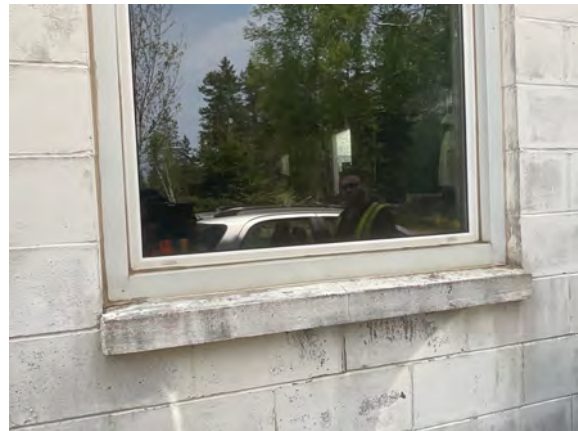
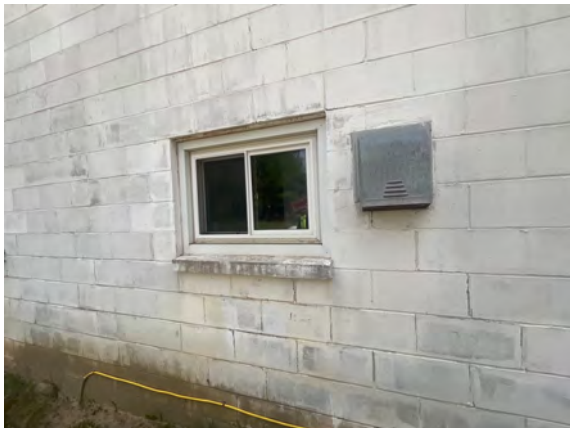
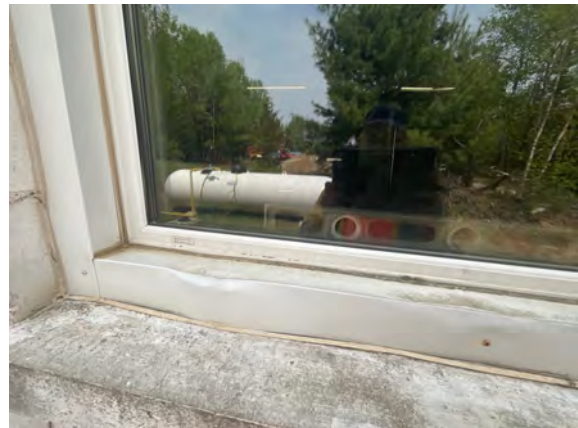
Palmer Public Works Garage - B202001

No significant deficiencies were observed or reported. However the system, based on age, has surpassed its expected useful life and may experience sealant failure over time, resulting in potential leakage, condensation, energy loss, and discomfort for building occupants. Replacement is recommended in the short term.

<b>Recommendations #1 - Windows</b>	
Type	Life Cycle Replacement
Year	2026
Cost	\$29,396.39

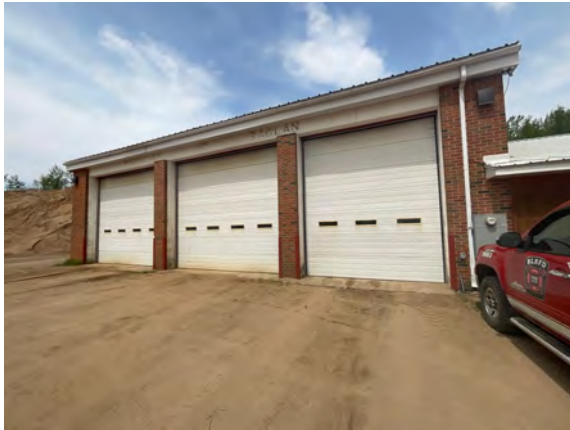
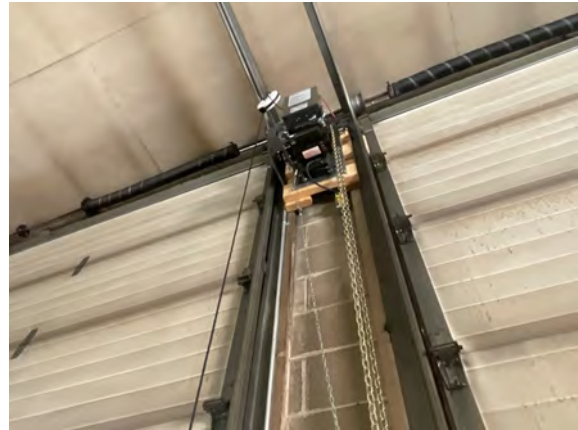
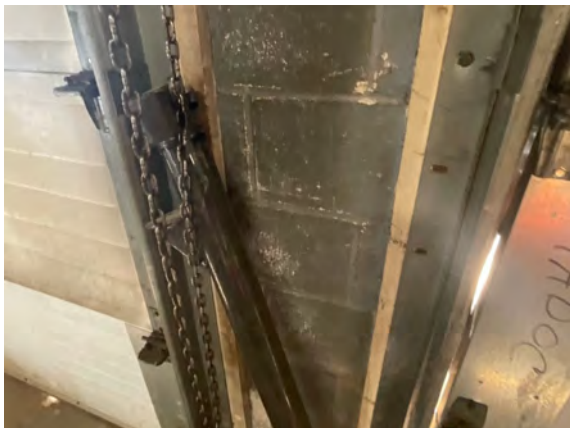
Palmer Public Works Garage - B203022

No significant deficiencies were observed or reported. The doors appear to have been updated with newer weatherstripping and lower panels. Some wear on the hardware was observed. Replacement is not anticipated in the short term.

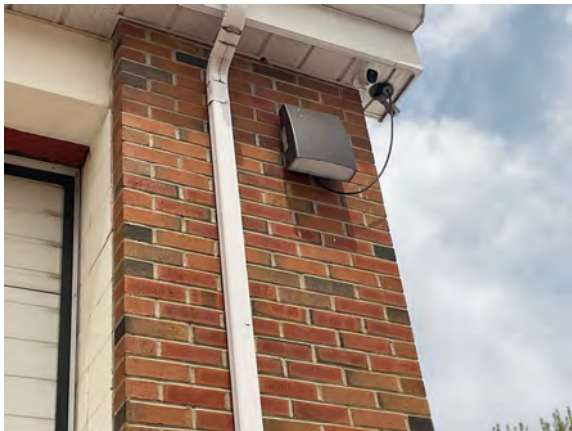
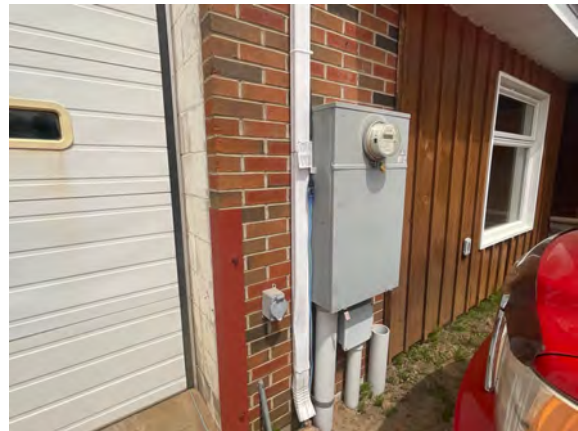
Palmer Public Works Garage - B301005

No significant deficiencies were observed or reported. Some fasteners appear to be corroded and causing staining on the fascia and soffit. Replacement is not anticipated in the short term.

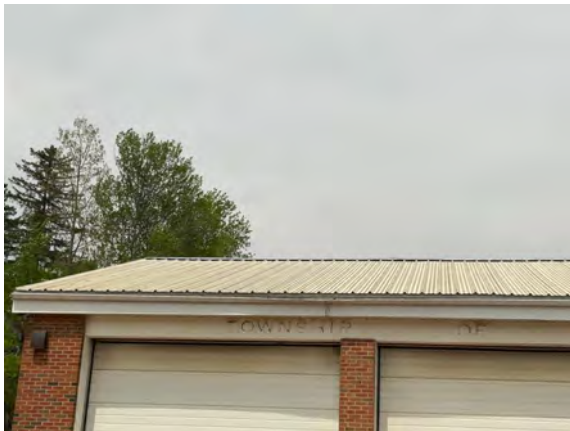
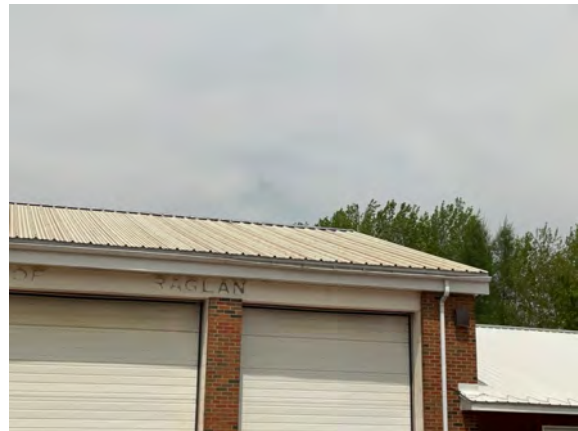
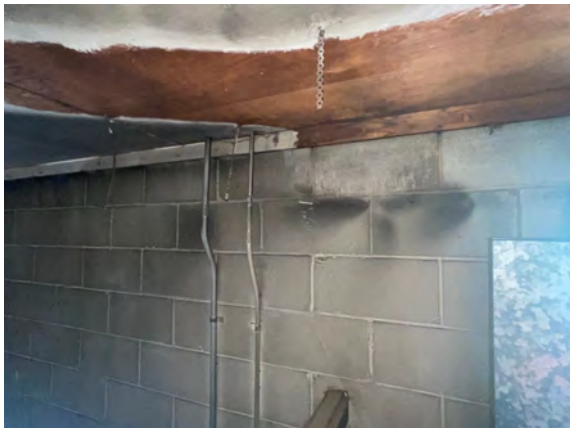
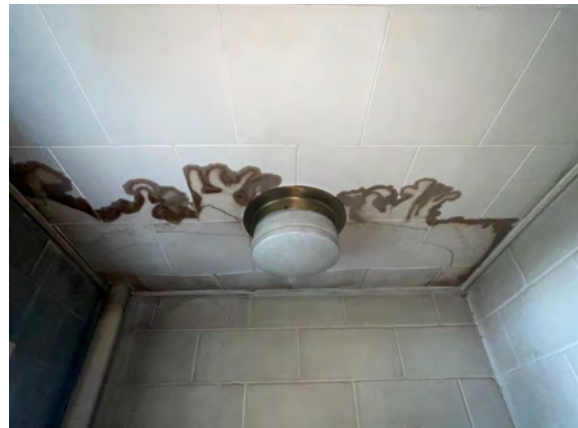
Palmer Public Works Garage - B301028

No significant deficiencies were observed or reported. However isolated areas of ceiling water stains suggest past roof leaks. The system, based on age may experience weakening of integrity over time, resulting in further moisture infiltration, damage to internal elements, and disruption to building operations. Replacement is recommended in the short term.

<b>Recommendations #1 - Metal Roofing</b>	
Type	Life Cycle Replacement
Year	2026
Cost	\$155,996.85

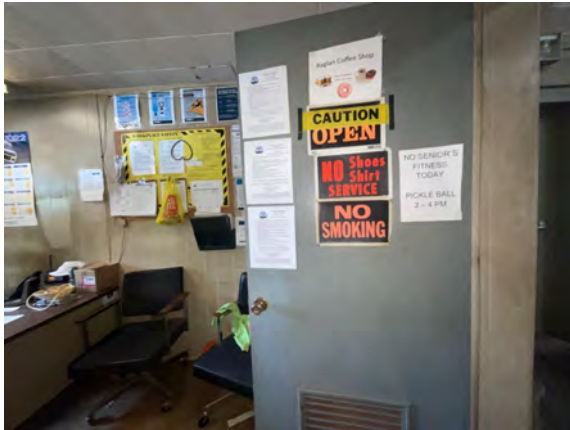
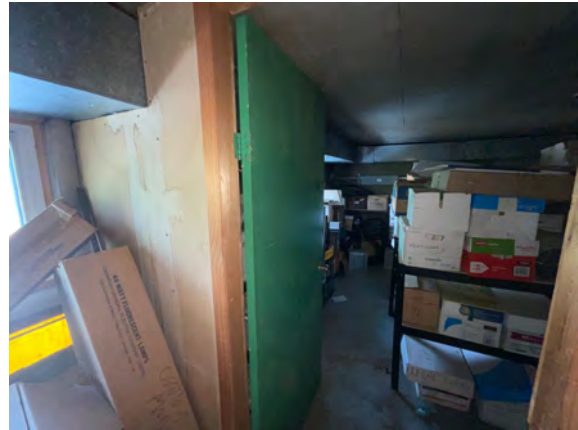
Palmer Public Works Garage - C102022

No significant deficiencies were observed or reported. However the system, based on age, is approaching or is past its expected useful life with performance and reliability likely diminishing over time. Replacement is recommended in the short term.

Recommendations #1 - Single Door - Wood	
Type	Life Cycle Replacement
Year	2026
Cost	\$6,859.16

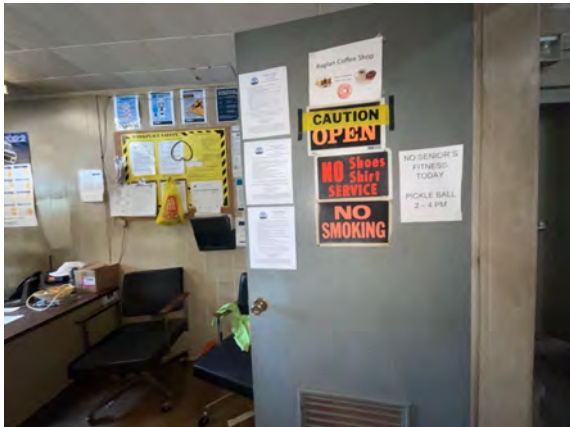
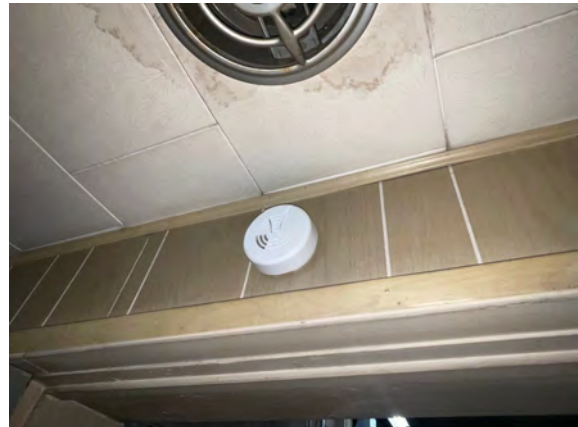
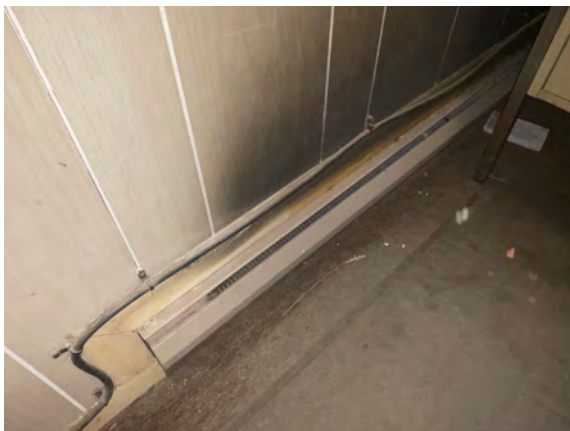
Palmer Public Works Garage - C301022

Deficiencies observed or reported during the assessment include staining, discoloration and fading. The deterioration is anticipated to progress due to age. Replacement is recommended in the short term.

<b>Recommendations #1 - Wood Wall Finish</b>	
Type	Life Cycle Replacement
Year	2024
Cost	\$4,164.49

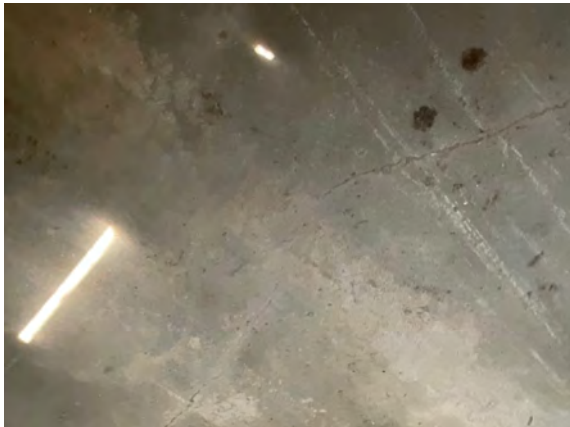
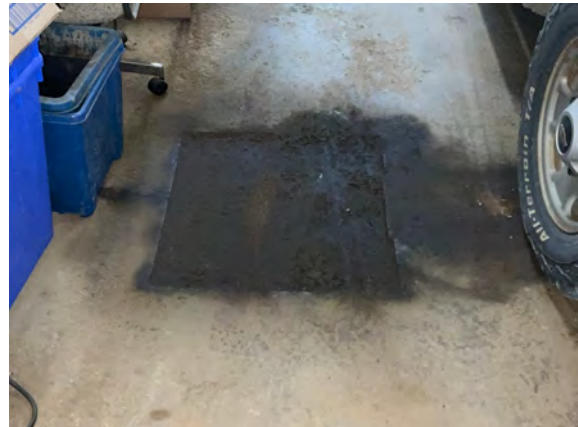
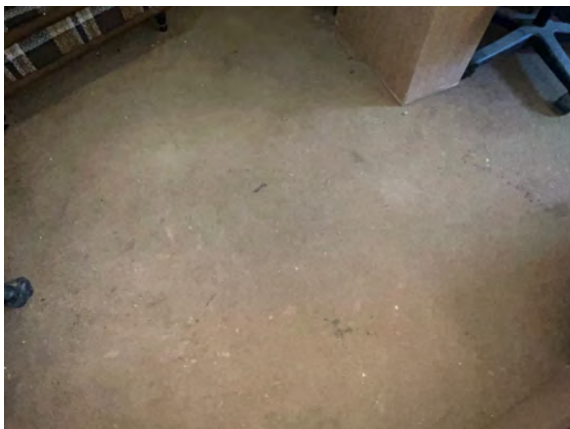
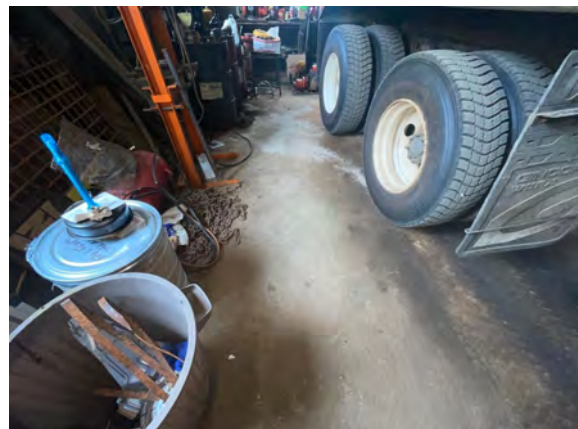
Palmer Public Works Garage - C302007

Deficiencies observed or reported during the assessment include stained, worn and peeling paint. The deterioration is anticipated to progress. Replacement is recommended in the short term.

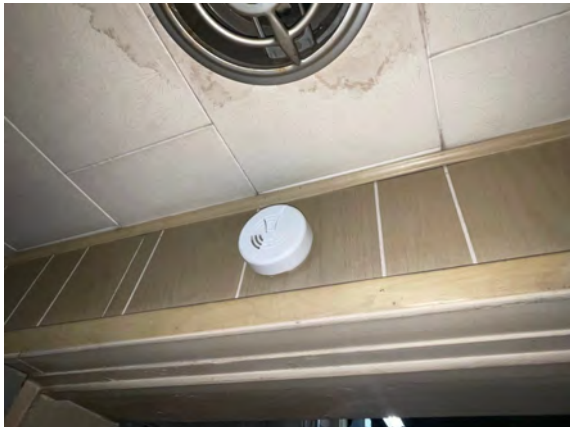
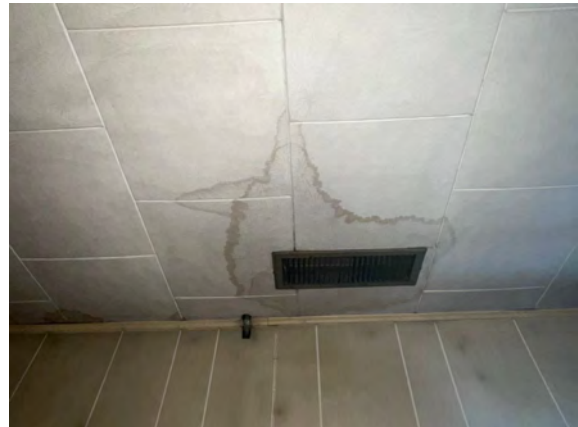
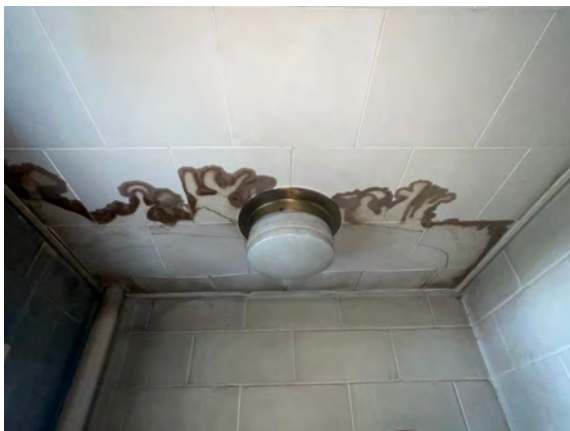
Palmer Public Works Garage - C303004

Deficiencies observed or reported during the assessment include staining, discoloration and fading. The deterioration is anticipated to progress due to age. Replacement is recommended in the short term.

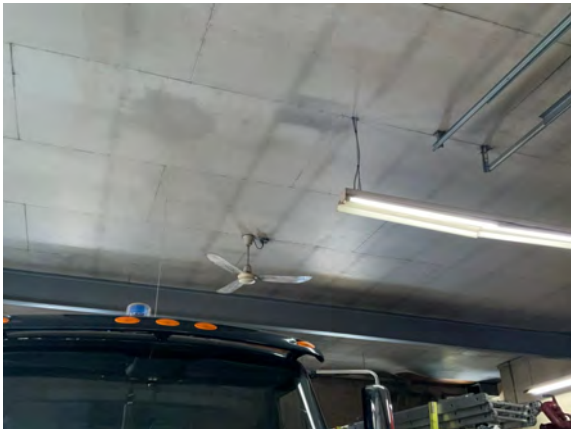
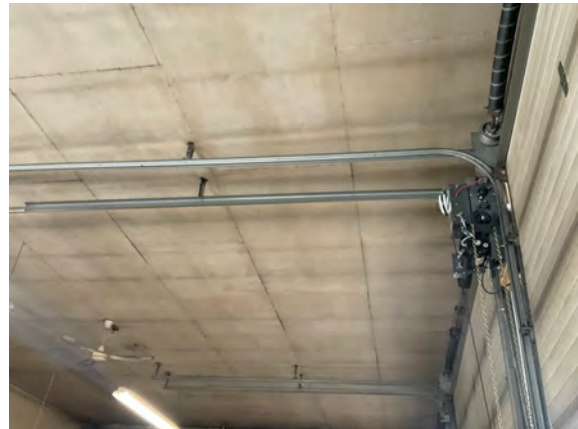
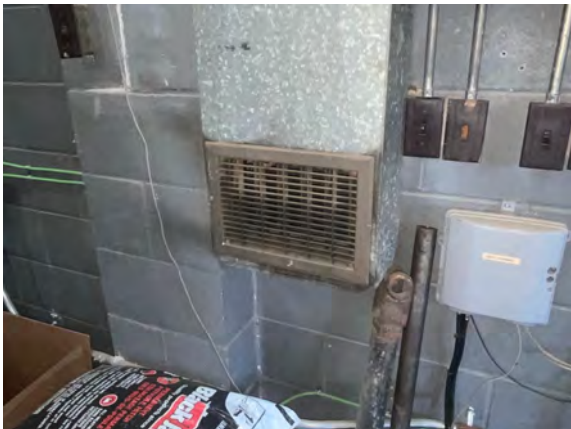
Palmer Public Works Garage - C303005

No significant deficiencies were observed or reported. However, dirt and particulate have accumulated on the wood panels. Repainting is recommended. Replacement is not anticipated in the short term.

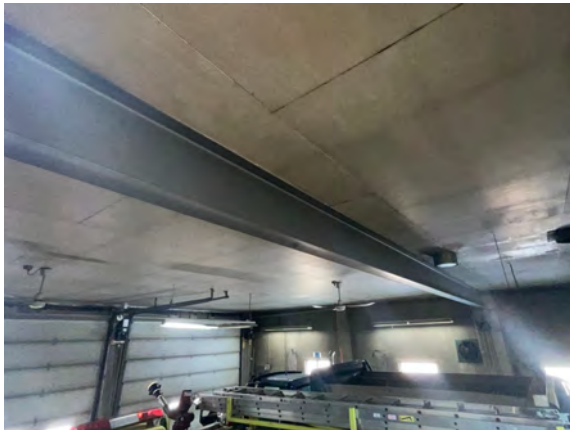
Palmer Public Works Garage - E103006

Element Description	
Name	D109007 - Overhead Cranes - Fixed - Workshop
Installation Year	1974
Condition	2 - Good
Expected Useful Life	30 Years
Remaining Useful Life	5 Years
Renewal Year	2029
Quantity / Unit of Measure	1 / Each
Unit Cost	\$9,850.00
Difficulty / Regional / Soft Cost / Replacement	1.00 / 1.04688 / 1.30000 / 1.0000
Element Cost	\$13,405.30

No significant deficiencies were observed or reported. Replacement is not anticipated in the short term.

Recommendations #1 - Overhead Cranes - Fixed	
Type	Life Cycle Replacement
Year	2029
Cost	\$13,405.30

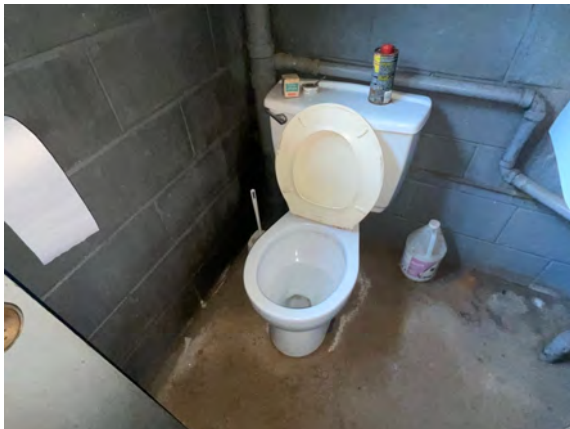
Palmer Public Works Garage - D201001

Element Description	
Name	D201001 - Water Closets - Workshop
Installation Year	2013
Condition	2 - Good
Expected Useful Life	35 Years
Remaining Useful Life	24 Years
Renewal Year	2048
Quantity / Unit of Measure	1 / Each
Unit Cost	\$1,200.00
Difficulty / Regional / Soft Cost / Replacement	1.00 / 1.04688 / 1.30000 / 1.0000
Element Cost	\$1,633.13

No significant deficiencies or leaks were observed or reported. Replacement is not anticipated in the short term.

Recommendations #1 - Water Closets	
Type	Life Cycle Replacement
Year	2048
Cost	\$1,633.13

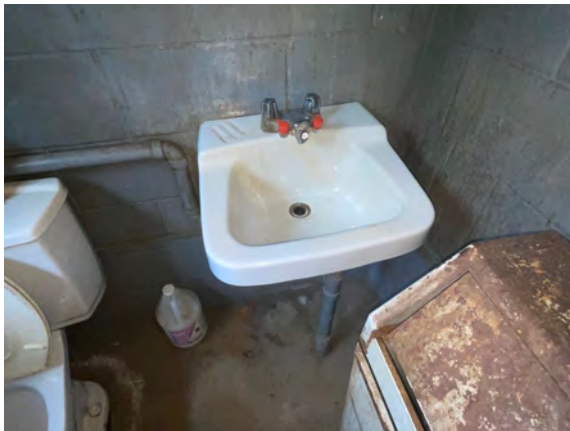
Palmer Public Works Garage - D201003

<b>Element Description</b>	
Name	D201003 - Lavatories - Workshop
Installation Year	1974
Condition	3 - Fair
Expected Useful Life	35 Years
Remaining Useful Life	2 Years
Renewal Year	2026
Quantity / Unit of Measure	1 / Each
Unit Cost	\$1,200.00
Difficulty / Regional / Soft Cost / Replacement	1.00 / 1.04688 / 1.30000 / 1.0000
Element Cost	\$1,633.13

No significant deficiencies were observed or reported. However the system, based on age, is approaching or is past its expected useful life with performance and reliability likely diminishing over time. Replacement is recommended in the short term.

<b>Recommendations #1 - Lavatories</b>	
Type	Life Cycle Replacement
Year	2026
Cost	\$1,633.13

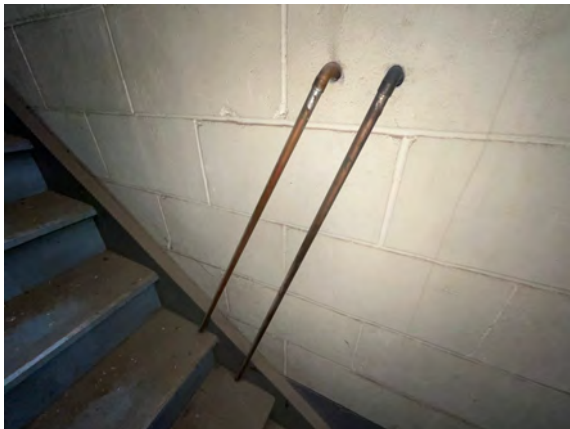
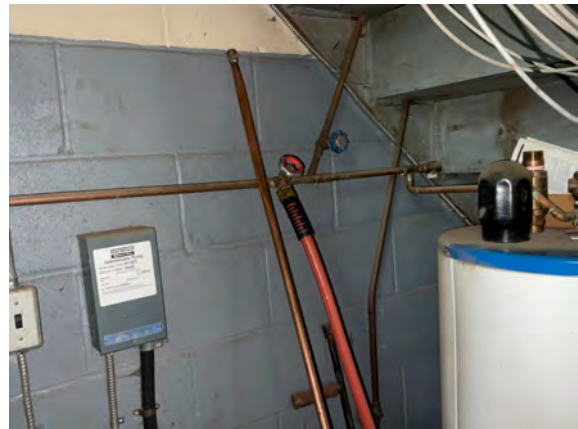
Palmer Public Works Garage - D202001

<b>Element Description</b>	
Name	D202001 - Domestic Water Piping and Fittings - Workshop
Installation Year	1974
Condition	3 - Fair
Expected Useful Life	40 Years
Remaining Useful Life	2 Years
Renewal Year	2026
Quantity / Unit of Measure	240 / SM Building
Unit Cost	\$60.00
Difficulty / Regional / Soft Cost / Replacement	1.00 / 1.04688 / 1.30000 / 1.0000
Element Cost	\$19,597.59

No significant deficiencies were observed or reported. Some sections of piping appear to have been updated. However, the majority of the system appears to be original to building construction and due to age can experience piping fatigue over time which can result in failure. Replacement is recommended in the short term.

<b>Recommendations #1 - Domestic Water Piping and Fittings</b>	
Type	Life Cycle Replacement
Year	2026
Cost	\$19,597.59

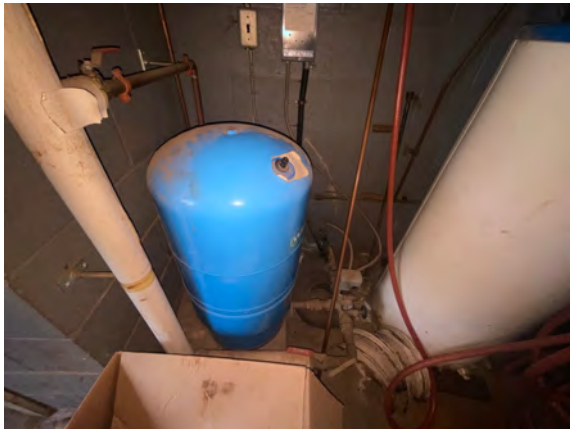
Palmer Public Works Garage - D202021

Element Description	
Name	D202008 - Domestic Water Expansion Tanks/Pressure Tanks - Workshop
Installation Year	1974
Condition	3 - Fair
Expected Useful Life	30 Years
Remaining Useful Life	2 Years
Renewal Year	2026
Quantity / Unit of Measure	1 / Each
Unit Cost	\$4,590.00
Difficulty / Regional / Soft Cost / Replacement	0.50 / 1.04688 / 1.30000 / 1.0000
Element Cost	\$3,123.37

No significant deficiencies were observed or reported. However the system, based on age, is approaching or is past its expected useful life with performance and reliability likely diminishing over time. Replacement is recommended in the short term.

Recommendations #1 - Domestic Water Expansion Tanks/Pressure Tanks	
Type	Life Cycle Replacement
Year	2026
Cost	\$3,123.37

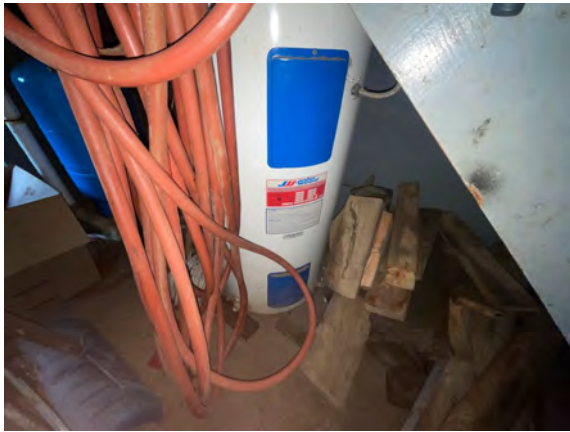
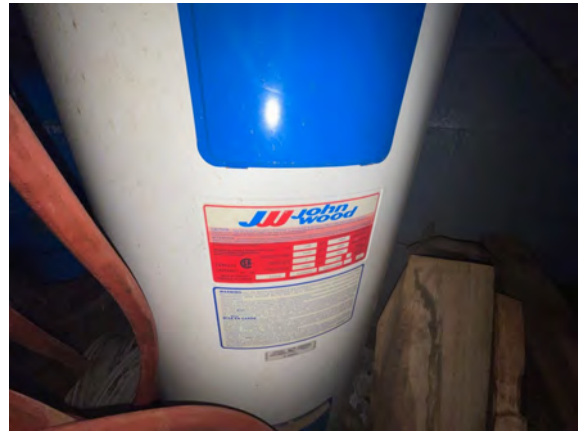
Palmer Public Works Garage - D202034

<b>Element Description</b>	
Name	D202033 - Domestic Water Heaters - Commercial Electric - Workshop
Installation Year	1995
Condition	4 - Poor
Expected Useful Life	15 Years
Remaining Useful Life	0 Years
Renewal Year	2024
Quantity / Unit of Measure	175 / Liter
Unit Cost	\$57.00
Difficulty / Regional / Soft Cost / Replacement	1.00 / 1.04688 / 1.30000 / 1.0000
Element Cost	\$13,575.42

No significant deficiencies were observed or reported. However, the system, based on age, is approaching or is past its expected useful life with performance and reliability likely diminishing over time. Replacement is recommended in the short term.

<b>Recommendations #1 - Domestic Water Heaters - Residential Gas-Fired</b>	
Type	Life Cycle Replacement
Year	2024
Cost	\$13,575.42

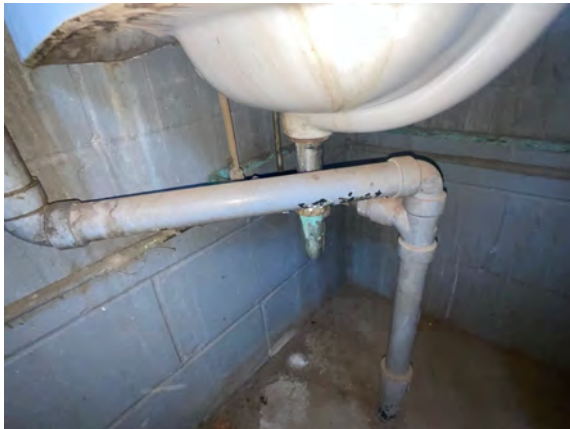
Palmer Public Works Garage - D203001

<b>Element Description</b>	
Name	D203001 - Sanitary Waste and Vent Piping and Fittings - Workshop
Installation Year	1974
Condition	2 - Good
Expected Useful Life	50 Years
Remaining Useful Life	5 Years
Renewal Year	2029
Quantity / Unit of Measure	240 / SM Building
Unit Cost	\$60.00
Difficulty / Regional / Soft Cost / Replacement	1.00 / 1.04688 / 1.30000 / 1.0000
Element Cost	\$19,597.59

No significant deficiencies were observed or reported. The system appears to have been updated. Replacement is not anticipated in the short term.

<b>Recommendations #1 - Sanitary Waste and Vent Piping and Fittings</b>	
Type	Life Cycle Replacement
Year	2026
Cost	\$19,597.59

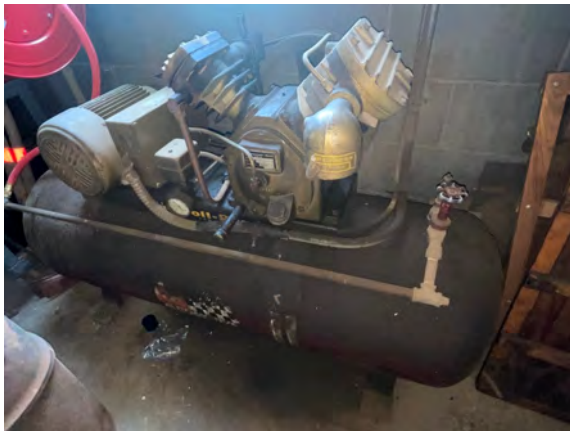
Palmer Public Works Garage - D209005

<b>Element Description</b>	
Name	D209005 - Compressed Air Piping and Fittings - Workshop
Installation Year	1974
Condition	4 - Poor
Expected Useful Life	30 Years
Remaining Useful Life	0 Years
Renewal Year	2024
Quantity / Unit of Measure	240 / SM
Unit Cost	\$27.00
Difficulty / Regional / Soft Cost / Replacement	1.00 / 1.04688 / 1.30000 / 1.0000
Element Cost	\$8,818.92

No significant deficiencies were observed or reported. However the system, based on age, is approaching or is past its expected useful life and can experience electrical or thermal breakdown over time which can eventually result in failure. Replacement is recommended in the short term.

<b>Recommendations #1 - Compressed Air Piping and Fittings</b>	
Type	Life Cycle Replacement
Year	2024
Cost	\$8,818.92

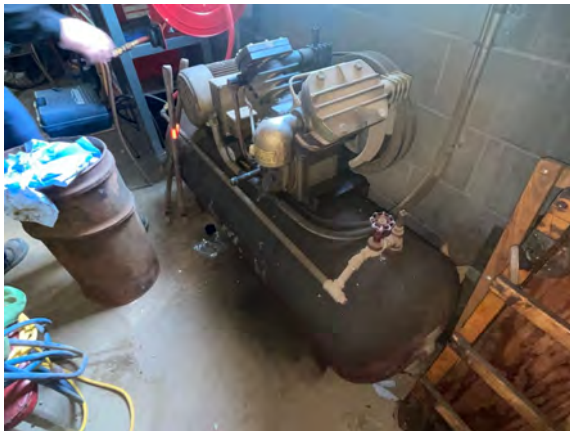
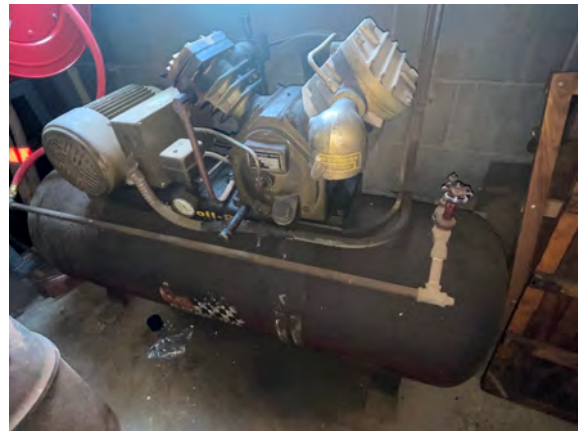
Palmer Public Works Garage - D209006

<b>Element Description</b>	
Name	D209006 - Air Compressors and Air Dryers - Workshop
Installation Year	1974
Condition	4 - Poor
Expected Useful Life	15 Years
Remaining Useful Life	0 Years
Renewal Year	2024
Quantity / Unit of Measure	1 / Each
Unit Cost	\$8,800.00
Difficulty / Regional / Soft Cost / Replacement	1.00 / 1.04688 / 1.30000 / 1.0000
Element Cost	\$11,976.31

No significant deficiencies were observed or reported. However, the system, based on age, is approaching or is past its expected useful life with performance and reliability likely diminishing over time. Replacement is recommended in the short term.

<b>Recommendations #1 - Air Compressors and Air Dryers</b>	
Type	Life Cycle Replacement
Year	2024
Cost	\$11,976.31

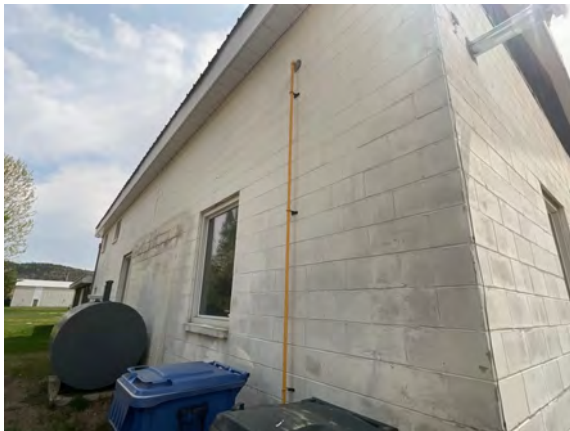
Palmer Public Works Garage - D301001

Element Description	
Name	D301002 - Natural Gas Supply Piping and Fittings - Workshop
Installation Year	2022
Condition	2 - Good
Expected Useful Life	40 Years
Remaining Useful Life	38 Years
Renewal Year	2062
Quantity / Unit of Measure	240 / SM
Unit Cost	\$30.00
Difficulty / Regional / Soft Cost / Replacement	1.00 / 1.04688 / 1.30000 / 1.0000
Element Cost	\$9,798.80

No significant deficiencies were observed or reported. Replacement is not anticipated in the short term.

Recommendations #1 - Gas Distribution (Natural or Propane)	
Type	Life Cycle Replacement
Year	2072
Cost	\$9,798.80

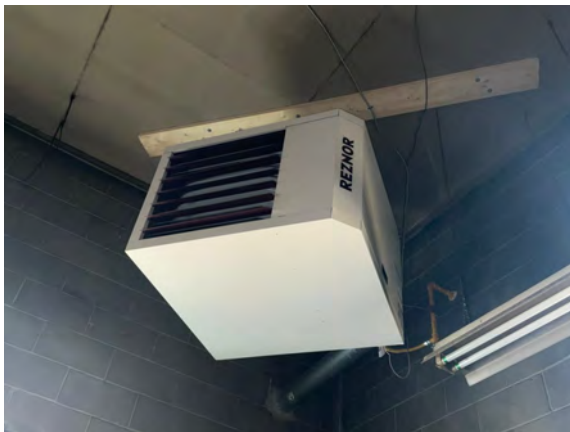
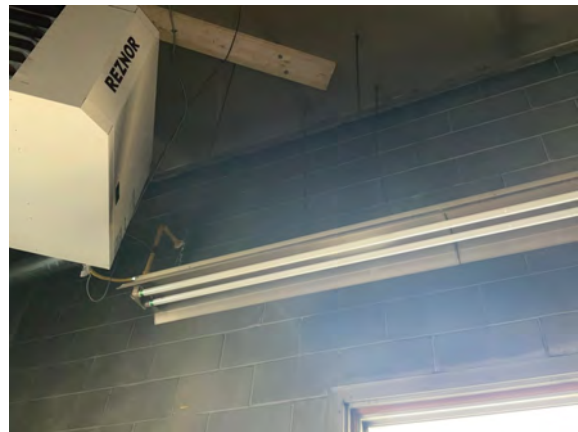
Palmer Public Works Garage - D302004

<b>Element Description</b>	
Name	D302004 - Fuel-Fired Unit Heaters - Workshop
Installation Year	2022
Condition	2 - Good
Expected Useful Life	18 Years
Remaining Useful Life	16 Years
Renewal Year	2040
Quantity / Unit of Measure	1 / Each
Unit Cost	\$3,940.00
Difficulty / Regional / Soft Cost / Replacement	1.00 / 1.04688 / 1.30000 / 1.0000
Element Cost	\$5,362.12

No significant deficiencies were observed or reported. Replacement is not anticipated in the short term.

<b>Recommendations #1 - Fuel-Fired Unit Heaters</b>	
Type	Life Cycle Replacement
Year	2040
Cost	\$5,362.12

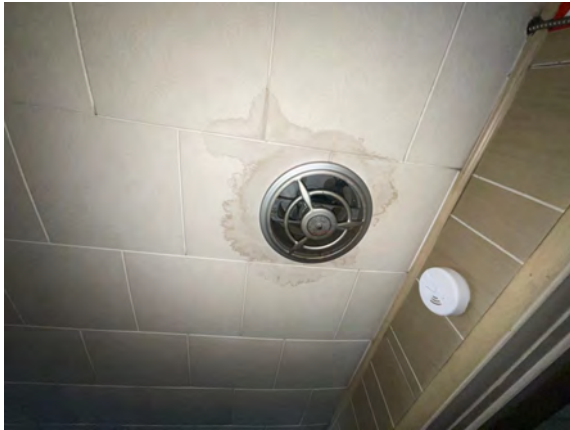
Palmer Public Works Garage - D304033

<b>Element Description</b>	
Name	D304033 - Exhaust Fans - Residential - Workshop
Installation Year	1974
Condition	3 - Fair
Expected Useful Life	25 Years
Remaining Useful Life	2 Years
Renewal Year	2026
Quantity / Unit of Measure	1 / Each
Unit Cost	\$1,150.00
Difficulty / Regional / Soft Cost / Replacement	1.00 / 1.04688 / 1.30000 / 1.0000
Element Cost	\$1,565.09

No significant deficiencies were observed or reported. However the system, based on age, is approaching or is past its expected useful life with performance and reliability likely diminishing over time. Replacement is recommended in the short term.

<b>Recommendations #1 - Exhaust Fans - Residential</b>	
Type	Life Cycle Replacement
Year	2026
Cost	\$1,565.09

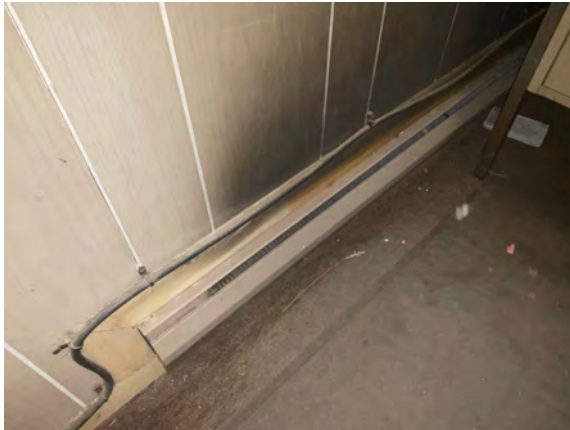
Palmer Public Works Garage - D305010

<b>Element Description</b>	
Name	D305010 - Electric Baseboard Heaters - Workshop
Installation Year	1974
Condition	4 - Poor
Expected Useful Life	18 Years
Remaining Useful Life	1 Year
Renewal Year	2025
Quantity / Unit of Measure	1 / Each
Unit Cost	\$360.00
Difficulty / Regional / Soft Cost / Replacement	1.00 / 1.04688 / 1.30000 / 1.0000
Element Cost	\$489.94

No significant deficiencies were observed or reported. However, the system, based on age, is approaching or is past its expected useful life with performance and reliability likely diminishing over time. Replacement is recommended in the short term.

<b>Recommendations #1 - Electric Baseboard Heaters</b>	
Type	Life Cycle Replacement
Year	2026
Cost	\$489.94

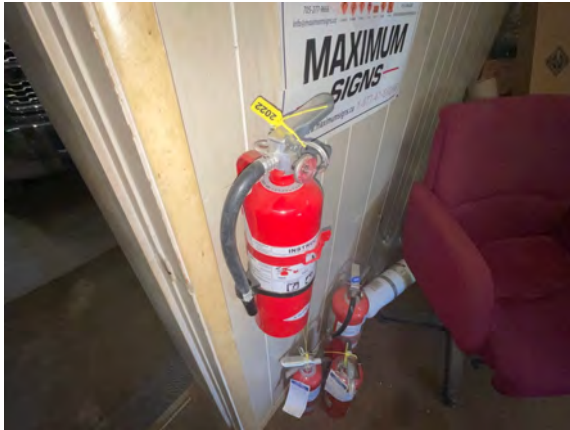
Palmer Public Works Garage - D403002

Element Description	
Name	D403001 - Individual Fire Extinguishers - Workshop
Installation Year	2017
Condition	2 - Good
Expected Useful Life	10 Years
Remaining Useful Life	5 Years
Renewal Year	2029
Quantity / Unit of Measure	4 / Each
Unit Cost	\$258.00
Difficulty / Regional / Soft Cost / Replacement	1.00 / 1.04688 / 1.30000 / 1.0000
Element Cost	\$1,404.49

No significant deficiencies were observed or reported. Replacement is not anticipated in the short term.

Recommendations #1 - Individual Fire Extinguishers	
Type	Life Cycle Replacement
Year	2029
Cost	\$1,404.49

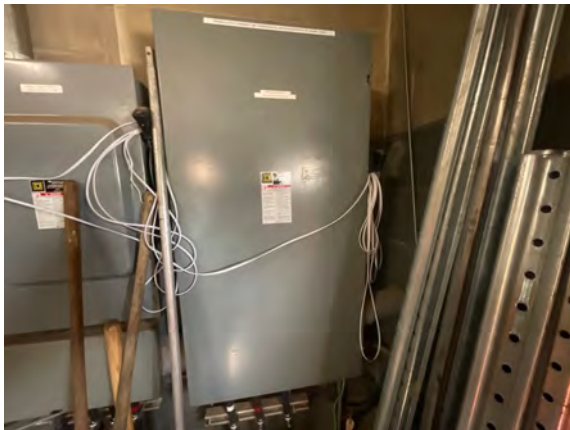
Palmer Public Works Garage - D501025

Element Description	
Name	D501025 - Main Service Disconnects - Workshop
Installation Year	2013
Condition	2 - Good
Expected Useful Life	40 Years
Remaining Useful Life	29 Years
Renewal Year	2053
Quantity / Unit of Measure	1 / Each
Unit Cost	\$12,560.00
Difficulty / Regional / Soft Cost / Replacement	1.00 / 1.04688 / 1.30000 / 1.0000
Element Cost	\$17,093.46

No significant deficiencies were observed or reported. Replacement is not anticipated in the short term.

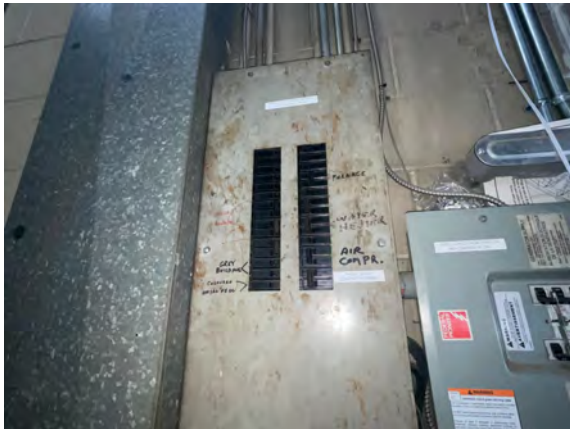
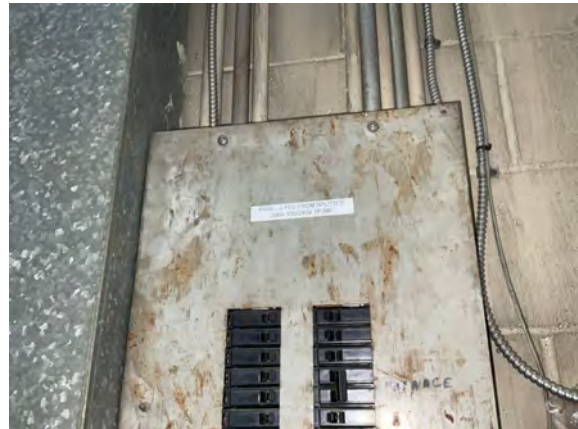
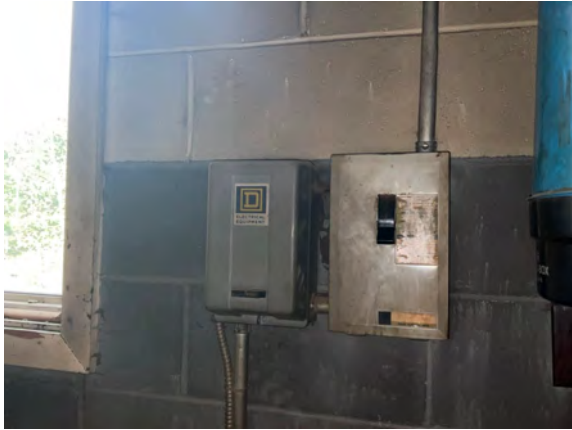
Palmer Public Works Garage - D501031

No significant deficiencies were observed or reported. However, the system based on age, is approaching or is past its expected useful life and can experience electrical or thermal breakdown over time. Replacement is recommended in the short term.

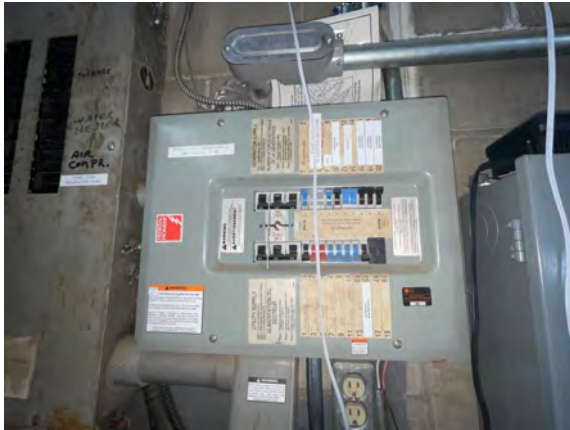
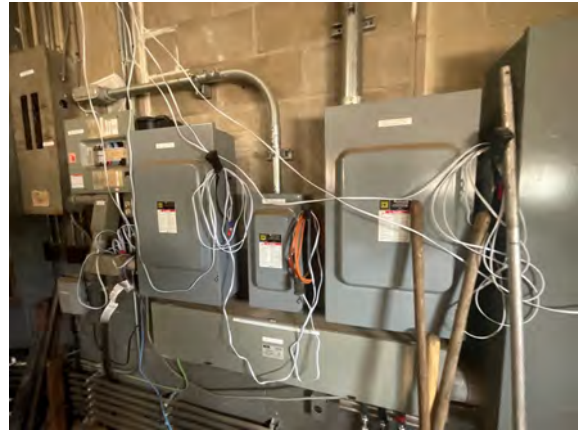
Palmer Public Works Garage - D501031

No significant deficiencies were observed or reported. Replacement is not anticipated in the short term.

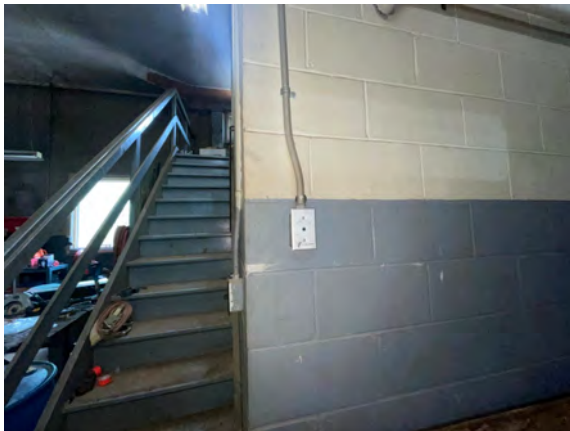
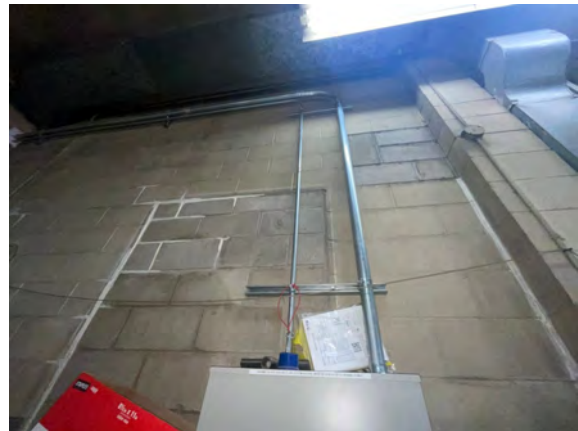
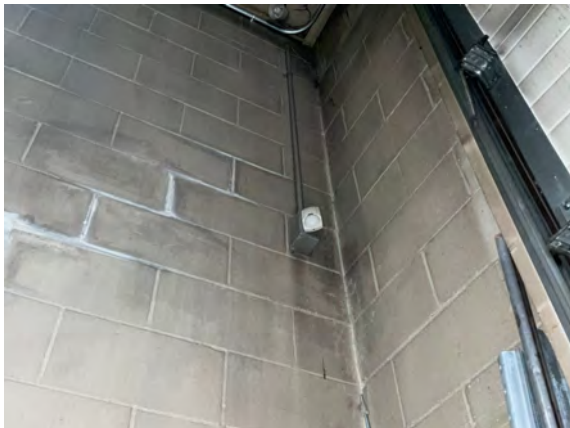
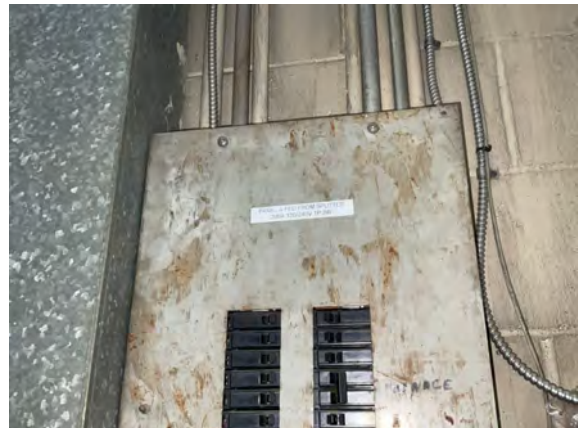
Palmer Public Works Garage - D502001

No significant deficiencies were observed or reported. Some wiring was added over time. However the system, based on age, is approaching or is past its expected useful life and can experience insulation breakdown over time. Replacement is recommended in the short term.

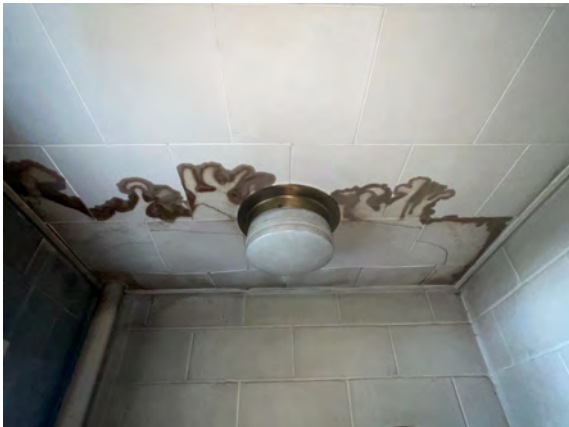
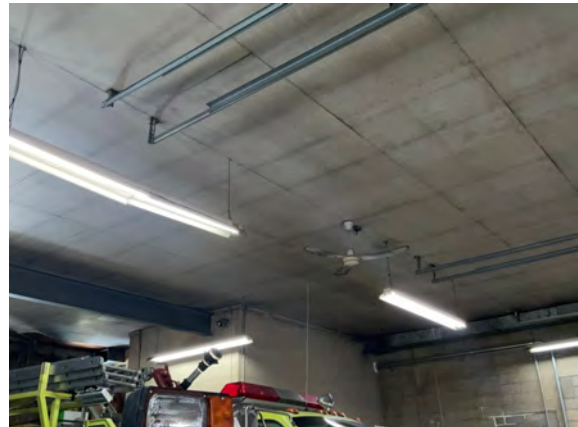
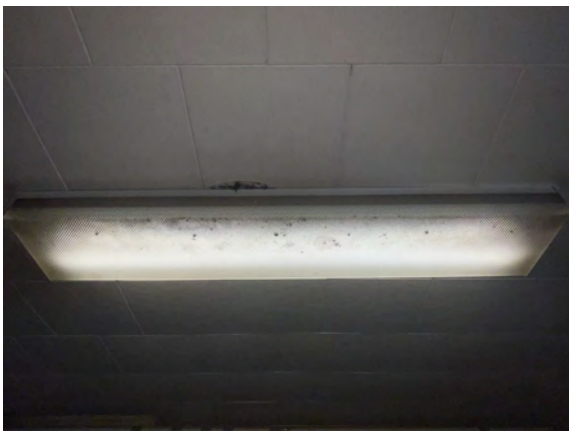
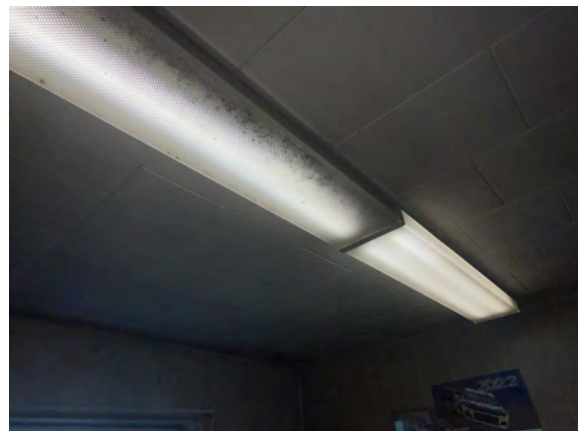
Palmer Public Works Garage - D502002

No significant deficiencies were observed or reported. However the lighting is energy inefficient. Replacement with upgrade to LED is recommended.

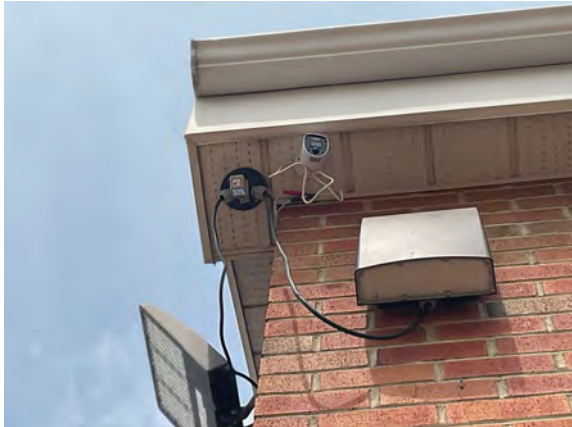
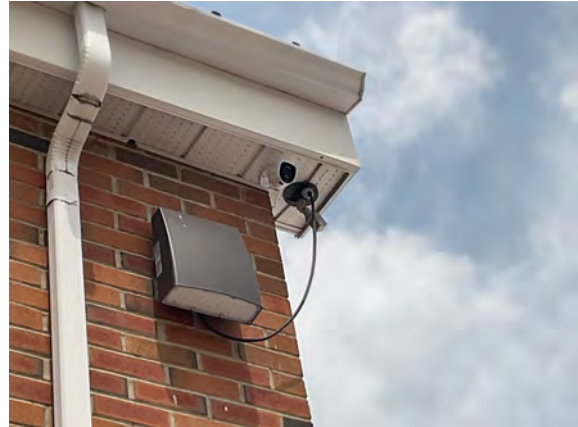
Palmer Public Works Garage - D502041

No significant deficiencies were observed or reported. Replacement is not anticipated in the short term.

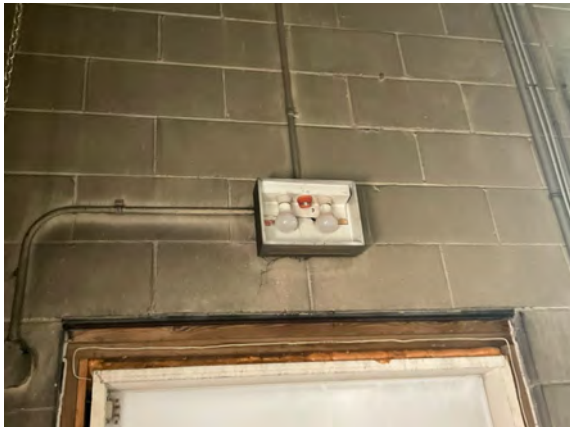
Palmer Public Works Garage - D502051

Deficiencies observed or reported at the time of the assessment include damaged fixtures and poor illumination. Replacement with upgrade to pictogram exit signs is recommended in the short term.

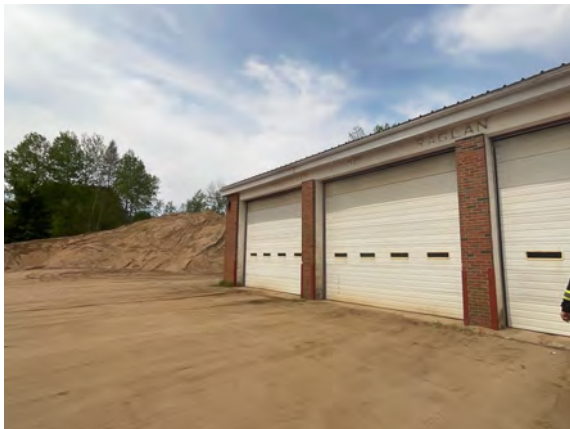
Palmer Public Works Garage - G201025

Deterioration in the form of rutting, and potholes was evident at isolated sections of the gravel paved surface. Repair of the deteriorated sections of the roadway is recommended.

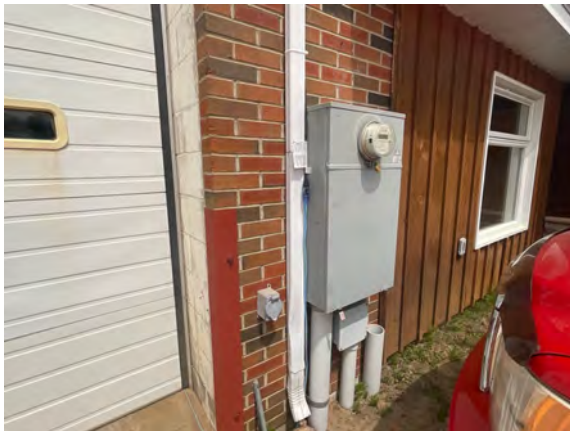
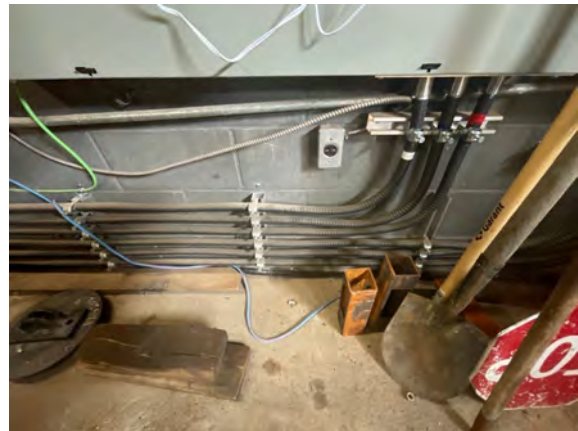
Palmer Public Works Garage - G401011

No significant deficiencies were observed or reported. Replacement is not anticipated in the short term. The service was upgraded in 2013.
