# Brudenell Lyndoch and Raglan

Submission to Township of Brudenell, Lyndoch, and Raglan

Roth IAMS Ltd.  
207-1075 North Service Rd W, Oakville ON, L6M 2G2  
[www.rothiams.com](http://www.rothiams.com)  
Project No. 23502

**Facility Condition Assessment Report**  
**Brudenell Fire Hall #4**

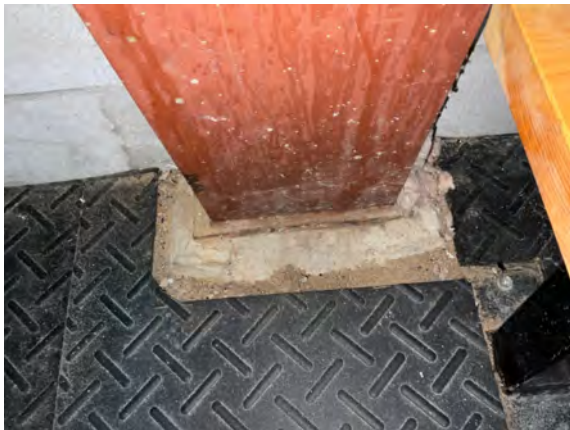
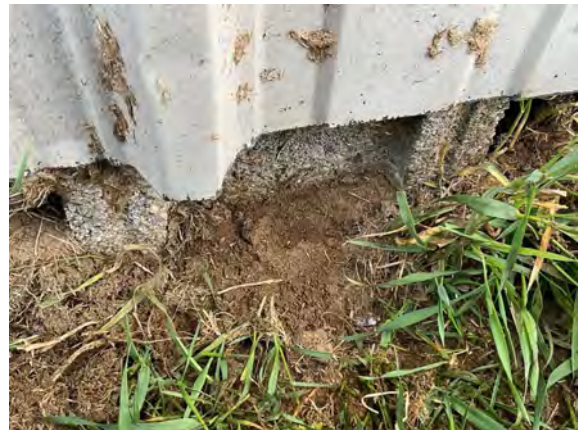
Palmer Rec Center - A101001

No significant deficiencies were observed or reported on the exposed superstructure or interior finishes to suggest differential settlement or deterioration of the building foundations.

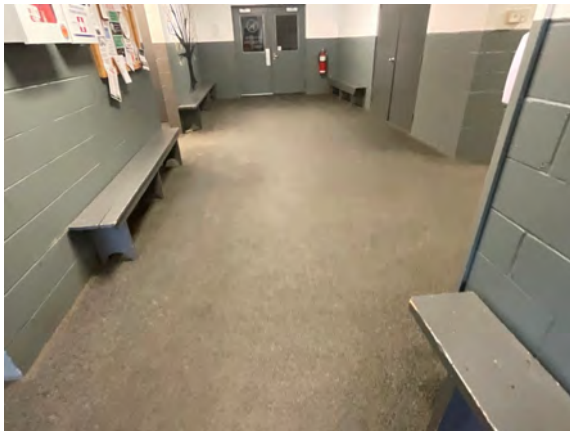
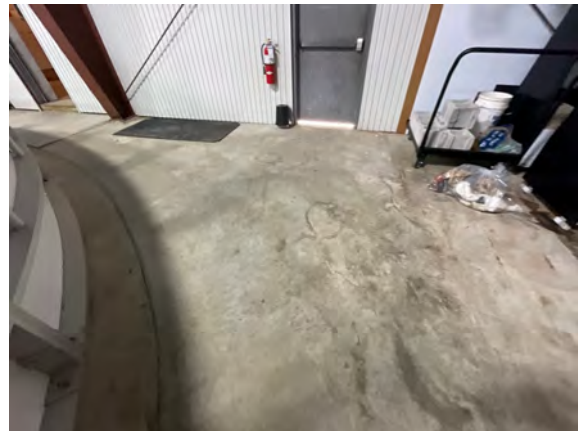
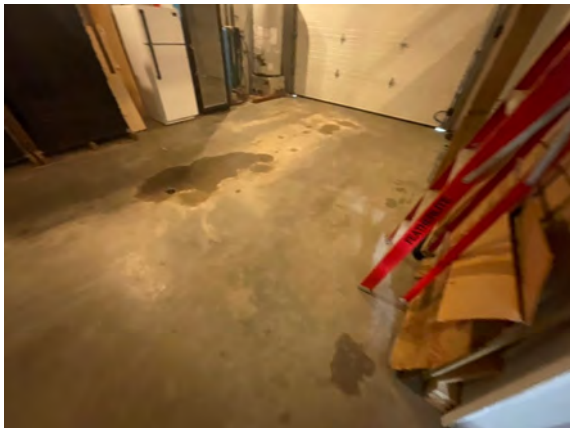
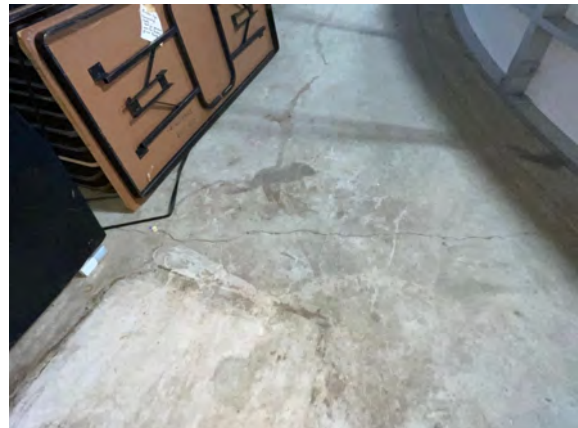
Palmer Rec Center - A103001

No major deficiencies were observed or reported. Some minor isolated cracking was observed, no significant elevation difference to suggest differential settlement of the concrete slab-on-grade was noted.

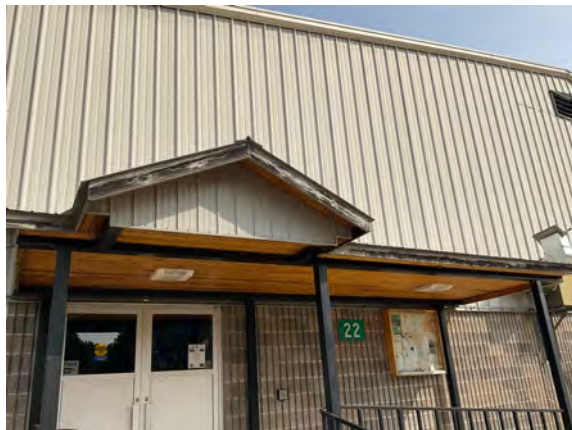
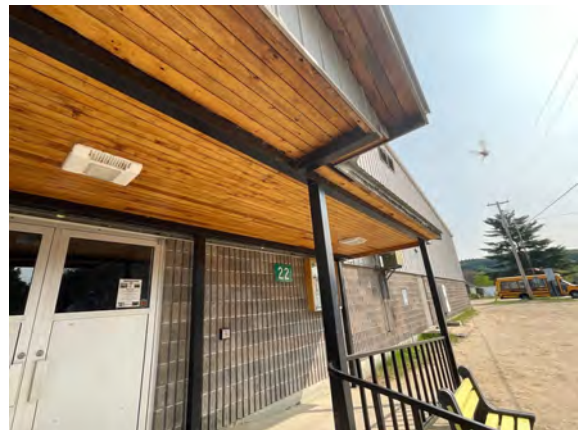
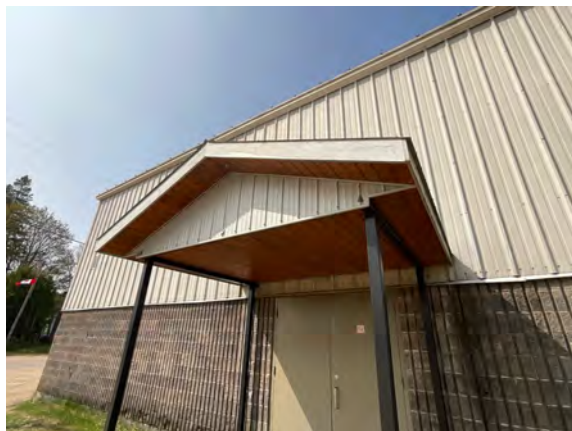
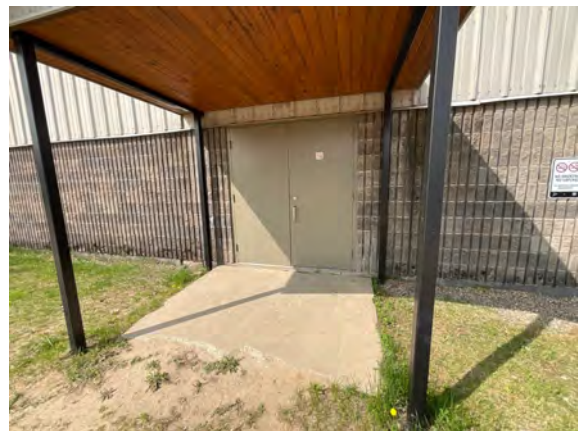
Palmer Rec Center - B102004

No significant deficiencies were observed or reported. Replacement is not anticipated in the short term.

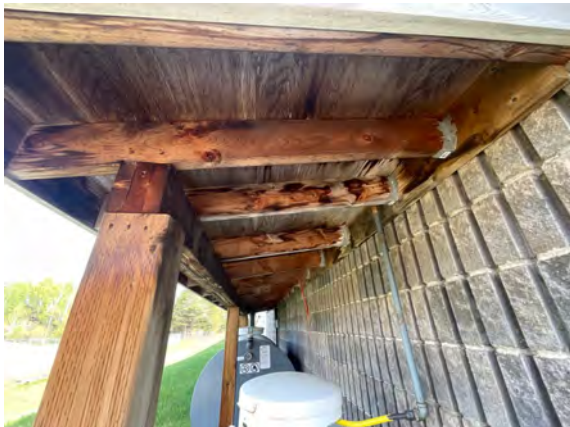
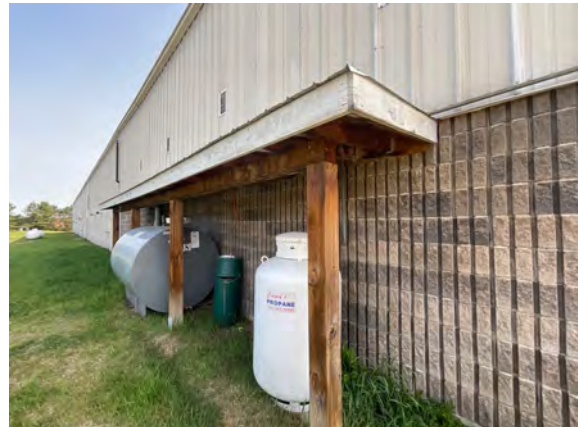
Palmer Rec Center - B102004

No significant deficiencies were observed or reported. Replacement is not anticipated in the short term.

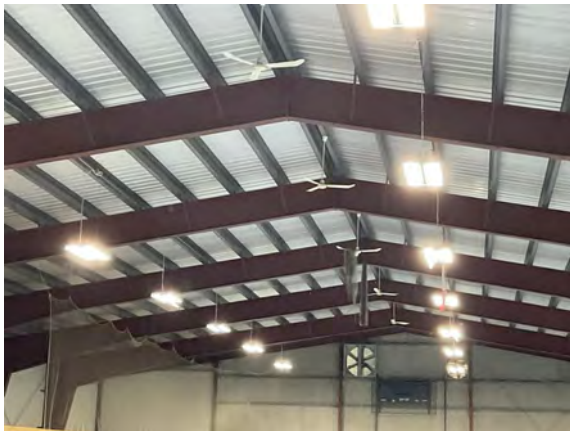
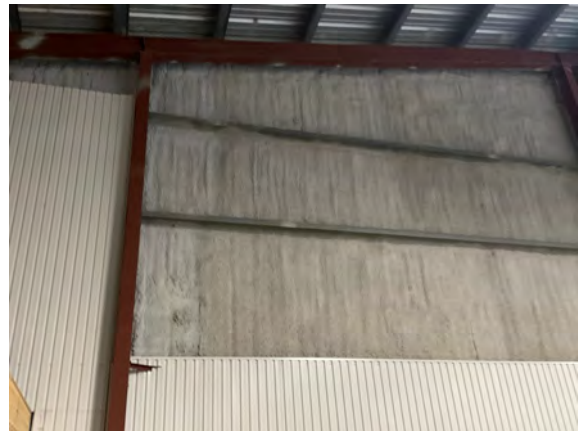
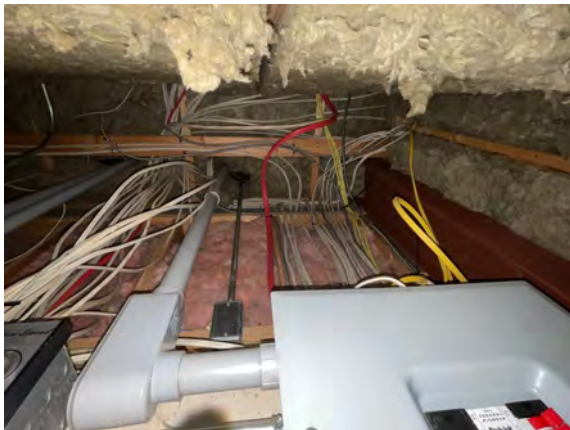
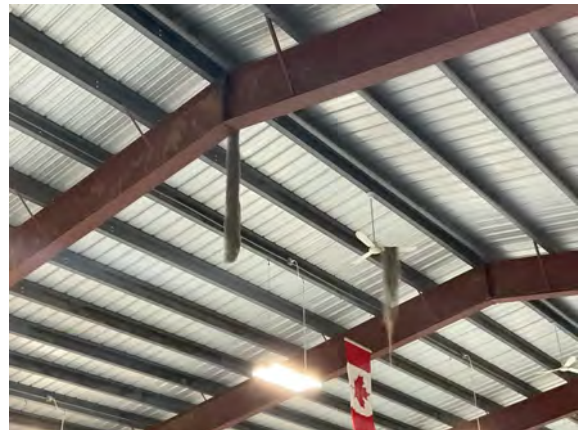
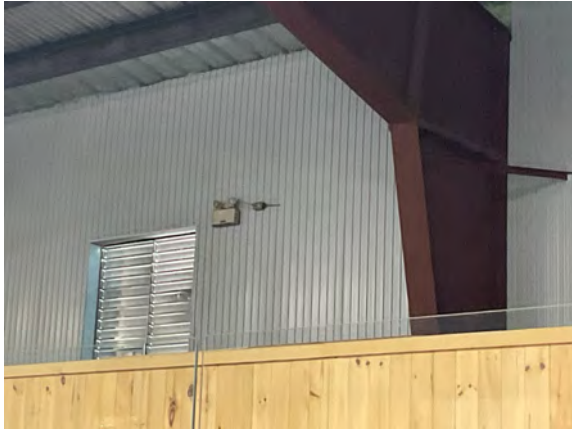
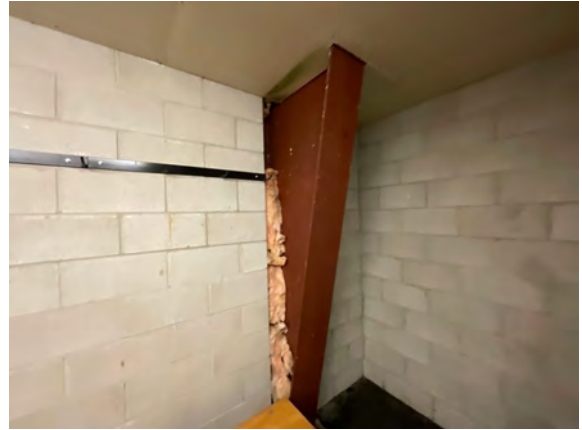
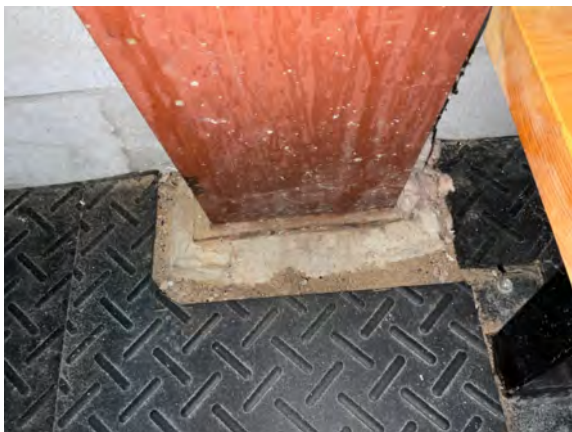
Palmer Rec Center - B103001

No significant deterioration was noted or signs to suggest the movement of the building structure.

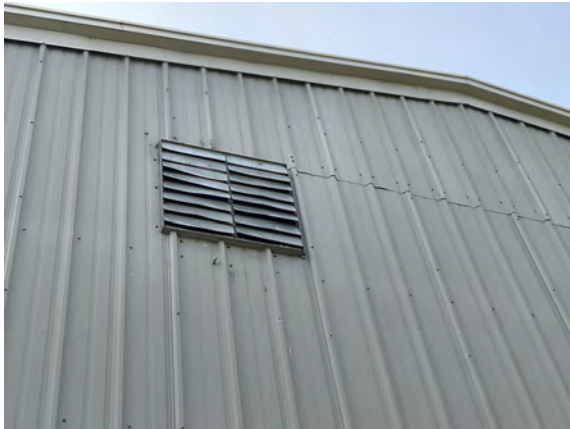
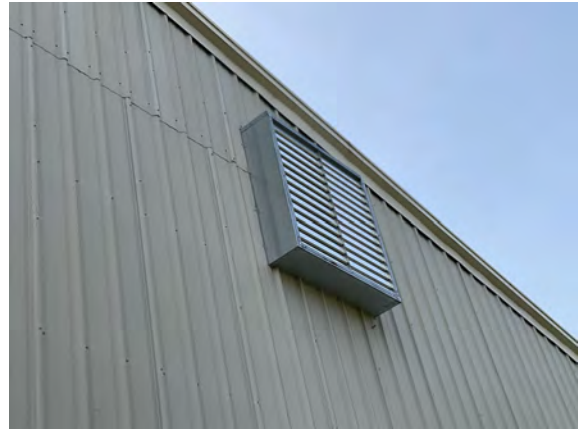
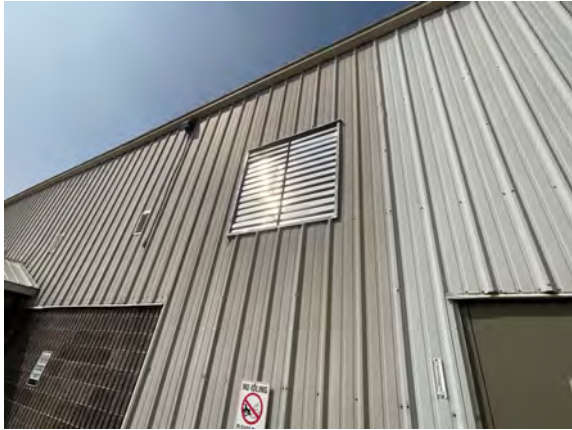
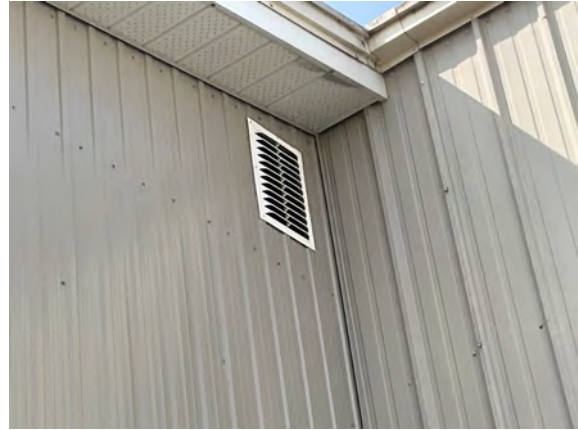
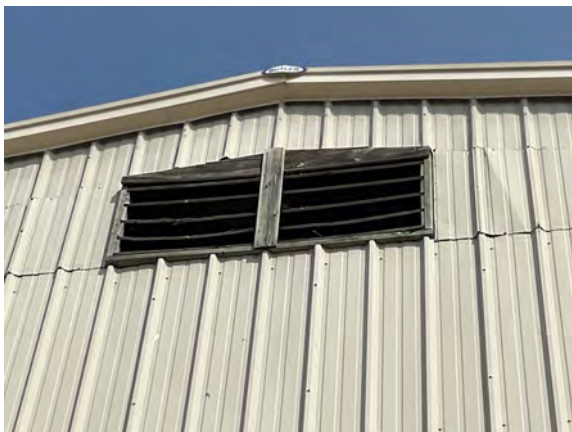
Palmer Rec Center - B201005

No significant deficiencies were observed or reported. However, deficiencies observed or reported during the assessment include damaged louvres and improper flashing of the original louvres. The deterioration is anticipated to progress due to age and exposure to the elements. Repair or replacement is recommended.

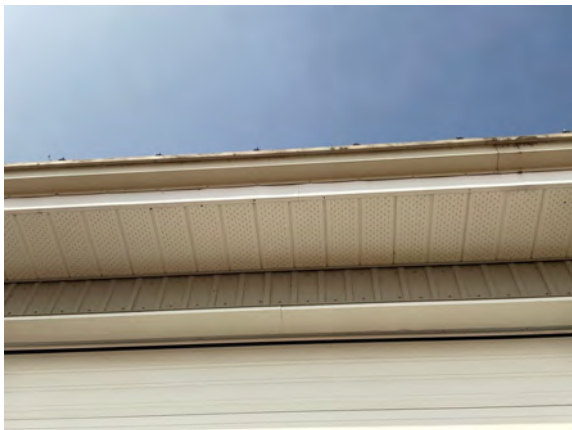
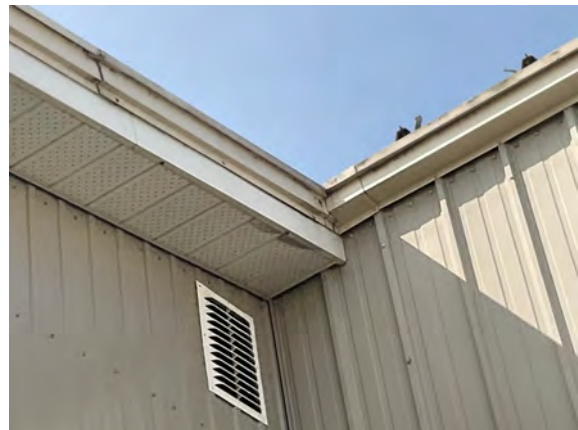
Palmer Rec Center - B201008

No significant deficiencies were observed or reported. Replacement is not anticipated in the short term.

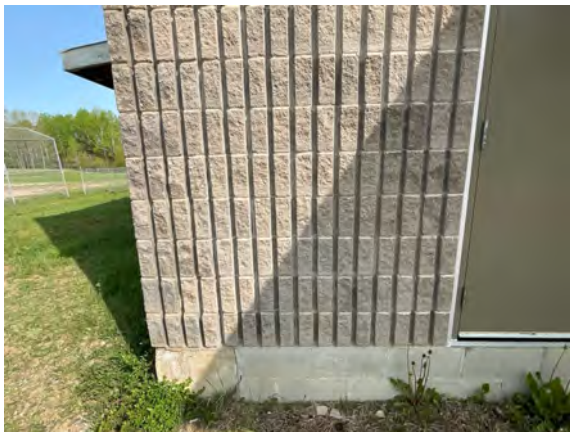
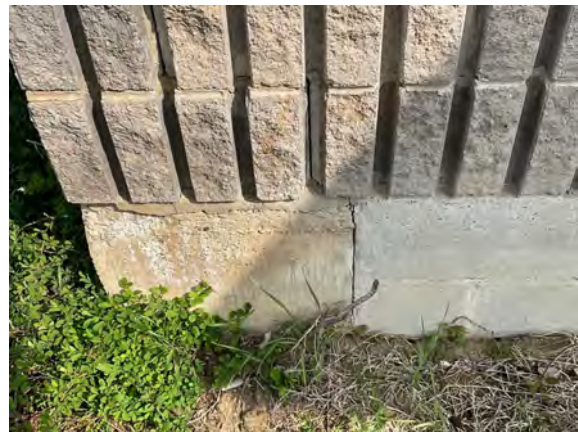
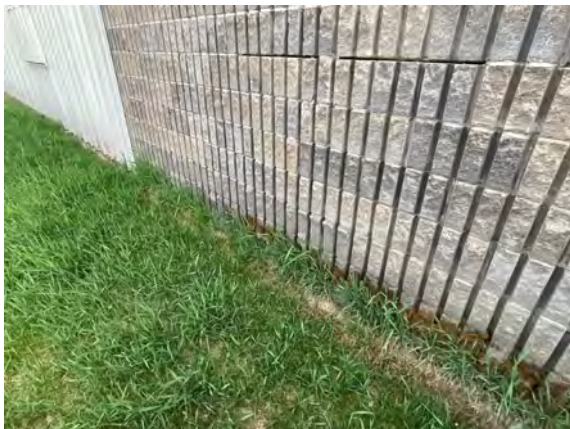
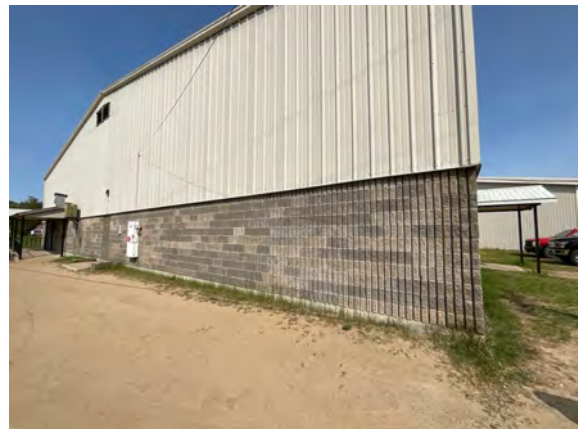
Palmer Rec Center - B201032

No significant deficiencies were observed or reported. Replacement is not anticipated in the short term.

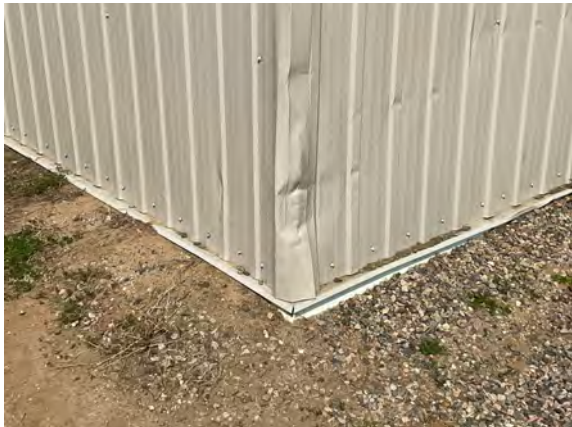
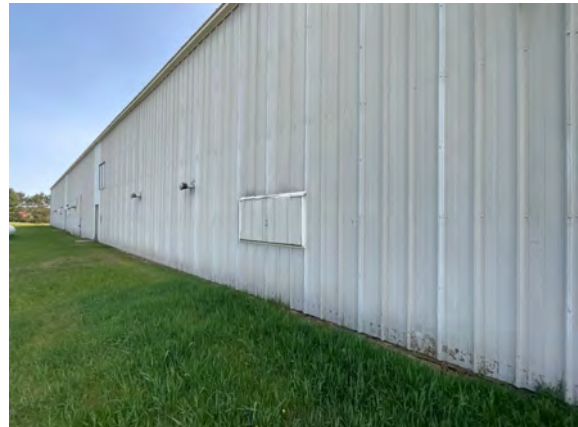
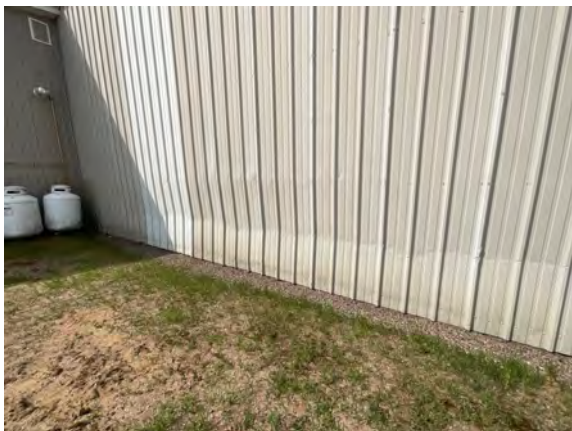
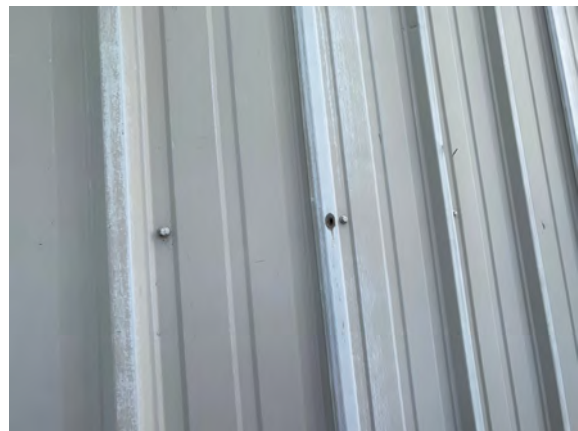
Palmer Rec Center - B201024

No significant deficiencies were observed or reported. However, damage due to ice was noted, recommend repair as a part of ongoing maintenance. Replacement is not anticipated in the short term.

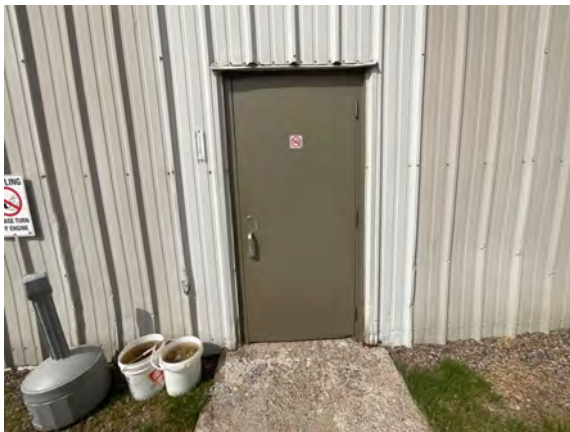
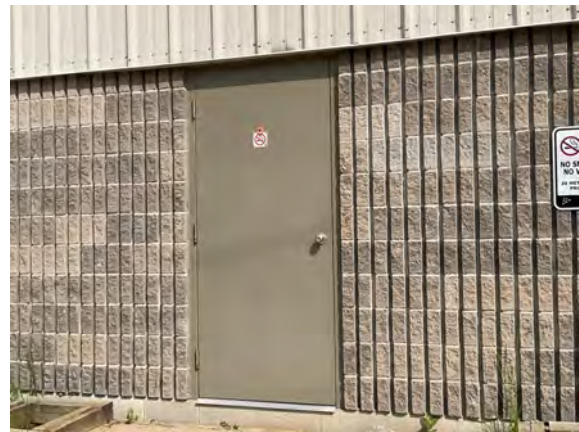
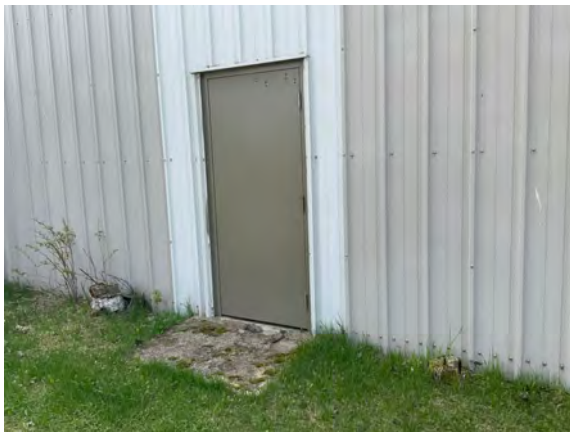
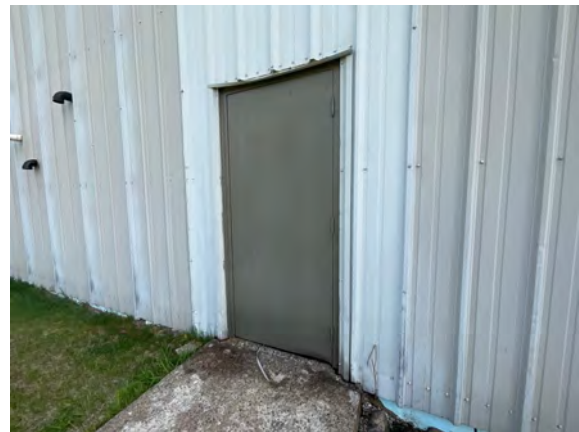
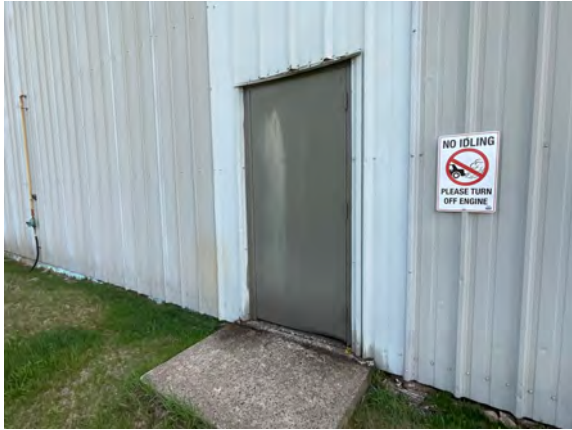
Palmer Rec Center - B203023

No significant deficiencies were observed or reported. Replacement is not anticipated in the short term.

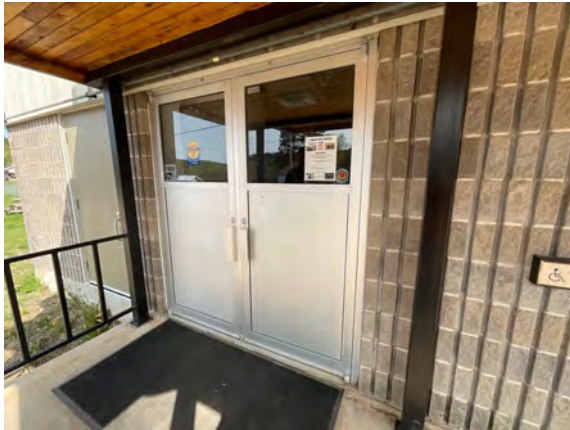
Palmer Rec Center - B203028

No significant deficiencies were observed or reported. Replacement is not anticipated in the short term.

<b>Recommendations #1 - Double Door - Aluminum and Glass</b>	
Type	Life Cycle Replacement
Year	2045
Cost	\$15,392.28

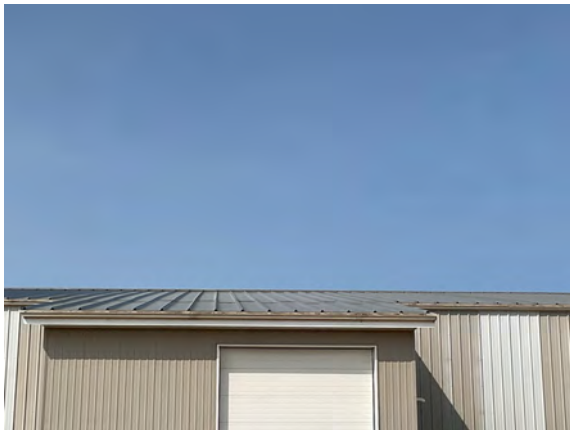
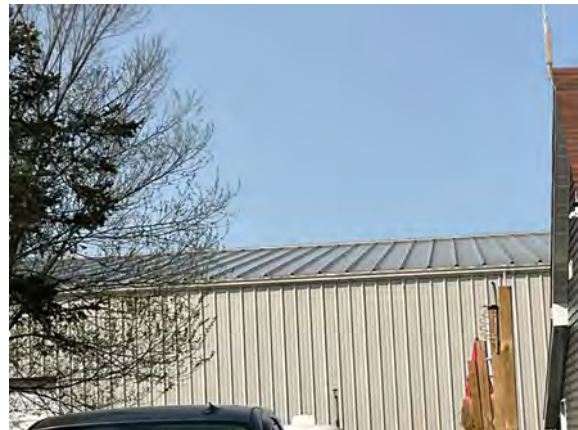
Palmer Rec Center - B301028

No significant deficiencies were observed or reported. Replacement is not anticipated in the short term.

Recommendations #1 - Metal Roofing	
Type	Life Cycle Replacement
Year	2030
Cost	\$1,449,470.69

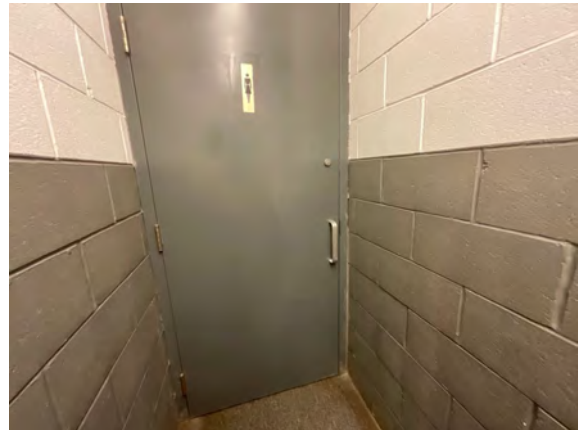
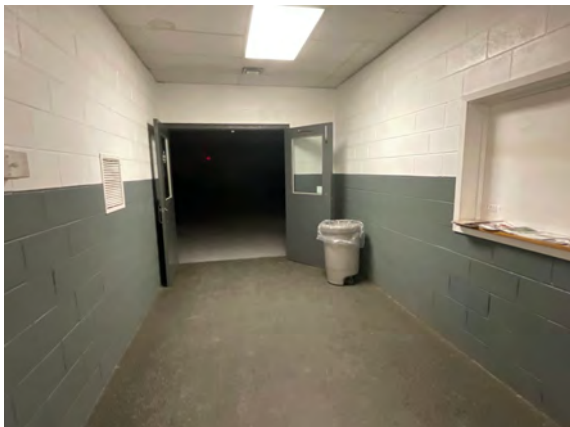
Palmer Rec Center - C101001

No significant deficiencies were observed or reported. Replacement is not anticipated in the short term.

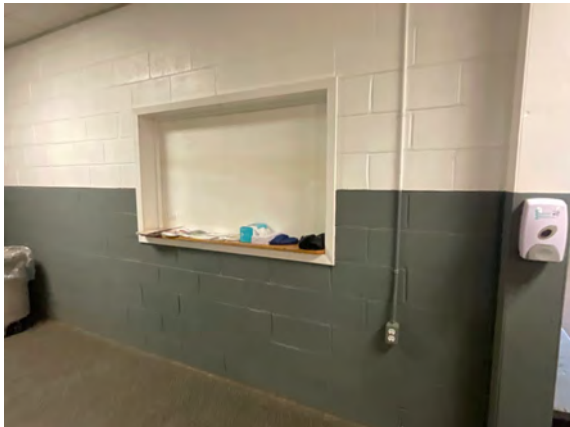
Palmer Rec Center - C101027

No significant deficiencies were observed or reported. Replacement is not anticipated in the short term.

<b>Recommendations #1 - Retractable Partitions - Overhead Counter Shutter</b>	
Type	Life Cycle Replacement
Year	2040
Cost	\$5,130.76

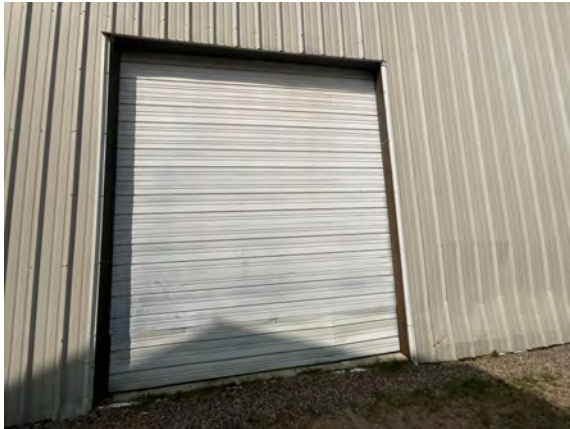
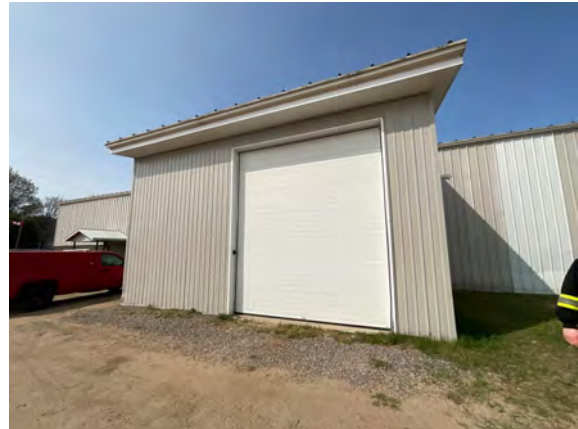
Palmer Rec Center - C102006

No significant deficiencies were observed or reported. Replacement is not anticipated in the short term.

<b>Recommendations #1 - Overhead Doors - Industrial</b>	
Type	Life Cycle Replacement
Year	2040
Cost	\$41,018.85

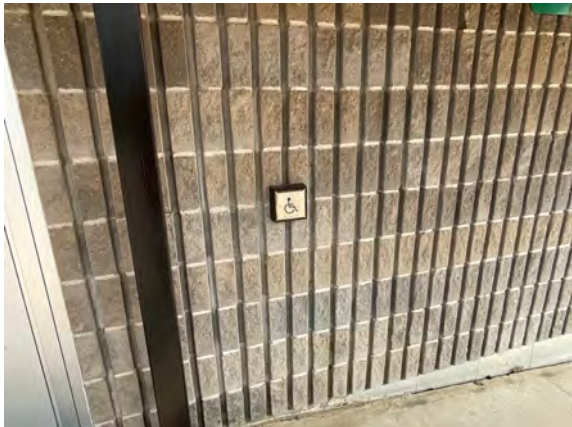
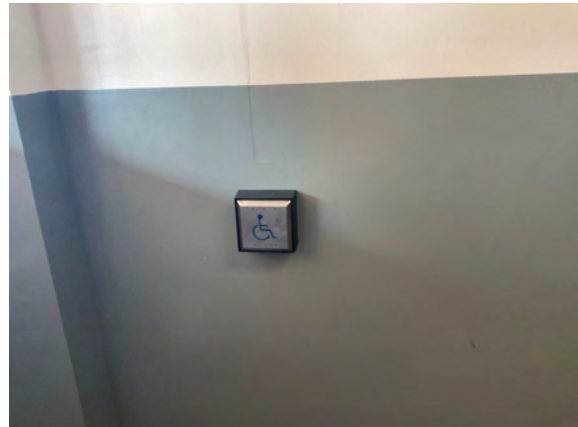
Palmer Rec Center - C102007

No significant deficiencies were observed or reported. Replacement is not anticipated in the short term.

<b>Recommendations #1 - Automatic Door Openers</b>	
Type	Life Cycle Replacement
Year	2039
Cost	\$13,691.10

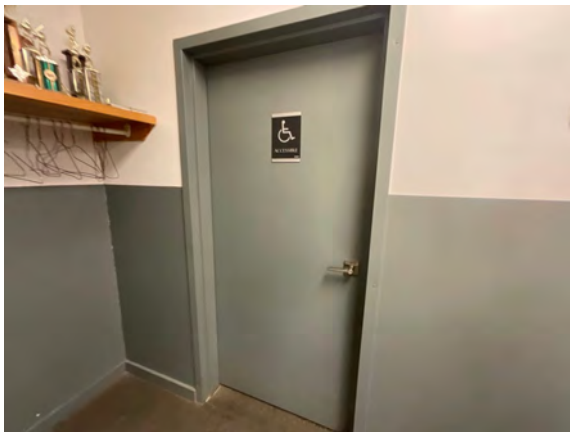
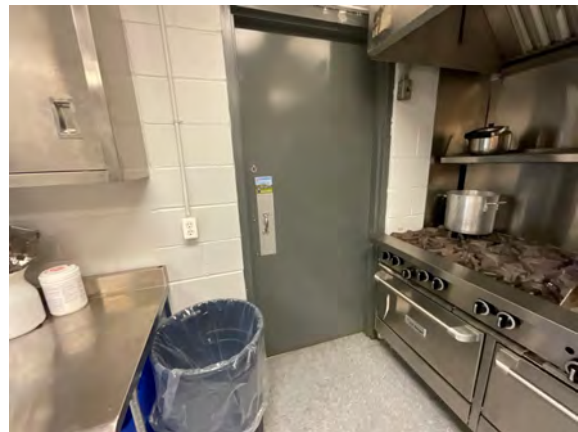
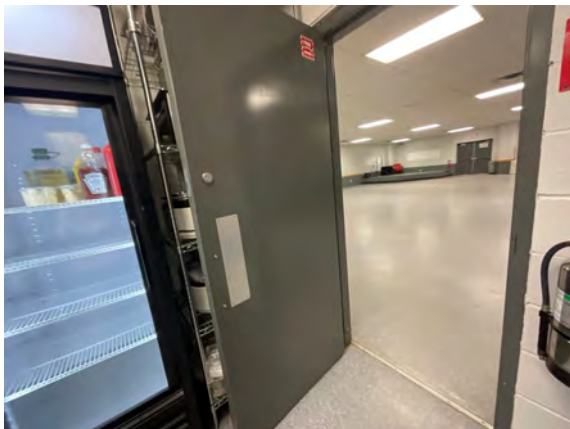
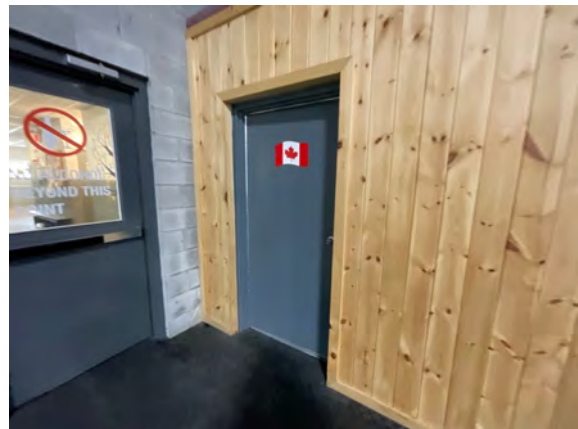
Palmer Rec Center - C102021

No significant deficiencies were observed or reported. Replacement is not anticipated in the short term.

<b>Recommendations #1 - Single Door - Hollow Metal</b>	
Type	Life Cycle Replacement
Year	2032
Cost	\$17,093.46

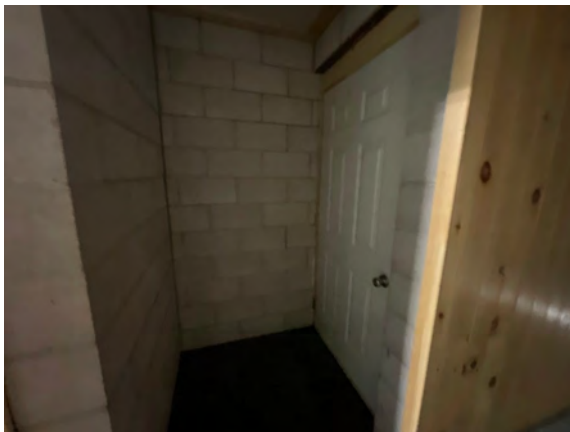
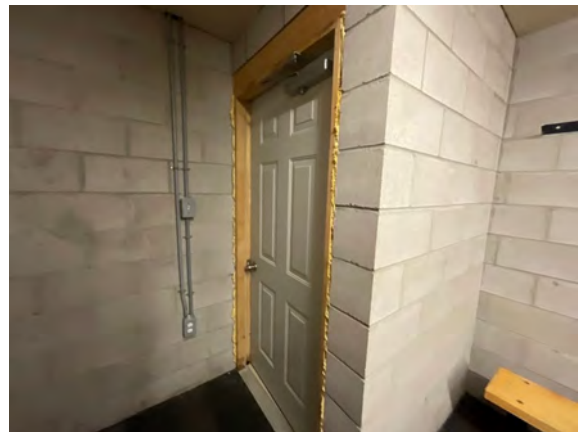
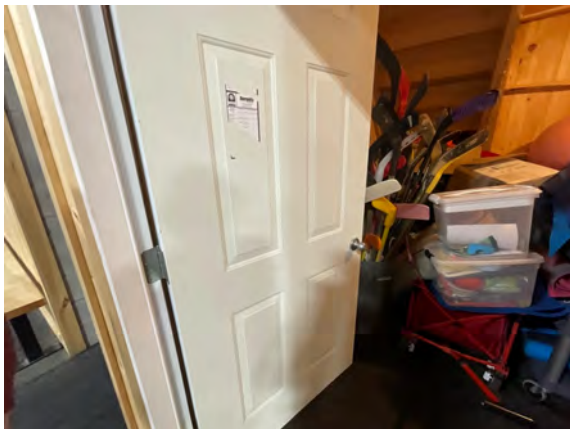
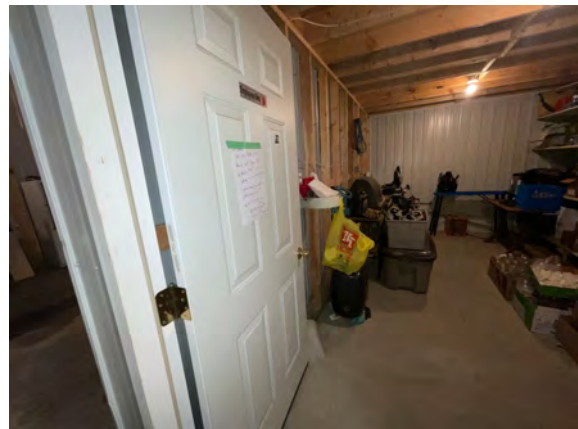
Palmer Rec Center - C102022

No significant deficiencies were observed or reported. Replacement is not anticipated in the short term.

<b>Recommendations #1 - Single Door - Wood</b>	
Type	Life Cycle Replacement
Year	2032
Cost	\$13,718.32

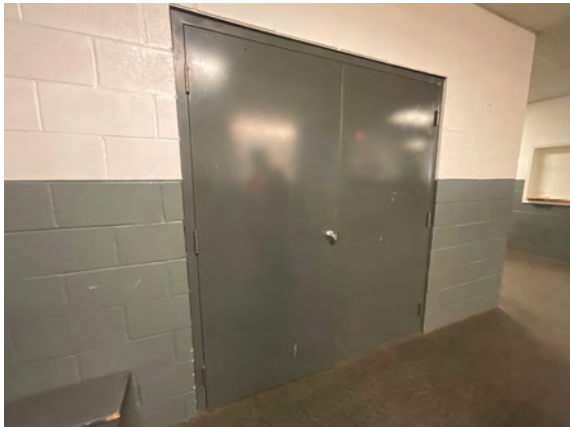
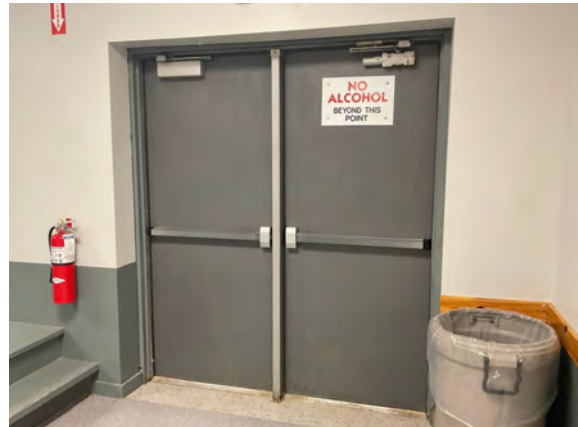
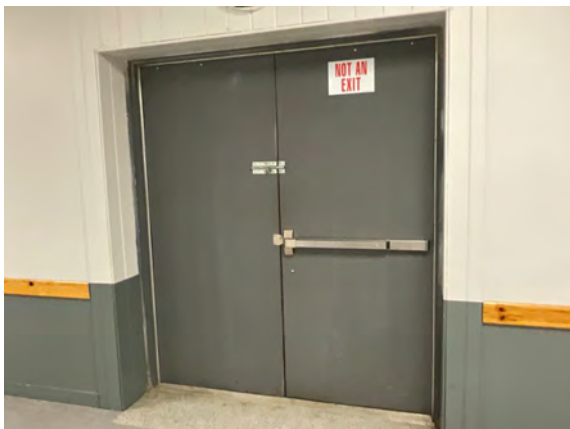
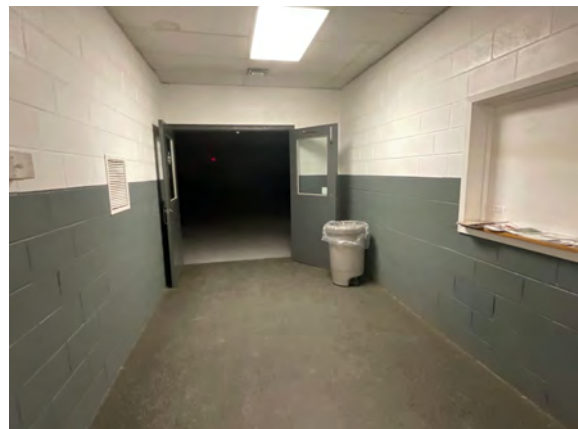
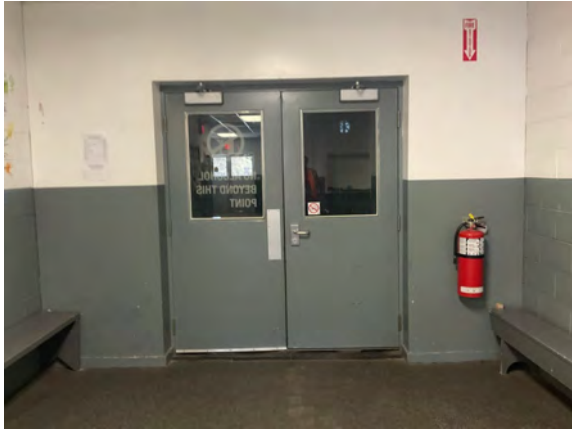
Palmer Rec Center - C102024

No significant deficiencies were observed or reported. Replacement is not anticipated in the short term.

<b>Recommendations #1 - Double Door - Hollow Metal</b>	
Type	Life Cycle Replacement
Year	2032
Cost	\$38,514.72

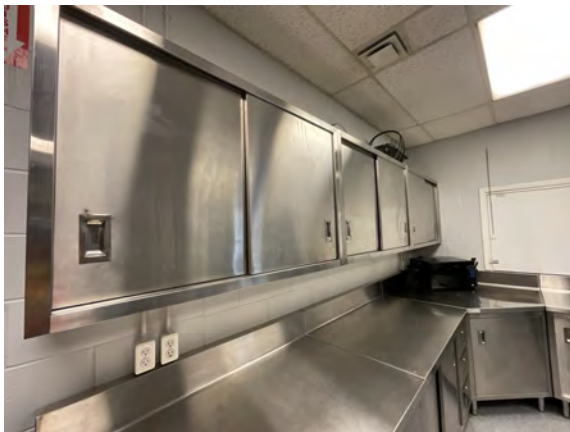
Palmer Rec Center - C103011

No significant deficiencies were observed or reported. Replacement is not anticipated in the short term.

<b>Recommendations #1 - Millwork</b>	
Type	Life Cycle Replacement
Year	2045
Cost	\$9,363.29

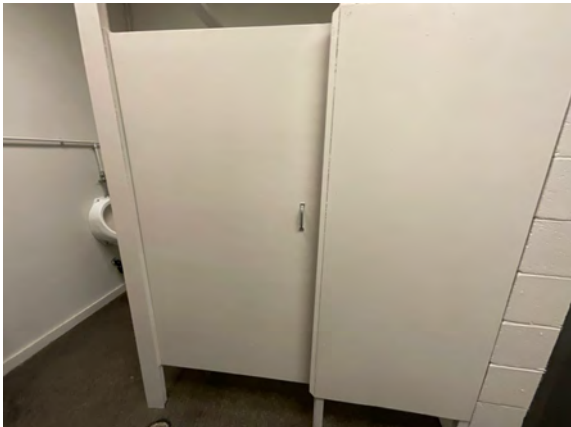
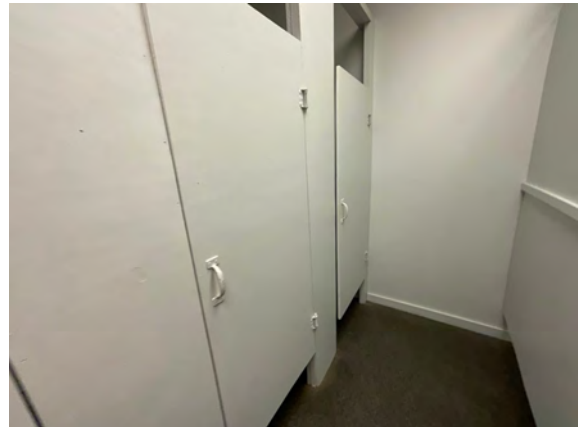
Palmer Rec Center - C103028

No significant deficiencies were observed or reported. Replacement is not anticipated in the short term.

<b>Recommendations #1 - Washroom Partitions - Laminated Fiberboard</b>	
Type	Life Cycle Replacement
Year	2029
Cost	\$6,573.36

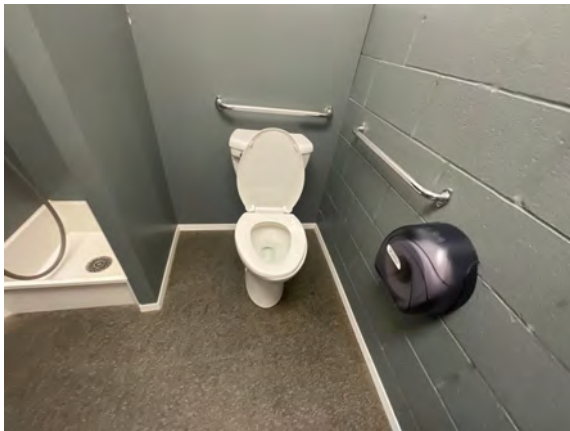
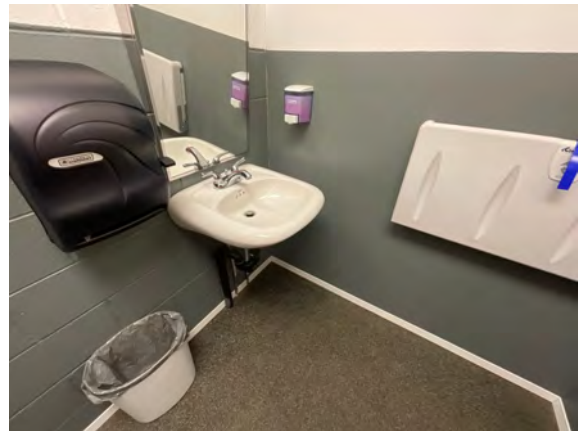
Palmer Rec Center - C104022

No significant deficiencies were observed or reported. Replacement is not anticipated in the short term.

<b>Recommendations #1 - Universal/Gender Neutral Washroom Refurbishment</b>	
Type	Life Cycle Replacement
Year	2043
Cost	\$48,299.90

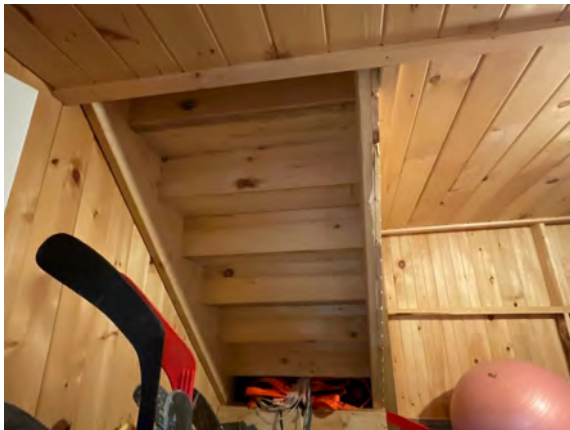
Palmer Rec Center - C201001

No significant deficiencies were observed or reported. Replacement is not anticipated in the short term.

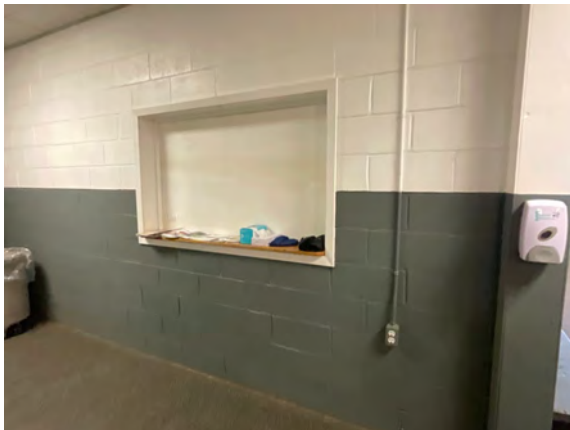
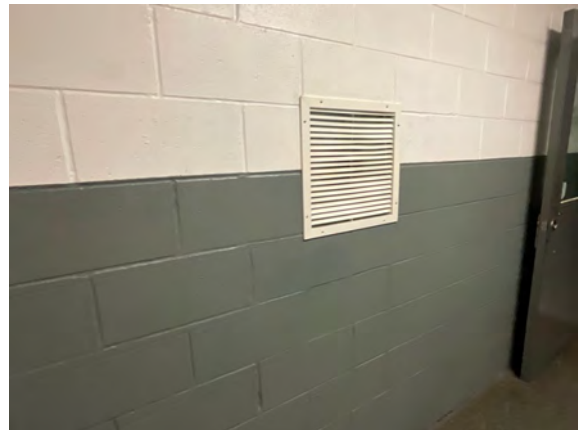
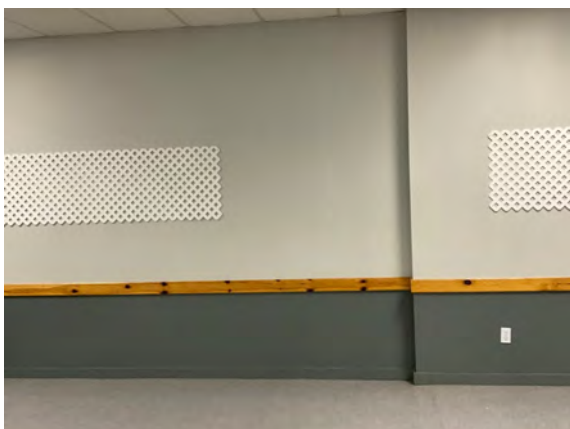
Palmer Rec Center - C301005

No significant deficiencies were observed or reported. Replacement is not anticipated in the short term.

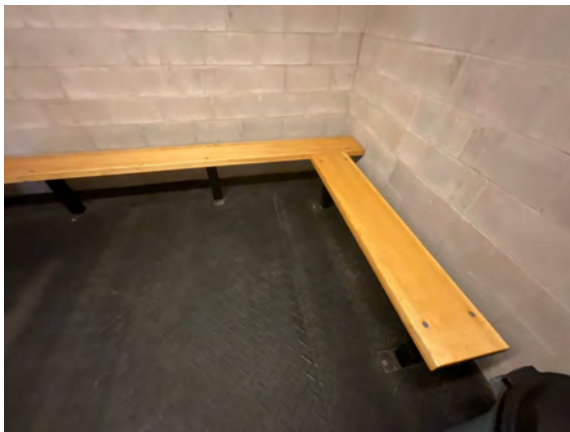
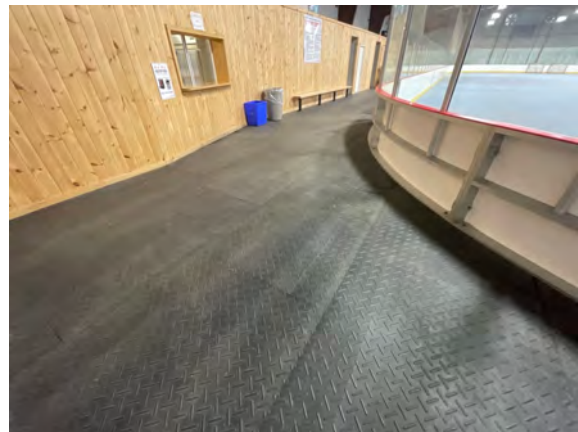
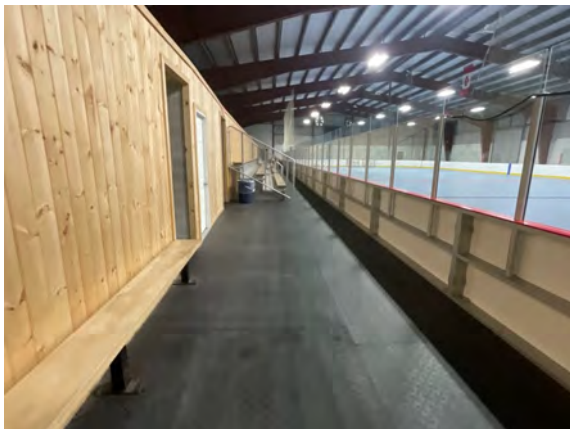
Palmer Rec Center - C302021

No significant deficiencies were observed or reported. Replacement is not anticipated in the short term.

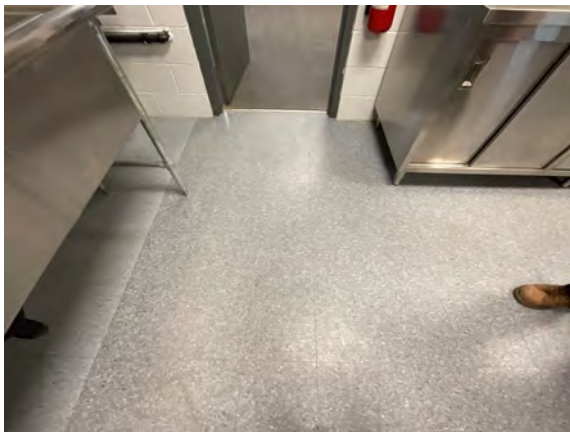
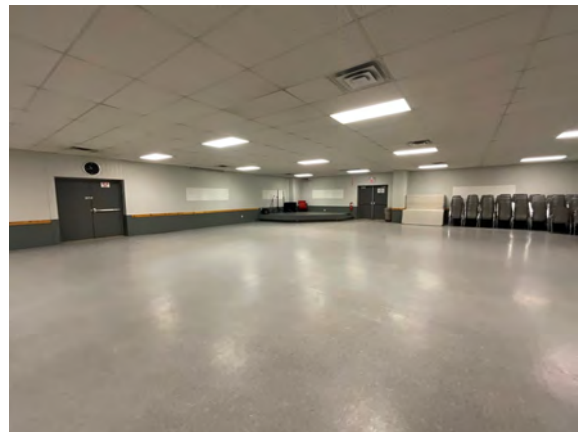
Palmer Rec Center - C302022

No significant deficiencies were observed or reported. Lifecycle replacement may be deferred.

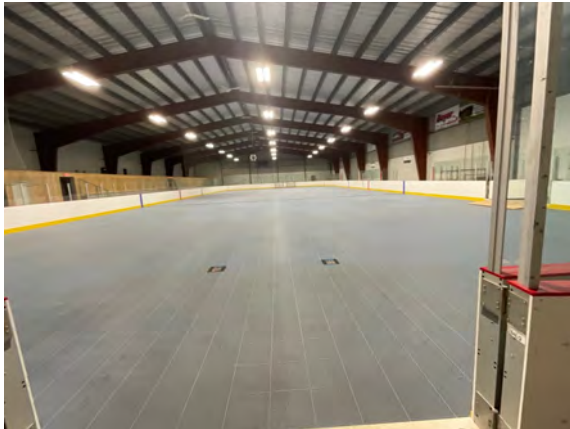
Palmer Rec Center - C302099

No significant deficiencies were observed or reported. Replacement is not anticipated in the short term.

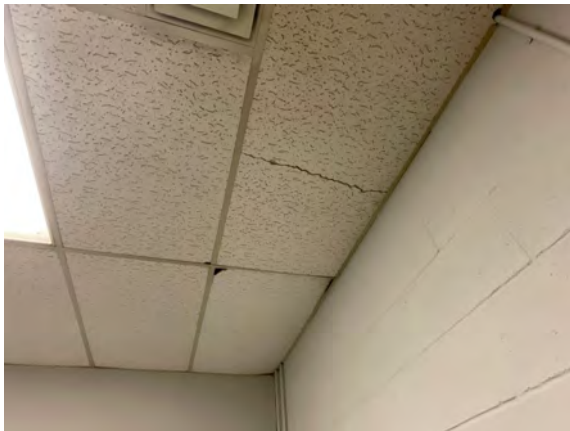
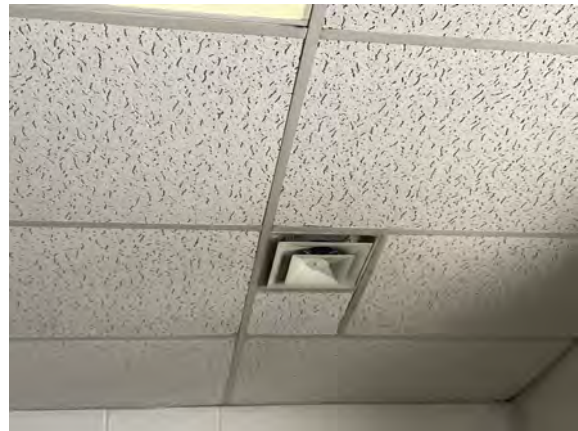
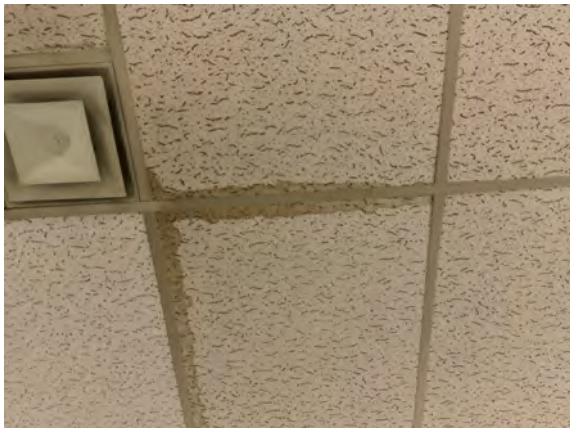
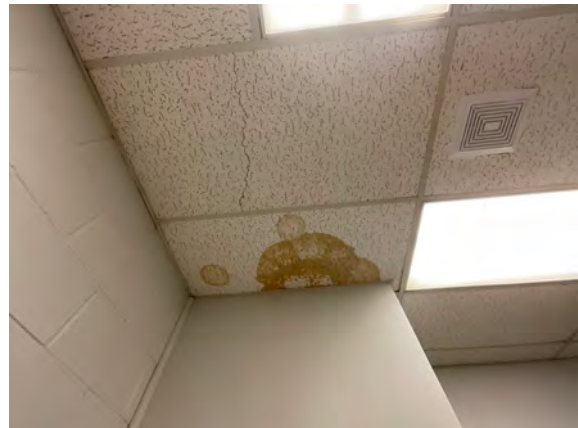
Palmer Rec Center - C303004

Deficiencies observed or reported during the assessment include damaged surfaces, staining, and discoloration, gaps in material coverage. The deterioration is anticipated to progress due to age and ongoing building activities and may lead to a weakening of integrity, and a loss of marketability. Replacement is recommended in the short term.

<b>Recommendations #1 - Acoustic Tile Ceiling</b>	
Type	Life Cycle Replacement
Year	2026
Cost	\$66,827.79
