# Brudenell Lyndoch and Raglan

Submission to Township of Brudenell, Lyndoch, and Raglan

Roth IAMS Ltd.  
207-1075 North Service Rd W, Oakville ON, L6M 2G2  
[www.rothiams.com](http://www.rothiams.com)  
Project No. 23502

**Facility Condition Assessment Report**  
**Brudenell Fire Hall #4**

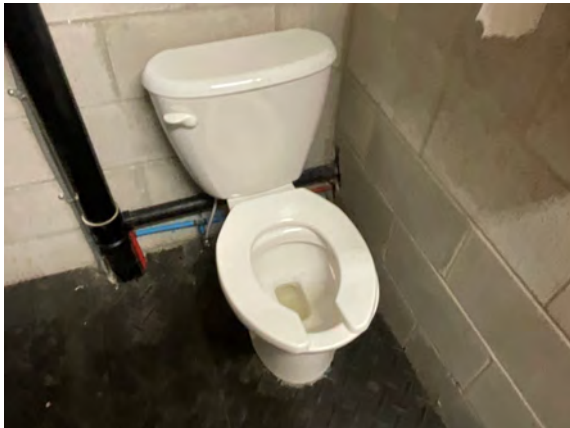
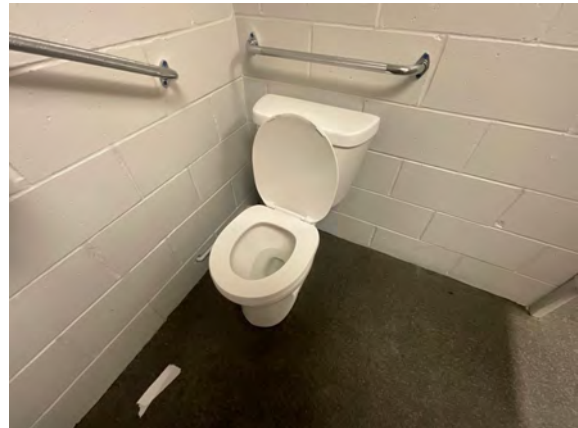
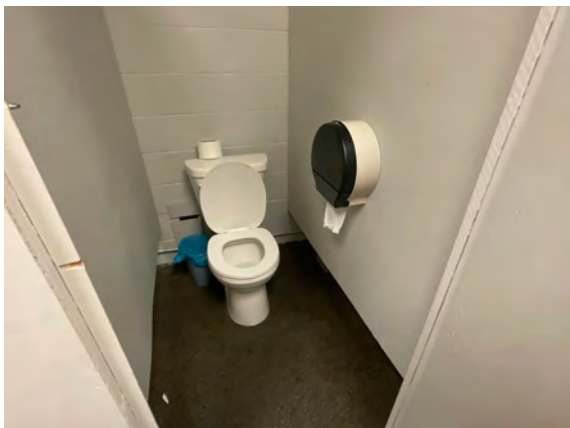
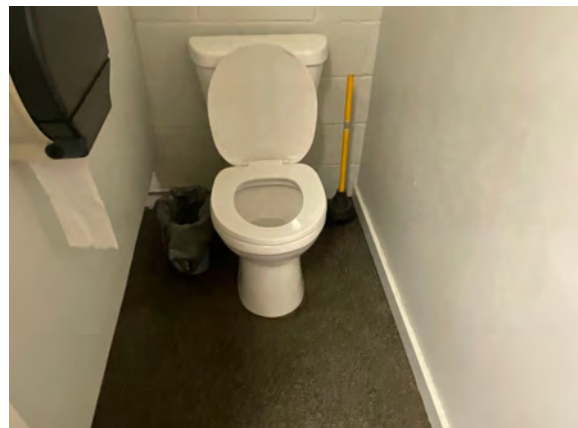
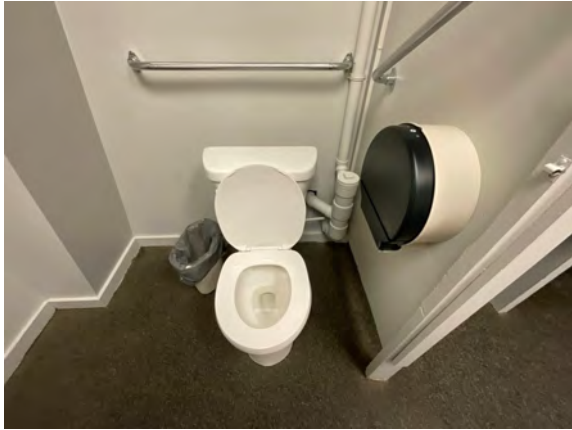
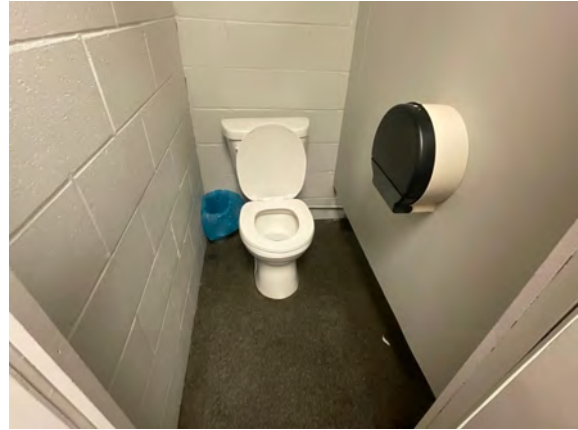
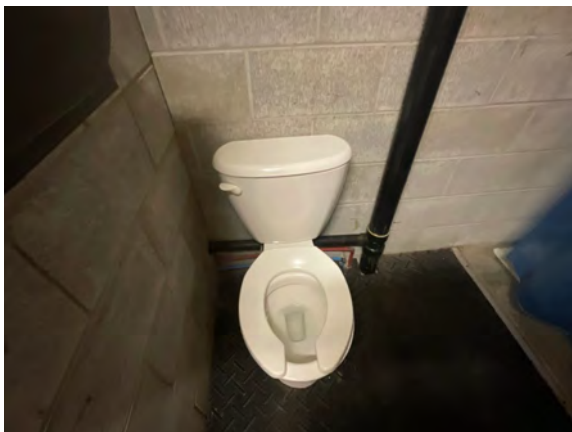
Palmer Rec Center - D201001

No significant deficiencies were observed or reported. Replacement is not anticipated in the short term.

<b>Recommendations #1 - Water Closets</b>	
Type	Life Cycle Replacement
Year	2055
Cost	\$11,431.93

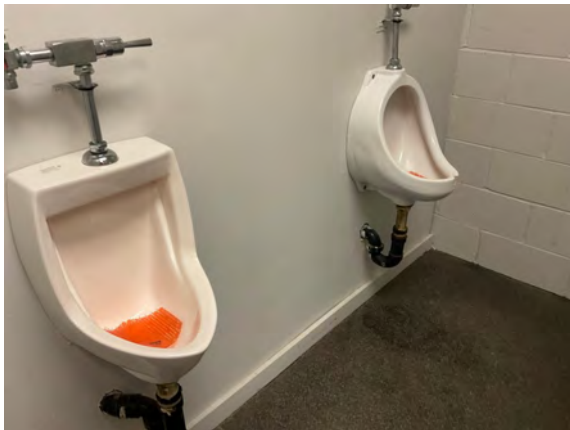
Palmer Rec Center - D201002

No significant deficiencies were observed or reported. However the urinals are energy inefficient. Replacement is recommended in the short term.

<b>Recommendations #1 - Urinals</b>	
Type	Life Cycle Replacement
Year	2027
Cost	\$3,266.27

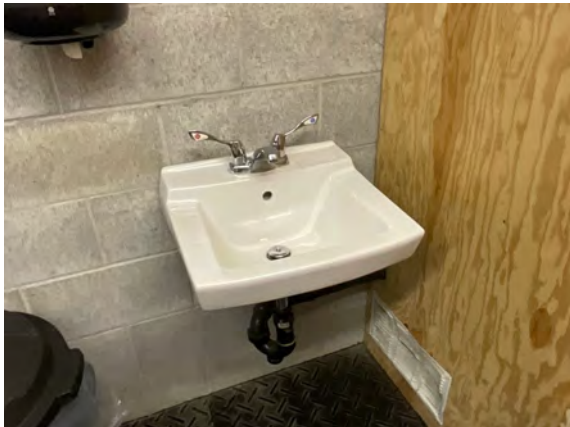
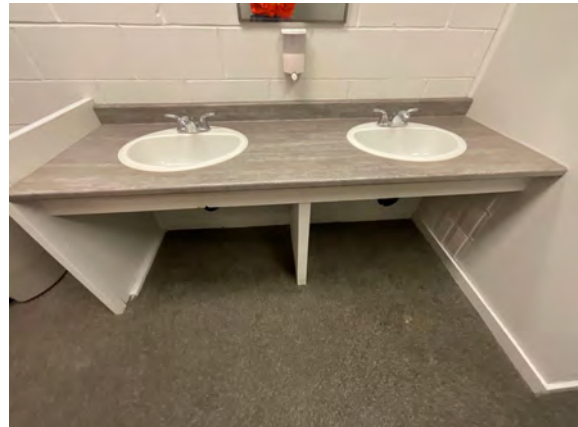
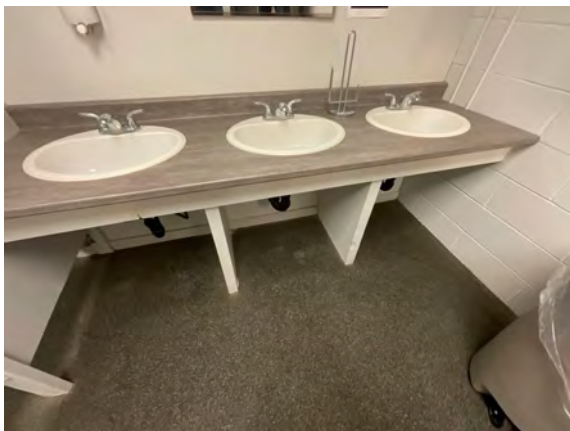
Palmer Rec Center - D201003

No significant deficiencies were observed or reported. Replacement is not anticipated in the short term.

<b>Recommendations #1 - Lavatories</b>	
Type	Life Cycle Replacement
Year	2045
Cost	\$9,798.80

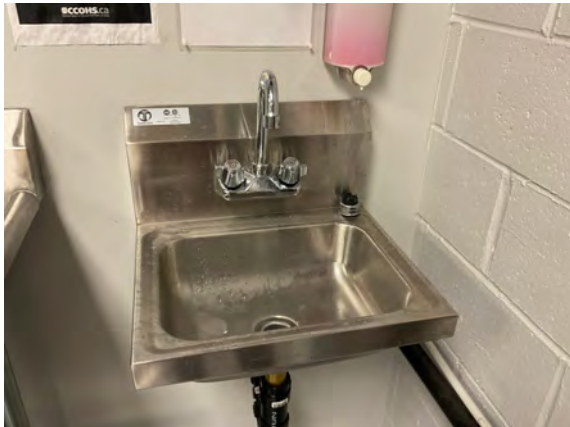
Palmer Rec Center - D201004

No significant deficiencies were observed or reported. Replacement is not anticipated in the short term.

<b>Recommendations #1 - Sinks</b>	
Type	Life Cycle Replacement
Year	2055
Cost	\$1,633.13

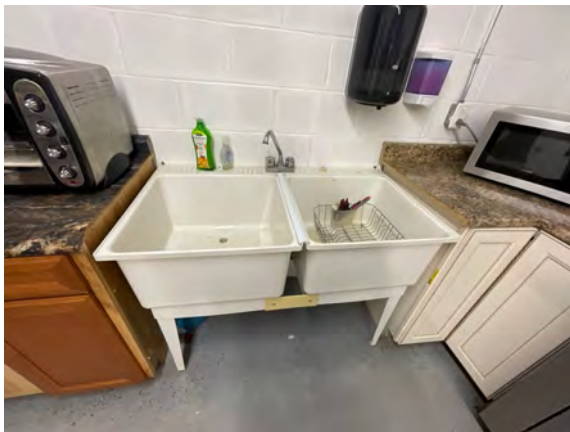
Palmer Rec Center - D201016

No significant deficiencies were observed or reported. Lifecycle replacement may be deferred.

<b>Recommendations #1 - Sinks</b>	
Type	Life Cycle Replacement
Year	2045
Cost	\$816.57

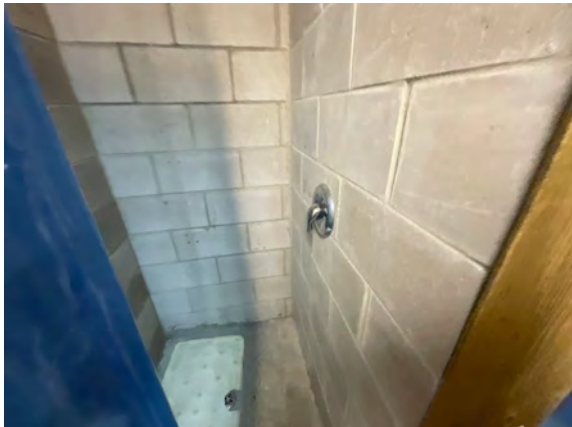
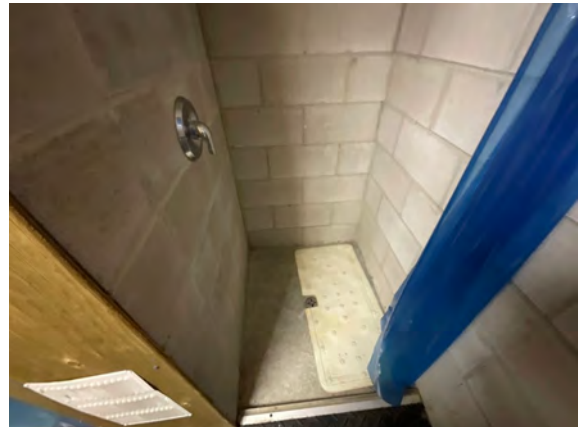
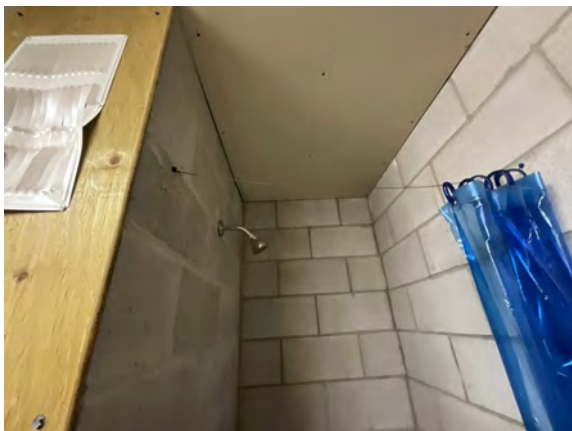
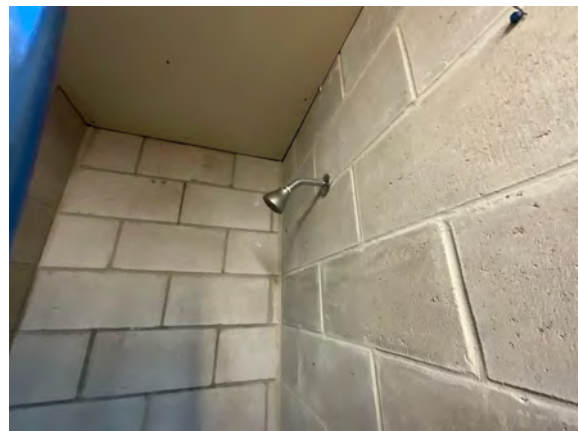
Palmer Rec Center - D201011

No significant deficiencies were observed or reported. Replacement is not anticipated in the short term.

<b>Recommendations #1 - Showers (Valve Set)</b>	
Type	Life Cycle Replacement
Year	2035
Cost	\$4,899.40

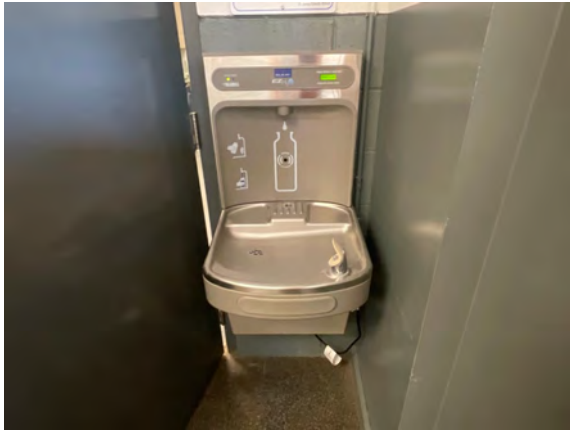
Palmer Rec Center - D201015

No significant deficiencies were observed or reported. Replacement is not anticipated in the short term.

<b>Recommendations #1 - Drinking Water Fountains - Refrigerated</b>	
Type	Life Cycle Replacement
Year	2035
Cost	\$7,144.96

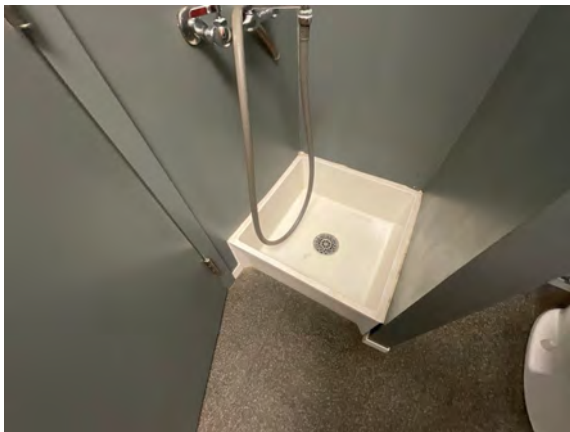
Palmer Rec Center - D201016

No significant deficiencies were observed or reported. Replacement is not anticipated in the short term.

<b>Recommendations #1 - Custodial Sinks</b>	
Type	Life Cycle Replacement
Year	2048
Cost	\$979.88

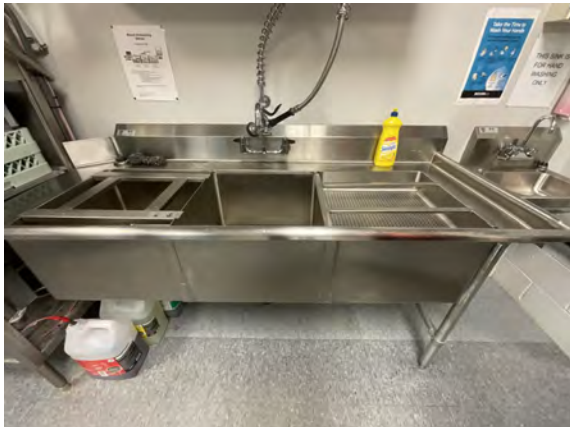
Palmer Rec Center - D201043

No significant deficiencies were observed or reported. Replacement is not anticipated in the short term.

<b>Recommendations #1 - Commercial Kitchen Sinks</b>	
Type	Life Cycle Replacement
Year	2050
Cost	\$4,681.65

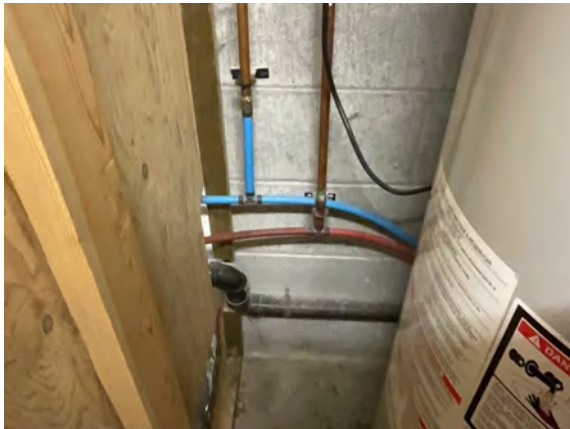
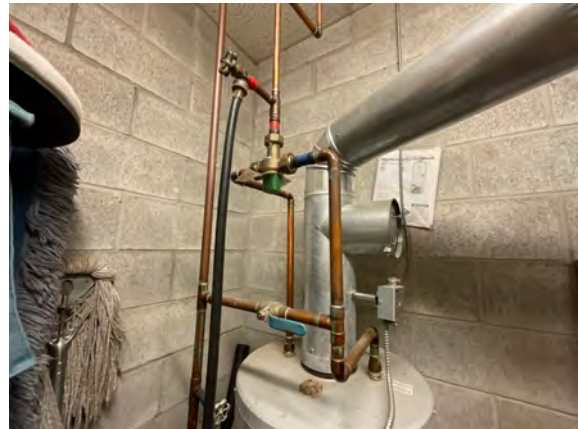
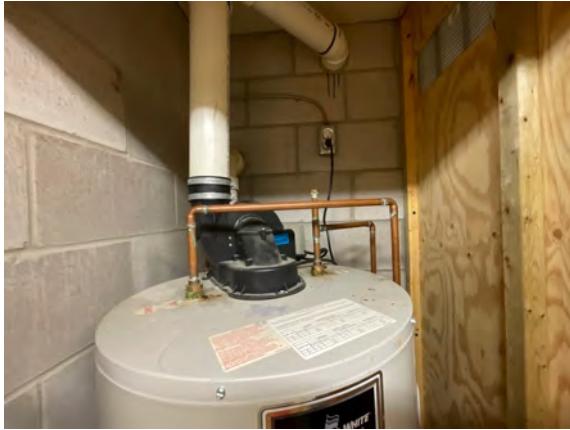
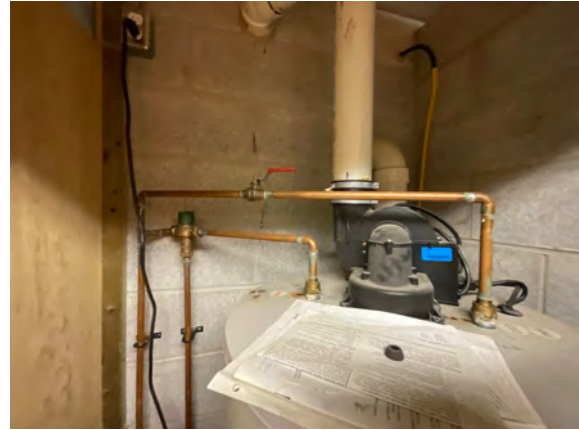
Palmer Rec Center - D202001

No significant deficiencies or leaks were observed or reported. Replacement is not anticipated in the short term.

<b>Recommendations #1 - Domestic Water Piping and Fittings</b>	
Type	Life Cycle Replacement
Year	2032
Cost	\$182,094.31

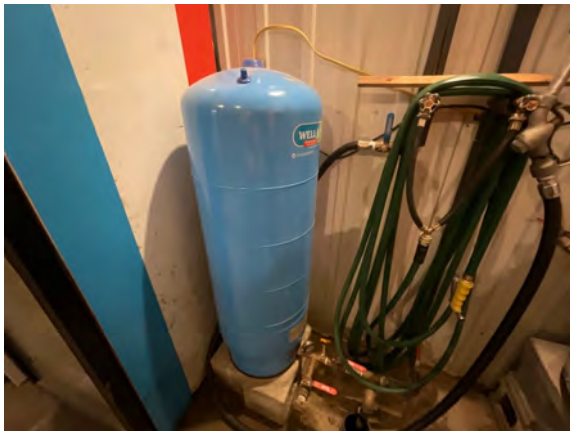
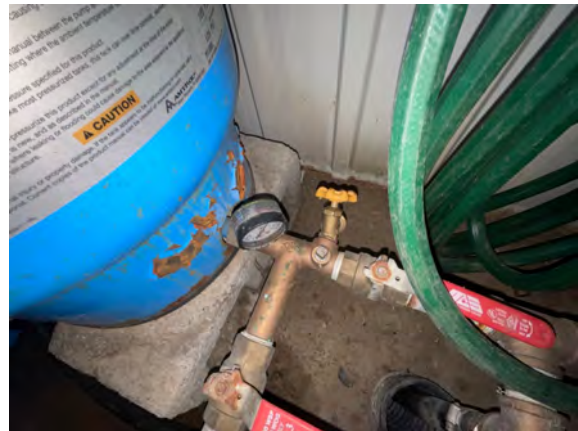
Palmer Rec Center - D202023

Deficiencies observed or reported during the assessment include corrosion along the bottom of the tank. Replacement is recommended in the short term.

Recommendations #1 - Domestic Water Expansion Tanks/Pressure Tanks	
Type	Life Cycle Replacement
Year	2024
Cost	\$3,123.37

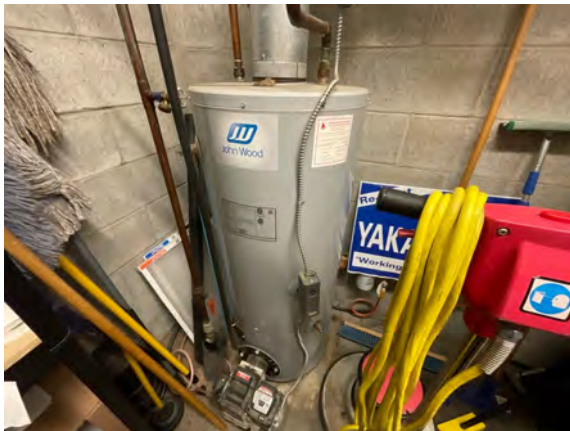
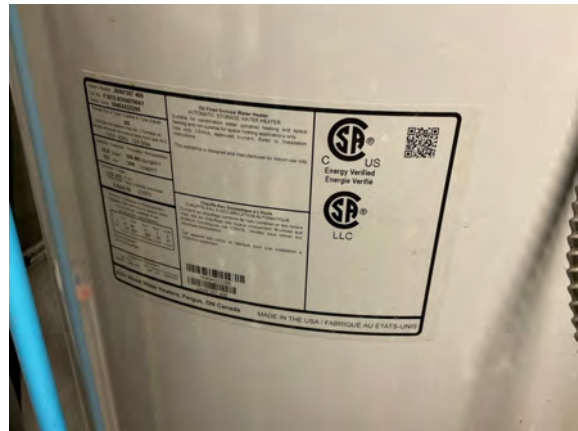
Palmer Rec Center - D202032

No significant deficiencies were observed or reported. Replacement is not anticipated in the short term.

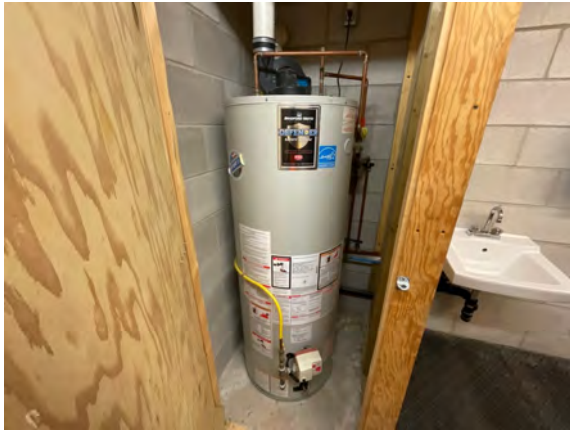
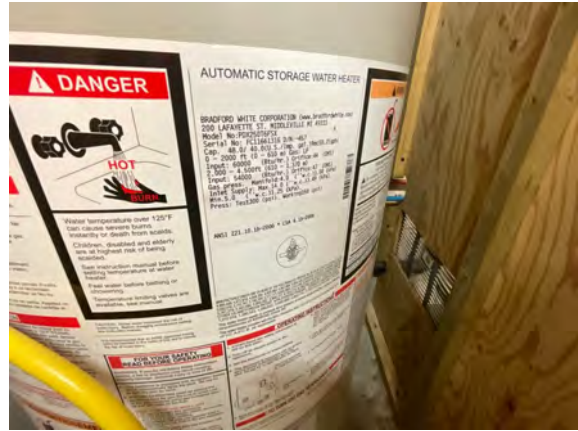
Palmer Rec Center - D202032

No significant deficiencies were observed or reported. Replacement is not anticipated in the short term.

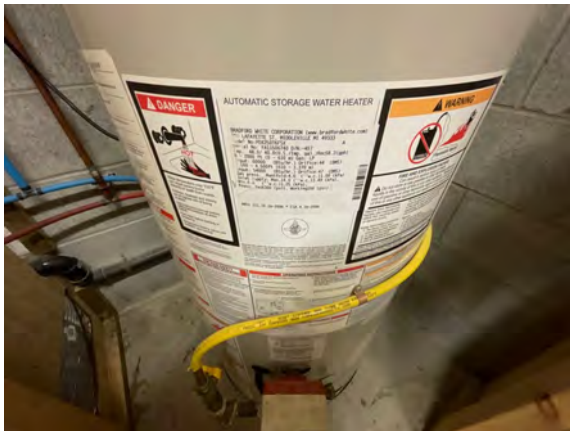
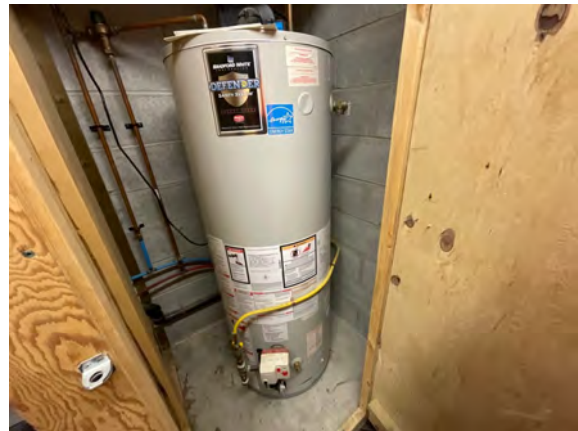
Palmer Rec Center - D202032

No significant deficiencies were observed or reported. Replacement is not anticipated in the short term.

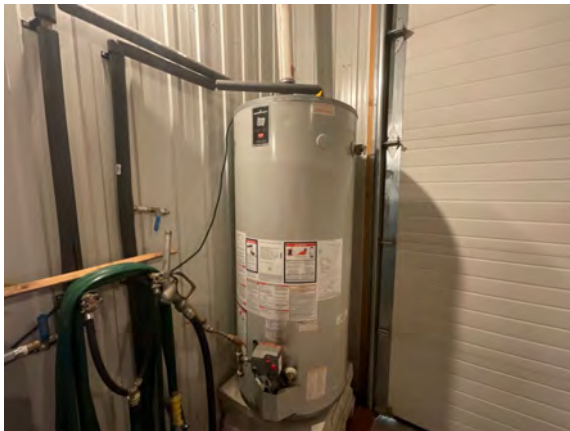
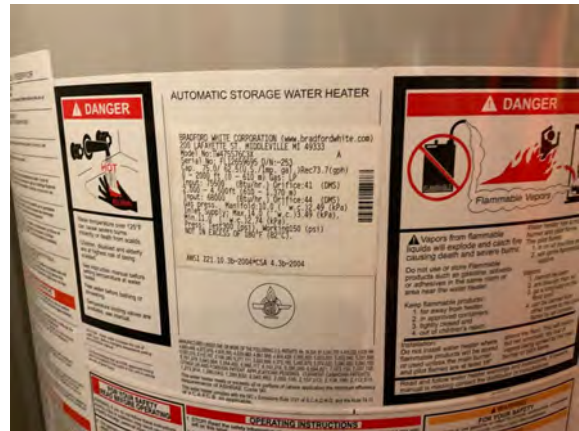
Palmer Rec Center - D202032

No significant deficiencies were observed or reported. Replacement is not anticipated in the short term.

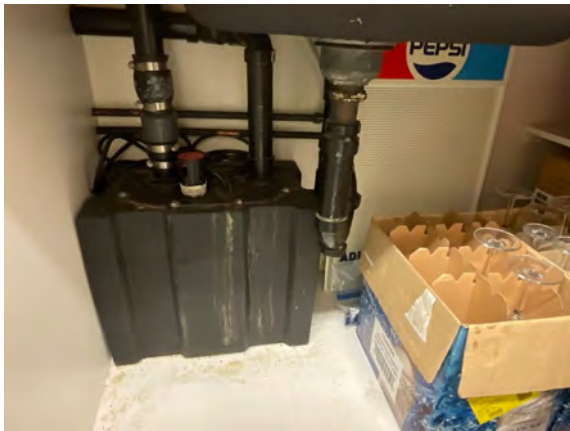
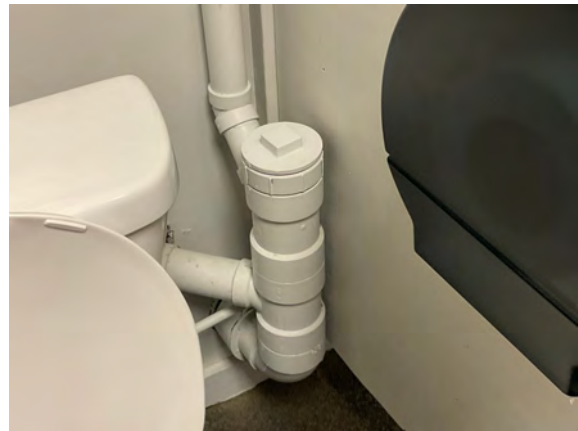
Palmer Rec Center - D203001

No significant deficiencies were observed or reported. Replacement is not anticipated in the short term.

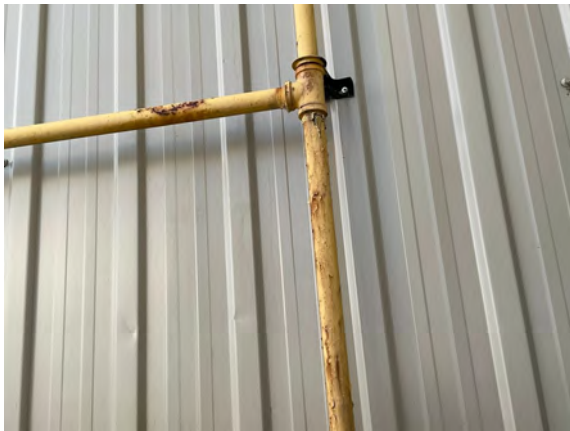
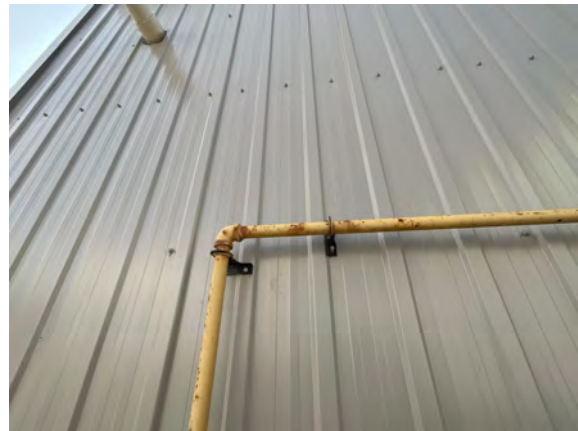
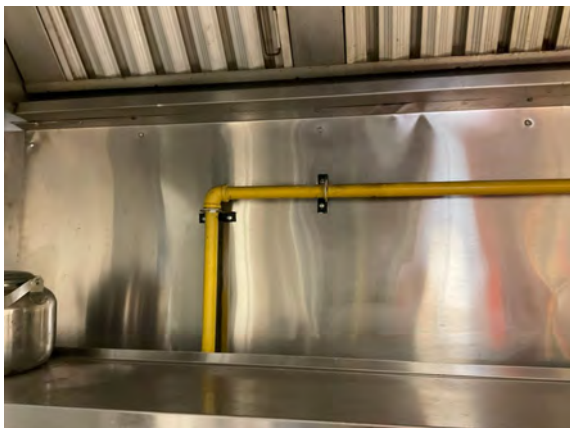
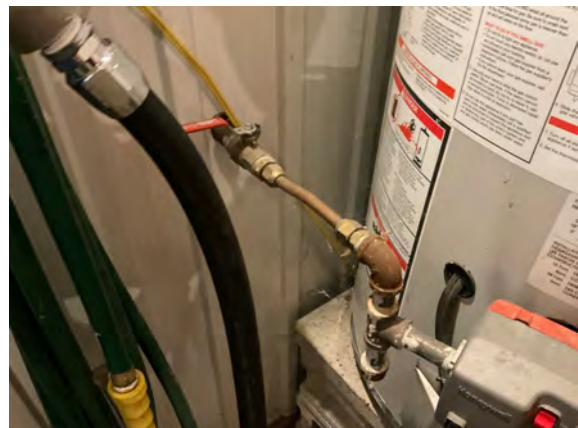
Palmer Rec Center - D301002

No significant deficiencies were observed or reported. Replacement is not anticipated in the short term.

<b>Recommendations #1 - Natural Gas Supply Piping and Fittings</b>	
Type	Life Cycle Replacement
Year	2050
Cost	\$91,047.15

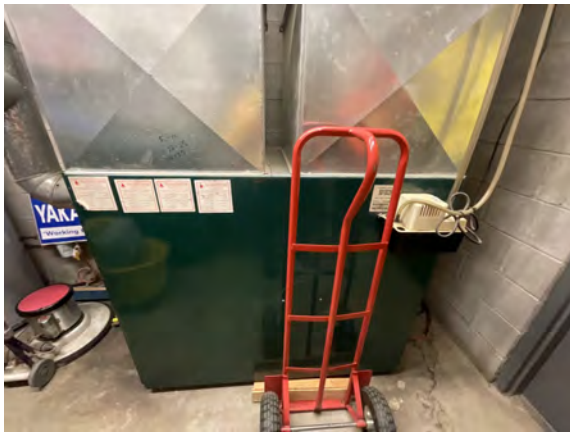
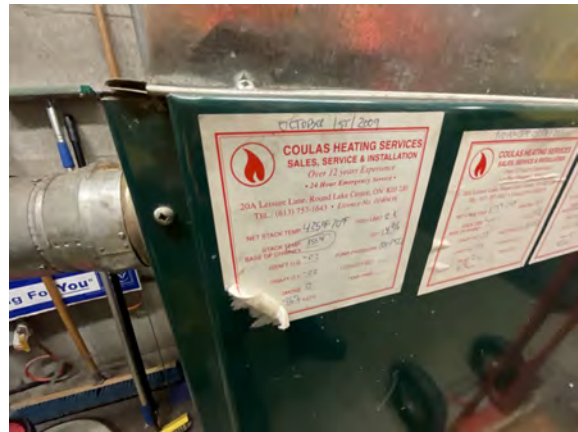
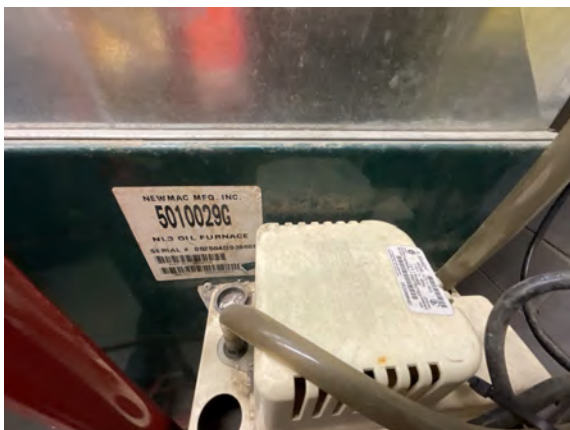
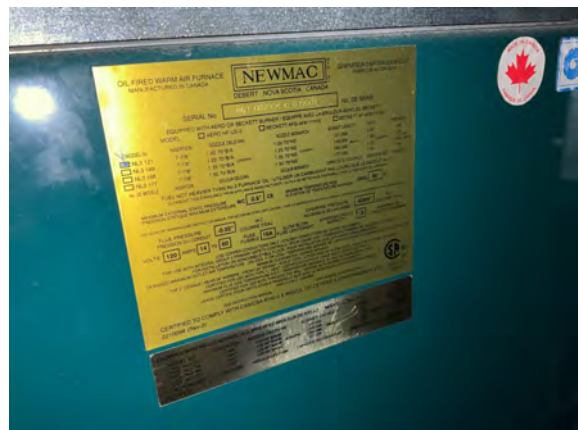
Palmer Rec Center - D302003

No significant deficiencies were observed or reported. Replacement is not anticipated in the short term.

<b>Recommendations #1 - Fuel Fired Forced Air Furnaces</b>	
Type	Life Cycle Replacement
Year	2028
Cost	\$12,485.30

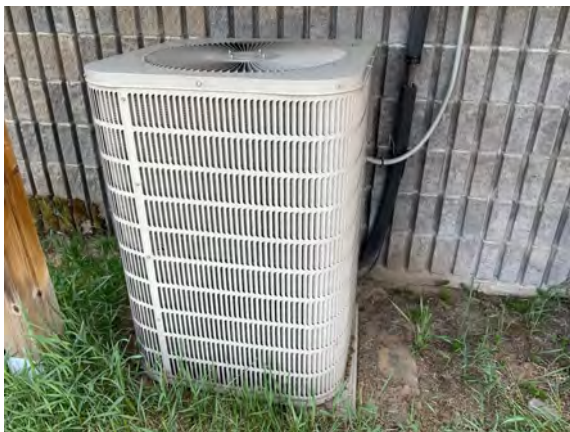
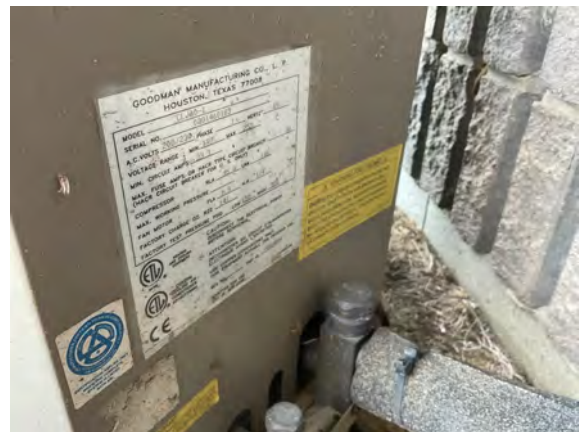
Palmer Rec Center - D303041

Building cooling includes a split system air conditioning system. The condensing unit is manufactured by Goodman Manufacturing CO., model CLJ60-1. The condenser is installed on grade. The system includes the refrigerant piping and evaporator unit.

No significant deficiencies were observed or reported. However the system, based on age, is approaching or is past its expected useful life with performance and reliability likely diminishing over time. The unit is charged with an HCFC refrigerant, an ozone depleting substance. HCFC refrigerants are no longer available for purchase as per legislation enacted by those authorities having jurisdiction. In the event of equipment failure or a gas leak the unit likely will need to be replaced as it will be unable to be re-charged. Replacement is recommended in the short term.

Recommendations #1 - Refrigerant DX Condensing Units - 1 to 5 Tons	
Type	Life Cycle Replacement
Year	2028
Cost	\$6,845.55

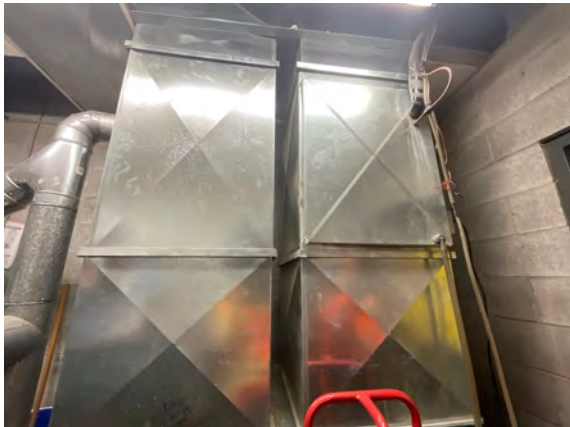
Palmer Rec Center - D304001

No significant deficiencies were observed or reported. Replacement is not anticipated in the short term.

<b>Recommendations #1 - Air Distribution Systems</b>	
Type	Life Cycle Replacement
Year	2041
Cost	\$152,616.26

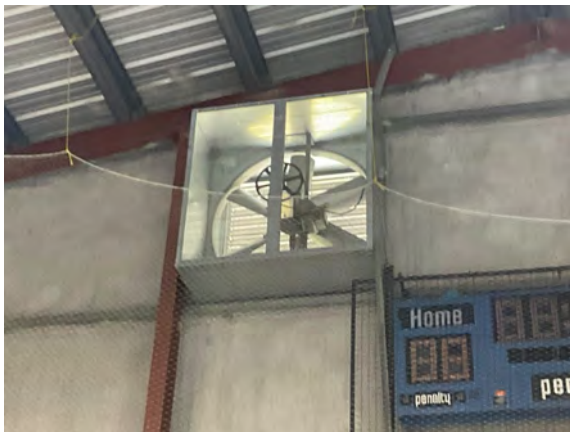
Palmer Rec Center - D304034

No significant deficiencies were observed or reported. Replacement is not anticipated in the short term.

<b>Recommendations #1 - Exhaust Fans - Axial</b>	
Type	Life Cycle Replacement
Year	2035
Cost	\$3,130.17

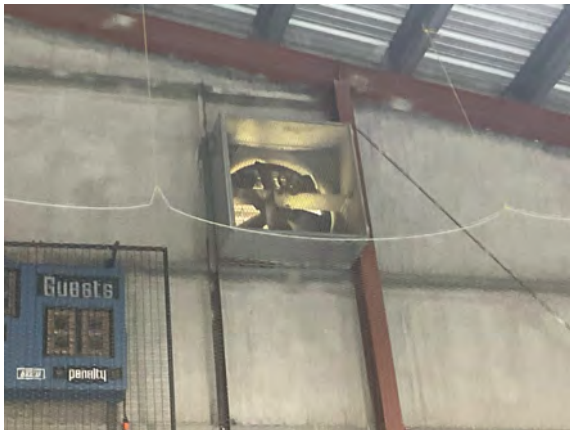
Palmer Rec Center - D304034

No significant deficiencies were observed or reported. However, the system, based on age, is approaching or is past its expected useful life with performance and reliability likely diminishing over time. Replacement is recommended in the short term.

<b>Recommendations #1 - Exhaust Fans - Axial</b>	
Type	Life Cycle Replacement
Year	2026
Cost	\$3,130.17

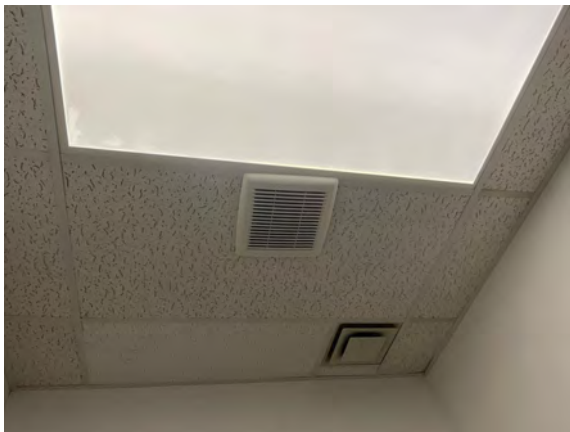
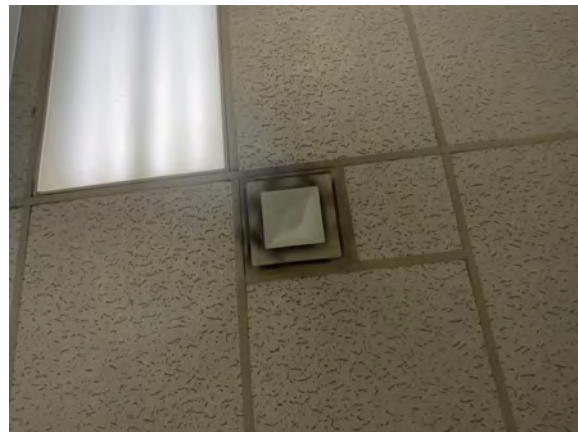
Palmer Rec Center - D304033

No significant deficiencies were observed or reported. Replacement is not anticipated in the short term.

<b>Recommendations #1 - Exhaust Fans - Residential</b>	
Type	Life Cycle Replacement
Year	2035
Cost	\$3,130.17

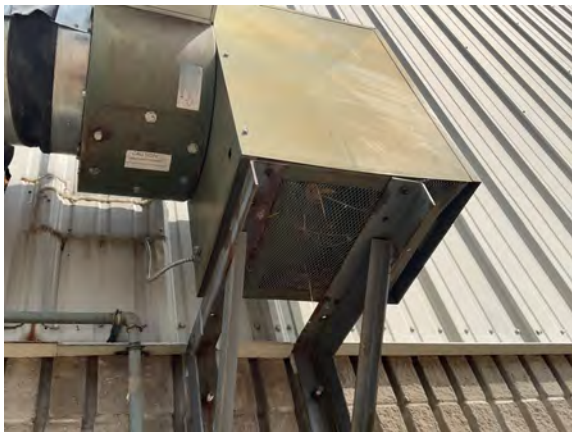
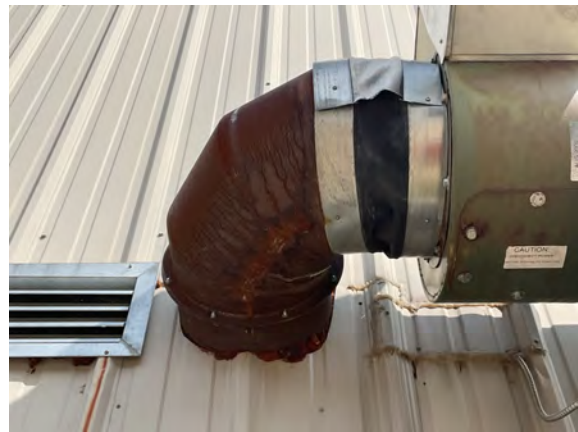
Palmer Rec Center - D304033

No significant deficiencies were observed or reported. Replacement is not anticipated in the short term.

<b>Recommendations #1 - Exhaust Fans - Large</b>	
Type	Life Cycle Replacement
Year	2030
Cost	\$12,820.09

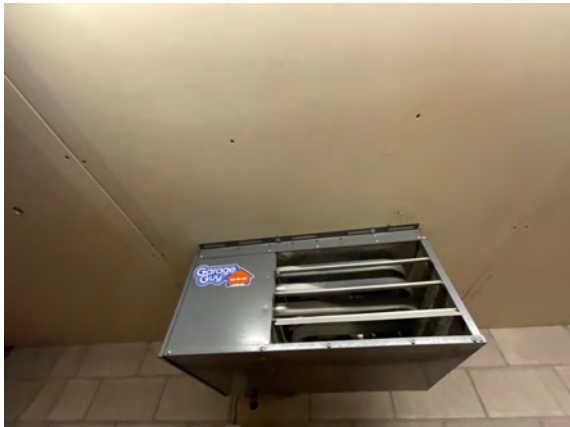
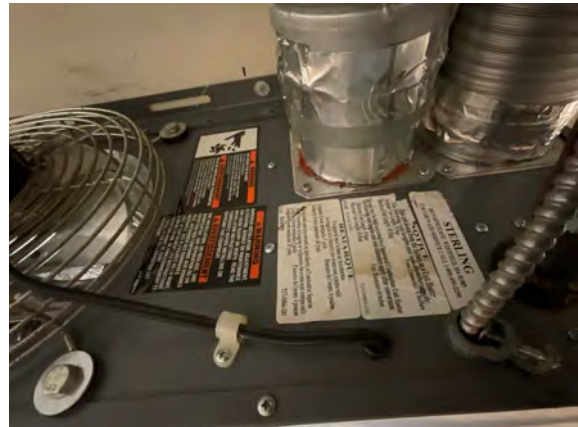
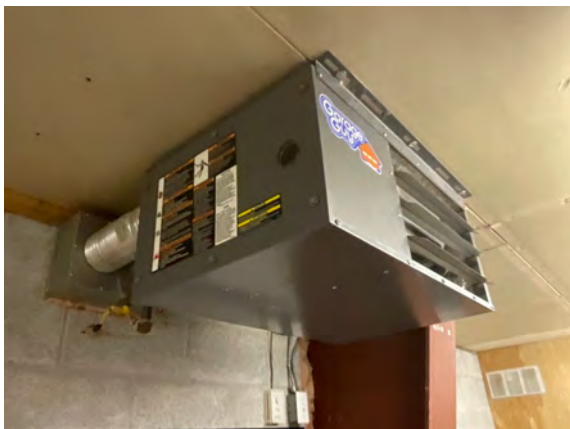
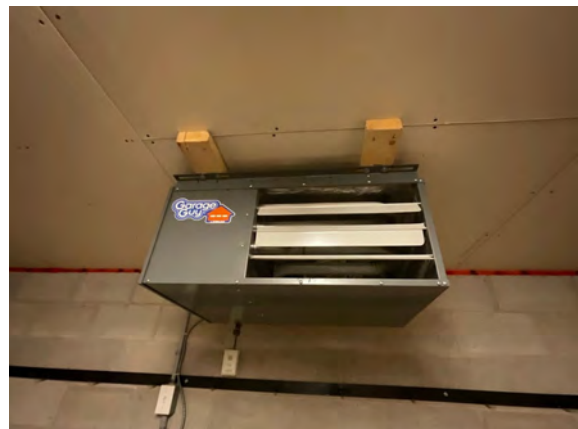
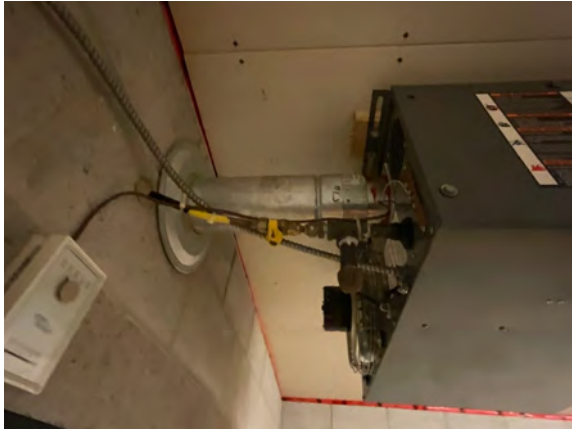
Palmer Rec Center - D305015

No significant deficiencies were observed or reported. Lifecycle replacement may be deferred.

<b>Recommendations #1 - Unit Heaters (Electric)</b>	
Type	Life Cycle Replacement
Year	2029
Cost	\$23,435.46

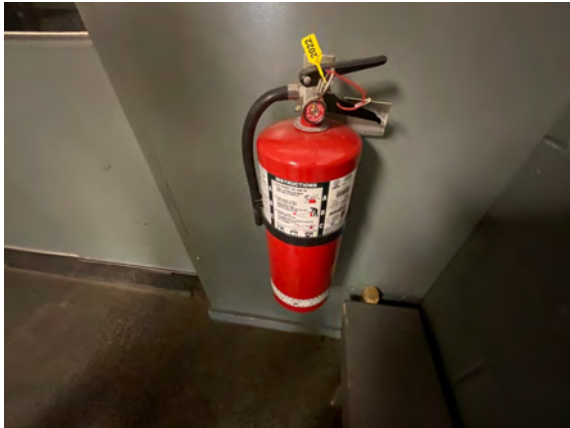
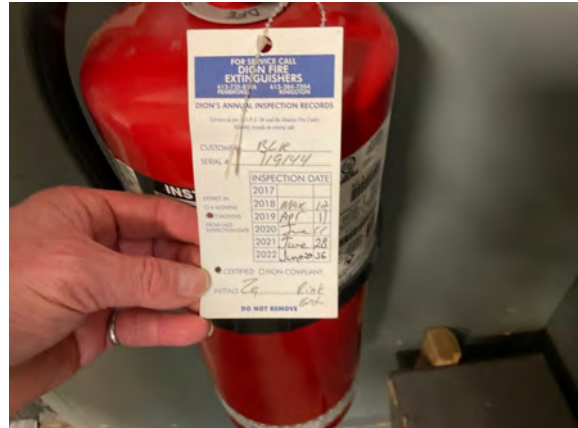
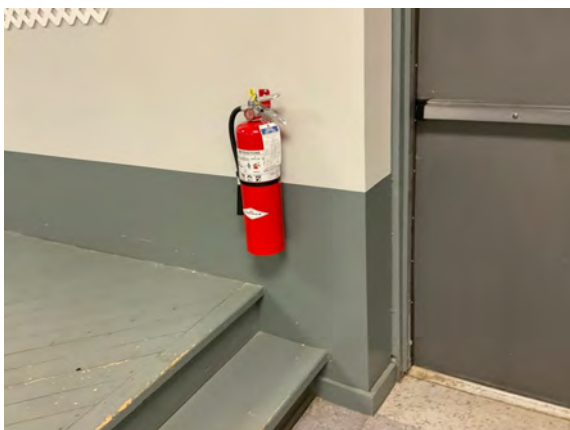
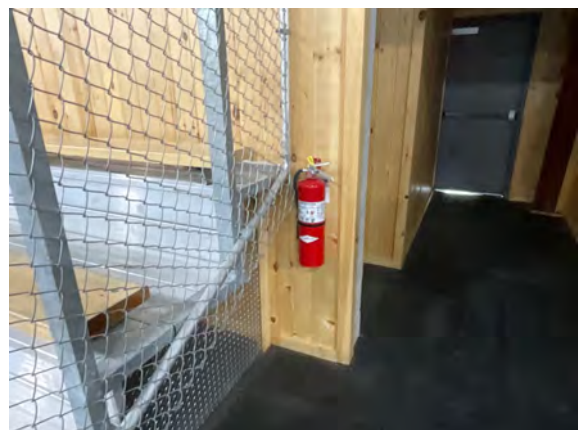
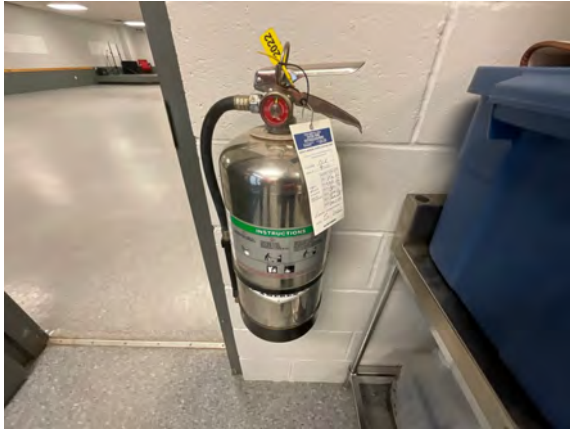
Palmer Rec Center - D403002

No significant deficiencies were observed or reported. Replacement is not anticipated in the short term.

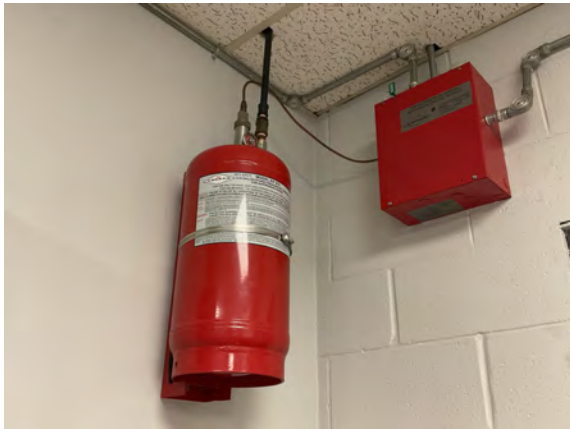
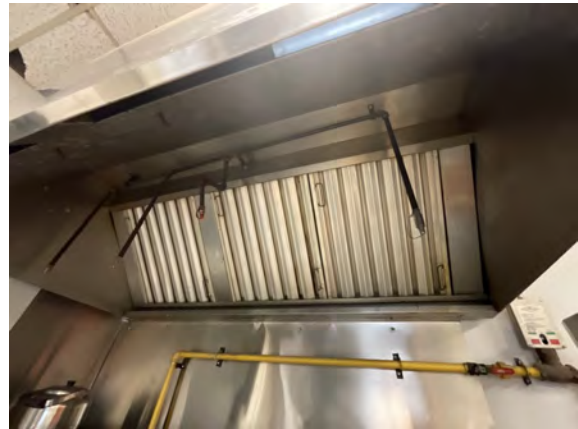
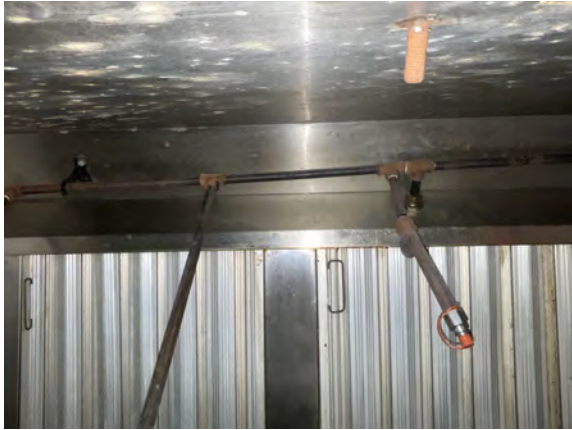
Palmer Rec Center - D409005

No significant deficiencies were observed or reported. Minor corrosion was observed on fittings. Replacement is not anticipated in the short term.

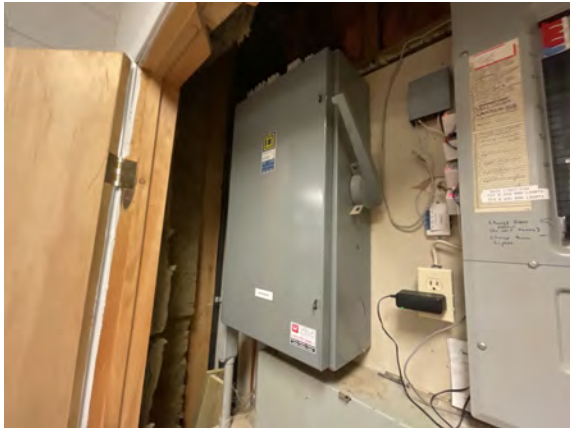
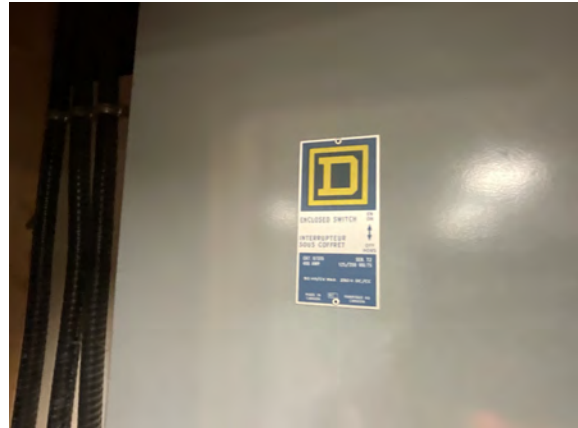
Palmer Rec Center - D501025

No significant deficiencies were observed or reported. Replacement is not anticipated in the short term.

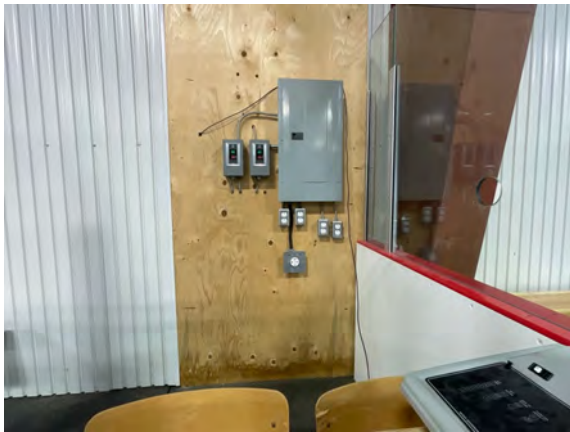
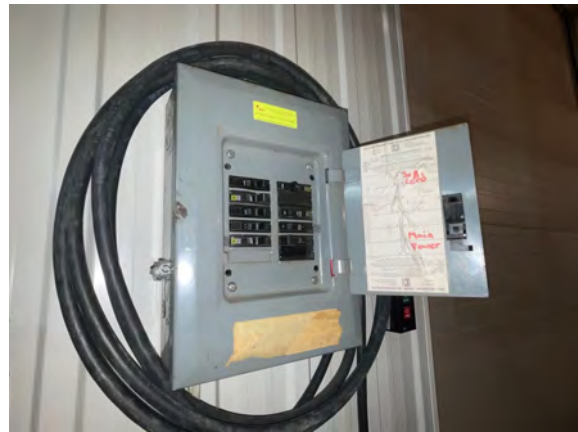
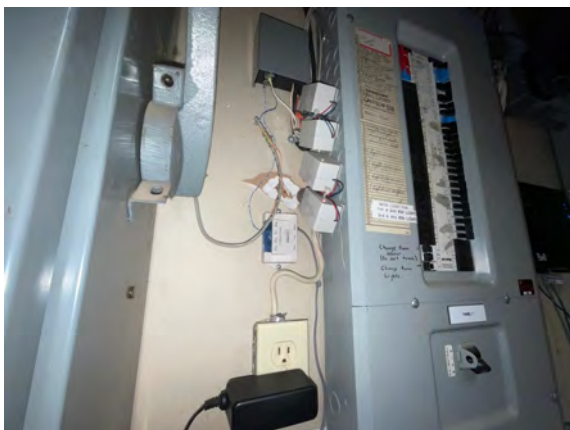
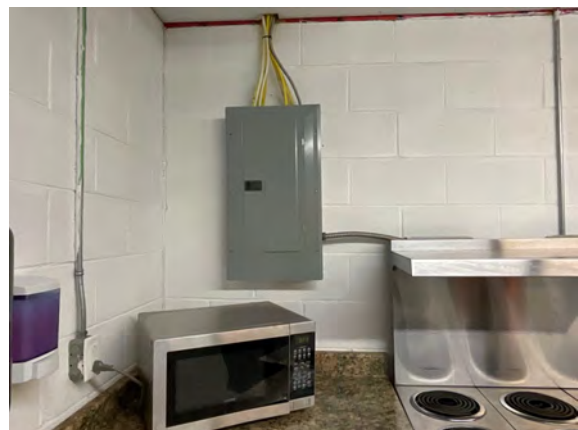
Palmer Rec Center - D501003

No significant deficiencies were observed or reported. Replacement is not anticipated in the short term.

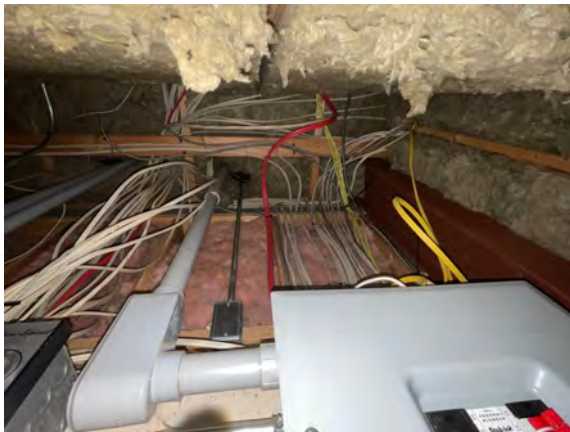
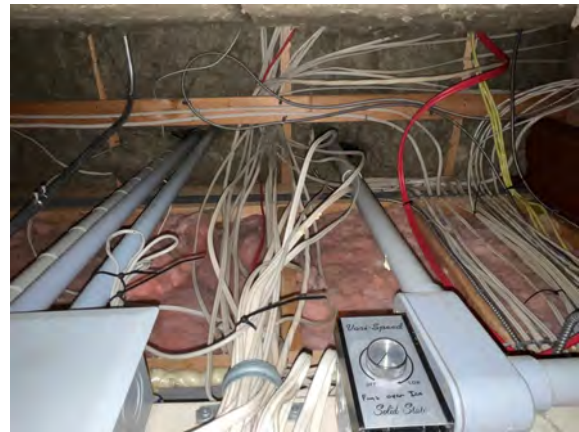
Palmer Rec Center - D502001

No significant deficiencies or leaks were observed or reported. Replacement is not anticipated in the short term.

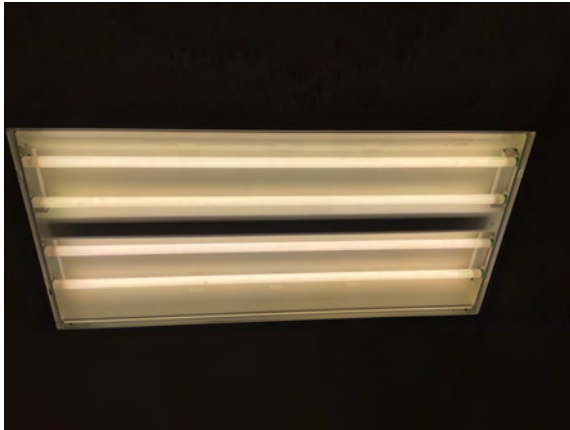
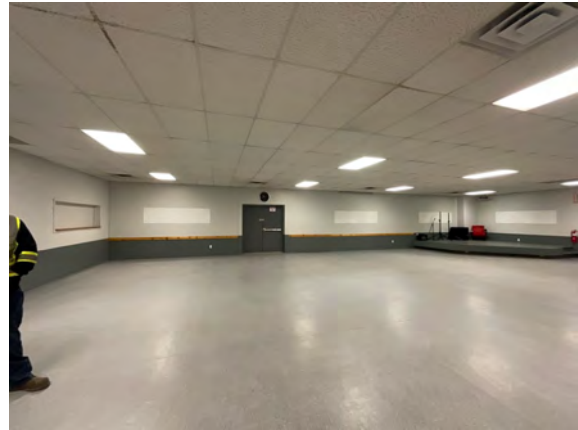
Palmer Rec Center - D502002

No significant deficiencies were observed or reported. However the lighting is energy inefficient. Replacement with upgrade to LED is recommended.

Recommendations #1 - Interior Lighting	
Type	Life Cycle Replacement
Year	2027
Cost	\$122,397.86

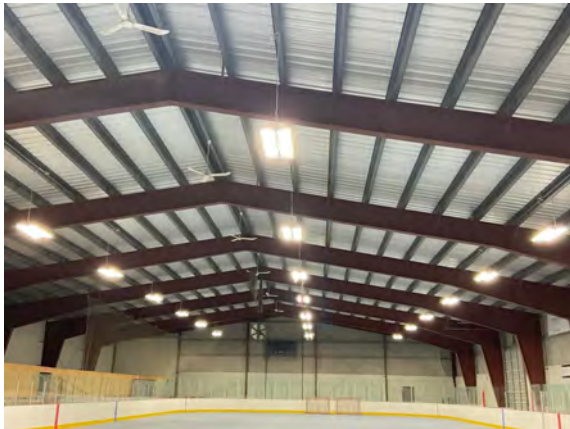
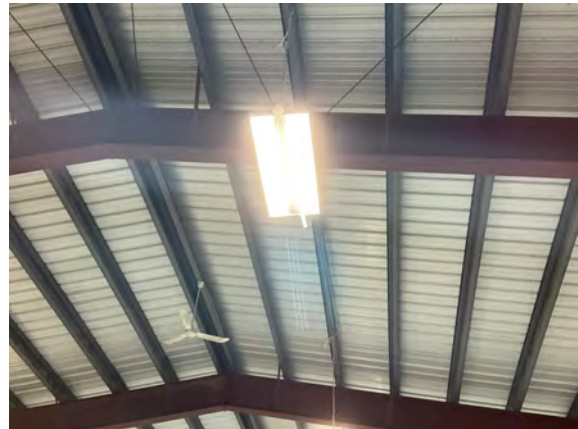
Palmer Rec Center - D502002

No significant deficiencies were observed or reported. Replacement is not anticipated in the short term.

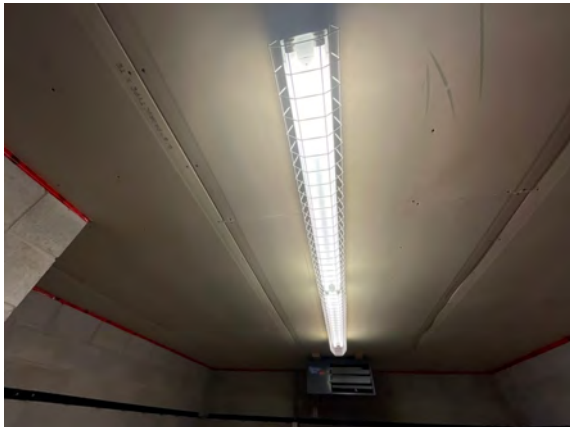
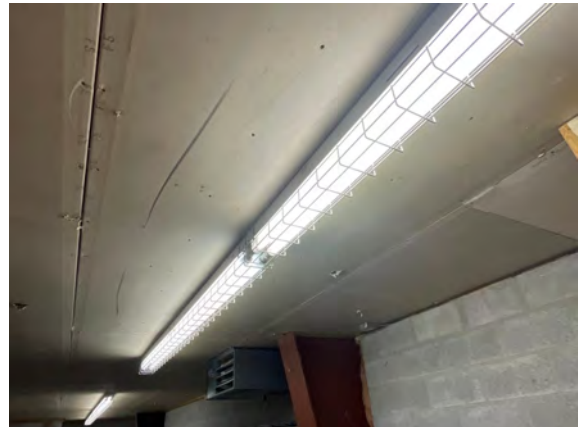
Palmer Rec Center - D502002

No significant deficiencies were observed or reported. Replacement is not anticipated in the short term.

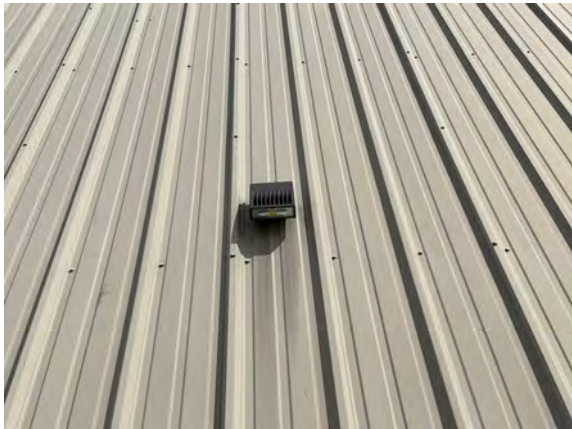
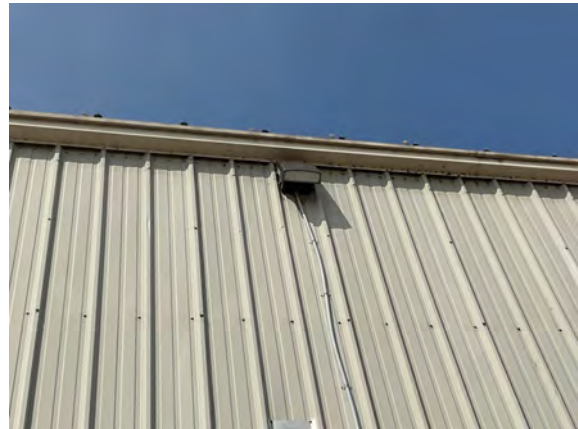
Palmer Rec Center - D502041

No significant deficiencies were observed or reported. Replacement is not anticipated in the short term.
