# Brudenell Lyndoch and Raglan

Submission to Township of Brudenell, Lyndoch, and Raglan

Roth IAMS Ltd.  
207-1075 North Service Rd W, Oakville ON, L6M 2G2  
[www.rothiams.com](http://www.rothiams.com)  
Project No. 23502

**Facility Condition Assessment Report**  
**Brudenell Fire Hall #4**

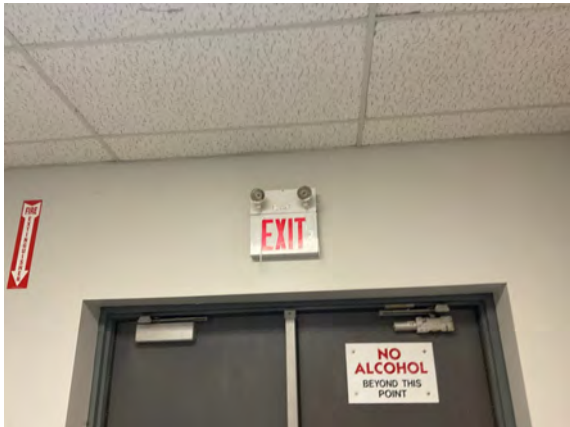
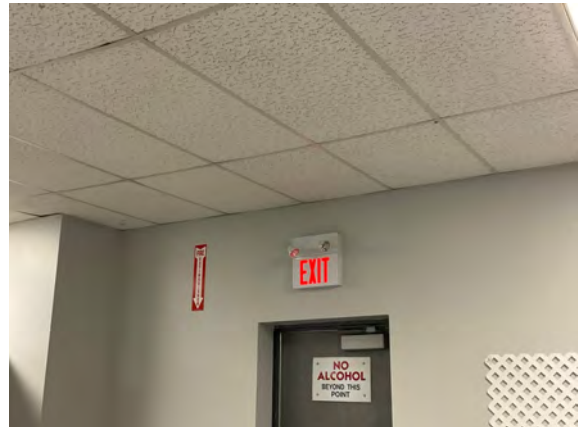
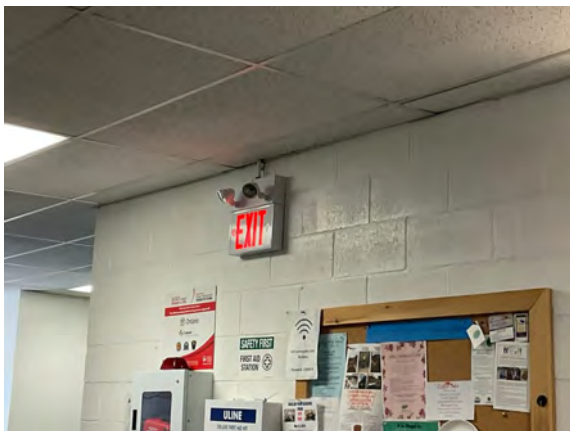
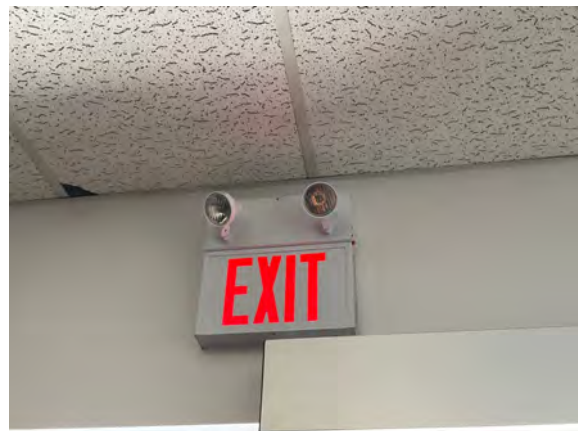
Palmer Rec Center - D502051

No significant deficiencies were observed or reported. Replacement is not anticipated in the short term.

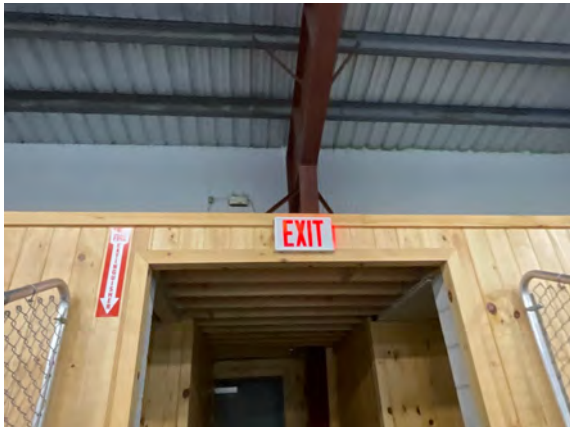
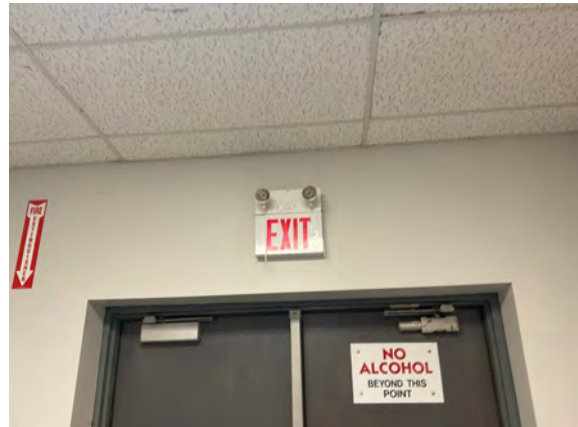
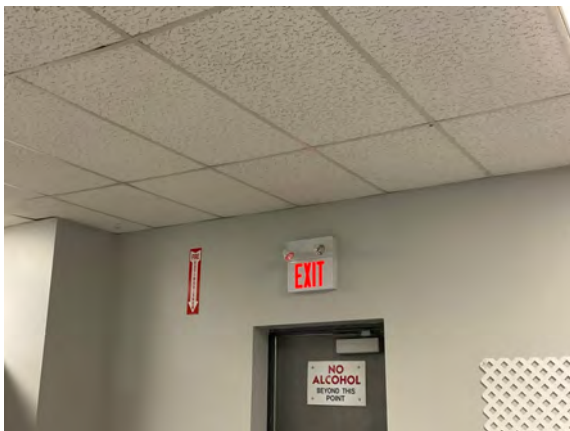
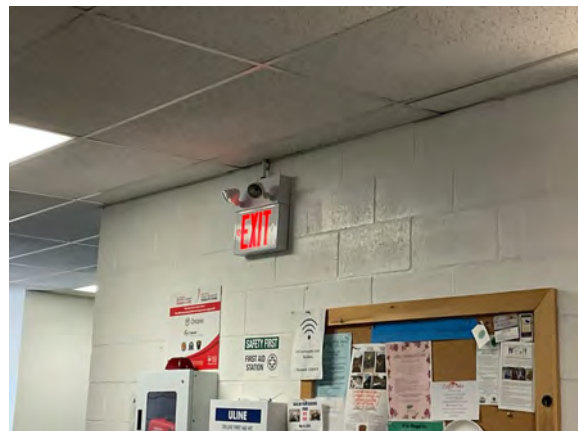
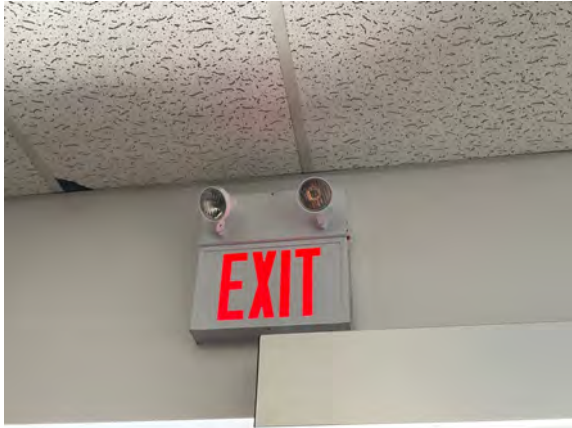
Palmer Rec Center - D502051

No significant deficiencies were observed or reported. Replacement is not anticipated in the short term.

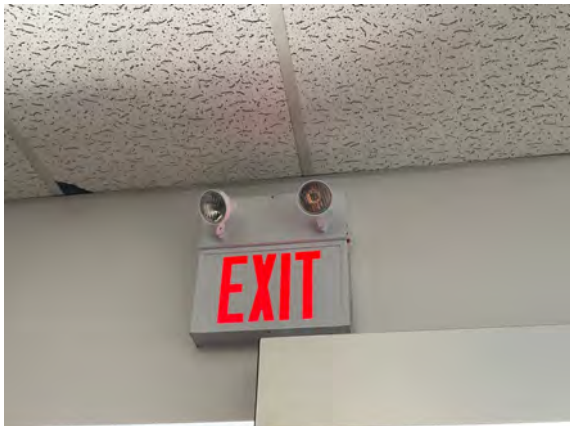
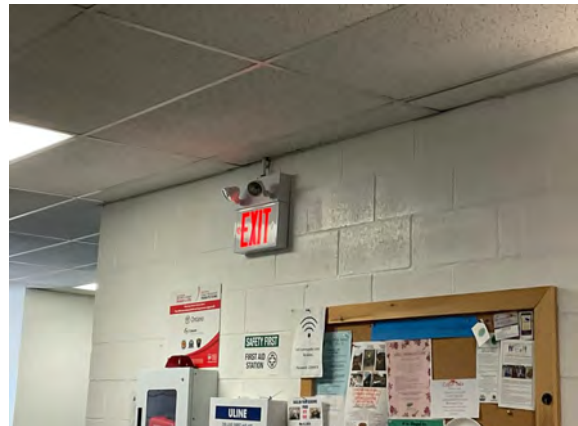
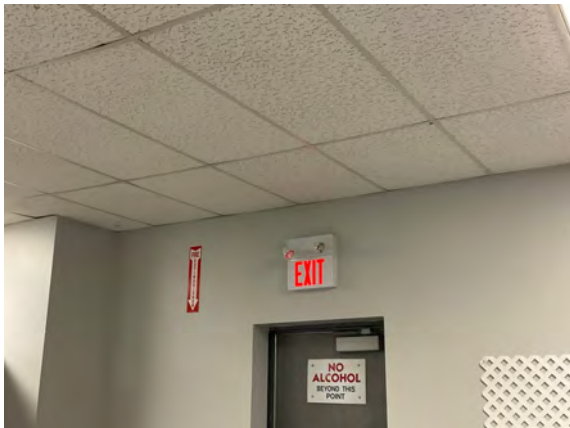
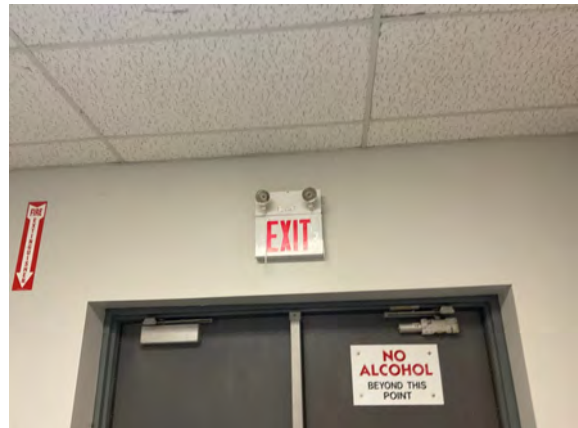
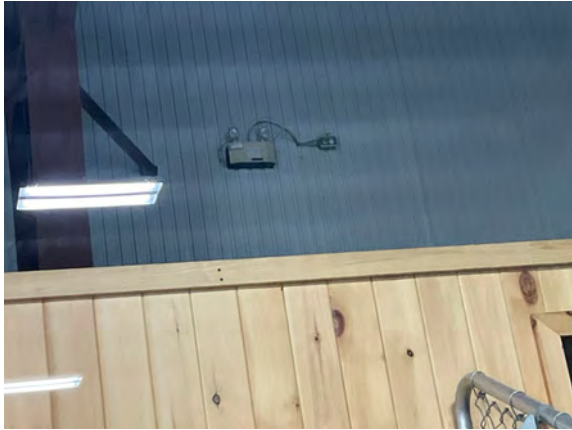
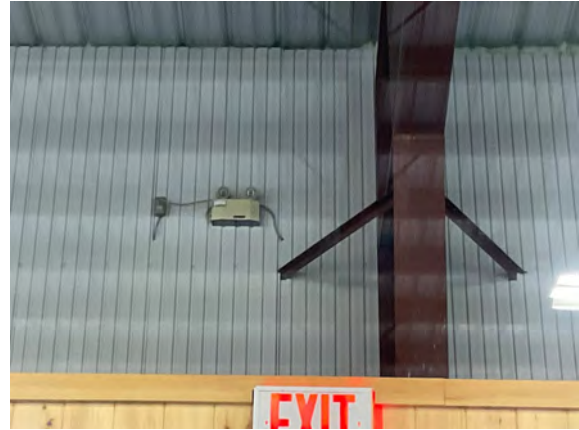
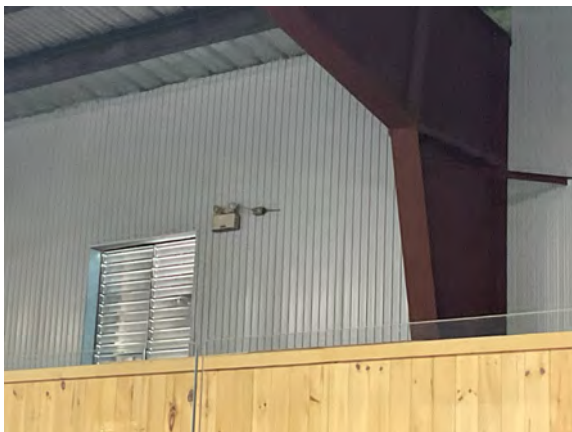
Palmer Rec Center - D509003

No significant deficiencies were observed or reported. However the lighting is energy inefficient. Replacement with upgrade to LED is recommended.

<b>Recommendations #1 - Emergency Lighting</b>	
Type	Life Cycle Replacement
Year	2026
Cost	\$18,209.43

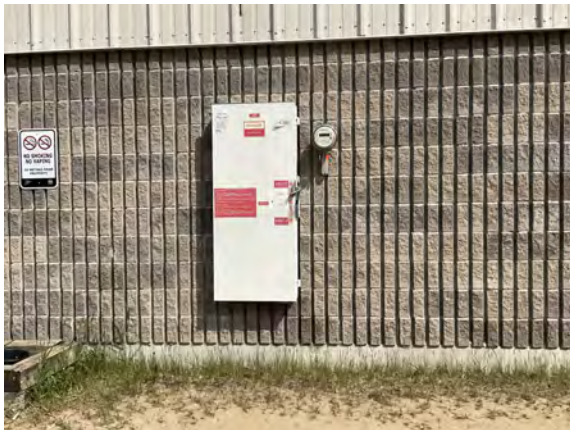
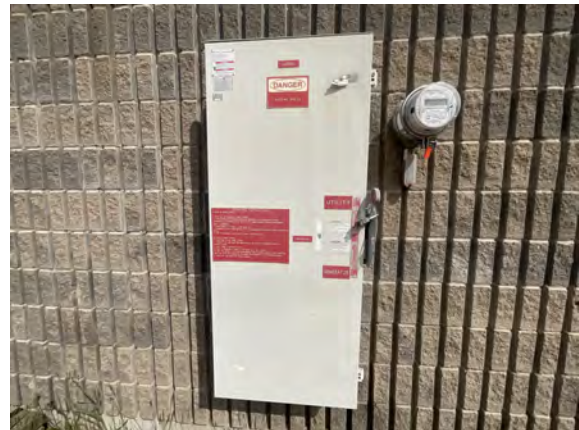
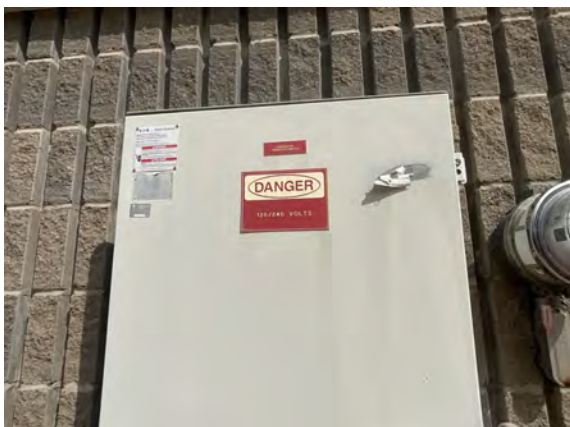
Palmer Rec Center - D509031

No significant deficiencies were observed or reported. Replacement is not anticipated in the short term.

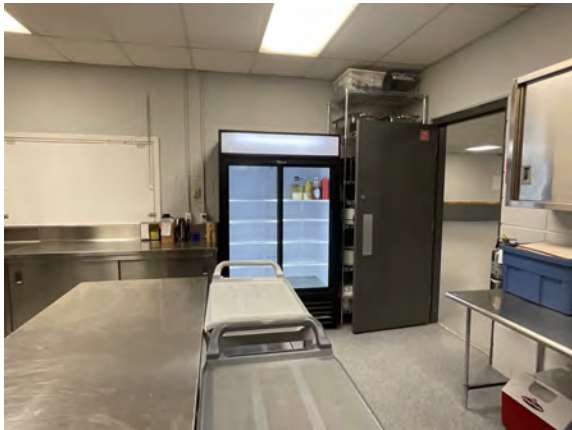
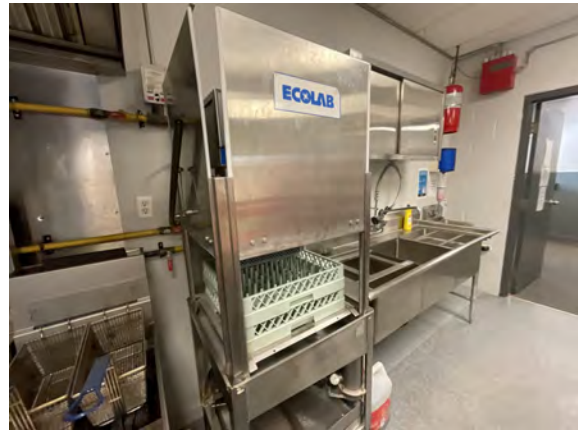
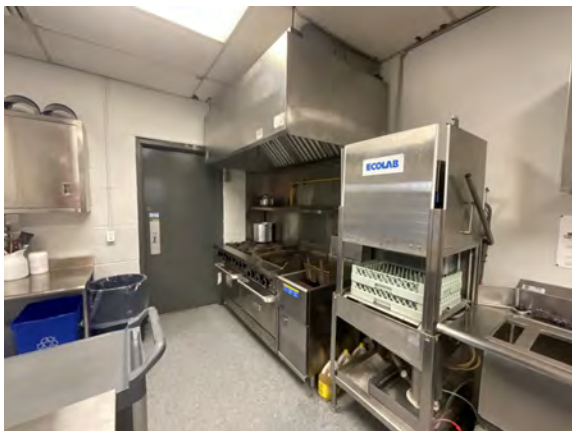
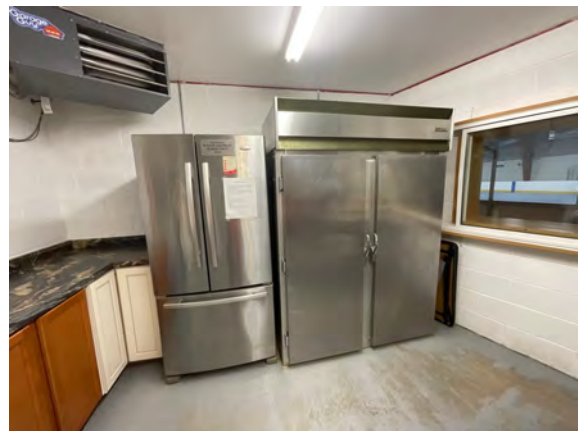
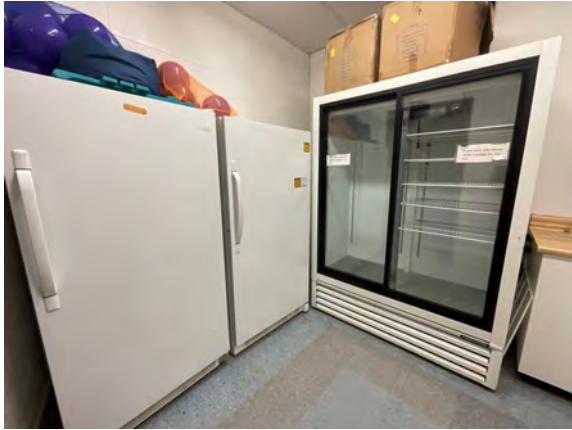
Palmer Rec Center - E101004

No significant deficiencies were observed or reported. Replacement is not anticipated in the short term.

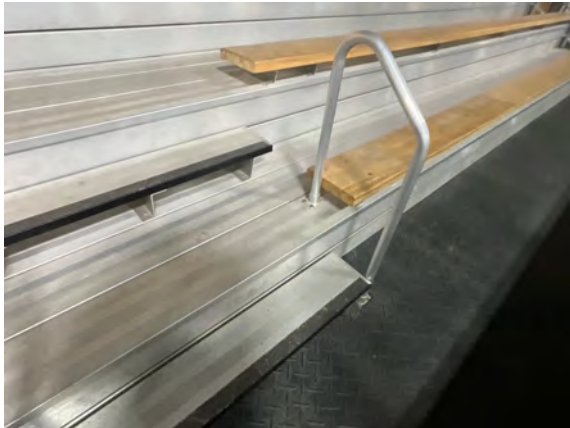
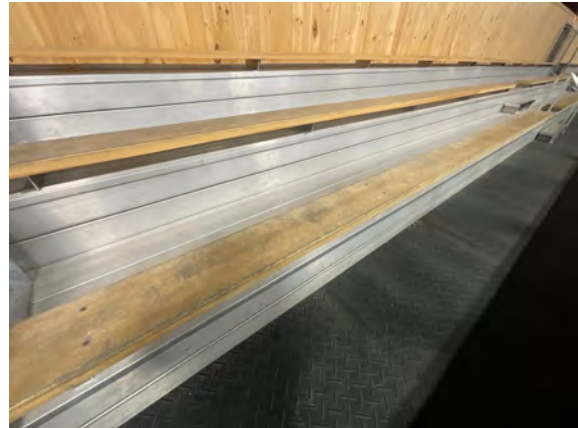
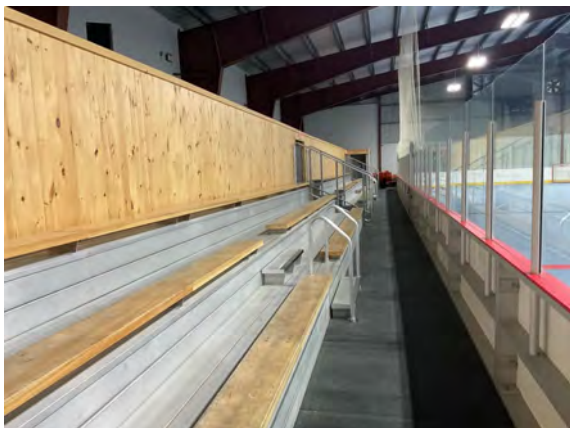
Palmer Rec Center - E201003

No significant deficiencies were observed or reported. Replacement is not anticipated in the short term.

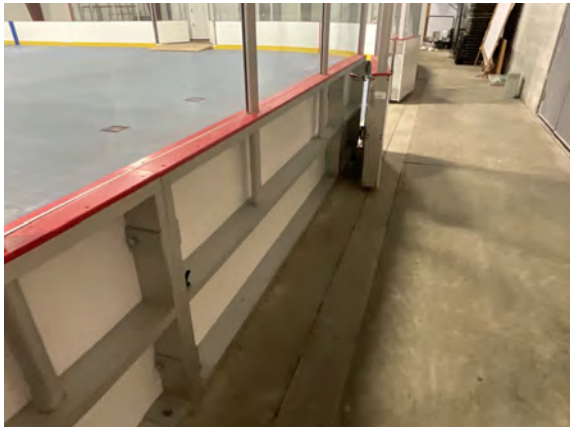
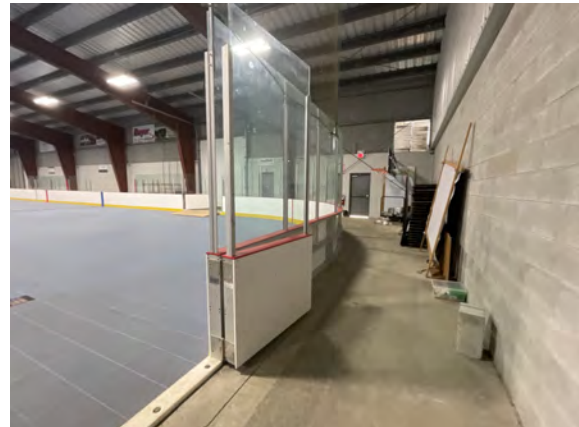
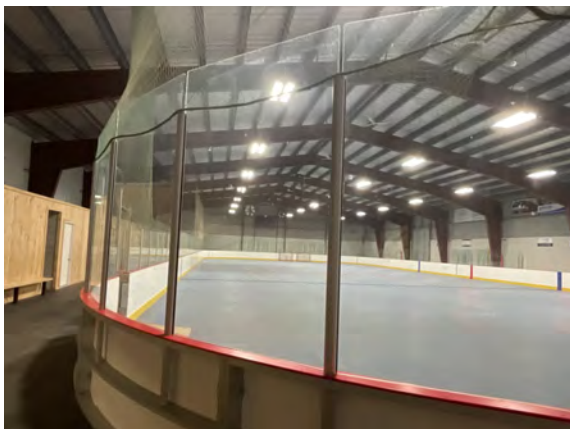
Palmer Rec Center - F104023

No significant deficiencies were observed or reported. Replacement is not anticipated in the short term.

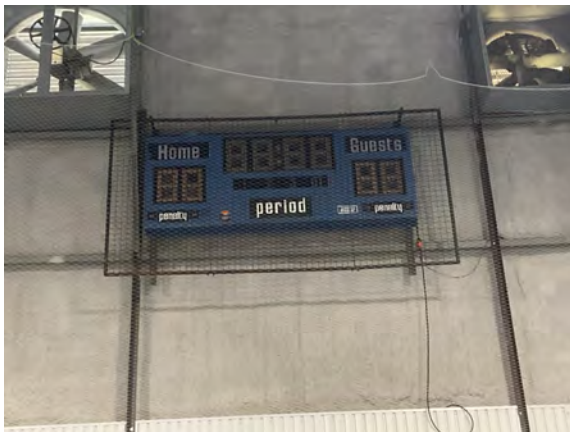
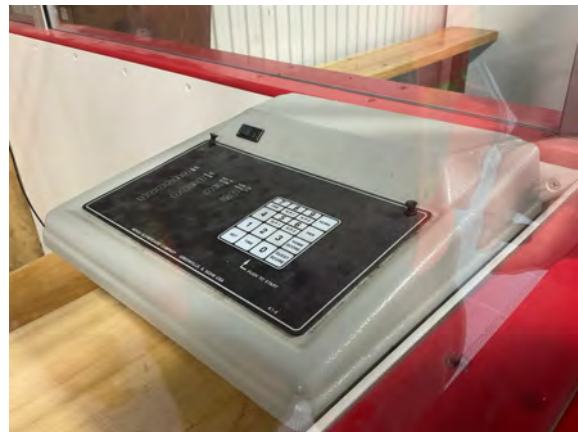
Palmer Rec Center - F104026

No significant deficiencies were observed or reported. Replacement is not anticipated in the short term.

Recommendations #1 - Ice Rink Scoreboards	
Type	Life Cycle Replacement
Year	2029
Cost	\$17,093.46

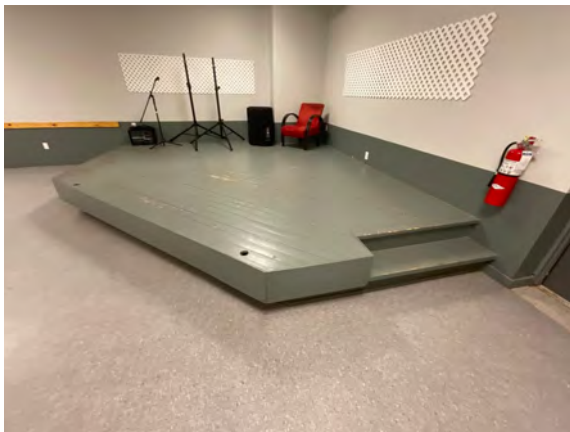
Palmer Rec Center - F104099

No significant deficiencies were observed or reported. Replacement is not anticipated in the short term.

<b>Recommendations #1 - Other Special Facilities</b>	
Type	Life Cycle Replacement
Year	2029
Cost	\$6,804.72

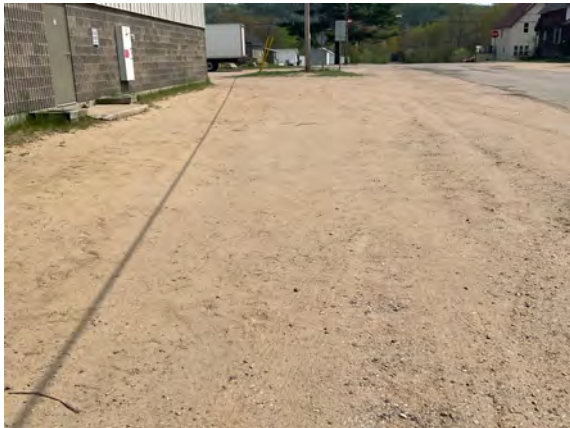
Palmer Rec Center - G202024

No significant deficiencies were observed or reported. Replacement is not anticipated in the short term.

<b>Recommendations #1 - Gravel Paved Surface - Parking Area</b>	
Type	Life Cycle Replacement
Year	2029
Cost	\$43,550.21

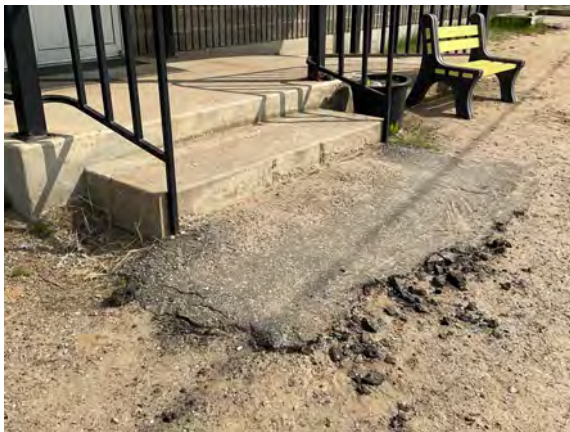
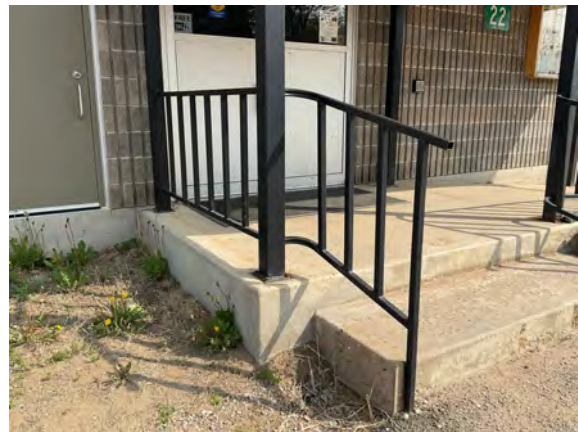
Palmer Rec Center - G203026

No significant deficiencies were observed or reported. Replacement is not anticipated in the short term.

<b>Recommendations #1 - Exterior Site Stairs - Concrete</b>	
Type	Life Cycle Replacement
Year	2050
Cost	\$1,714.79

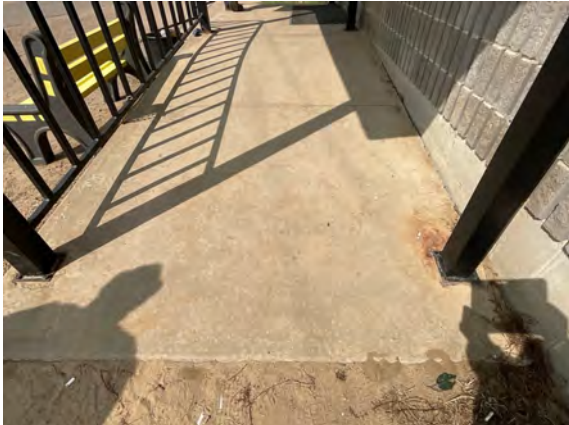
Palmer Rec Center - G203030

No significant deficiencies were observed or reported. Replacement is not anticipated in the short term.

<b>Recommendations #1 - Exterior Ramps - Concrete</b>	
Type	Life Cycle Replacement
Year	2050
Cost	\$6,859.16

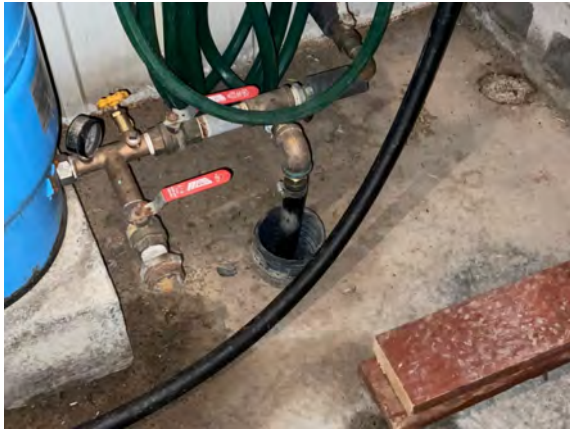
Palmer Rec Center - G301021

No significant deficiencies were observed or reported. Replacement is not anticipated in the short term.

Recommendations #1 - Water Supply Service	
Type	Life Cycle Replacement
Year	2060
Cost	\$29,668.58

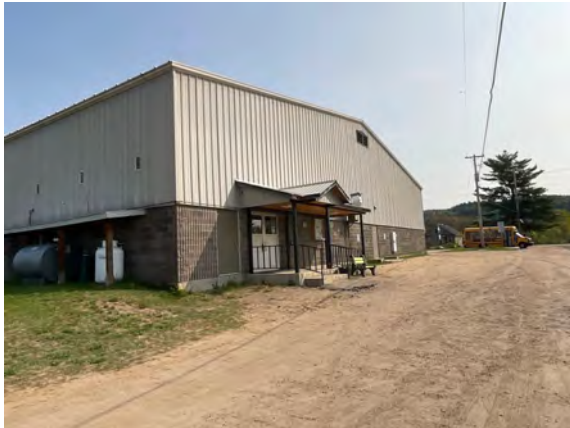
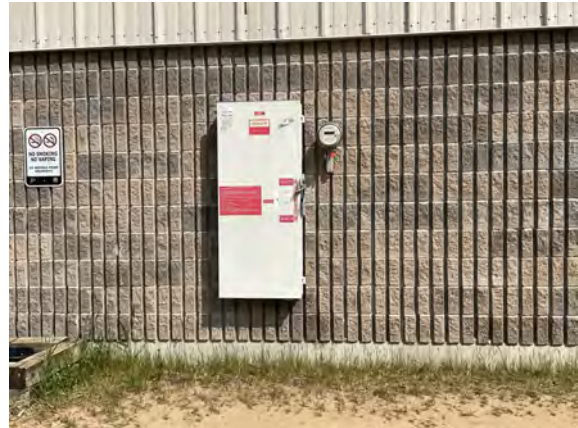
Palmer Rec Center - G401011

No significant deficiencies were observed or reported. Replacement is not anticipated in the short term.

Recommendations #1 - Electrical Service	
Type	Life Cycle Replacement
Year	2042
Cost	\$18,985.17

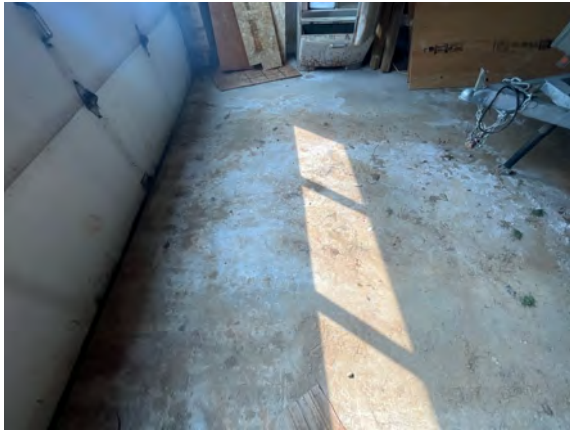
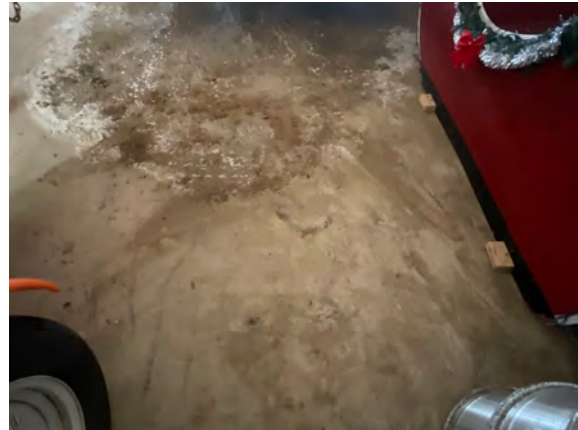
Palmer Storage Shed - A103001

No major deficiencies were observed or reported. No cracking in concrete was observed.

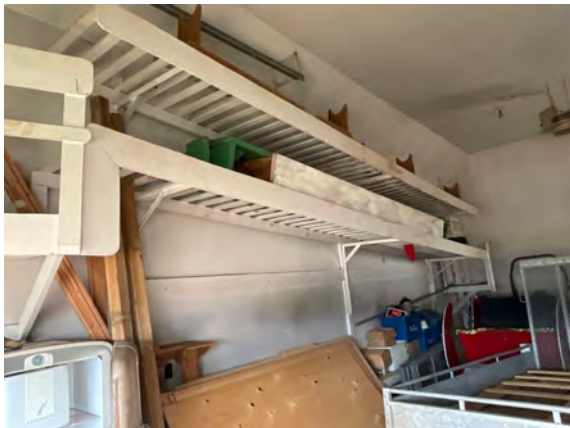
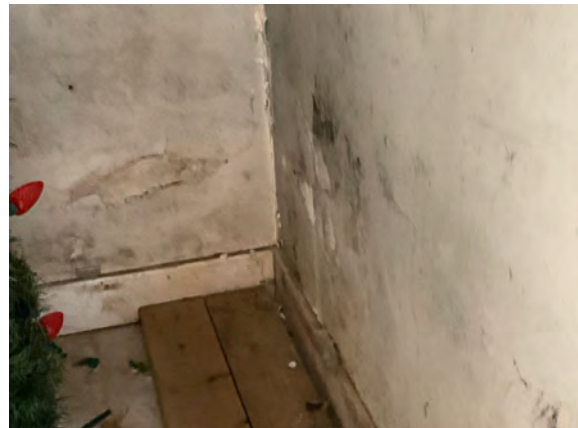
Palmer Storage Shed - B103001

No major deficiencies were observed or reported on the exposed structural framing system. No significant deterioration was noted or signs to suggest any deterioration or twisting/ movement of the building structure.

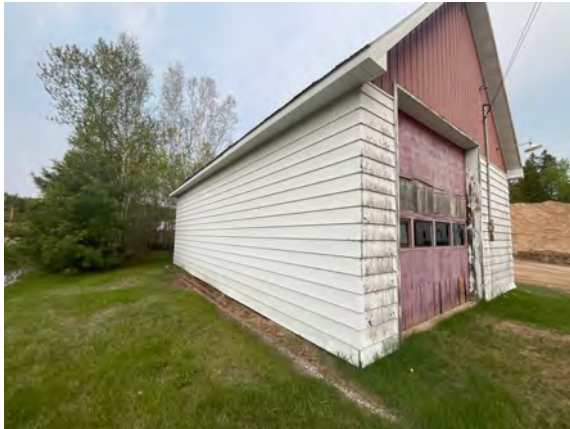
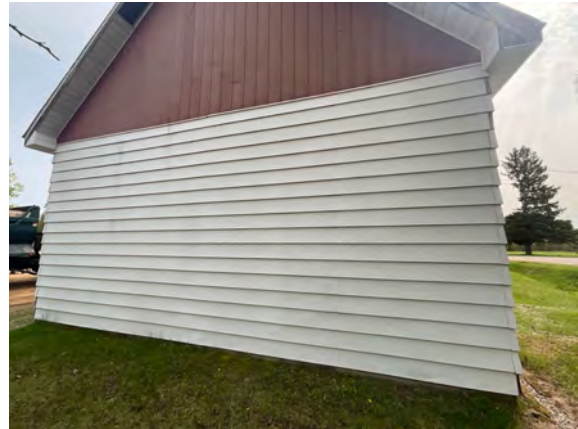
Palmer Storage Shed - B201010

Deficiencies observed or reported during the assessment include staining, fading, and discolouration. The deterioration is anticipated to progress due to age and exposure to the elements. Replacement is recommended in the short term.

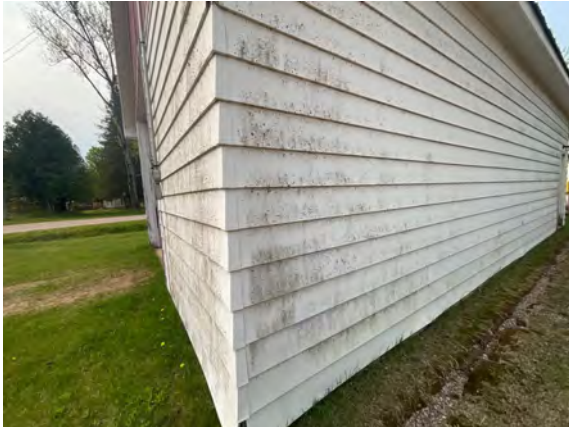
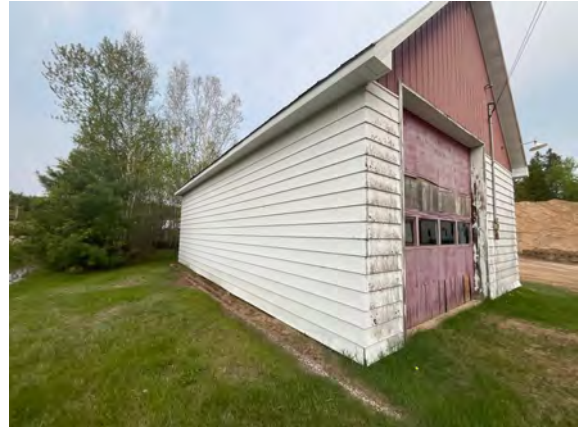
Palmer Storage Shed - B201026

No significant deficiencies were observed or reported. Replacement is not anticipated in the short term.

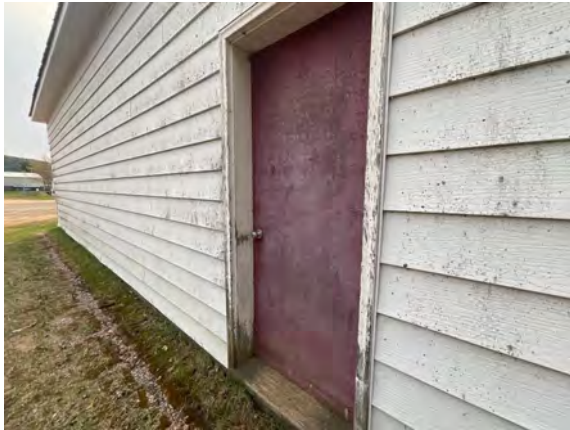
Palmer Storage Shed - B203024

Deficiencies observed or reported during the assessment include delamination, wood rot, worn or discolored finishes. The deterioration is anticipated to progress due to age. Replacement is recommended in the short term.

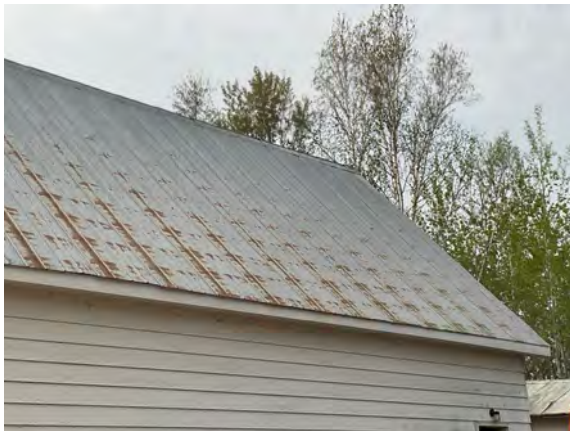
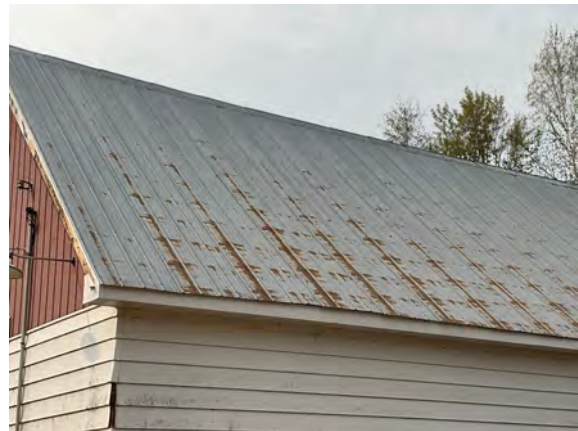
Palmer Storage Shed - B301028

Deficiencies observed or reported during the assessment include corroded panels and missing or failed fasteners. The deterioration is anticipated to progress due to age and exposure to the elements. Replacement is recommended in the short term.

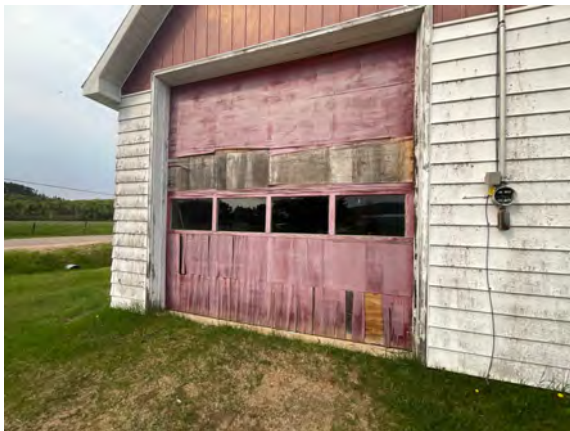
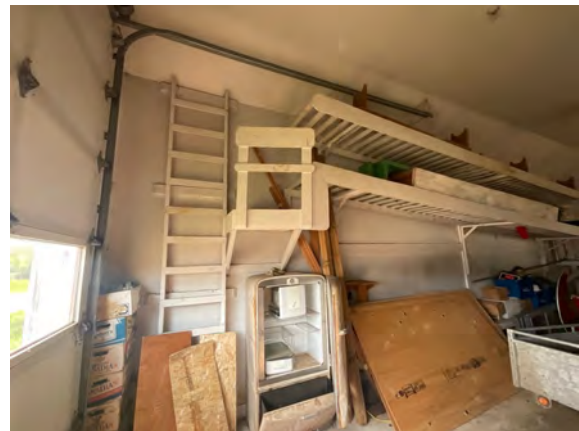
Palmer Storage Shed - C102005

Deficiencies observed or reported during the assessment include delamination, wood rot, worn or discolored finishes, water and air infiltration. The deterioration is anticipated to progress due to age. Replacement is recommended in the short term.

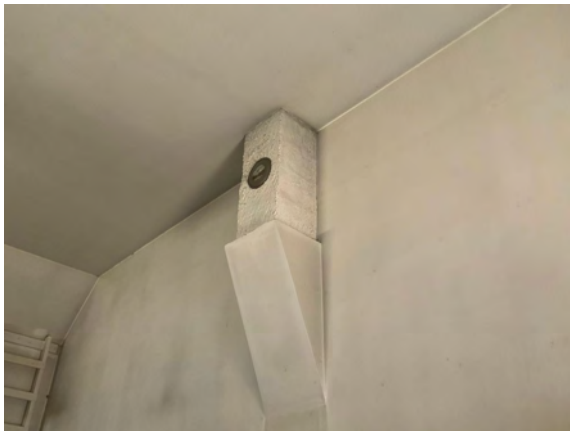
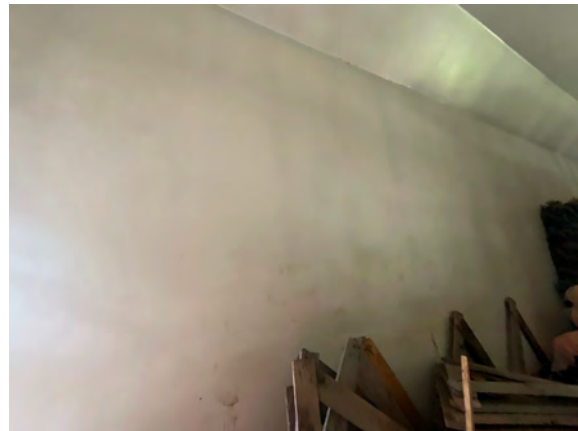
Palmer Storage Shed - C301005

Deficiencies observed or reported during the assessment include staining and discoloration, fading, wear, and deterioration. The deterioration is anticipated to progress due to age and ongoing building activities and may lead to a loss of marketability. Replacement is recommended in the short term.

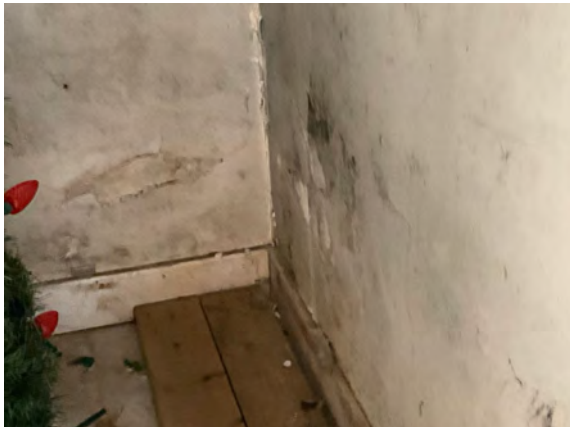
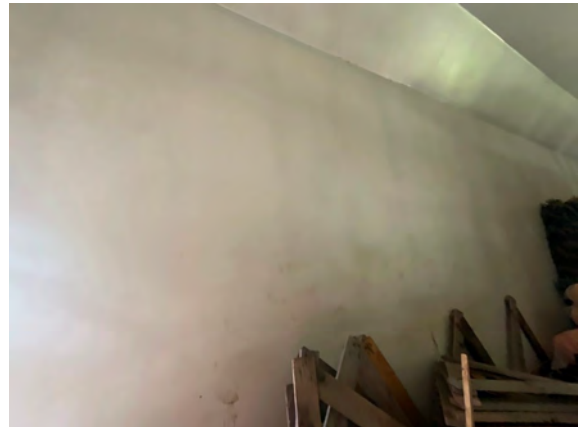
Palmer Storage Shed - C301022

No significant deficiencies were observed or reported. Localized damage should be repaired as part of maintenance. Replacement is not anticipated in the short term.

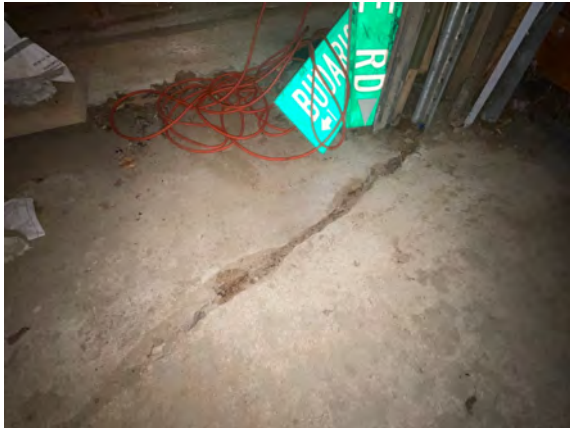
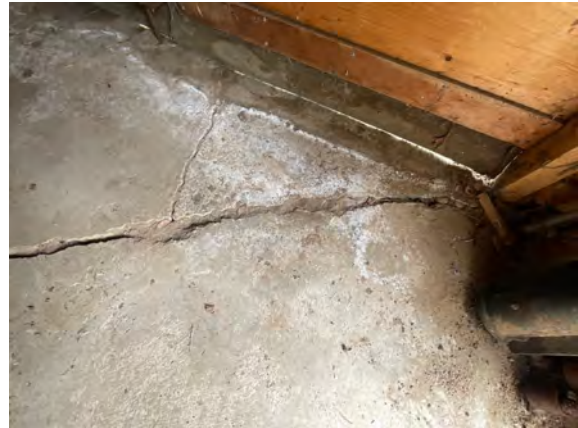
Palmer Storage Shed 2 - A103001

Deficiencies observed include significant lateral cracks. Although no significant elevation difference to suggest differential settlement of the concrete slab-on-grade was observed, replacement is recommended.

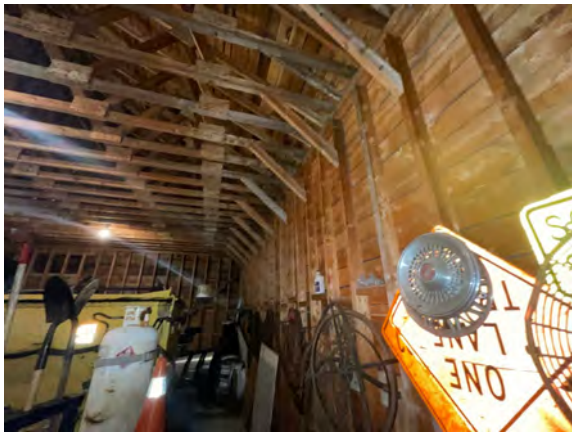
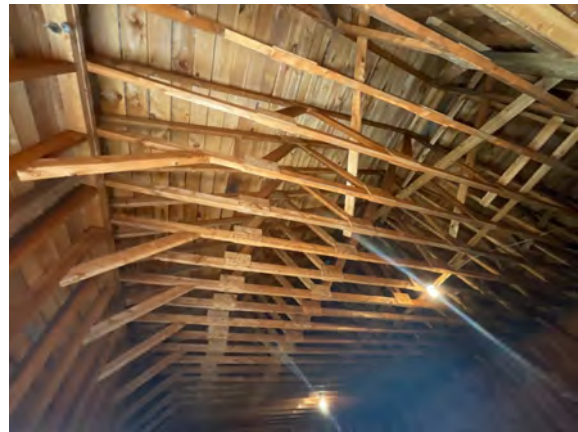
Palmer Storage Shed 2 - B103001

No significant deficiencies were observed or reported. Replacement is not anticipated in the short term.

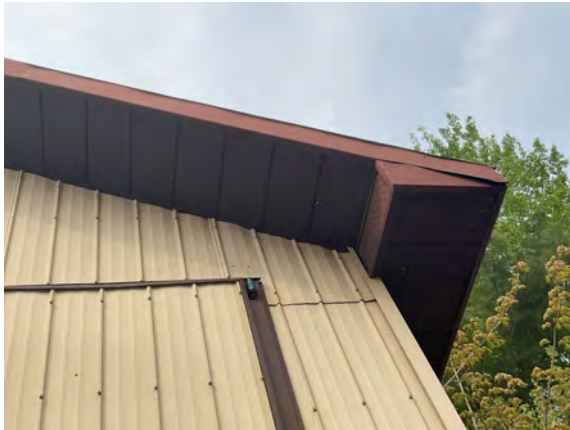
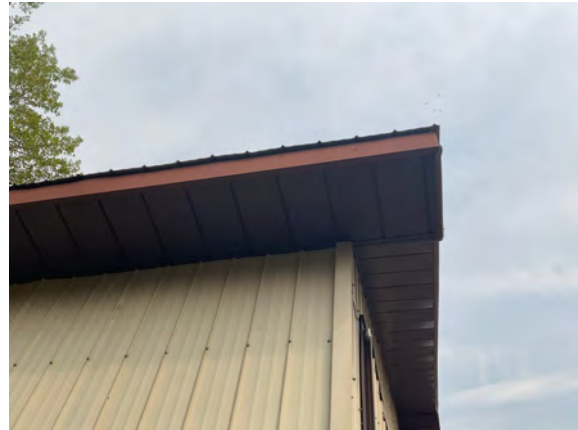
Palmer Storage Shed 2 - B201008

No significant deficiencies were observed or reported. Replacement is not anticipated in the short term.

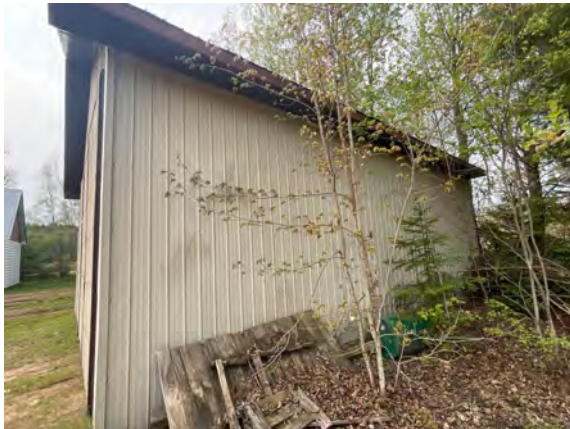
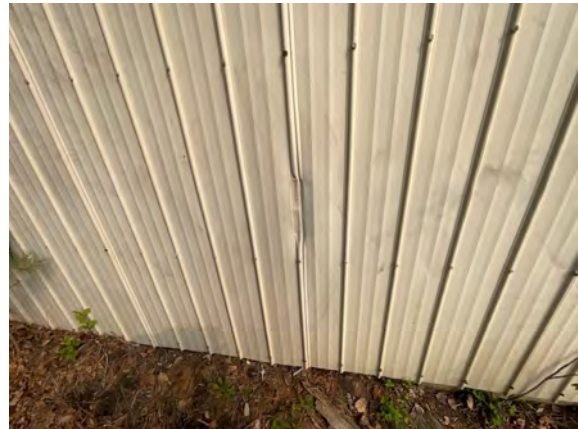
Palmer Storage Shed 2 - B201099

No significant deficiencies were observed or reported. Minor ice and impact damage was observed. Replacement is not anticipated in the short term.

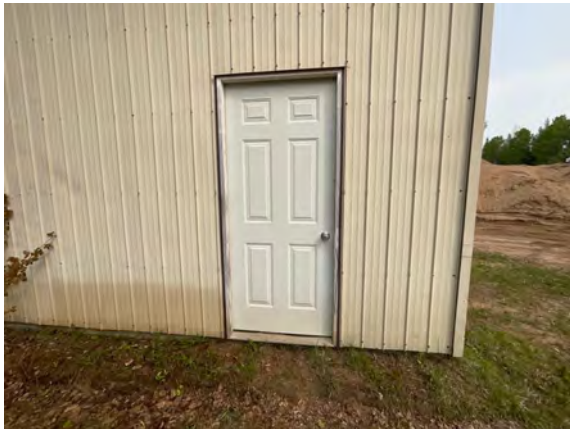
Palmer Storage Shed 2 - C102021

No significant deficiencies were observed or reported.

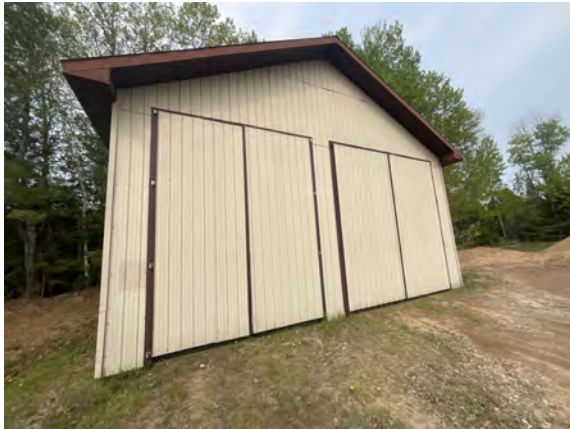
Palmer Storage Shed 2 - C102024

No significant deficiencies were observed or reported. Replacement is not anticipated in the short term.

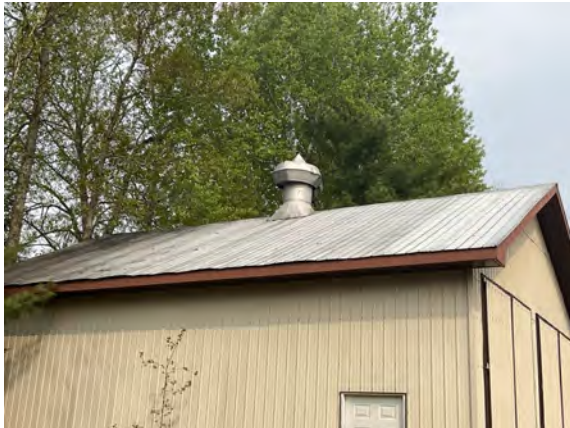
Palmer Storage Shed 2 - B301028

No significant deficiencies were observed or reported. Replacement is not anticipated in the short term.

Recommendations #1 - Metal Roofing	
Type	Life Cycle Replacement
Year	2029
Cost	\$54,166.09

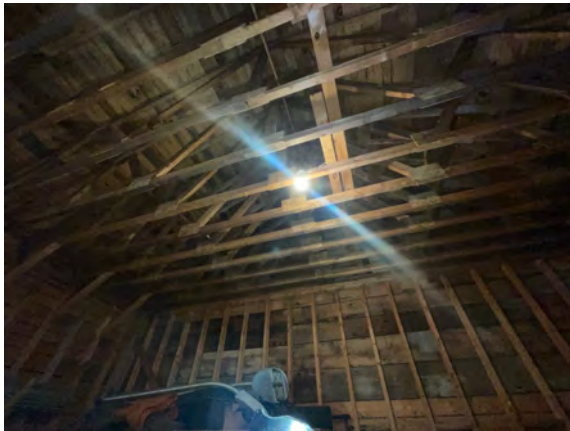
Palmer Storage Shed 2 - D502002

No significant deficiencies were observed or reported. However the system, based on age, is approaching or is past its expected useful life with reliability likely diminishing over time. Replacement is recommended.

Recommendations #1 - Incandescent Light Fixtures	
Type	Life Cycle Replacement
Year	2026
Cost	\$156.51

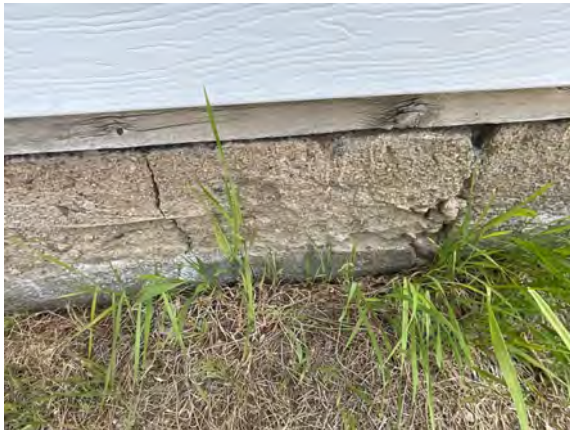
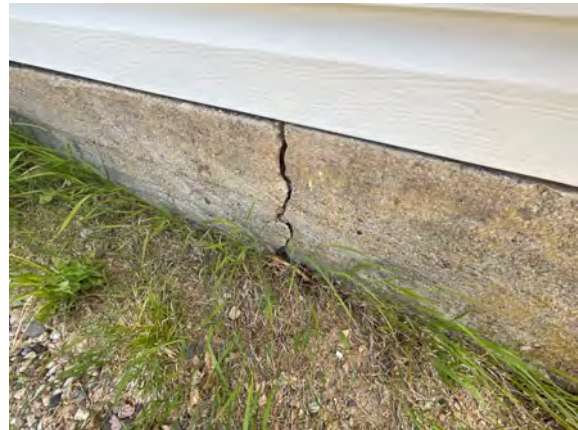
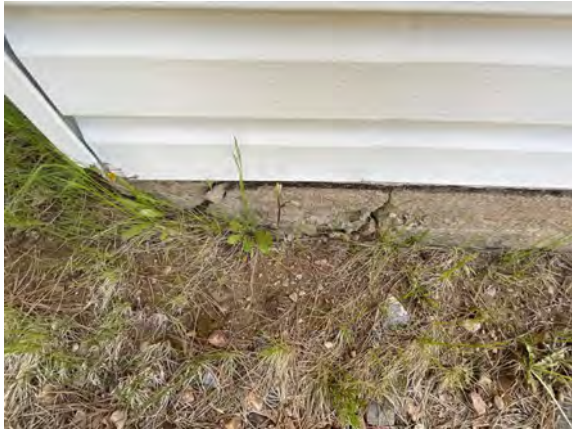
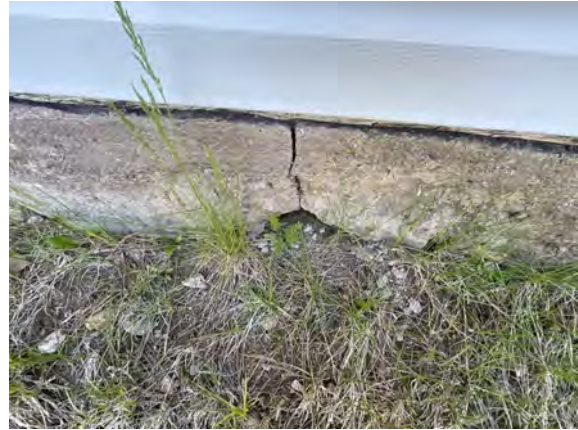
Quadville Fire Hall #3 - A101001

Deficiencies observed or reported at the time of the assessment include numerous vertical cracks. A study to determine the cause and extent of the cracks with a major repair based on the outcome of the study is recommended.

<b>Recommendations #1 - Standard Foundations</b>	
Type	Engineering Study
Year	2023
Cost	\$10,000.00

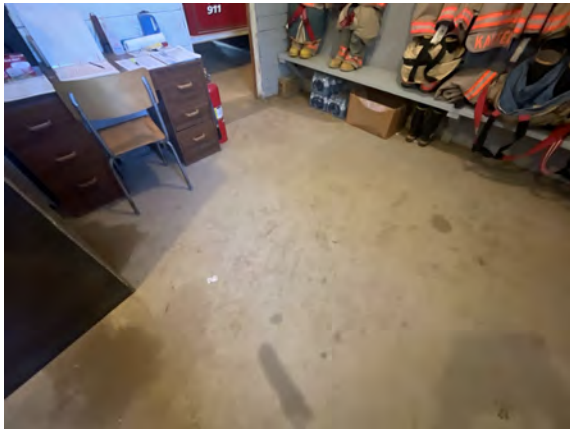
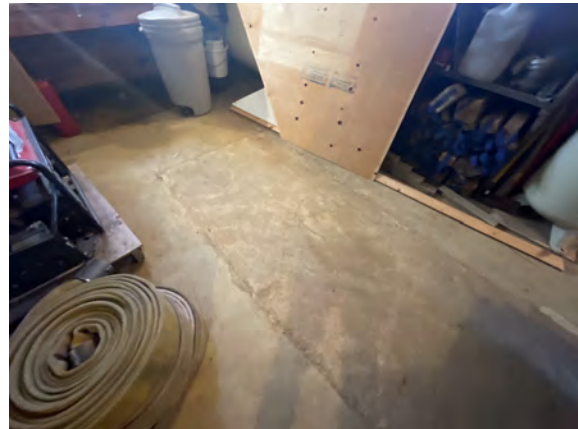
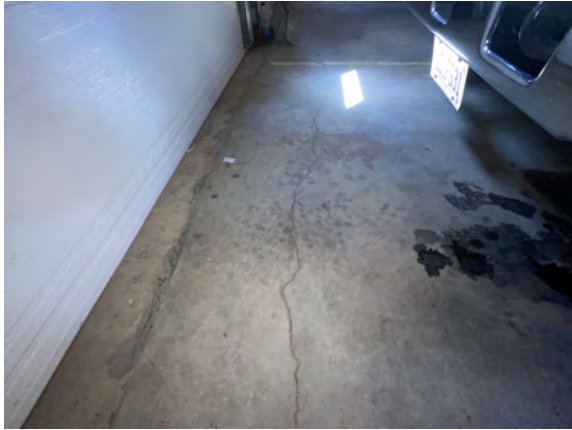
Quadville Fire Hall #3 - A103001

Some minor isolated cracking was observed, no significant elevation difference to suggest differential settlement of the concrete slab-on-grade was noted. However, the cracks are recommended to be monitored and should a significant magnitude change be noted, a professional/experienced structural engineer be retained.

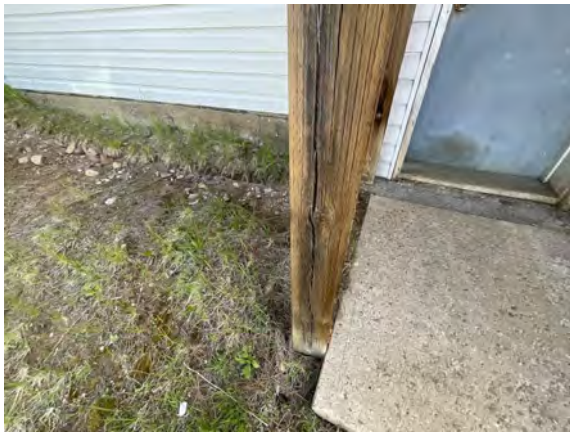
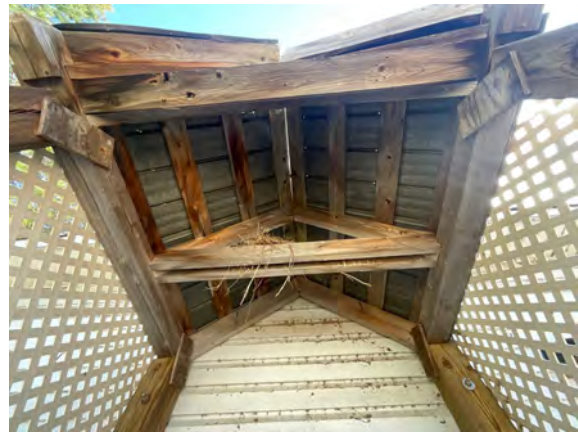
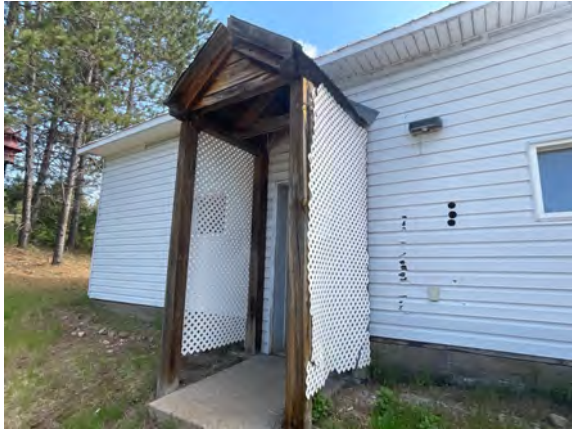
Quadville Fire Hall #3 - F101099

Deterioration in the form of wood rot and wood split was noted on the guards. The observed deterioration is anticipated to progress. Replacement is recommended.

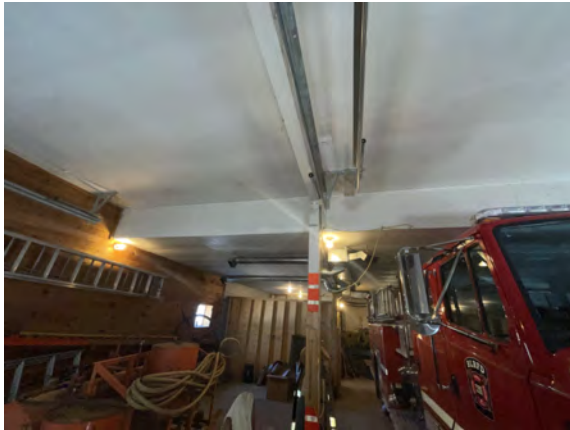
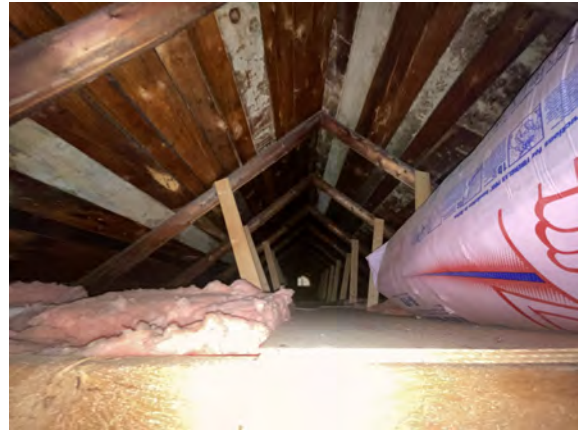
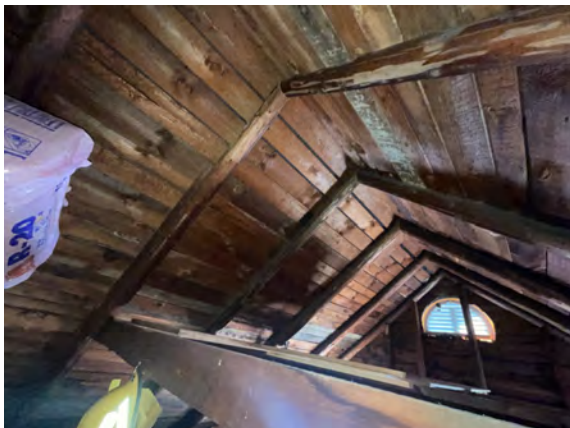
Quadville Fire Hall #3 - B103001

No significant deficiencies were observed or reported on the exposed structural framing system.

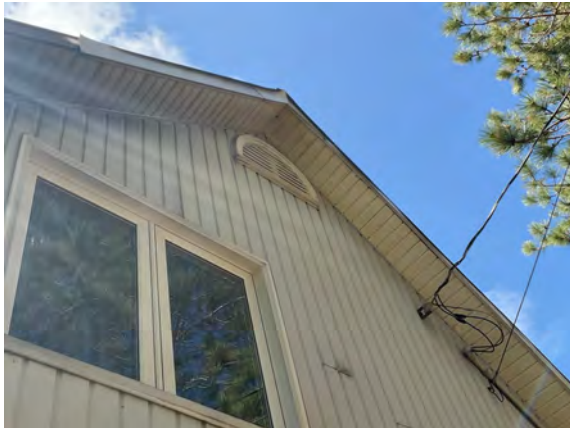
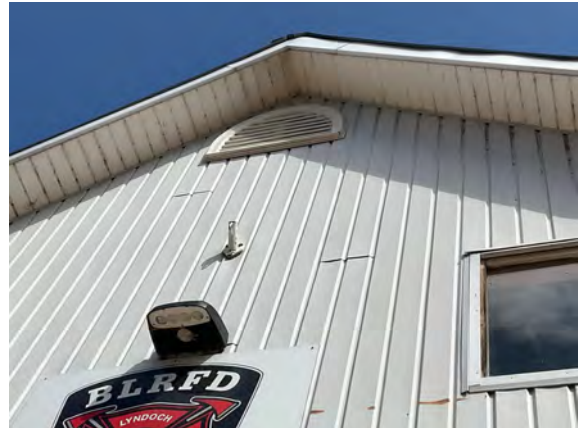
Quadville Fire Hall #3 - B201005

No significant deficiencies were observed or reported. Replacement is not anticipated in the short term.
