# Brudenell Lyndoch and Raglan

Submission to Township of Brudenell, Lyndoch, and Raglan

Roth IAMS Ltd.  
207-1075 North Service Rd W, Oakville ON, L6M 2G2  
[www.rothiams.com](http://www.rothiams.com)  
Project No. 23502

**Facility Condition Assessment Report**  
**Brudenell Fire Hall #4**

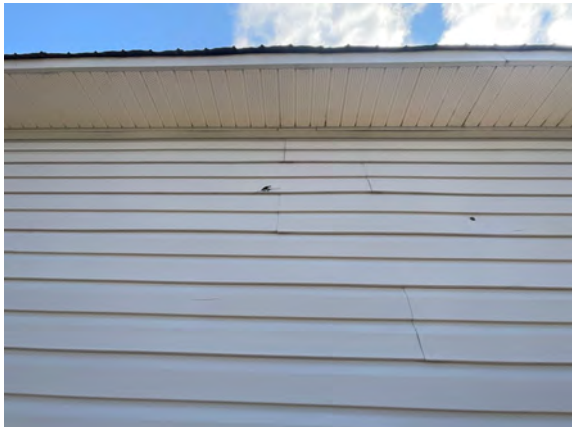
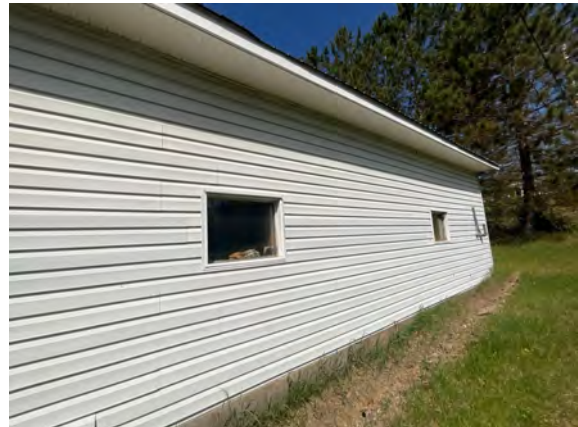
Quadville Fire Hall #3 - B201008

No significant deficiencies or leaks were observed or reported. Replacement is not anticipated in the short term.

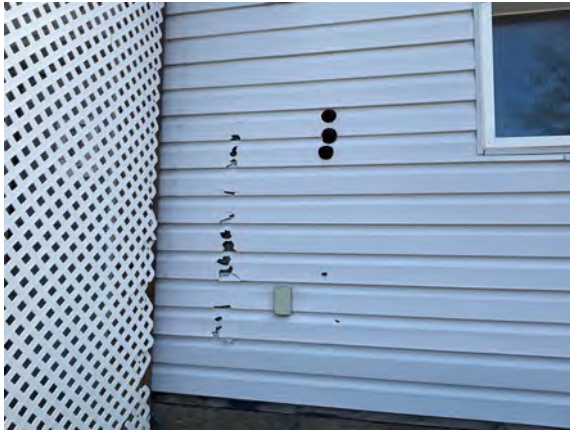
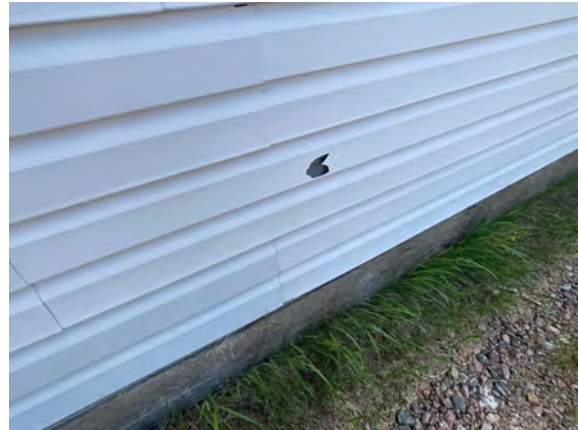
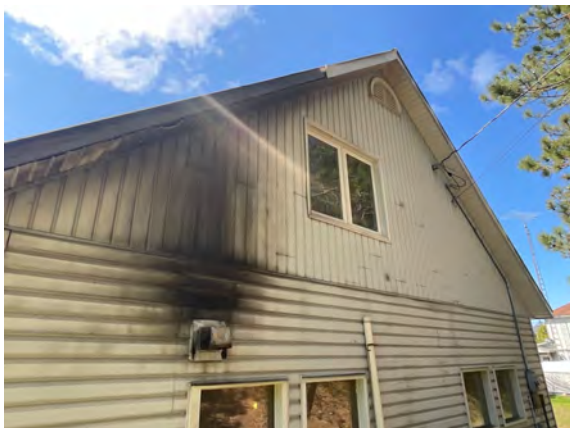
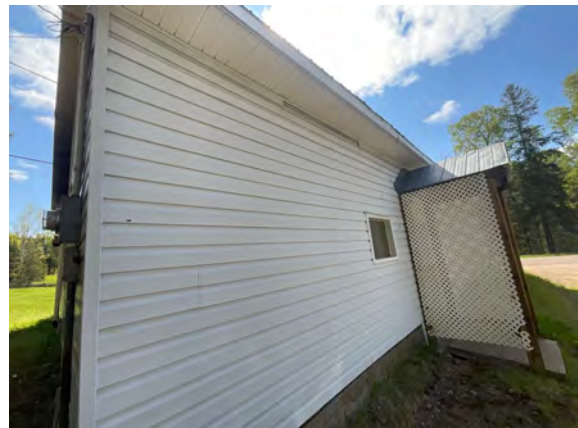
Quadville Fire Hall #3 - B201025

Deficiencies observed or reported during the assessment include damaged siding, staining, fading, and gaps in material coverage. The deterioration is anticipated to progress due to age and exposure to the elements. Replacement is recommended in the short term.

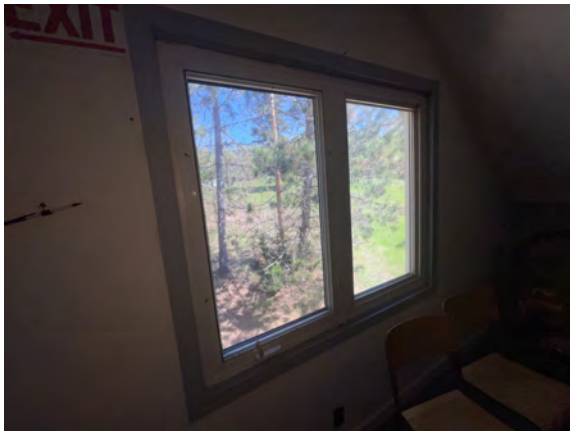
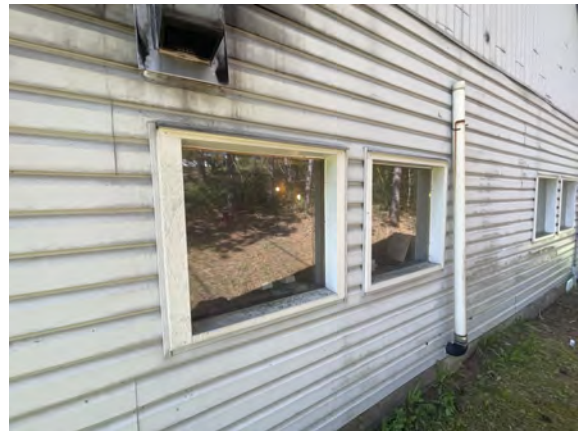
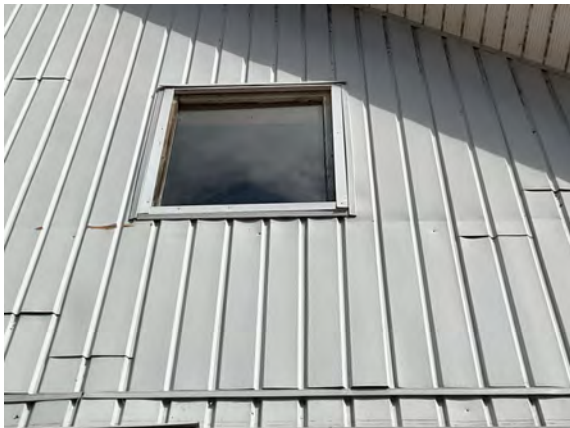
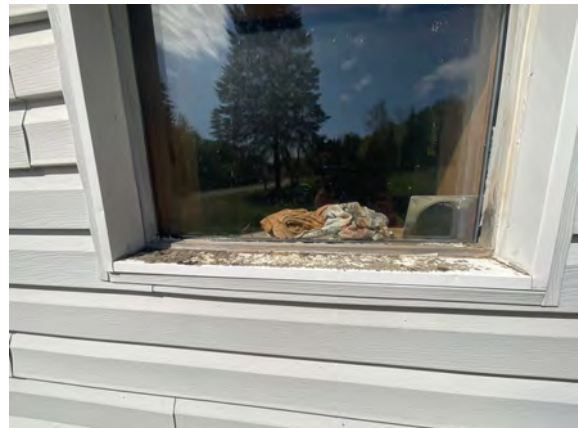
Quadville Fire Hall #3 - B202001

No significant deficiencies were observed or reported. However, the system, based on age, has surpassed its expected useful life and may experience sealant failure over time, resulting in potential leakage, condensation, energy loss, and discomfort for building occupants. Replacement is recommended in the short term.

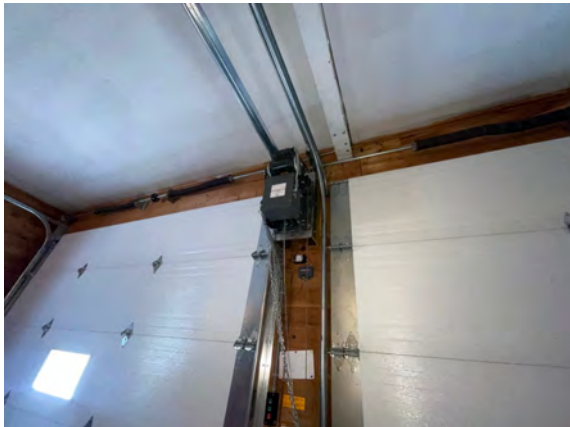
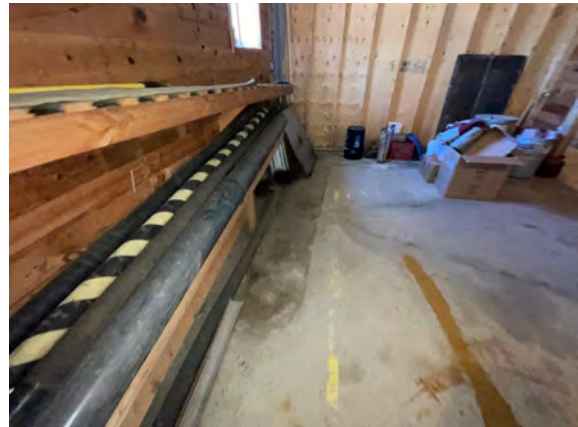
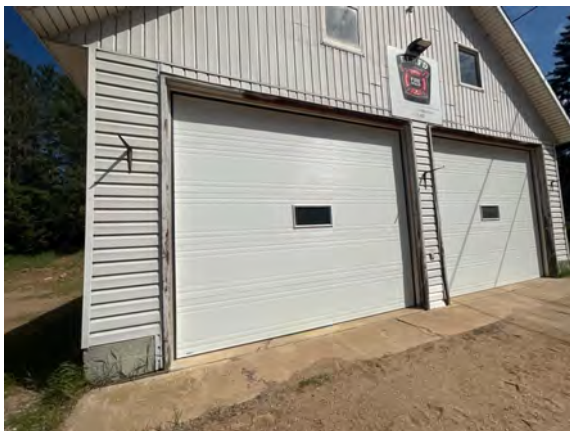
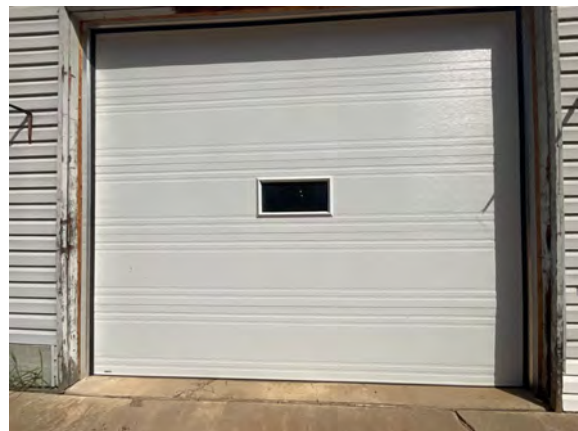
Quadville Fire Hall #3 - B203022

No significant deficiencies were observed or reported. Replacement is not anticipated in the short term.

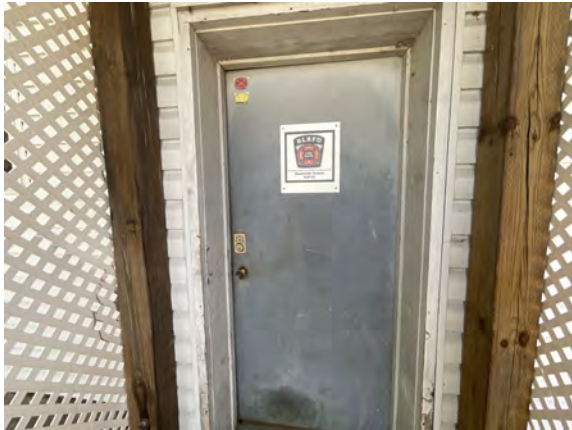
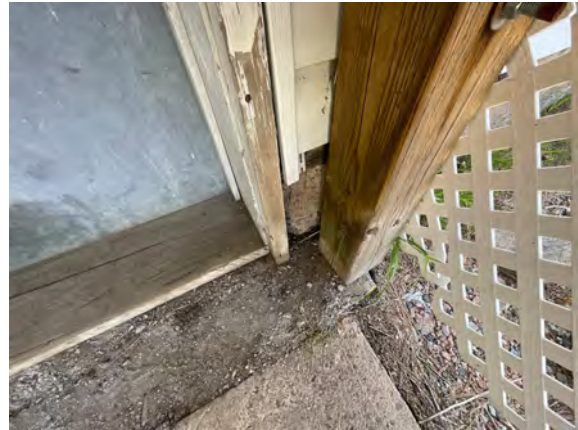
Quadville Fire Hall #3 - C102021

Deficiencies observed or reported include damaged and worn door panel and door frame, and worn hardware. Replacement is recommended in the short term.

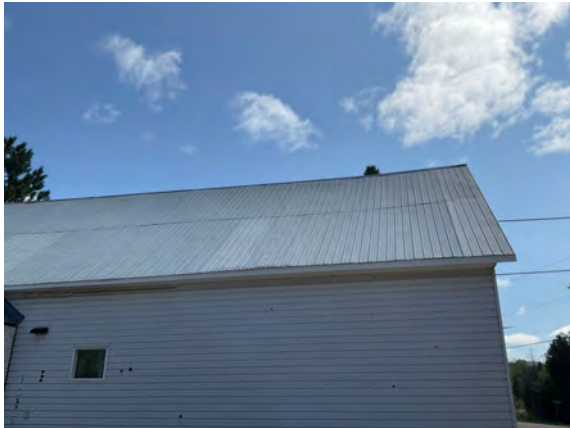
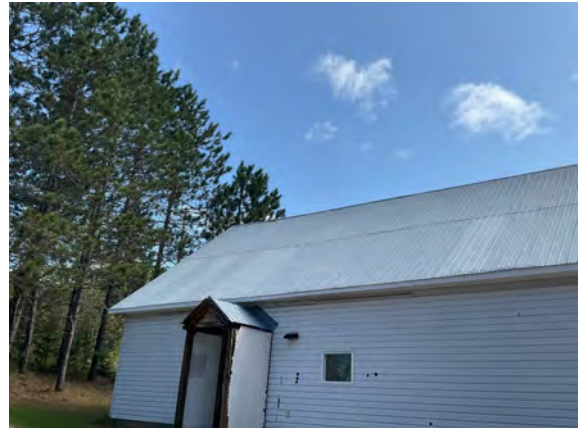
Quadville Fire Hall #3 - B301028

No significant deficiencies or leaks were observed or reported. Replacement is not anticipated in the short term.

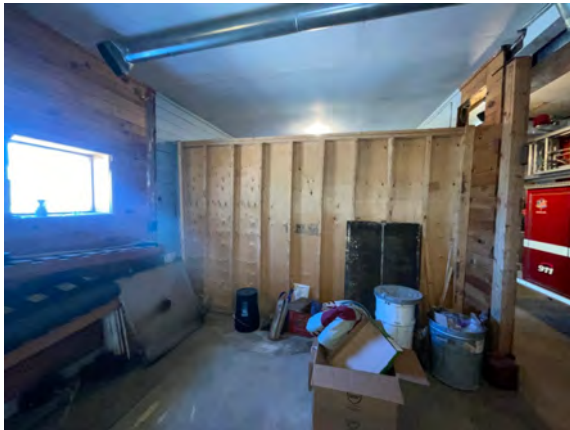
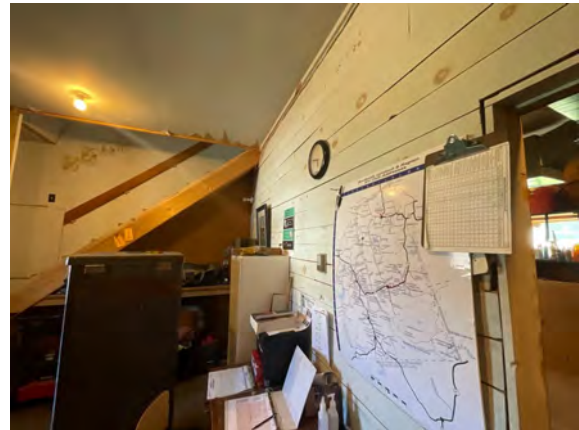
Quadville Fire Hall #3 - C101001

No significant deficiencies were observed or reported. Replacement is not anticipated in the short term.

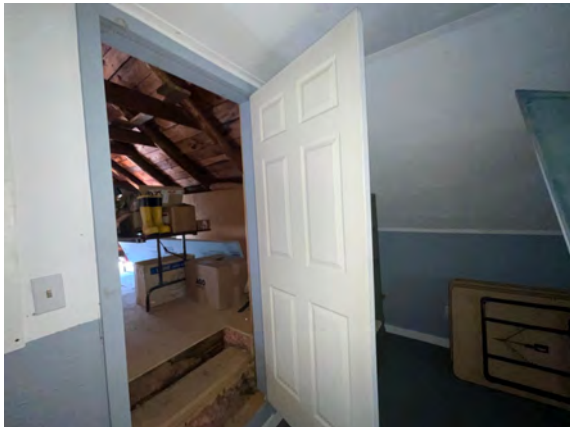
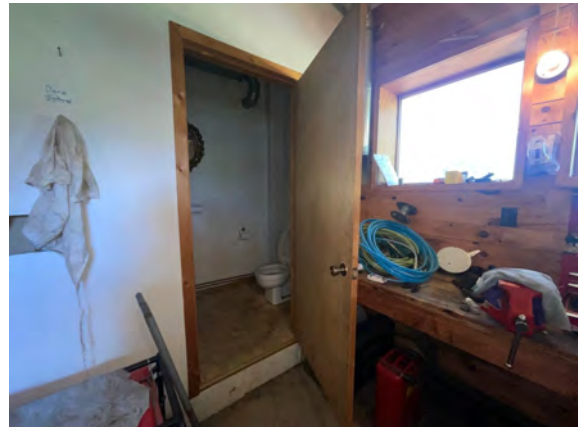
Quadville Fire Hall #3 - C102022

No significant deficiencies were observed or reported. Replacement is not anticipated in the short term.

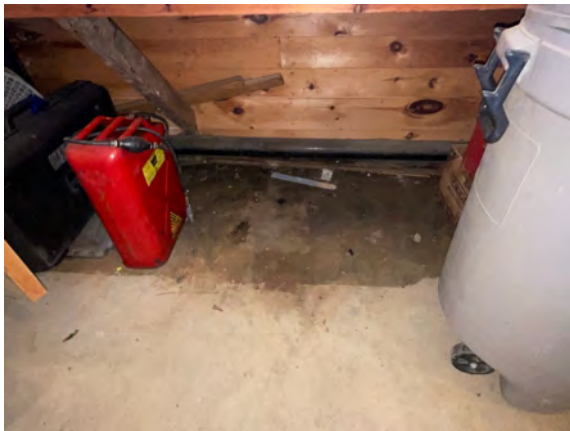
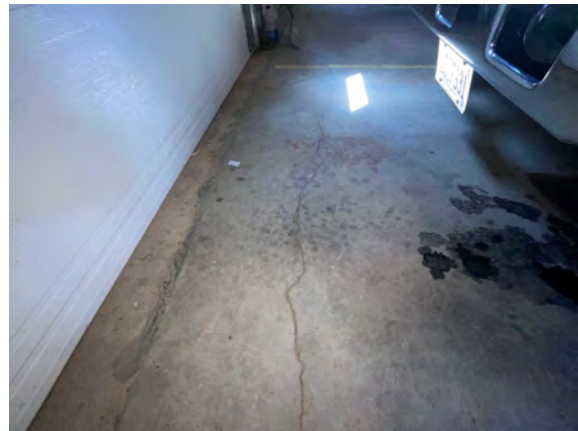
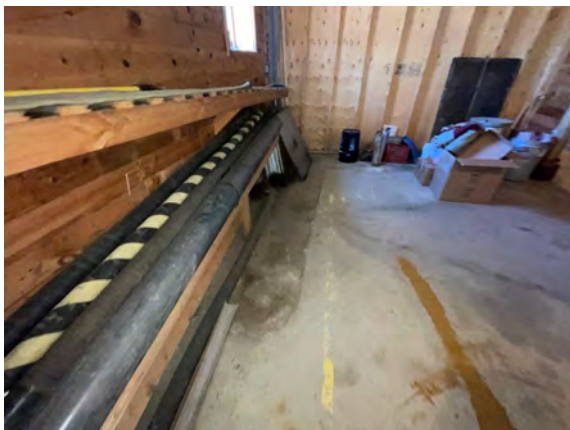
Quadville Fire Hall #3 - C302007

Element Description	
Name	C302007 - Painted / Sealed Floor - Firehall (Township)
Installation Year	1990
Condition	3 - Fair
Expected Useful Life	15 Years
Remaining Useful Life	2 Years
Renewal Year	2026
Quantity / Unit of Measure	140 / SM
Unit Cost	\$53.00
Difficulty / Regional / Soft Cost / Replacement	1.00 / 1.04688 / 1.30000 / 1.0000
Element Cost	\$10,098.20

Deficiencies observed or reported during the assessment include stained, worn and peeling paint. The deterioration is anticipated to progress. Replacement is recommended in the short term.

<b>Recommendations #1 - Painted / Sealed Floor</b>	
Type	Life Cycle Replacement
Year	2026
Cost	\$10,098.20

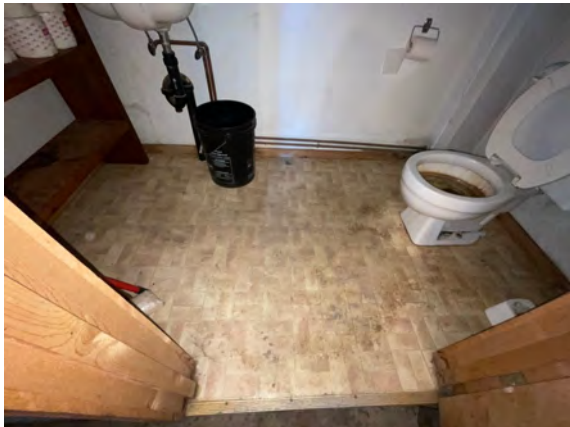
Quadville Fire Hall #3 - C302023

<b>Element Description</b>	
Name	C302023 - Vinyl Sheet Floor - Firehall (Township)
Installation Year	1990
Condition	3 - Fair
Expected Useful Life	15 Years
Remaining Useful Life	2 Years
Renewal Year	2026
Quantity / Unit of Measure	4 / SM
Unit Cost	\$158.00
Difficulty / Regional / Soft Cost / Replacement	1.00 / 1.04688 / 1.30000 / 1.0000
Element Cost	\$860.12

Deficiencies observed or reported during the assessment include worn surfaces. The deterioration is anticipated to progress. Replacement is recommended in the short term.

<b>Recommendations #1 - Vinyl Sheet Floor</b>	
Type	Life Cycle Replacement
Year	2026
Cost	\$860.12

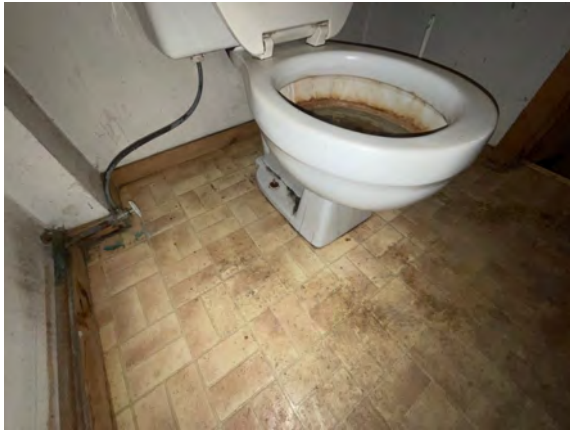
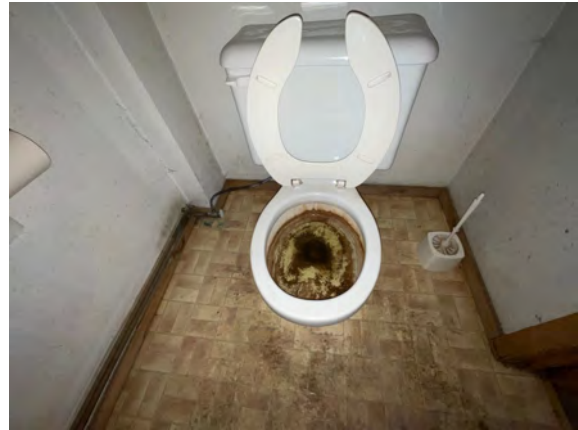
Quadville Fire Hall #3 - D201001

Element Description	
Name	D201001 - Water Closets - Firehall (Township)
Installation Year	1990
Condition	4 - Poor
Expected Useful Life	35 Years
Remaining Useful Life	0 Years
Renewal Year	2024
Quantity / Unit of Measure	1 / Each
Unit Cost	\$1,200.00
Difficulty / Regional / Soft Cost / Replacement	1.00 / 1.04688 / 1.30000 / 1.0000
Element Cost	\$1,633.13

Deficiencies observed or reported at the time of the assessment include stains. Replacement is recommended in the short term.

Recommendations #1 - Water Closets	
Type	Life Cycle Replacement
Year	2024
Cost	\$1,633.13

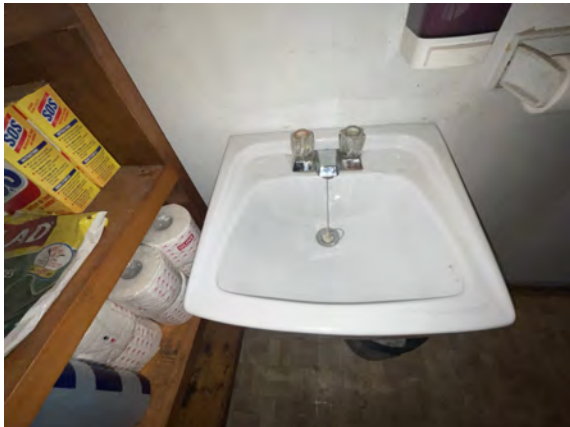
Quadville Fire Hall #3 - D201003

<b>Element Description</b>	
Name	D201003 - Lavatories - Firehall (Township)
Installation Year	1990
Condition	4 - Poor
Expected Useful Life	35 Years
Remaining Useful Life	0 Years
Renewal Year	2024
Quantity / Unit of Measure	1 / Each
Unit Cost	\$1,200.00
Difficulty / Regional / Soft Cost / Replacement	1.00 / 1.04688 / 1.30000 / 1.0000
Element Cost	\$1,633.13

Deficiencies observed or reported at the time of the assessment include leaking and energy-inefficient tap sets. Replacement is recommended in the short term.

<b>Recommendations #1 - Lavatories</b>	
Type	Life Cycle Replacement
Year	2024
Cost	\$1,633.13

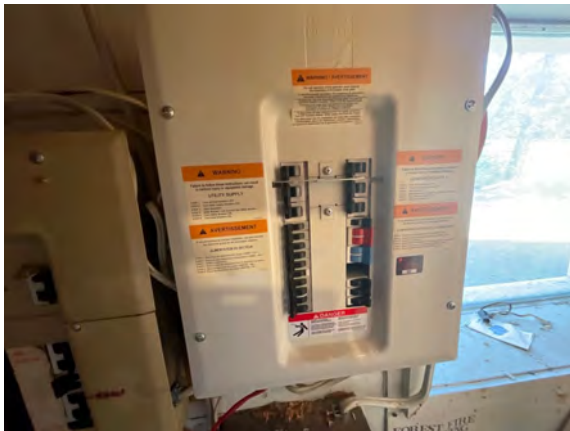
Quadville Fire Hall #3 - D501025

Element Description	
Name	D501005 - Panelboards up to 400A - Firehall (Township)
Installation Year	2014
Condition	2 - Good
Expected Useful Life	40 Years
Remaining Useful Life	30 Years
Renewal Year	2054
Quantity / Unit of Measure	1 / Each
Unit Cost	\$6,280.00
Difficulty / Regional / Soft Cost / Replacement	1.00 / 1.04688 / 1.30000 / 1.0000
Element Cost	\$8,546.73

No significant deficiencies were observed or reported. Replacement is not anticipated in the short term. It should be noted that the blue circuit breakers are known to fail to trip and should be replaced

Recommendations #1 - Panelboards up to 400A	
Type	Major Repair
Year	2023
Cost	\$500.00

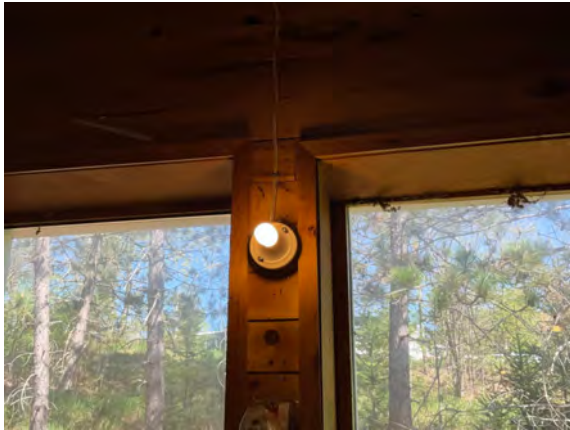
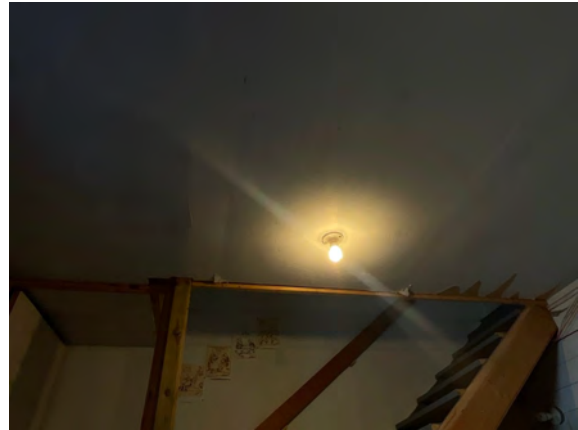
Quadville Fire Hall #3 - D502002

No significant deficiencies were observed or reported. However, the lighting is energy inefficient. Replacement or upgrade to LED is recommended in the short term /should be considered.

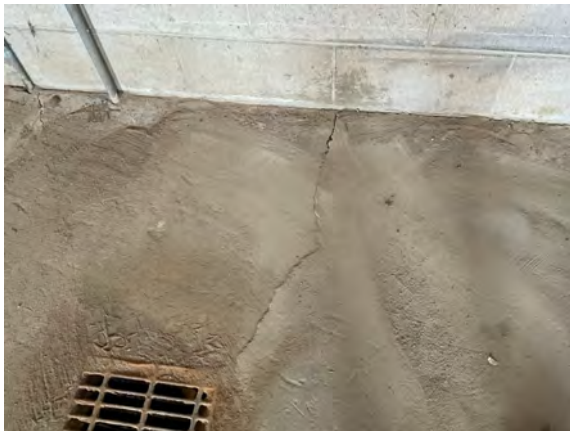
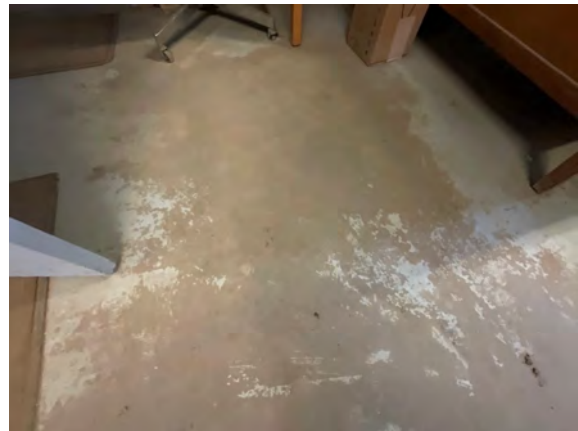
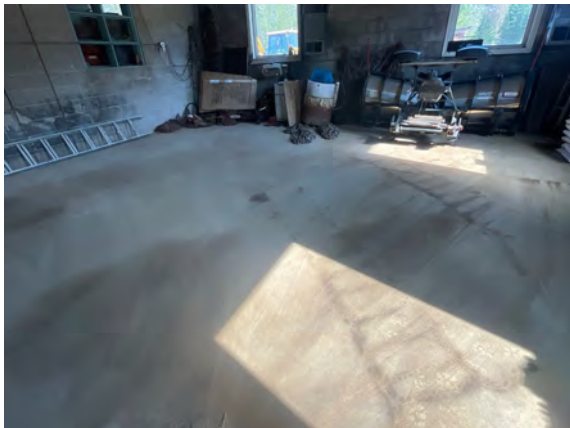
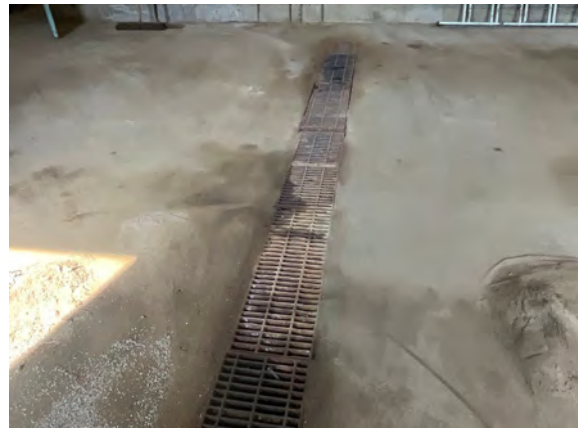
Quadville Public Works Garage - A103001

Some minor isolated cracking was observed, but no significant elevation difference to suggest differential settlement of the concrete slab-on-grade was noted.

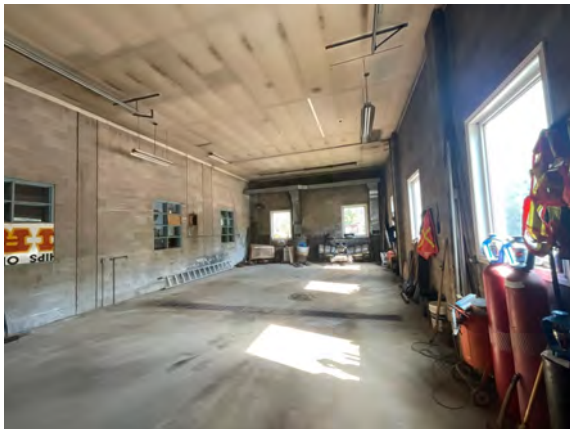
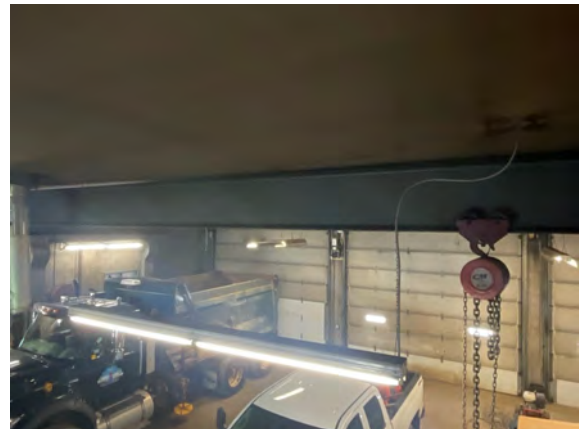
Quadville Public Works Garage - B103001

No significant deficiencies were observed or reported. Replacement is not anticipated in the short term.

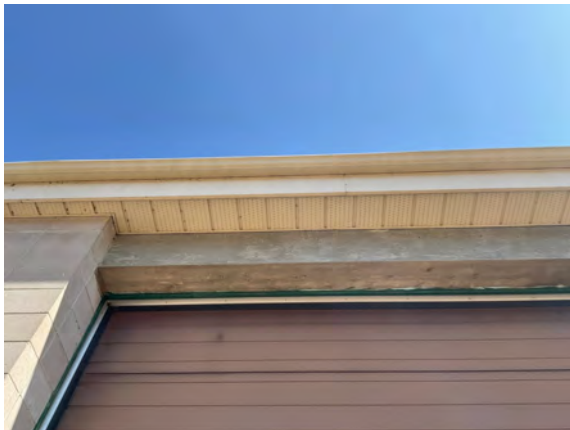
Quadville Public Works Garage - B201008

No significant deficiencies were observed or reported. Replacement is not anticipated in the short term.

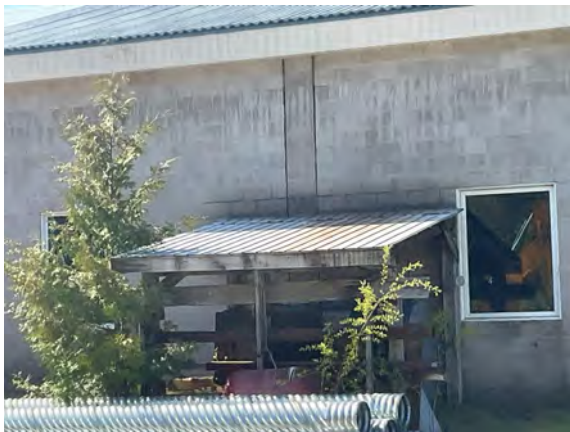
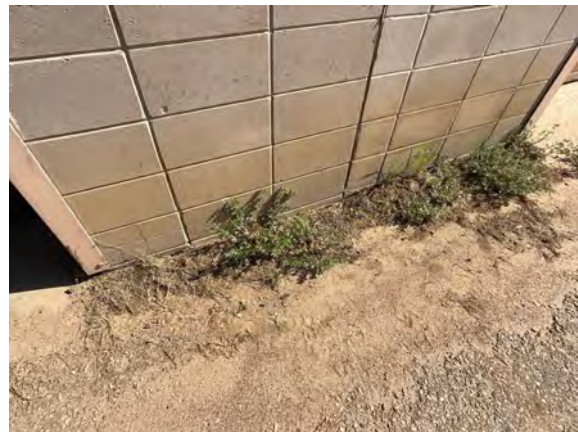
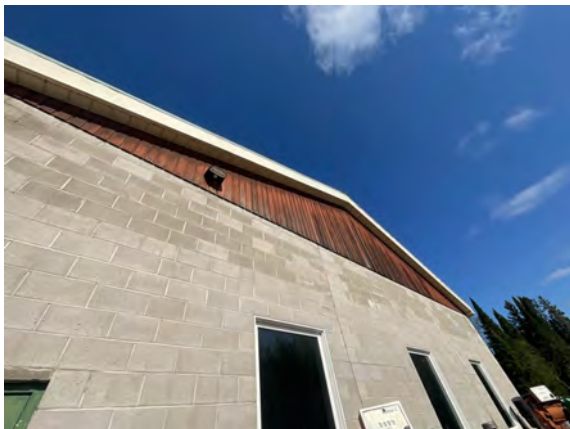
Quadville Public Works Garage - B201021

No significant deficiencies were observed or reported. Replacement is not anticipated in the short term.

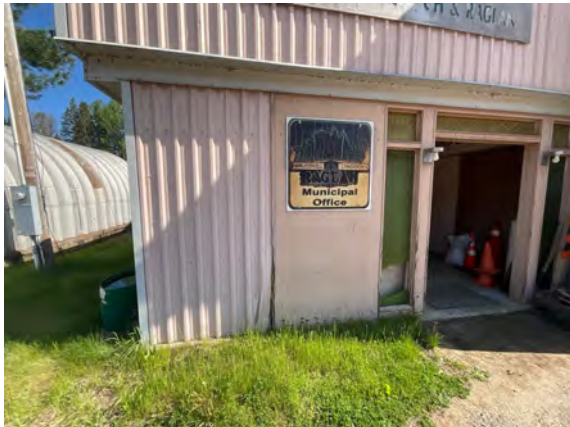
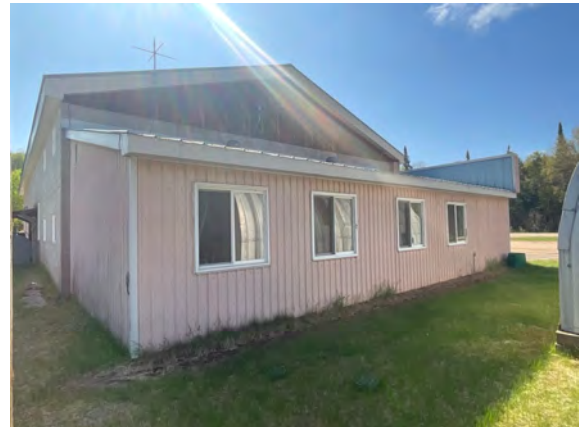
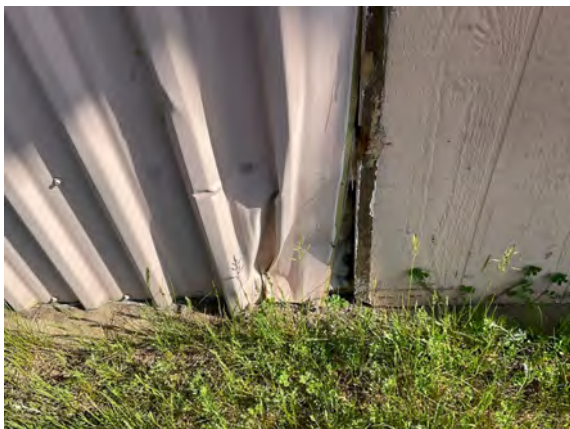
Quadville Public Works Garage - B201024

No significant deficiencies were observed or reported. Impact damage should be repaired as part of maintenance. Replacement is not anticipated in the short term.

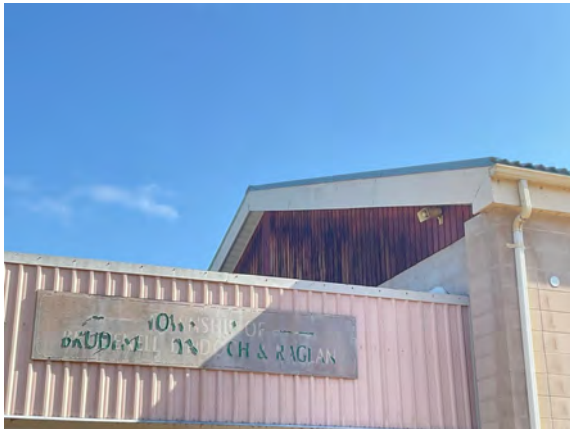
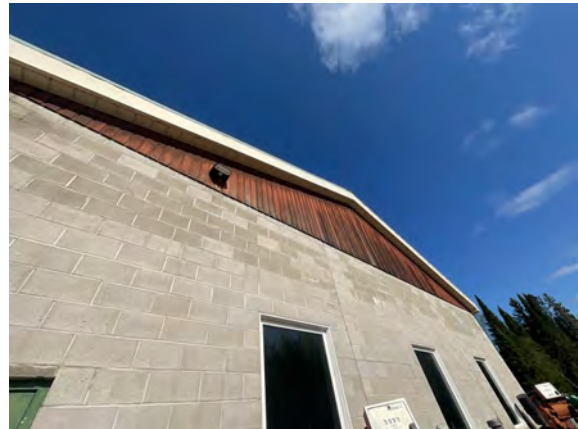
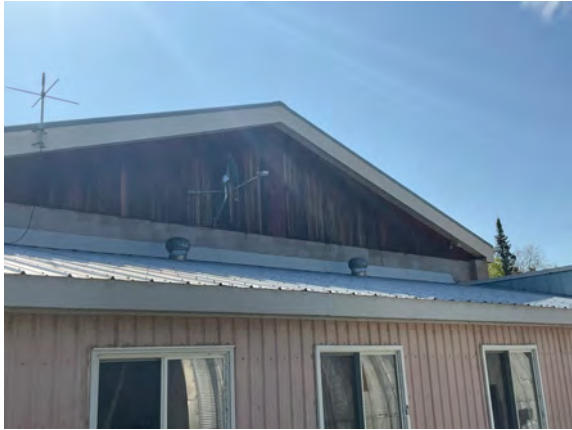
Quadville Public Works Garage - B201026

Deficiencies observed or reported during the assessment include damaged surfaces, delamination, deformation, loose connections, loose components, staining, fading, and gaps in material coverage. The deterioration is anticipated to progress due to age and exposure to the elements and may lead to moisture infiltration, a weakening of integrity, and a loss of marketability. Replacement is recommended in the short term.

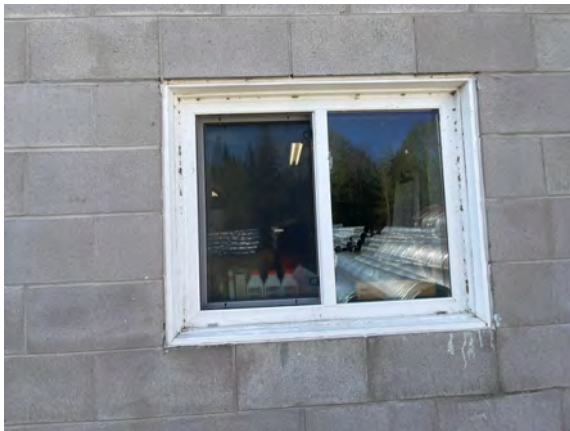
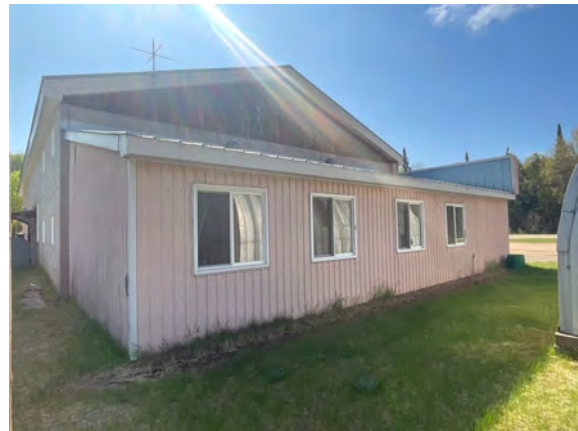
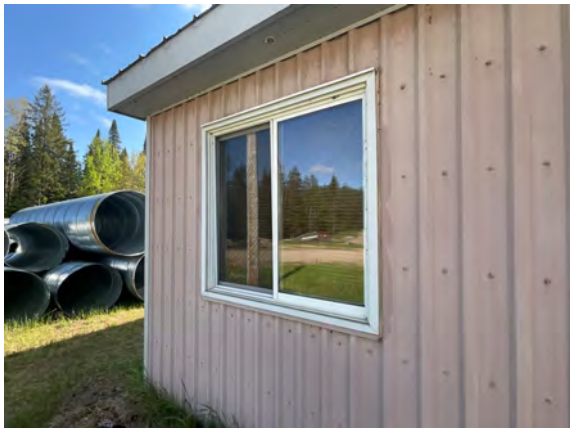
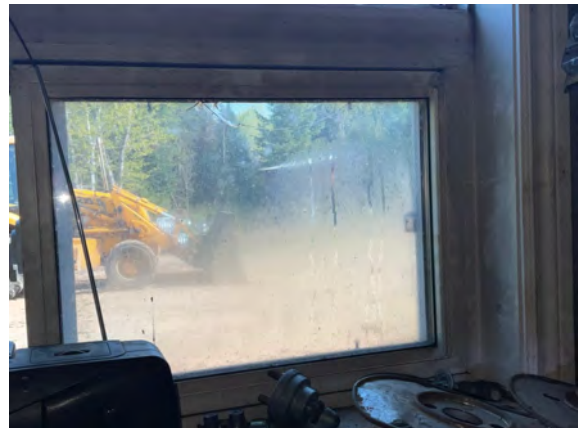
Quadville Public Works Garage - B202001

Deficiencies observed at the time of the assessment include failed window seals. The system, based on age, has surpassed its expected useful life and may experience sealant failure over time, resulting in potential leakage, condensation, energy loss, and discomfort for building occupants. Replacement is recommended in the short term.

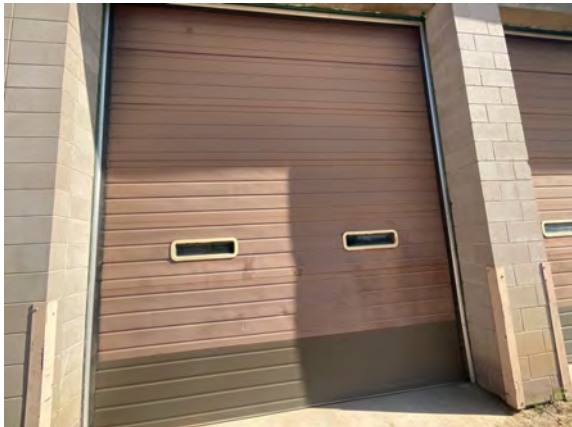
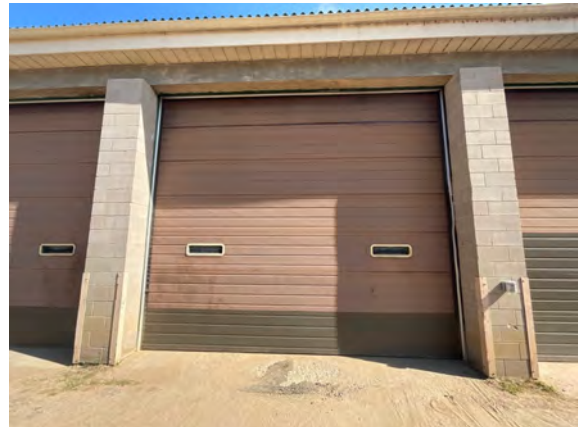
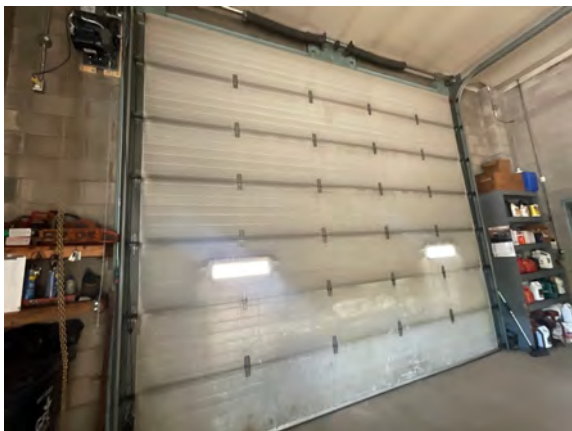
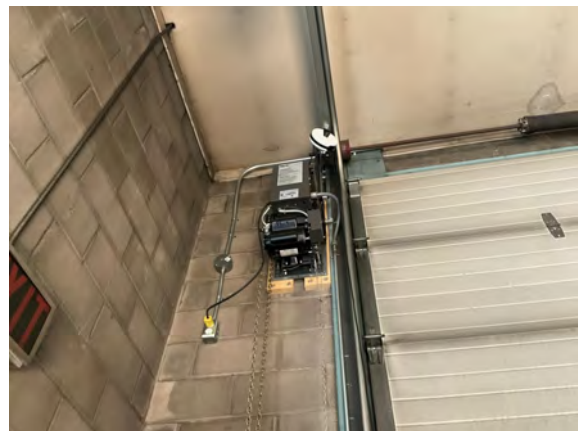
Quadville Public Works Garage - B203022

No significant deficiencies were observed or reported. The doors appear to have been repaired over time. Replacement is not anticipated in the short term.

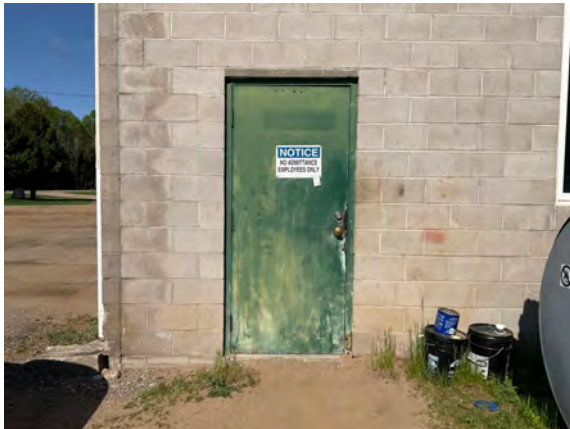
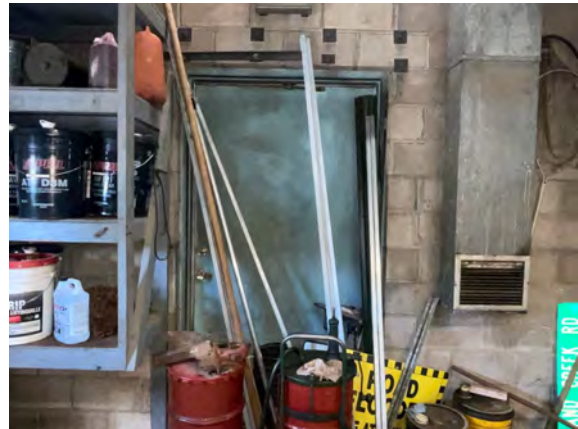
Quadville Public Works Garage - B203023

Deficiencies observed at the time of the assessment include damaged and worn door panel, worn paint and worn hardware. Replacement is recommended in the short term.

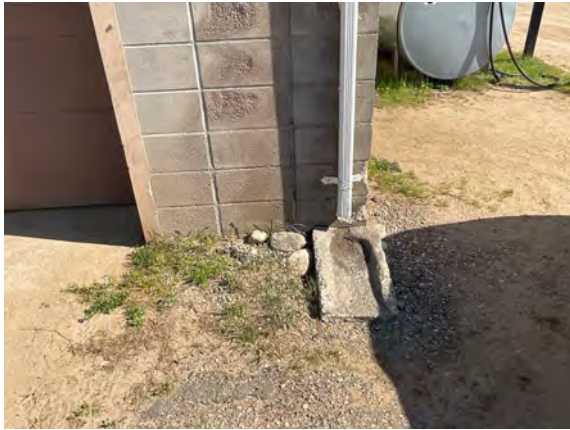
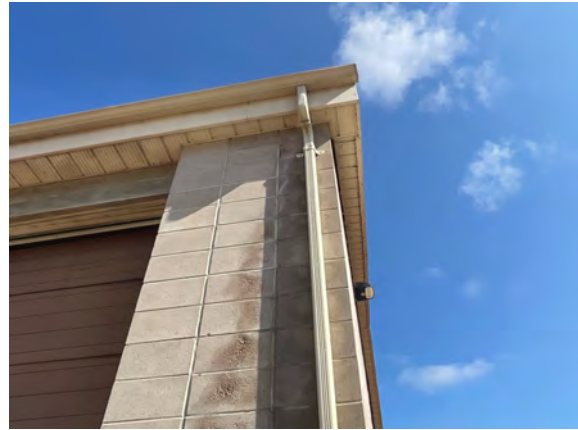
Quadville Public Works Garage - B301005

No significant deficiencies were observed or reported. Lifecycle replacement may be deferred.

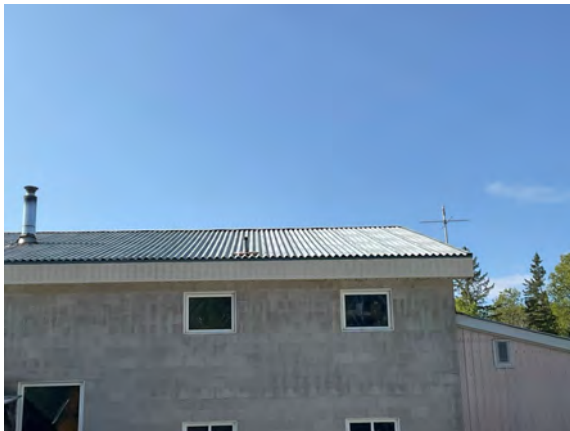
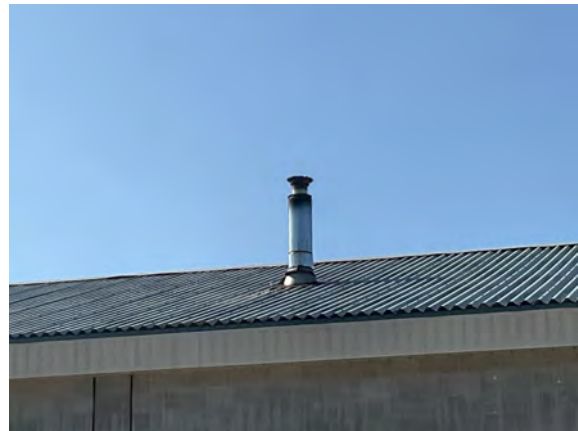
Quadville Public Works Garage - B301028

No significant deficiencies were observed or reported. However isolated areas of ceiling water stains suggest past roof leaks. The system, based on age may experience weakening of integrity over time, resulting in further moisture infiltration, damage to internal elements, and disruption to building operations. Replacement is recommended in the short term.

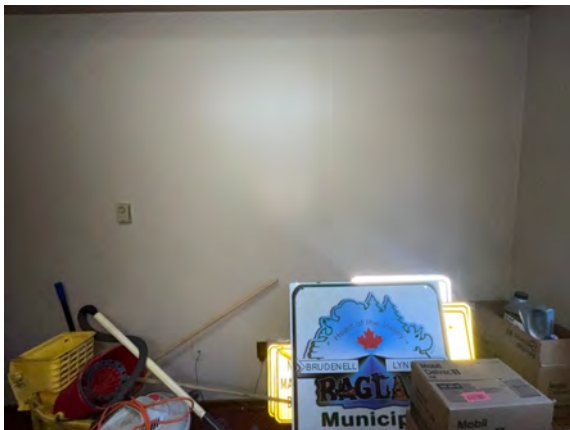
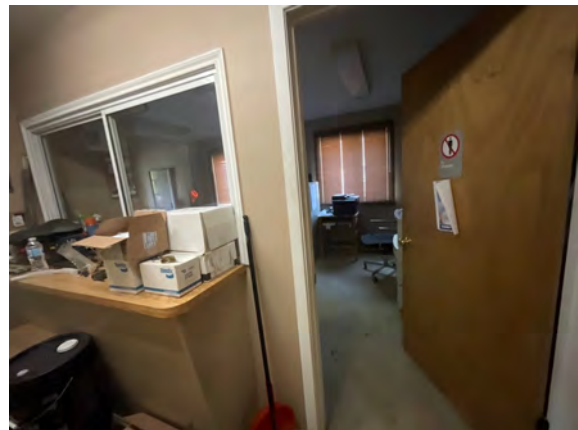
Quadville Public Works Garage - C101001

No significant deficiencies were observed or reported. Replacement is not anticipated in the short term.

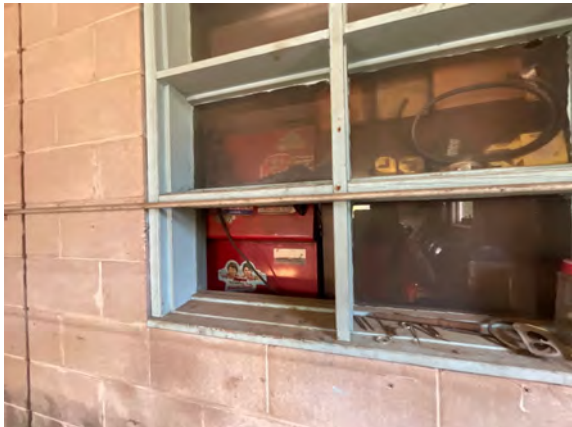
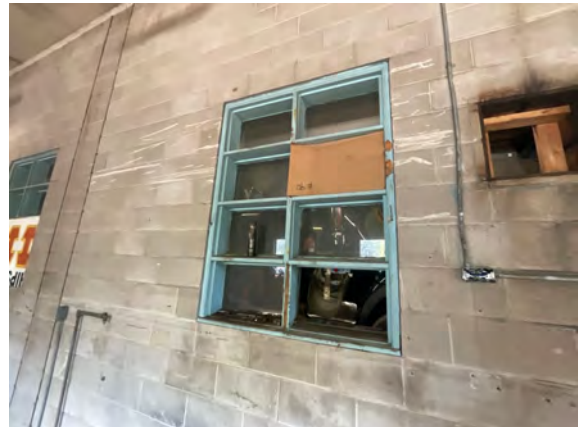
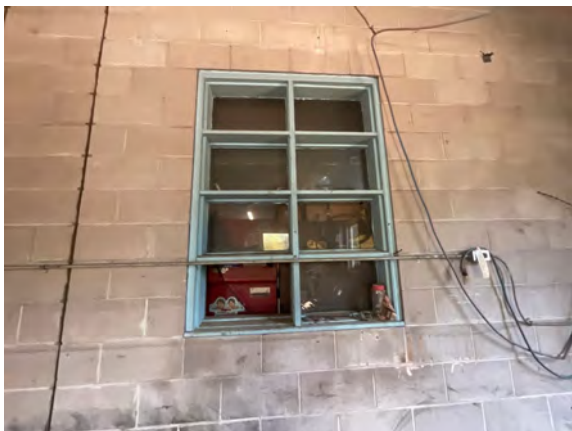
Quadville Public Works Garage - C101005

Deficiencies observed or reported during the assessment include missing glazing, degraded sealant. Replacement is recommended in the short term.

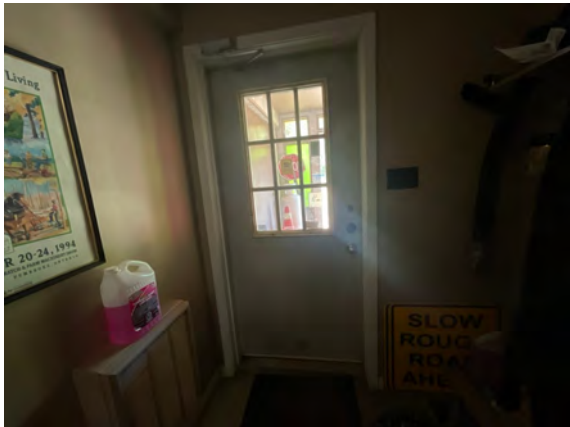
Quadville Public Works Garage - C102021

No significant deficiencies were observed or reported. Replacement is not anticipated in the short term.

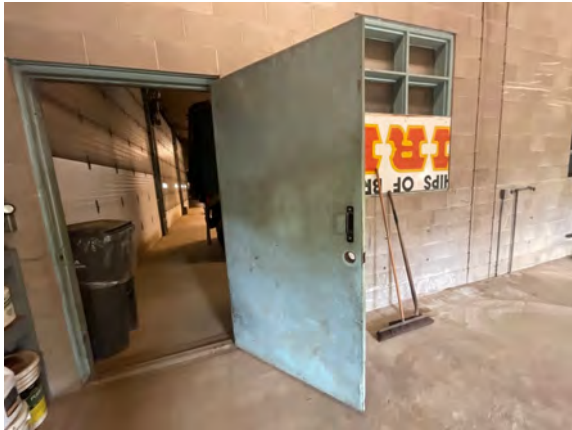
Quadville Public Works Garage - C102022

No significant deficiencies were observed or reported. However, one door needs to be replaced. Replacement is recommended. Assuming the recommended replacement will be undertaken, replacement of the system is not anticipated in the short term.

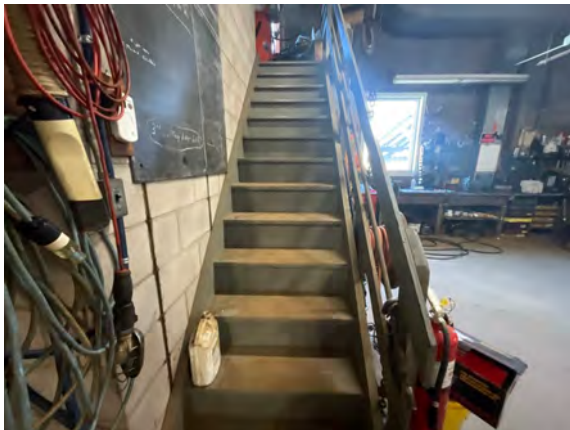
Quadville Public Works Garage - C201001

Element Description	
Name	C201001 - Interior Stair Construction - Workshop
Installation Year	1970
Condition	2 - Good
Expected Useful Life	75 Years
Remaining Useful Life	21 Years
Renewal Year	2045
Quantity / Unit of Measure	14 / Per Riser
Unit Cost	\$1,140.00
Difficulty / Regional / Soft Cost / Replacement	1.00 / 1.04688 / 1.30000 / 1.0000
Element Cost	\$21,720.67

No significant deficiencies were observed or reported. Replacement is not anticipated in the short term.

Recommendations #1 - Interior Stair Construction	
Type	Life Cycle Replacement
Year	2045
Cost	\$21,720.67

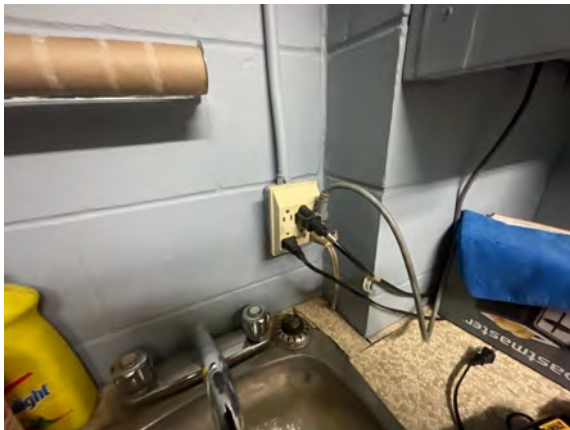
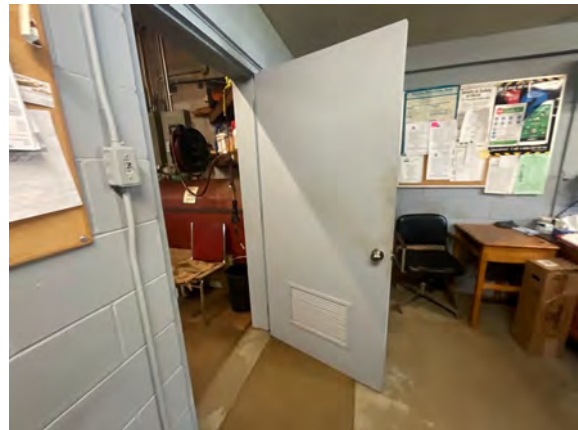
Quadville Public Works Garage - C301005

Element Description	
Name	C301005 - Paint Wall Covering - Workshop
Installation Year	2000
Condition	2 - Good
Expected Useful Life	10 Years
Remaining Useful Life	5 Years
Renewal Year	2029
Quantity / Unit of Measure	30 / SM Building
Unit Cost	\$53.00
Difficulty / Regional / Soft Cost / Replacement	1.00 / 1.04688 / 1.30000 / 1.0000
Element Cost	\$2,163.90

No significant deficiencies were observed or reported. Replacement is not anticipated in the short term.

Recommendations #1 - Paint Wall Covering	
Type	Life Cycle Replacement
Year	2029
Cost	\$2,163.90

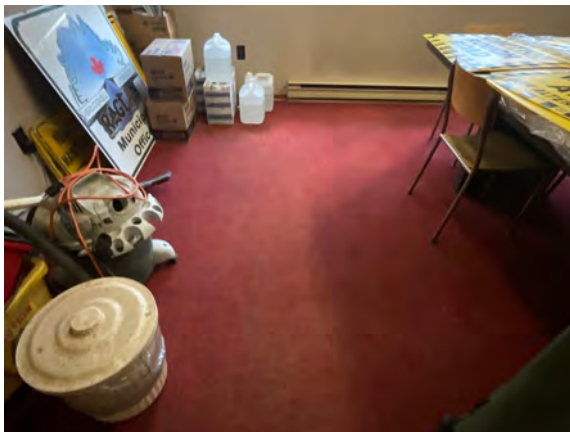
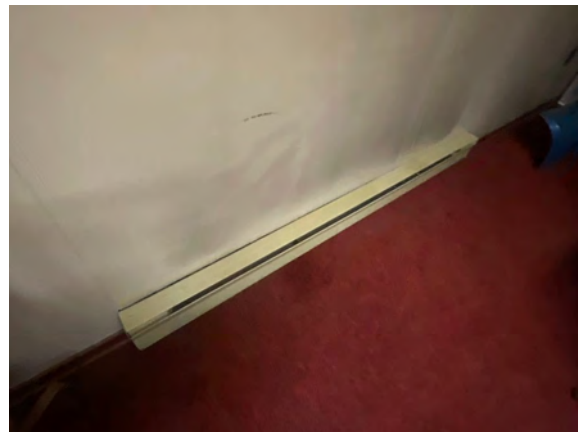
Quadville Public Works Garage - C302005

<b>Element Description</b>	
Name	C302005 - Carpet Floor - Workshop
Installation Year	2000
Condition	2 - Good
Expected Useful Life	10 Years
Remaining Useful Life	5 Years
Renewal Year	2029
Quantity / Unit of Measure	10 / SM
Unit Cost	\$114.00
Difficulty / Regional / Soft Cost / Replacement	1.00 / 1.04688 / 1.30000 / 1.0000
Element Cost	\$1,551.48

No significant deficiencies were observed or reported. Replacement is not anticipated in the short term.

<b>Recommendations #1 - Carpet Floor</b>	
Type	Life Cycle Replacement
Year	2029
Cost	\$1,551.48

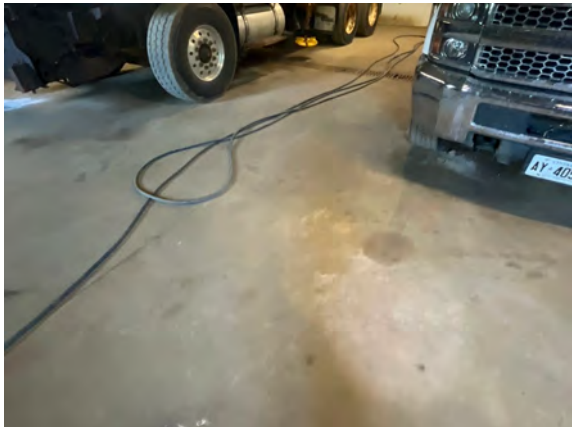
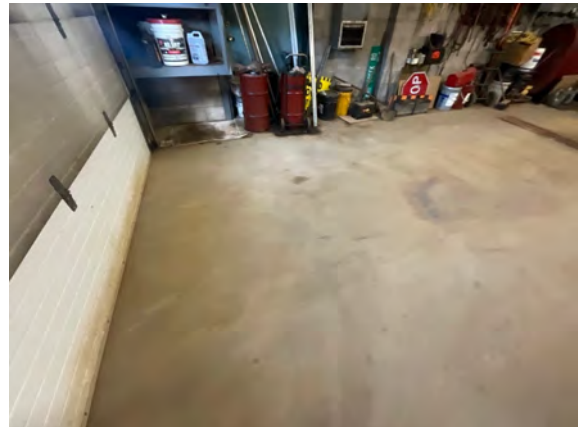
Quadville Public Works Garage - C302007

<b>Element Description</b>	
Name	C302007 - Painted / Sealed Floor - Workshop
Installation Year	2000
Condition	2 - Good
Expected Useful Life	15 Years
Remaining Useful Life	5 Years
Renewal Year	2029
Quantity / Unit of Measure	320 / SM
Unit Cost	\$53.00
Difficulty / Regional / Soft Cost / Replacement	1.00 / 1.04688 / 1.30000 / 1.0000
Element Cost	\$23,081.61

No significant deficiencies were observed or reported. Some stains were observed and should be treated as part of maintenance. Replacement is not anticipated in the short term.

<b>Recommendations #1 - Painted / Sealed Floor</b>	
Type	Life Cycle Replacement
Year	2029
Cost	\$23,081.61

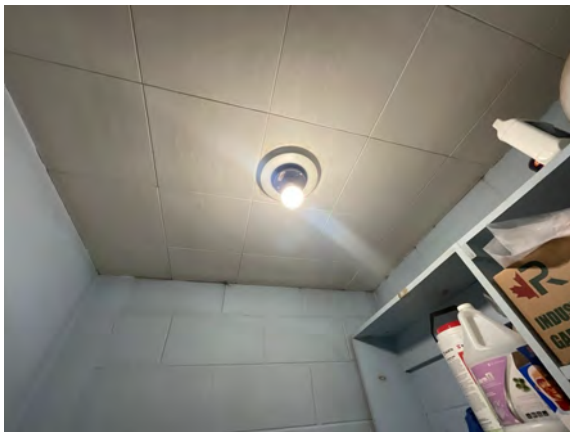
Quadville Public Works Garage - C303004

<b>Element Description</b>	
Name	C303004 - Acoustic Tile Ceiling - Workshop
Installation Year	1970
Condition	2 - Good
Expected Useful Life	30 Years
Remaining Useful Life	5 Years
Renewal Year	2029
Quantity / Unit of Measure	30 / SM
Unit Cost	\$88.00
Difficulty / Regional / Soft Cost / Replacement	0.30 / 1.04688 / 1.30000 / 1.0000
Element Cost	\$1,077.87

No significant deficiencies were observed or reported. Replacement is not anticipated in the short term.

<b>Recommendations #1 - Acoustic Tile Ceiling</b>	
Type	Life Cycle Replacement
Year	2029
Cost	\$1,077.87
