# Brudenell Lyndoch and Raglan

Submission to Township of Brudenell, Lyndoch, and Raglan

Roth IAMS Ltd.  
207-1075 North Service Rd W, Oakville ON, L6M 2G2  
[www.rothiams.com](http://www.rothiams.com)  
Project No. 23502

**Facility Condition Assessment Report**  
**Brudenell Fire Hall #4**

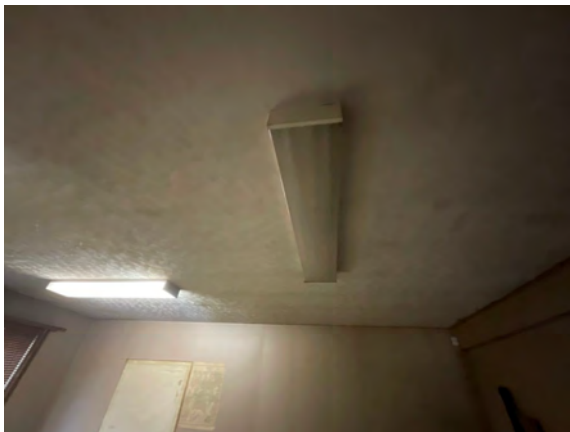
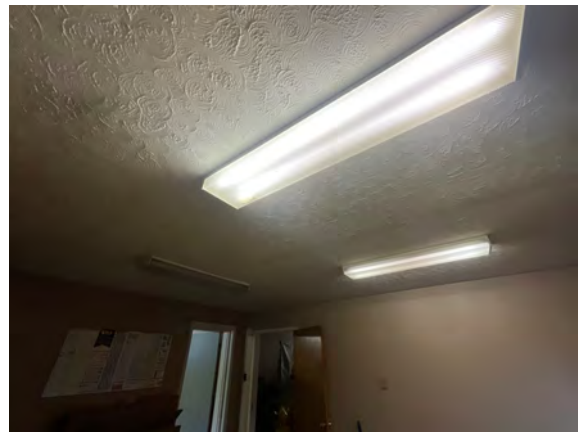
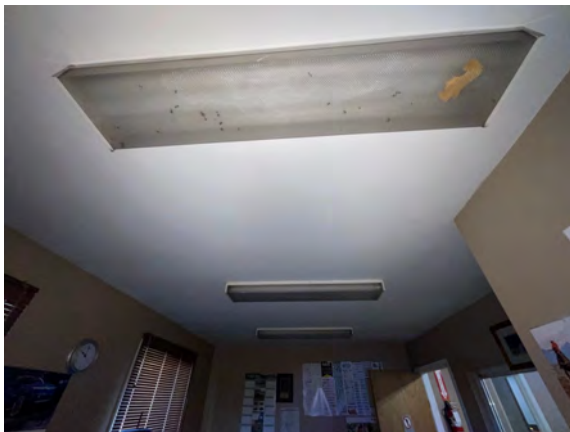
Quadville Public Works Garage - C303099

Element Description	
Name	C303006 - Painted Ceiling Structures - Workshop
Installation Year	2000
Condition	2 - Good
Expected Useful Life	15 Years
Remaining Useful Life	6 Years
Renewal Year	2030
Quantity / Unit of Measure	50 / SM
Unit Cost	\$38.00
Difficulty / Regional / Soft Cost / Replacement	1.00 / 1.04688 / 1.30000 / 1.0000
Element Cost	\$2,585.79

No significant deficiencies were observed or reported. Replacement is not anticipated in the short term.

<b>Recommendations #1 - Painted Ceiling Structures</b>	
Type	Life Cycle Replacement
Year	2030
Cost	\$2,585.79

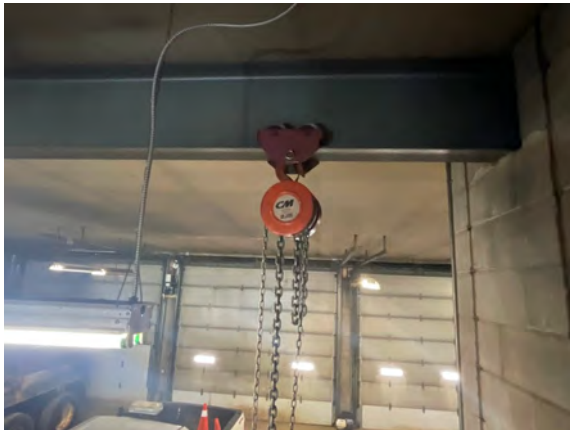
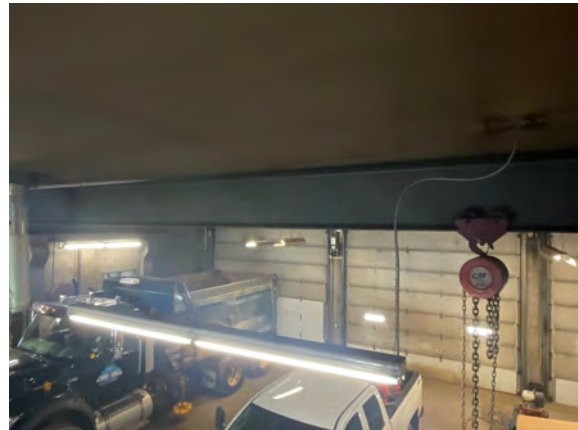
Quadville Public Works Garage - D109007

Element Description	
Name	D109007 - Overhead Cranes - Fixed - Workshop
Installation Year	2000
Condition	2 - Good
Expected Useful Life	30 Years
Remaining Useful Life	6 Years
Renewal Year	2030
Quantity / Unit of Measure	1 / Each
Unit Cost	\$9,850.00
Difficulty / Regional / Soft Cost / Replacement	1.00 / 1.04688 / 1.30000 / 1.0000
Element Cost	\$13,405.30

No significant deficiencies were observed or reported. Replacement is not anticipated in the short term.

Recommendations #1 - Overhead Cranes - Fixed	
Type	Life Cycle Replacement
Year	2030
Cost	\$13,405.30

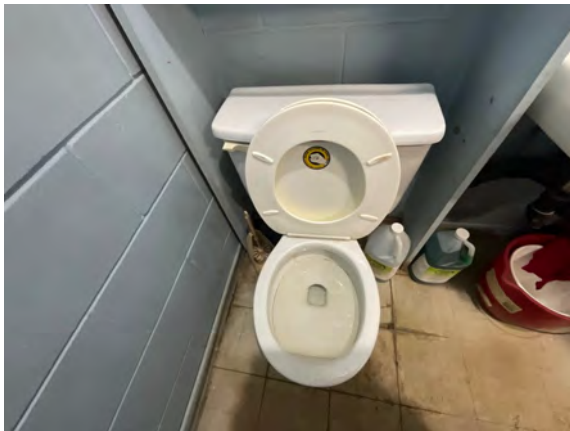
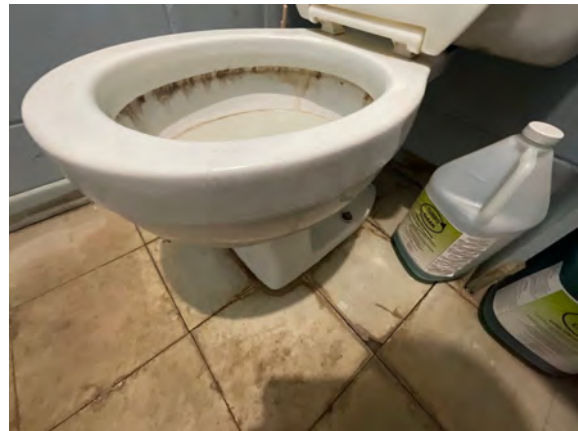
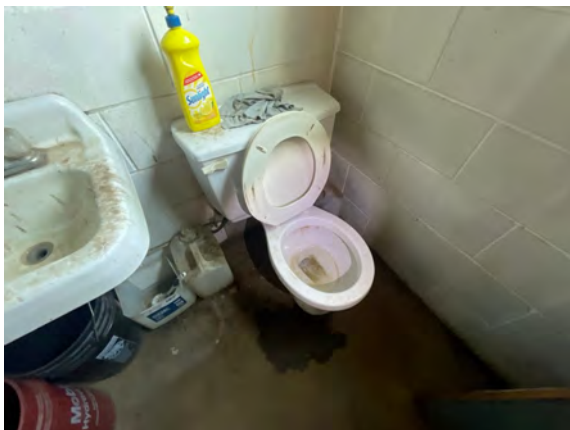
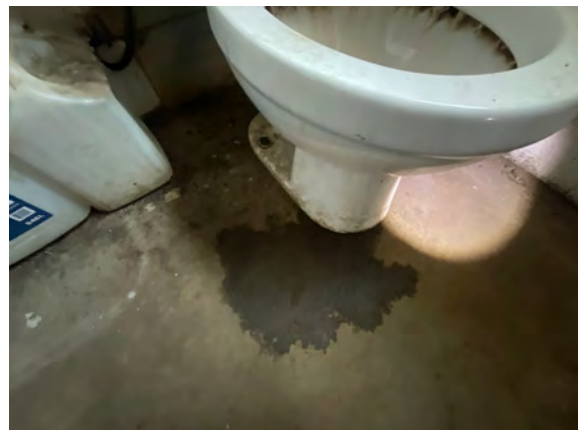
Quadville Public Works Garage - D201001

Element Description	
Name	D201001 - Water Closets - Workshop
Installation Year	1970
Condition	4 - Poor
Expected Useful Life	35 Years
Remaining Useful Life	0 Years
Renewal Year	2024
Quantity / Unit of Measure	2 / Each
Unit Cost	\$1,200.00
Difficulty / Regional / Soft Cost / Replacement	1.00 / 1.04688 / 1.30000 / 1.0000
Element Cost	\$3,266.27

Deficiencies observed or reported at the time of the assessment include stains. Replacement is recommended in the short term.

<b>Recommendations #1 - Water Closets</b>	
Type	Life Cycle Replacement
Year	2024
Cost	\$3,266.27

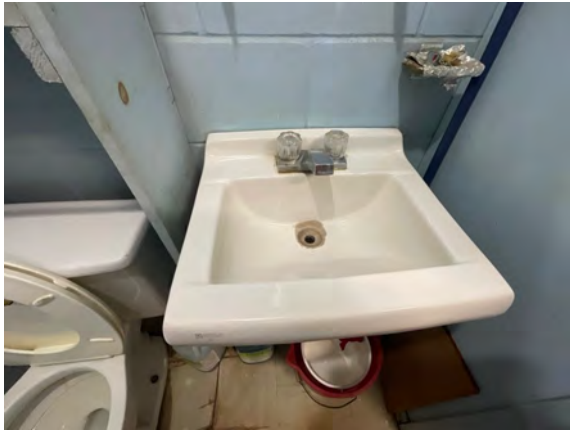
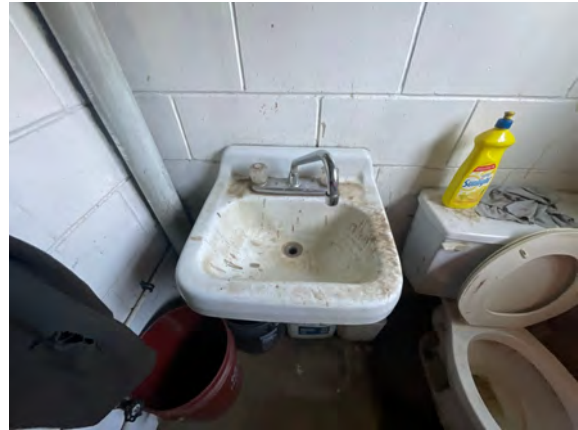
Quadville Public Works Garage - D201003

Element Description	
Name	D201003 - Lavatories - Workshop
Installation Year	1970
Condition	3 - Fair
Expected Useful Life	35 Years
Remaining Useful Life	2 Years
Renewal Year	2026
Quantity / Unit of Measure	2 / Each
Unit Cost	\$1,200.00
Difficulty / Regional / Soft Cost / Replacement	1.00 / 1.04688 / 1.30000 / 1.0000
Element Cost	\$3,266.27

Deficiencies observed or reported at the time of the assessment include stains and worn tap sets. Replacement is recommended in the short term.

Recommendations #1 - Lavatories	
Type	Life Cycle Replacement
Year	2026
Cost	\$3,266.27

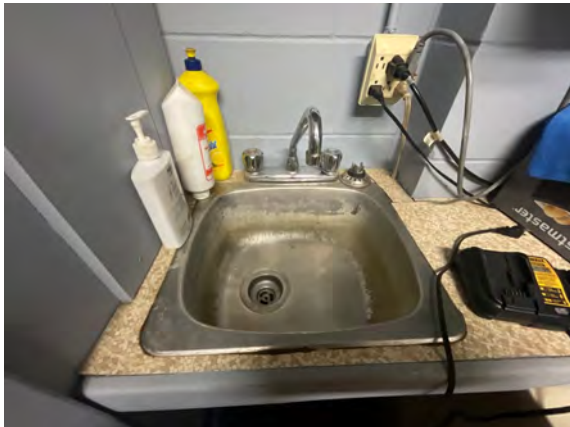
Quadville Public Works Garage - D201004

<b>Element Description</b>	
Name	D201004 - Sinks - Workshop
Installation Year	1970
Condition	4 - Poor
Expected Useful Life	35 Years
Remaining Useful Life	0 Years
Renewal Year	2024
Quantity / Unit of Measure	1 / Each
Unit Cost	\$1,200.00
Difficulty / Regional / Soft Cost / Replacement	1.00 / 1.04688 / 1.30000 / 1.0000
Element Cost	\$1,633.13

Deficiencies observed or reported at the time of the assessment include stains and worn tap sets. Replacement is recommended in the short term.

<b>Recommendations #1 - Sinks</b>	
Type	Life Cycle Replacement
Year	2024
Cost	\$1,633.13

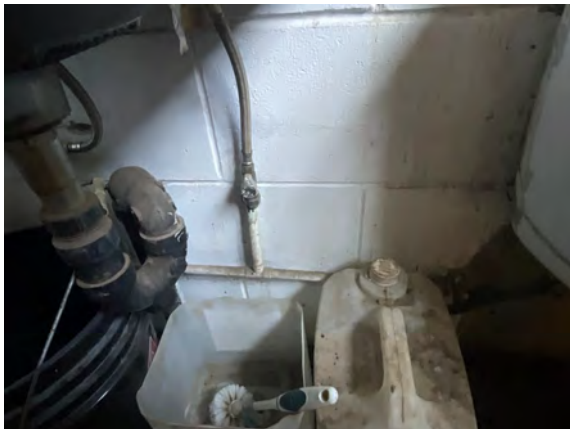
Quadville Public Works Garage - D202001

<b>Element Description</b>	
Name	D202001 - Domestic Water Piping and Fittings - Workshop
Installation Year	1970
Condition	3 - Fair
Expected Useful Life	40 Years
Remaining Useful Life	2 Years
Renewal Year	2026
Quantity / Unit of Measure	320 / SM Building
Unit Cost	\$60.00
Difficulty / Regional / Soft Cost / Replacement	1.00 / 1.04688 / 1.30000 / 1.0000
Element Cost	\$26,130.12

No significant deficiencies were observed or reported. Some sections of piping appear to have been updated. However, the majority of the system appears to be original to building construction and due to age can experience piping fatigue over time which can result in failure. Replacement is recommended in the short term.

<b>Recommendations #1 - Domestic Water Piping and Fittings</b>	
Type	Life Cycle Replacement
Year	2026
Cost	\$26,130.12

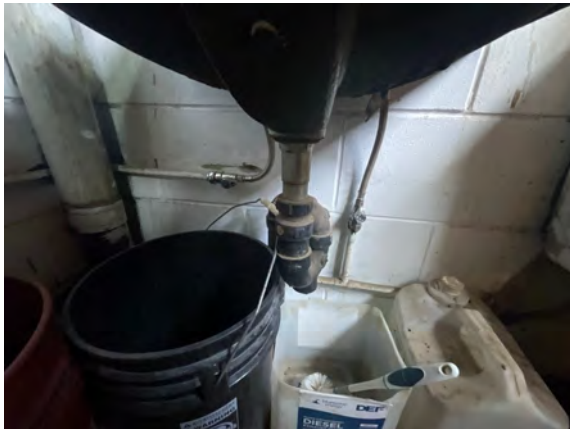
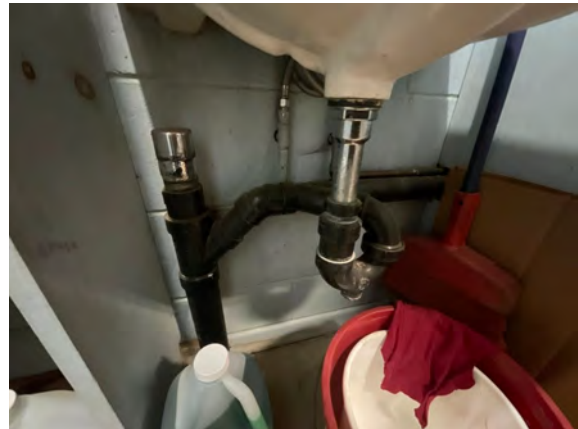
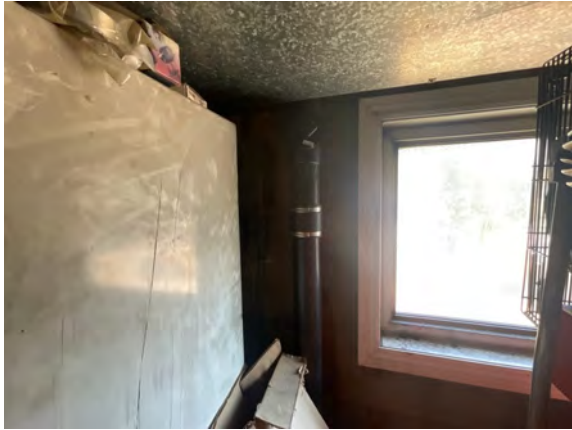
Quadville Public Works Garage - D203001

Element Description	
Name	D203001 - Sanitary Waste and Vent Piping and Fittings - Workshop
Installation Year	1970
Condition	2 - Good
Expected Useful Life	50 Years
Remaining Useful Life	5 Years
Renewal Year	2029
Quantity / Unit of Measure	320 / SM Building
Unit Cost	\$60.00
Difficulty / Regional / Soft Cost / Replacement	1.00 / 1.04688 / 1.30000 / 1.0000
Element Cost	\$26,130.12

No significant deficiencies were observed or reported. The system appears to have been updated. Replacement is not anticipated in the short term.

<b>Recommendations #1 - Sanitary Waste and Vent Piping and Fittings</b>	
Type	Life Cycle Replacement
Year	2029
Cost	\$26,130.12

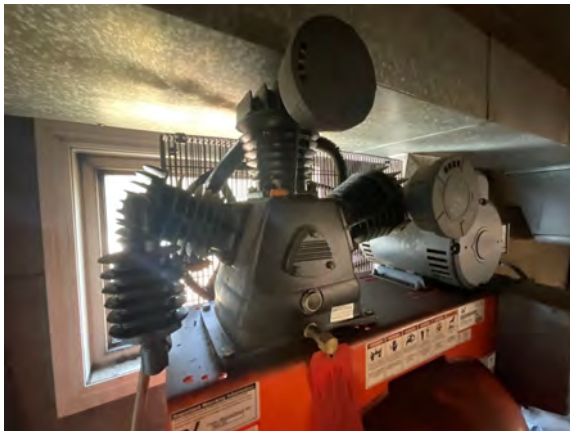
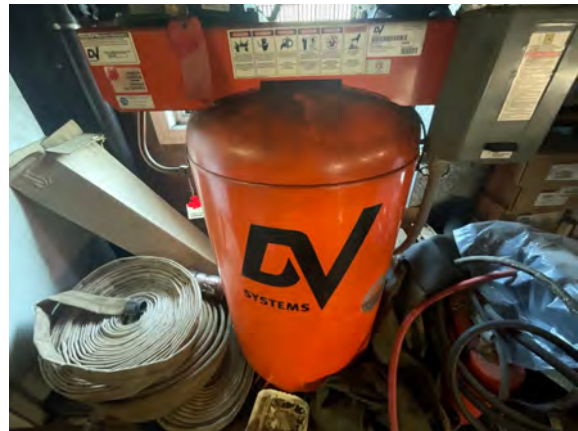
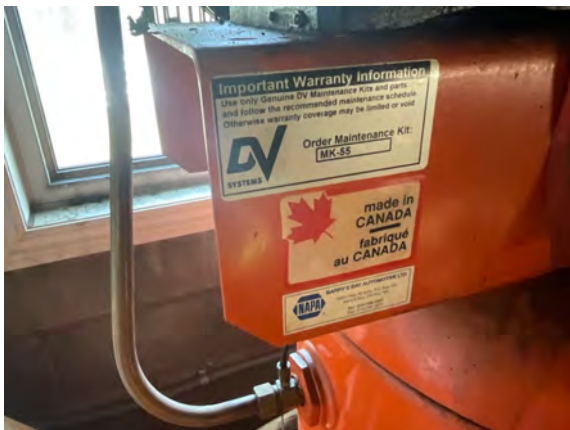
Quadville Public Works Garage - D209006

No significant deficiencies were observed or reported. However the system, based on age, is approaching or is past its expected useful life with performance and reliability likely diminishing over time. Replacement is recommended in the short term.

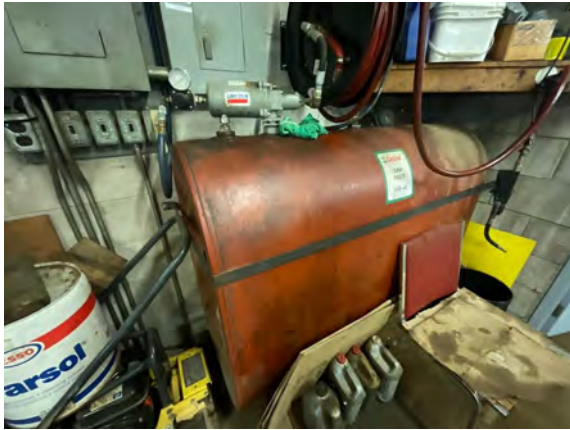
Quadville Public Works Garage - D301012

No significant deficiencies were observed or reported. Replacement is not anticipated in the short term.

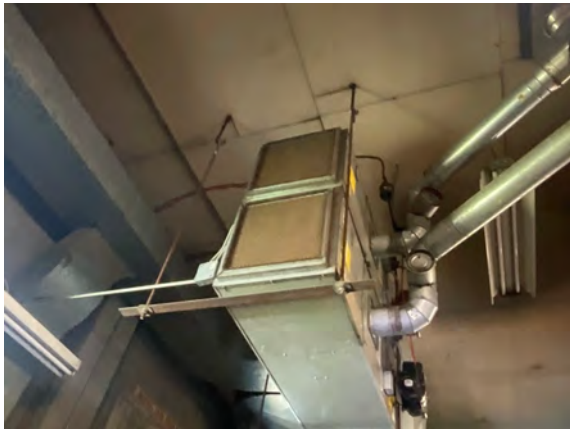
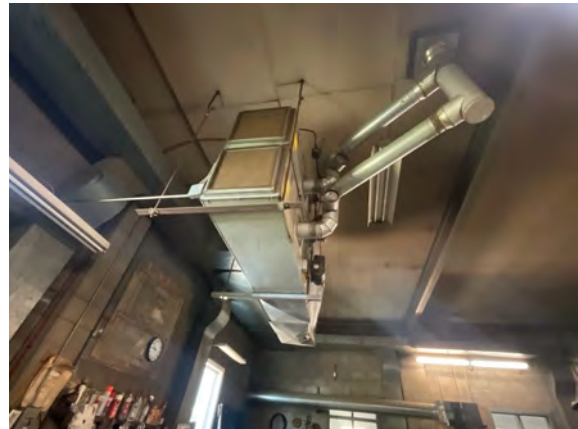
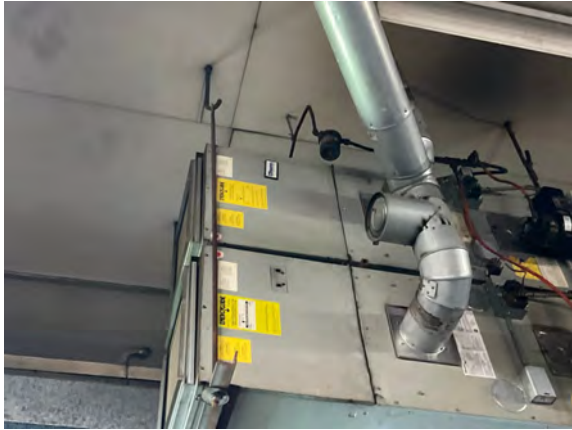
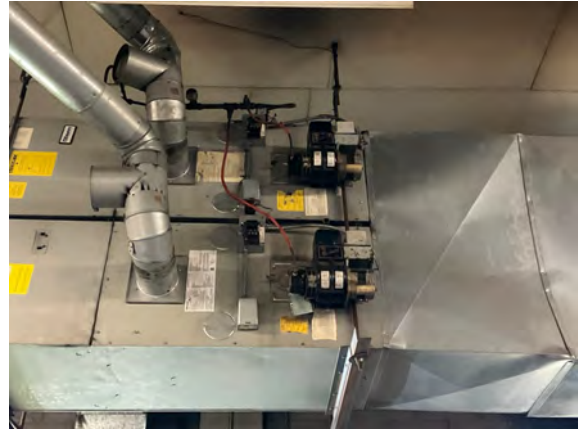
Quadville Public Works Garage - D302003

No significant deficiencies were observed or reported. However, the system, based on age, is approaching or is past its expected useful life with performance and reliability likely diminishing over time. Replacement is recommended in the short term. The furnaces are scheduled for replacement in 2024.

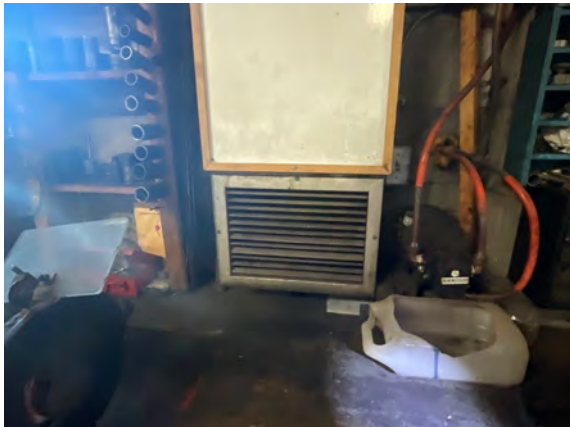
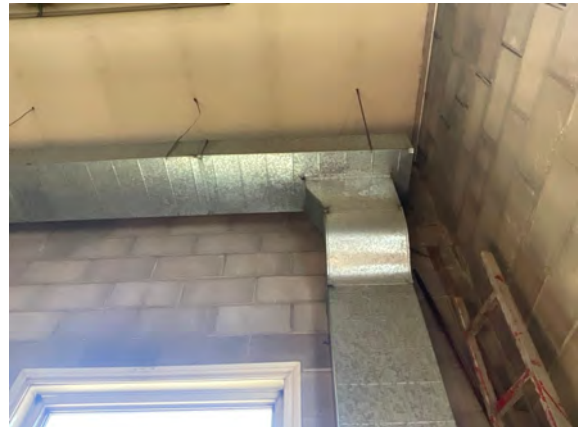
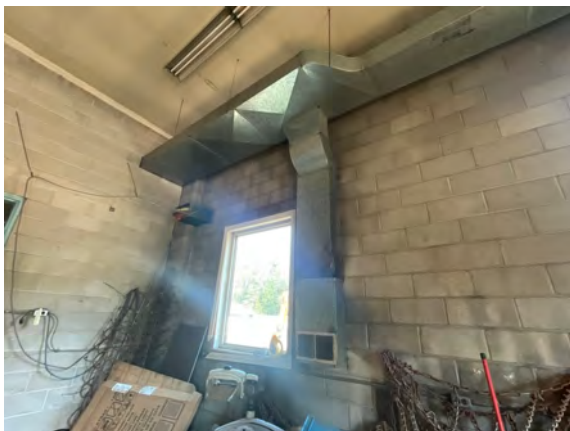
Quadville Public Works Garage - D304001

No significant deficiencies were observed or reported. Replacement is not anticipated in the short term.

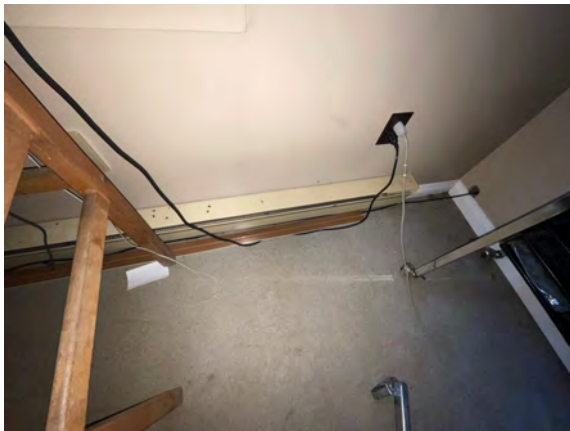
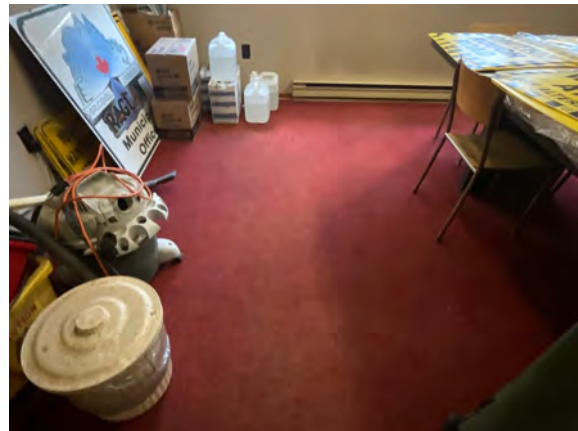
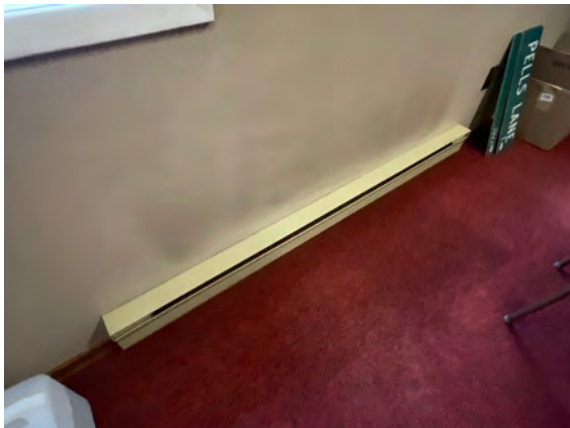
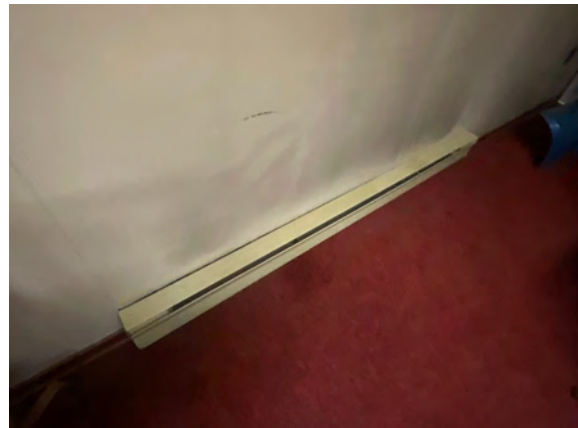
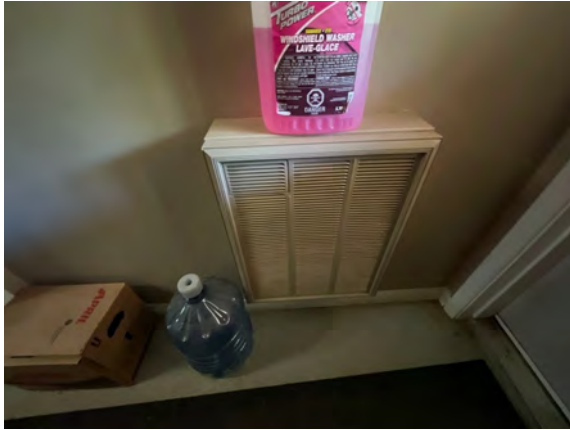
Element Description	
Name	D305010 - Electric Baseboard Heaters - Workshop
Installation Year	2000
Condition	4 - Poor
Expected Useful Life	18 Years
Remaining Useful Life	1 Year
Renewal Year	2025
Quantity / Unit of Measure	5 / Each
Unit Cost	\$360.00
Difficulty / Regional / Soft Cost / Replacement	1.00 / 1.04688 / 1.30000 / 1.0000
Element Cost	\$2,449.70

No significant deficiencies were observed or reported. However, the system, based on age, is approaching or is past its expected useful life with performance and reliability likely diminishing over time. Replacement is recommended in the short term.

<b>Recommendations #1 - Electric Baseboard Heaters</b>	
Type	Life Cycle Replacement
Year	2025
Cost	\$2,449.70

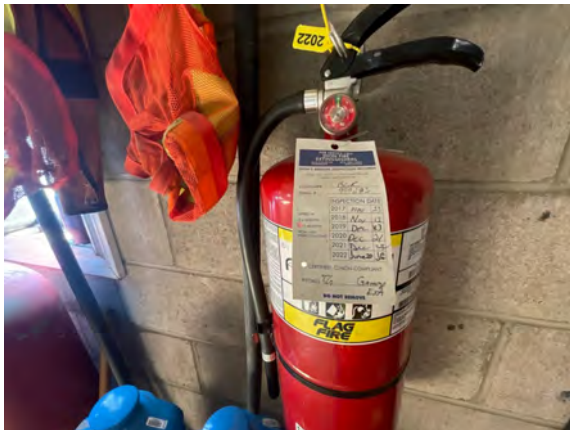
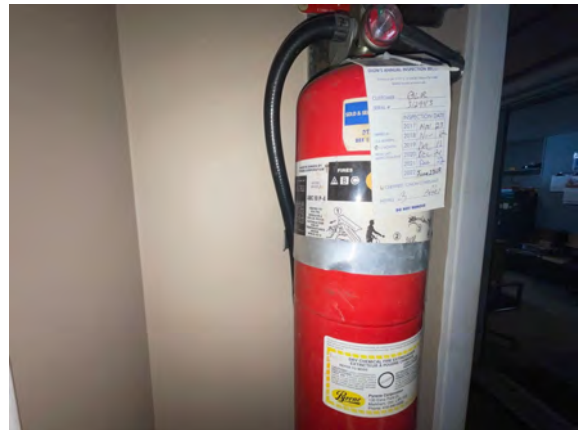
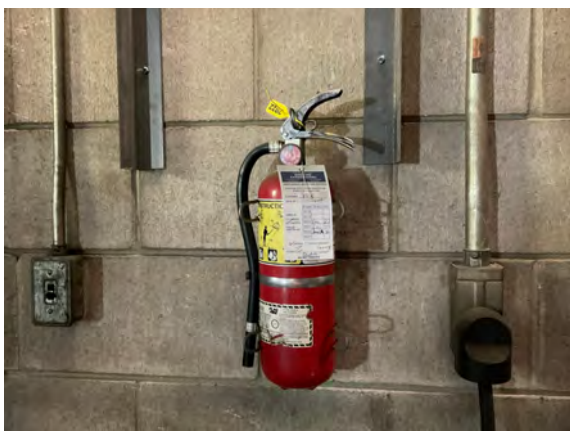
Element Description	
Name	D403001 - Individual Fire Extinguishers - Workshop
Installation Year	2017
Condition	2 - Good
Expected Useful Life	10 Years
Remaining Useful Life	5 Years
Renewal Year	2029
Quantity / Unit of Measure	4 / Each
Unit Cost	\$258.00
Difficulty / Regional / Soft Cost / Replacement	1.00 / 1.04688 / 1.30000 / 1.0000
Element Cost	\$1,404.49

No significant deficiencies were observed or reported. Replacement is not anticipated in the short term.

<b>Recommendations #1 - Individual Fire Extinguishers</b>	
Type	Life Cycle Replacement
Year	2029
Cost	\$1,404.49

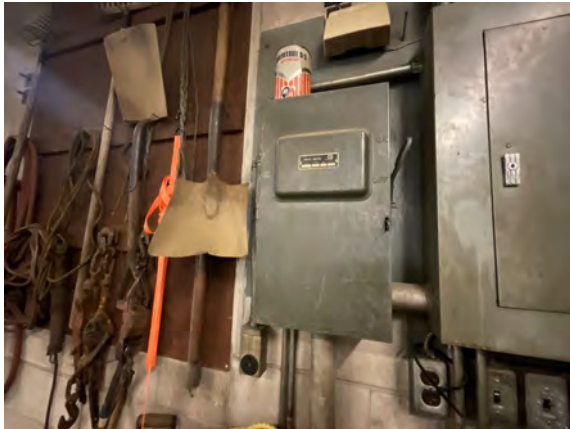
Element Description	
Name	D501025 - Main Service Disconnects - Workshop
Installation Year	1970
Condition	4 - Poor
Expected Useful Life	40 Years
Remaining Useful Life	0 Years
Renewal Year	2024
Quantity / Unit of Measure	1 / Each
Unit Cost	\$12,560.00
Difficulty / Regional / Soft Cost / Replacement	1.00 / 1.04688 / 1.30000 / 1.0000
Element Cost	\$17,093.46

No significant deficiencies were observed or reported. However, the system based on age, is approaching or is past its expected useful life and can experience electrical or thermal breakdown over time. Replacement is recommended in the short term.

Recommendations #1 - Main Service Disconnects	
Type	Life Cycle Replacement
Year	2024
Cost	\$17,093.46

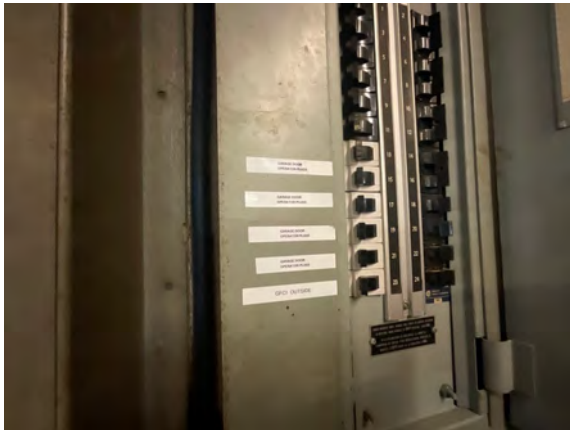
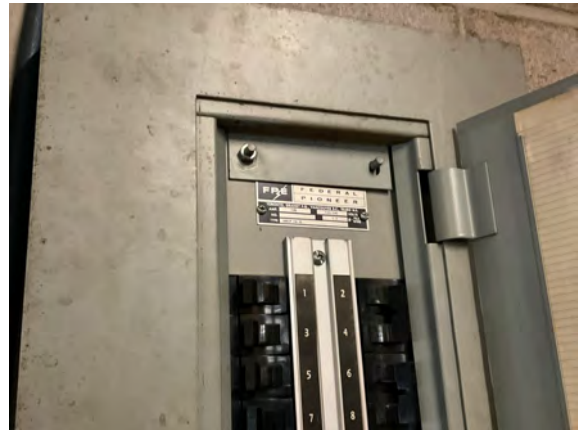
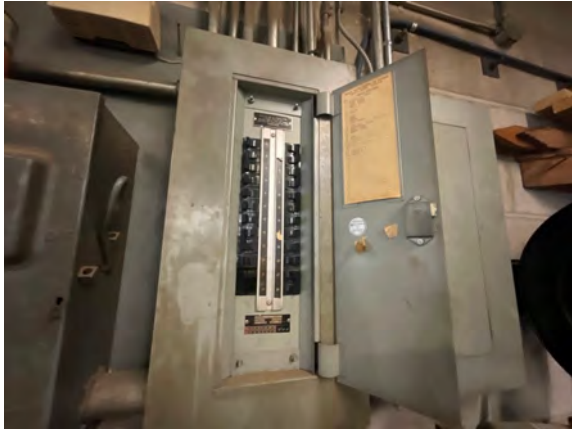
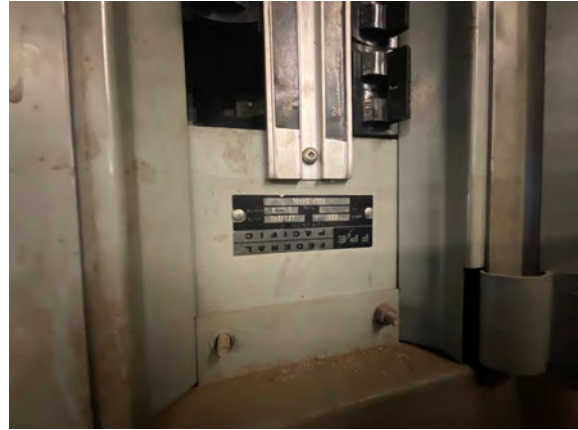
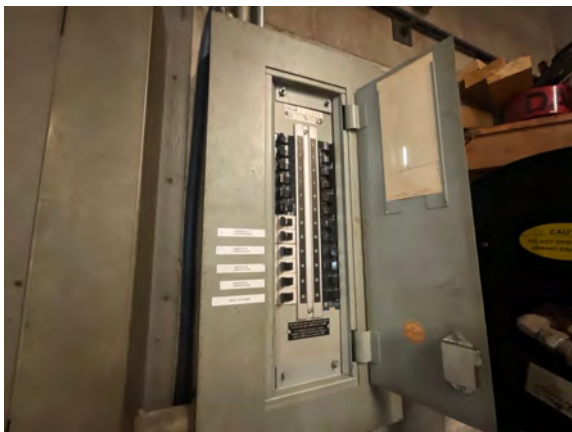
Element Description	
Name	D501031 - Electrical Distribution - Workshop
Installation Year	1970
Condition	4 - Poor
Expected Useful Life	40 Years
Remaining Useful Life	1 Year
Renewal Year	2025
Quantity / Unit of Measure	320 / SM Building
Unit Cost	\$79.00
Difficulty / Regional / Soft Cost / Replacement	1.00 / 1.04688 / 1.30000 / 1.0000
Element Cost	\$34,404.66

No significant deficiencies were observed or reported. However, the system based on age, is approaching or is past its expected useful life and can experience electrical or thermal breakdown over time. Some circuit breakers (light blue) are known to fail to trip and are on recall. Replacement is recommended in the short term.

Recommendations #1 - Electrical Distribution	
Type	Life Cycle Replacement
Year	2025
Cost	\$34,404.66

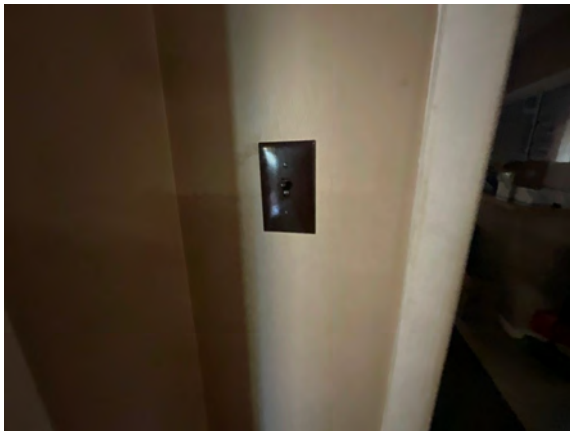
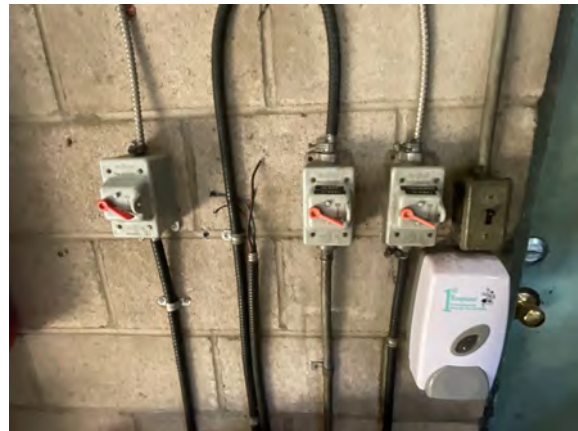
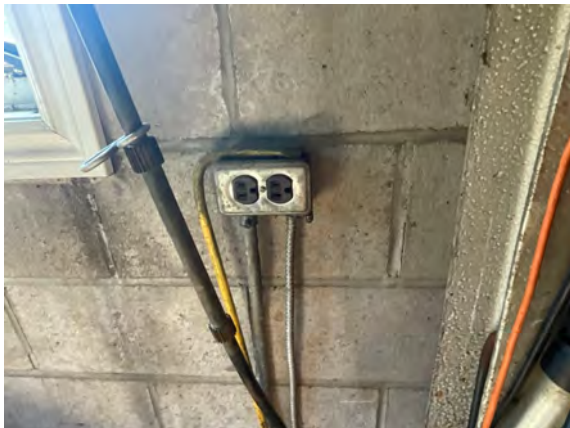
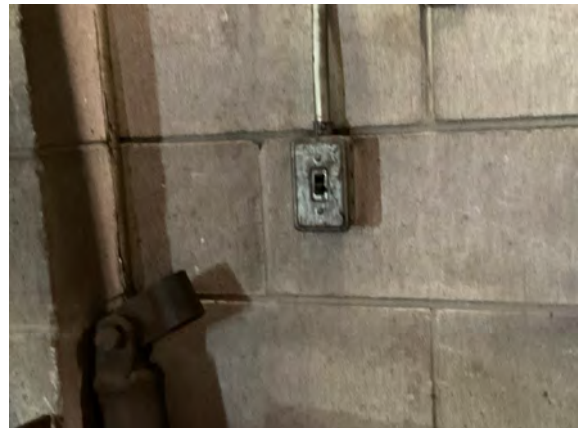
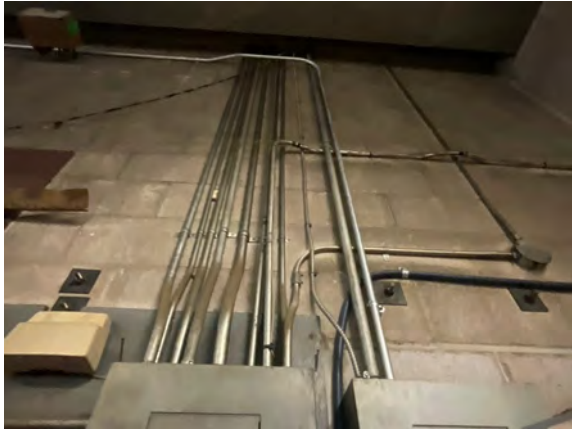
Quadville Public Works Garage - D502001

Element Description	
Name	D502001 - Branch Wiring and Devices - Workshop
Installation Year	1970
Condition	4 - Poor
Expected Useful Life	50 Years
Remaining Useful Life	1 Year
Renewal Year	2025
Quantity / Unit of Measure	320 / SM Building
Unit Cost	\$141.00
Difficulty / Regional / Soft Cost / Replacement	1.00 / 1.04688 / 1.30000 / 1.0000
Element Cost	\$61,405.79

No significant deficiencies were observed or reported. Some wiring was added over time. However the system, based on age, is approaching or is past its expected useful life and can experience insulation breakdown over time. Replacement is recommended in the short term.

<b>Recommendations #1 - Branch Wiring and Devices</b>	
Type	Life Cycle Replacement
Year	2025
Cost	\$61,405.79

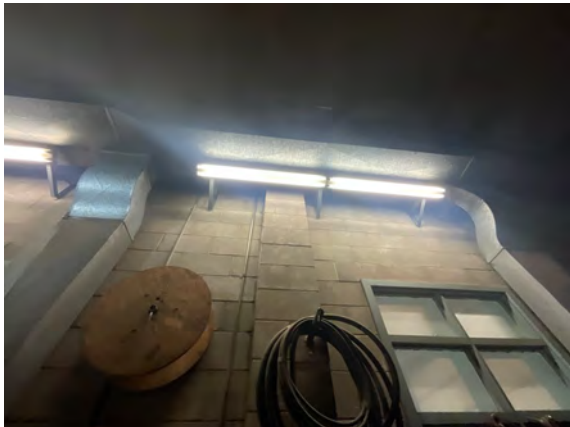
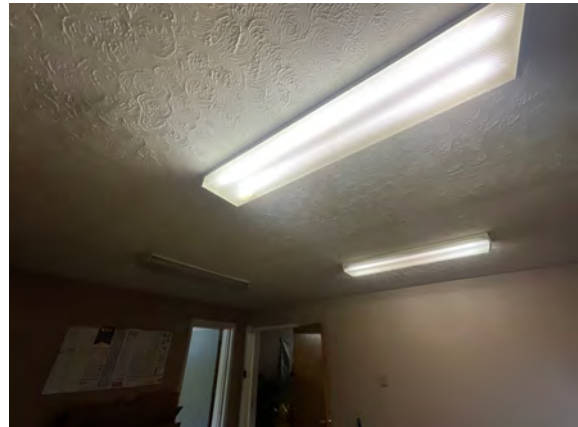
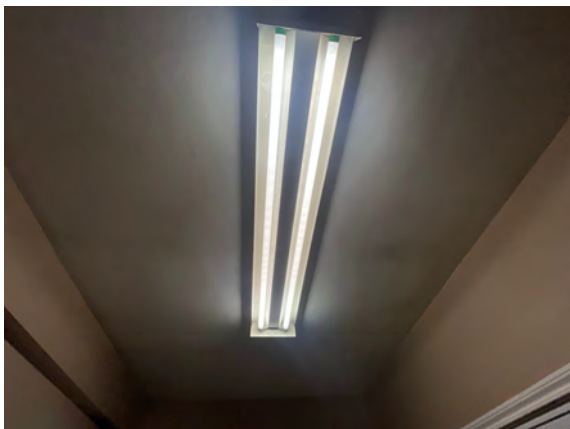
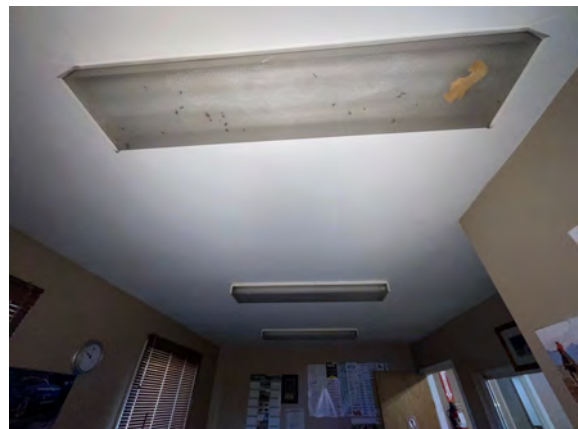
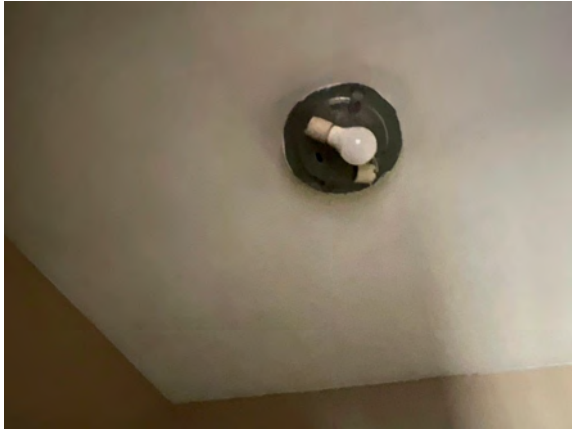
Quadville Public Works Garage - D502002

Element Description	
Name	D502002 - Interior Lighting - Workshop
Installation Year	2000
Condition	2 - Good
Expected Useful Life	35 Years
Remaining Useful Life	11 Years
Renewal Year	2035
Quantity / Unit of Measure	320 / SM Building
Unit Cost	\$112.00
Difficulty / Regional / Soft Cost / Replacement	1.00 / 1.04688 / 1.30000 / 1.0000
Element Cost	\$48,776.23

No significant deficiencies were observed or reported. Replacement is not anticipated in the short term. Upgrade to LED should be considered.

<b>Recommendations #1 - Interior Lighting</b>	
Type	Life Cycle Replacement
Year	2035
Cost	\$48,776.23

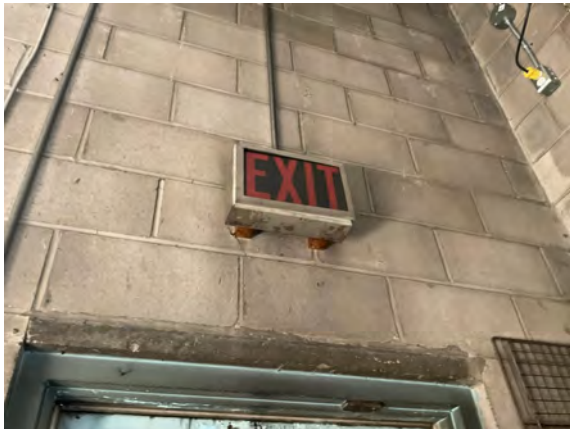
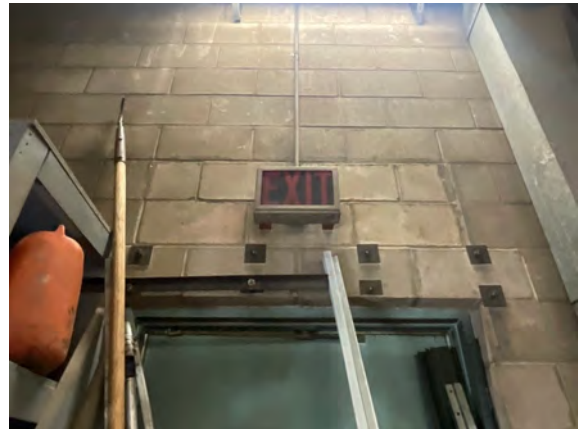
Quadville Public Works Garage - D502051

<b>Element Description</b>	
Name	D502051 - Exit Lighting - Workshop
Installation Year	1970
Condition	4 - Poor
Expected Useful Life	35 Years
Remaining Useful Life	0 Year
Renewal Year	2023
Quantity / Unit of Measure	320 / SM Building
Unit Cost	\$4.00
Difficulty / Regional / Soft Cost / Replacement	1.00 / 1.04688 / 1.30000 / 1.0000
Element Cost	\$1,742.01

Deficiencies observed or reported at the time of the assessment include damage and poor illumination. Replacement or upgrade to pictogram exit signs is recommended in the short term.

<b>Recommendations #1 - Exit Lighting</b>	
Type	Life Cycle Replacement
Year	2023
Cost	\$1,742.01

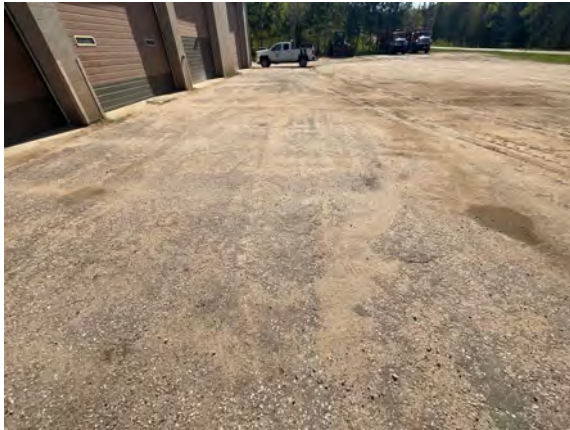
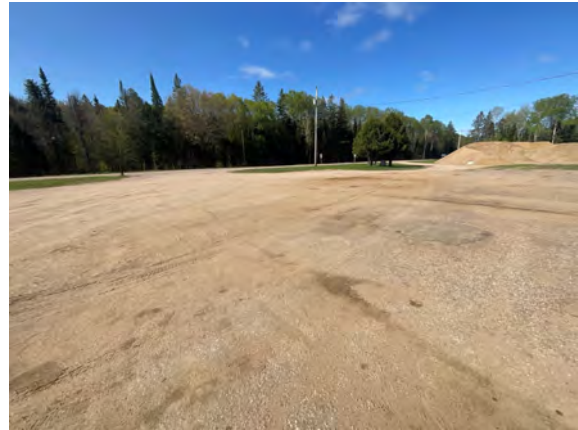
Quadville Public Works Garage - G202021

<b>Element Description</b>	
Name	G202021 - Asphalt Paved Surfaces - Parking Area - Workshop
Installation Year	1970
Condition	3 - Fair
Expected Useful Life	25 Years
Remaining Useful Life	2 Years
Renewal Year	2026
Quantity / Unit of Measure	400 / SM
Unit Cost	\$95.00
Difficulty / Regional / Soft Cost / Replacement	1.00 / 1.04688 / 1.30000 / 1.0000
Element Cost	\$51,715.87

Deficiencies observed or reported, at the time of assessment include ravelling and worn surfaces. Previous repairs appear to have been attempted. Replacement is recommended.

<b>Recommendations #1 - Asphalt Paved Surfaces - Parking Area</b>	
Type	Life Cycle Replacement
Year	2026
Cost	\$51,715.87

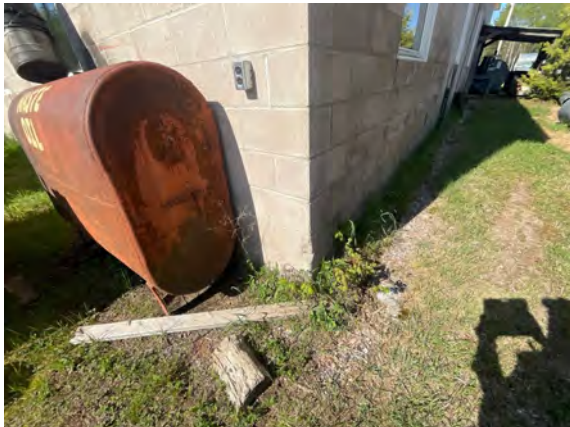
Quadville Public Works Garage - G306004

Deficiencies observed include corrosion. Replacement is recommended in the short term.

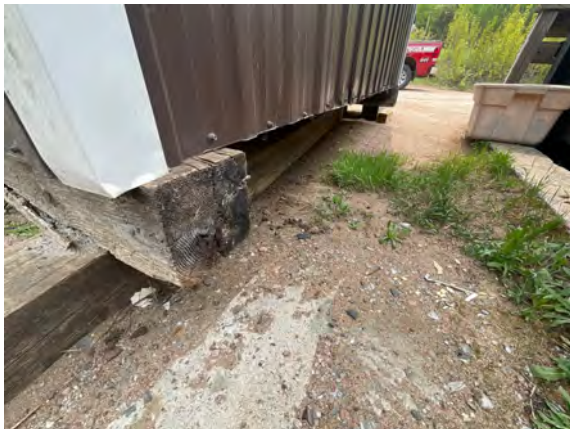
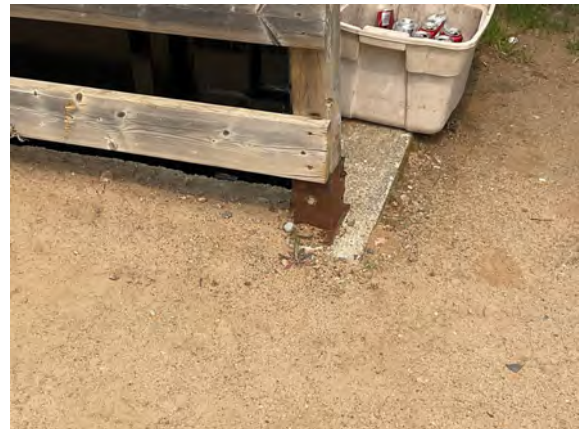
Raglan Transfer Station - A103001

No significant deficiencies were observed or reported. Replacement is not anticipated in the short term.

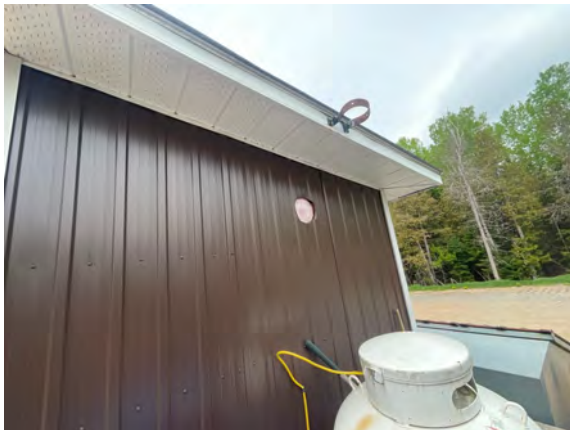
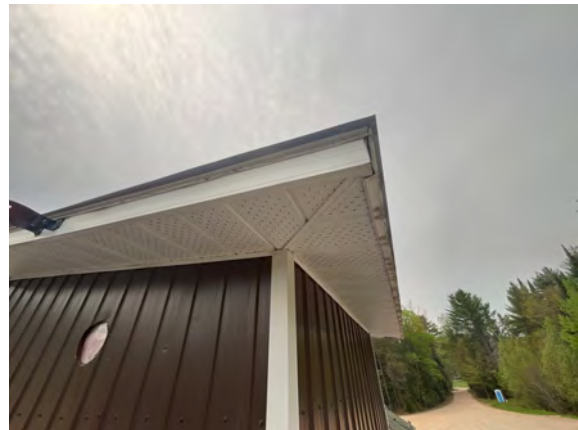
Raglan Transfer Station - B201008

Element Description	
Name	B201008 - Exterior Soffits - Warming Shack
Installation Year	2018
Condition	2 - Good
Expected Useful Life	50 Years
Remaining Useful Life	44 Years
Renewal Year	2068
Quantity / Unit of Measure	2 / SM
Unit Cost	\$139.00
Difficulty / Regional / Soft Cost / Replacement	1.00 / 1.04689 / 1.30000 / 1.0000
Element Cost	\$378.35

No significant deficiencies were observed or reported. Replacement is not anticipated in the short term.

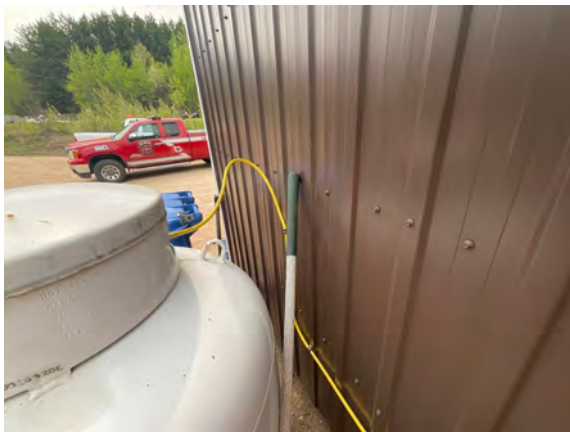
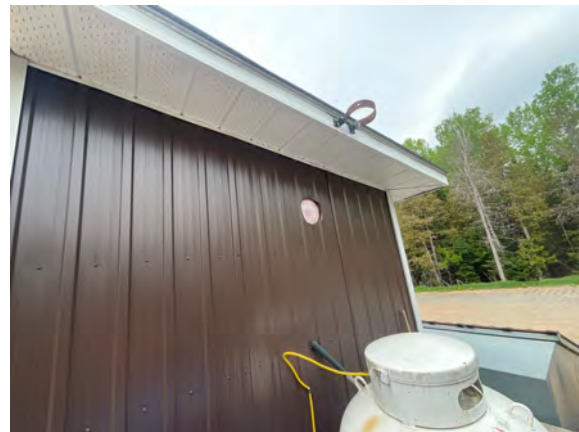
Raglan Transfer Station - B201024

Element Description	
Name	B201024 - Metal Cladding - Warming Shack
Installation Year	2018
Condition	2 - Good
Expected Useful Life	40 Years
Remaining Useful Life	34 Years
Renewal Year	2058
Quantity / Unit of Measure	18 / SM
Unit Cost	\$201.00
Difficulty / Regional / Soft Cost / Replacement	1.00 / 1.04689 / 1.30000 / 1.0000
Element Cost	\$4,923.94

No significant deficiencies were observed or reported. Replacement is not anticipated in the short term.

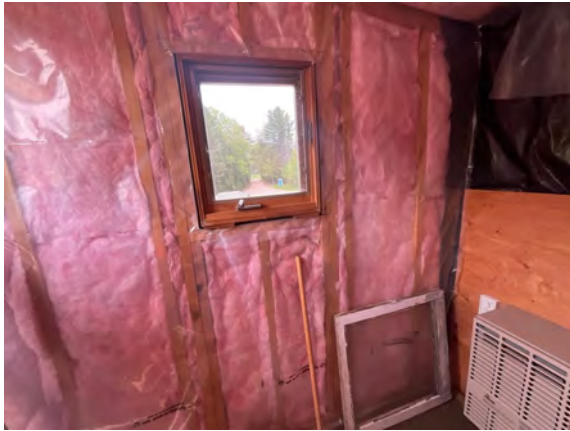
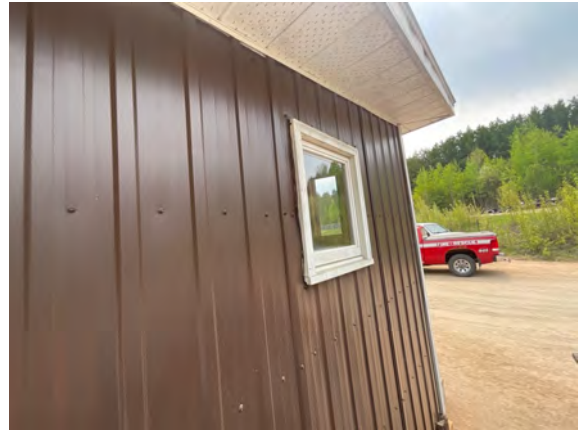
Raglan Transfer Station - B202001

<b>Element Description</b>	
Name	B202001 - Windows - Warming Shack
Installation Year	2018
Condition	2 - Good
Expected Useful Life	35 Years
Remaining Useful Life	29 Years
Renewal Year	2053
Quantity / Unit of Measure	1 / SM
Unit Cost	\$1,200.00
Difficulty / Regional / Soft Cost / Replacement	1.00 / 1.04689 / 1.30000 / 1.0000
Element Cost	\$1,633.15

No significant deficiencies were observed or reported. Replacement is not anticipated in the short term.

<b>Recommendations #1 - Windows</b>	
Type	Life Cycle Replacement
Year	2053
Cost	\$1,633.15

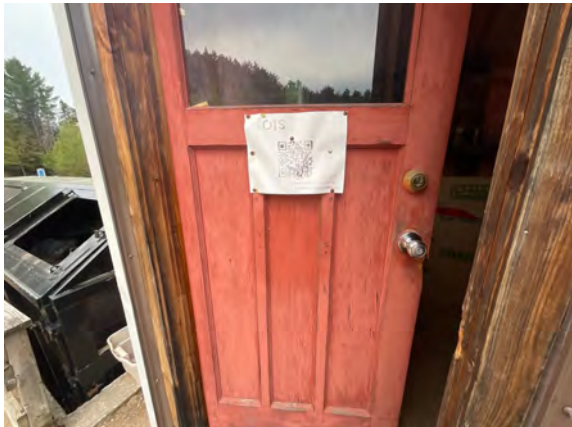
Raglan Transfer Station - C102022

Element Description	
Name	B203024 - Single Door - Wood - Warming Shack
Installation Year	2018
Condition	2 - Good
Expected Useful Life	25 Years
Remaining Useful Life	19 Years
Renewal Year	2043
Quantity / Unit of Measure	1 / Each
Unit Cost	\$3,400.00
Difficulty / Regional / Soft Cost / Replacement	1.00 / 1.04689 / 1.30000 / 1.0000
Element Cost	\$4,627.25

No significant deficiencies were observed or reported. Replacement is not anticipated in the short term.

Recommendations #1 - Single Door - Wood	
Type	Life Cycle Replacement
Year	2043
Cost	\$4,627.25

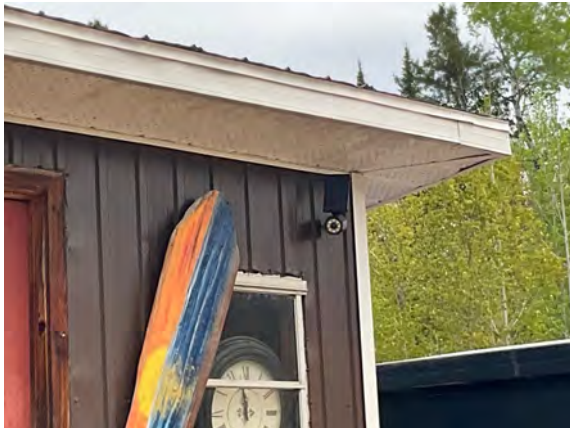
Raglan Transfer Station - B301028

No significant deficiencies were observed or reported. Replacement is not anticipated in the short term.

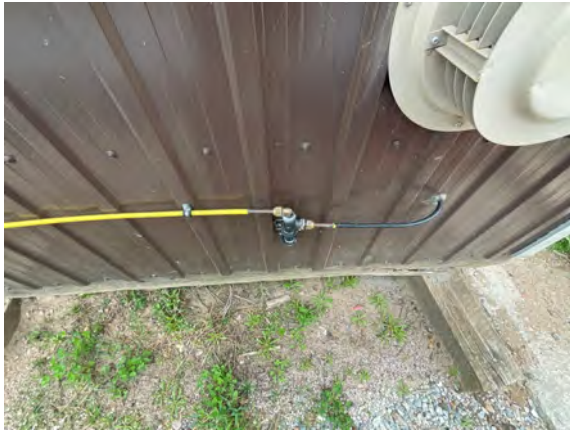
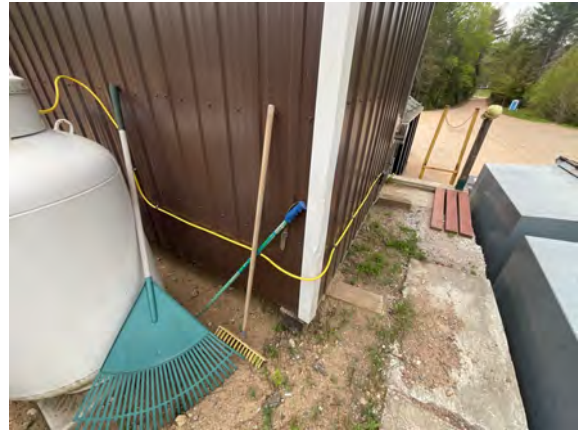
Raglan Transfer Station - D301002

No significant deficiencies were observed or reported. Replacement is not anticipated in the short term.

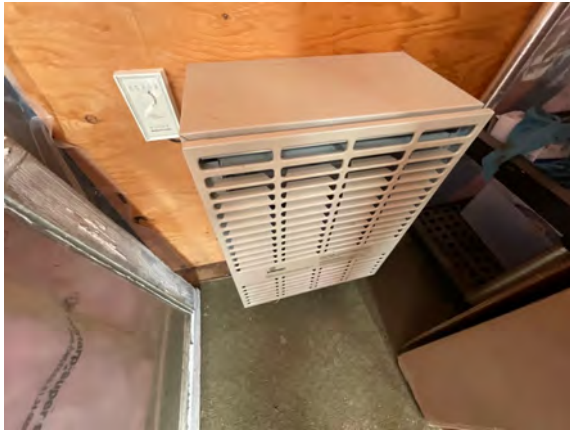
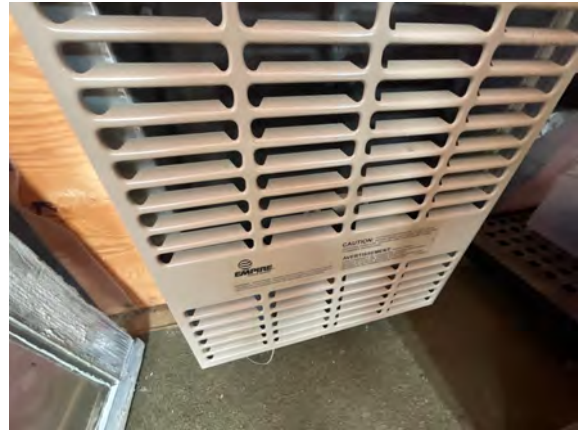
Raglan Transfer Station - D302004

Element Description	
Name	D302004 - Fuel-Fired Unit Heaters - Warming Shack
Installation Year	2018
Condition	2 - Good
Expected Useful Life	18 Years
Remaining Useful Life	12 Years
Renewal Year	2036
Quantity / Unit of Measure	1 / Each
Unit Cost	\$3,940.00
Difficulty / Regional / Soft Cost / Replacement	0.50 / 1.04689 / 1.30000 / 1.0000
Element Cost	\$2,681.09

No significant deficiencies were observed or reported. Replacement is not anticipated in the short term.

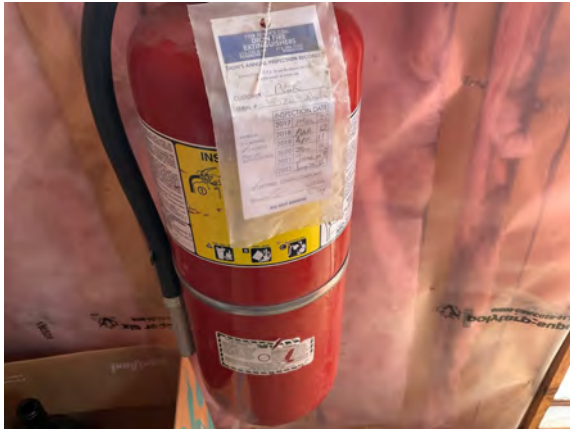
Raglan Transfer Station - D403002

No significant deficiencies were observed or reported. Replacement is not anticipated in the short term.

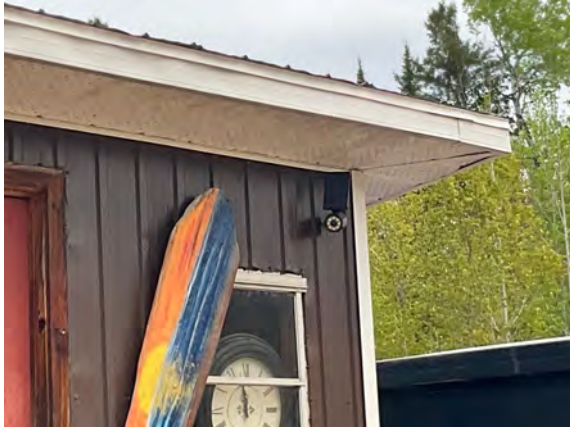
Raglan Transfer Station - G403099

No significant deficiencies were observed or reported. Replacement is not anticipated in the short term.

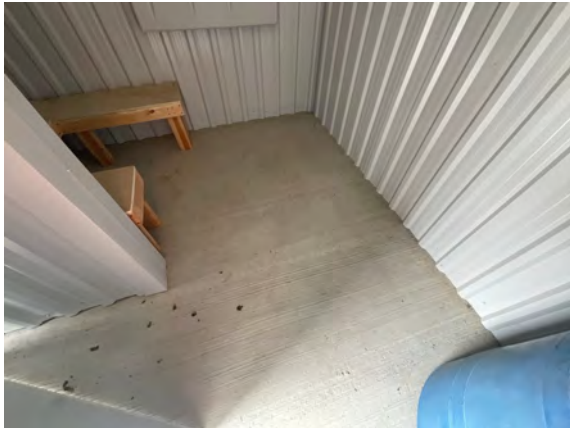
Raglan White Lake Beach - A103001

No major deficiencies were observed or reported. No cracking in concrete was observed.

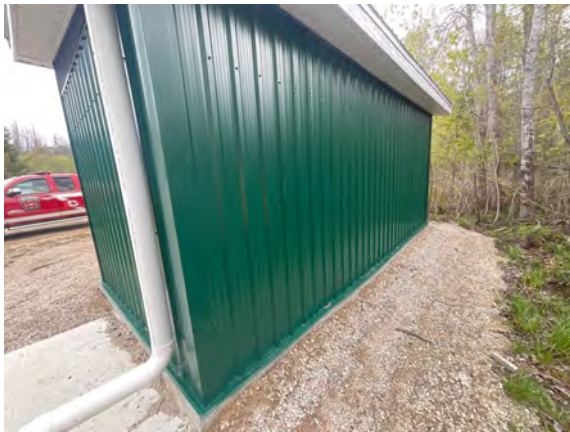
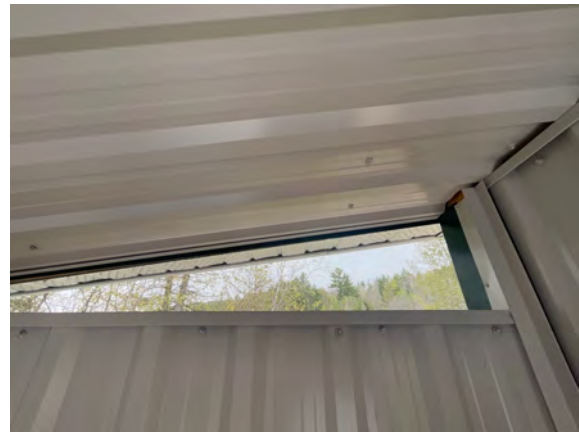
No significant deficiencies were observed or reported. Replacement is not anticipated in the short term.
