# Brudenell Lyndoch and Raglan

Submission to Township of Brudenell, Lyndoch, and Raglan

Roth IAMS Ltd.  
207-1075 North Service Rd W, Oakville ON, L6M 2G2  
[www.rothiams.com](http://www.rothiams.com)  
Project No. 23502

**Facility Condition Assessment Report**  
**Brudenell Fire Hall #4**

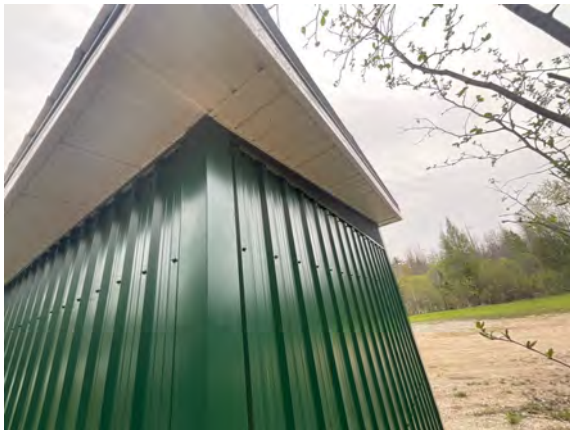
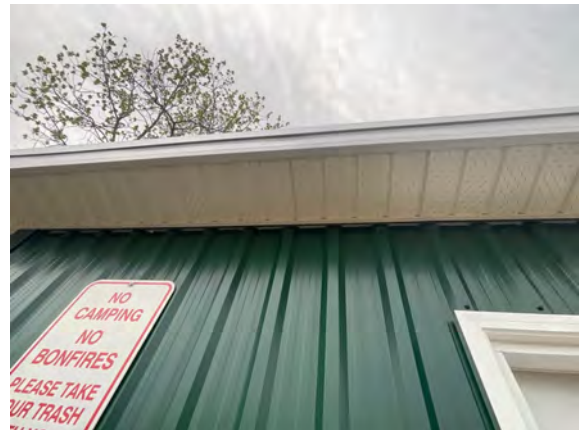
Raglan White Lake Beach - B201008

No significant deficiencies were observed or reported. Replacement is not anticipated in the short term.

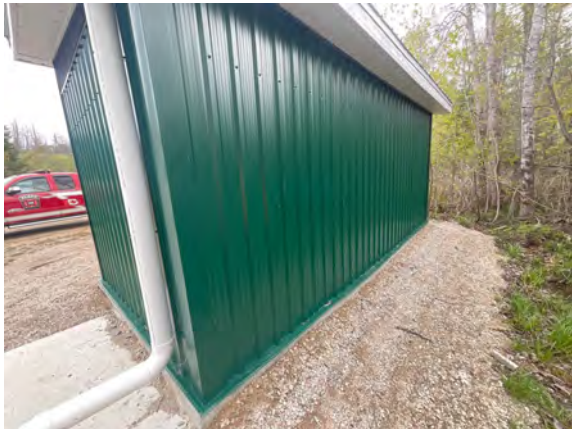
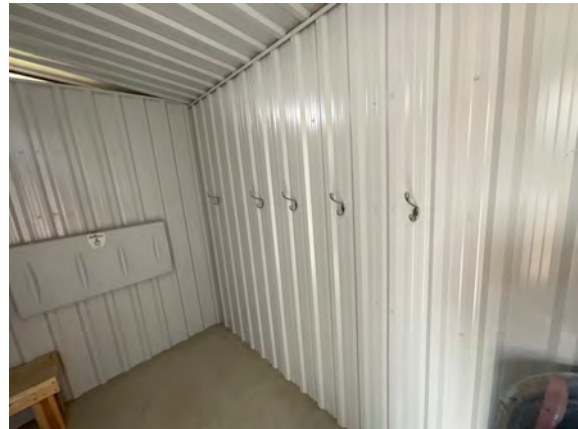
Raglan White Lake Beach - B201024

Element Description	
Name	B201024 - Metal Cladding - Washroom/Changeroom
Installation Year	2022
Condition	2 - Good
Expected Useful Life	40 Years
Remaining Useful Life	38 Years
Renewal Year	2062
Quantity / Unit of Measure	36 / SM
Unit Cost	\$201.00
Difficulty / Regional / Soft Cost / Replacement	1.00 / 1.04689 / 1.30000 / 1.0000
Element Cost	\$9,847.88

No significant deficiencies were observed or reported. Replacement is not anticipated in the short term.

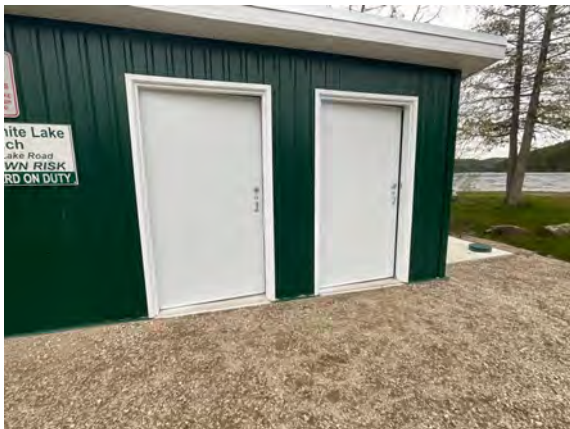
Raglan White Lake Beach - B203023

Element Description	
Name	B203023 - Single Door - Hollow Metal - Washroom/Changeroom
Installation Year	2022
Condition	2 - Good
Expected Useful Life	30 Years
Remaining Useful Life	28 Years
Renewal Year	2052
Quantity / Unit of Measure	2 / Each
Unit Cost	\$4,020.00
Difficulty / Regional / Soft Cost / Replacement	1.00 / 1.04689 / 1.30000 / 1.0000
Element Cost	\$10,942.09

No significant deficiencies were observed or reported. Replacement is not anticipated in the short term.

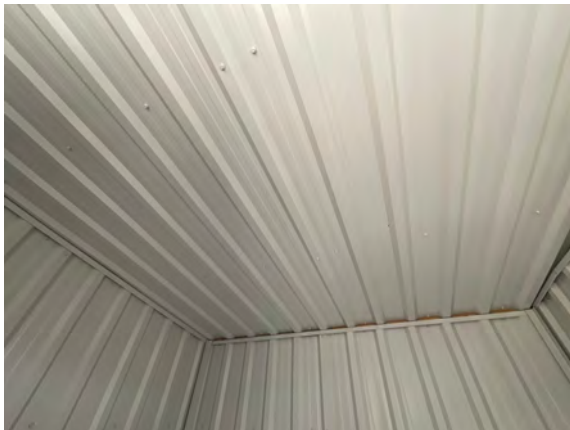
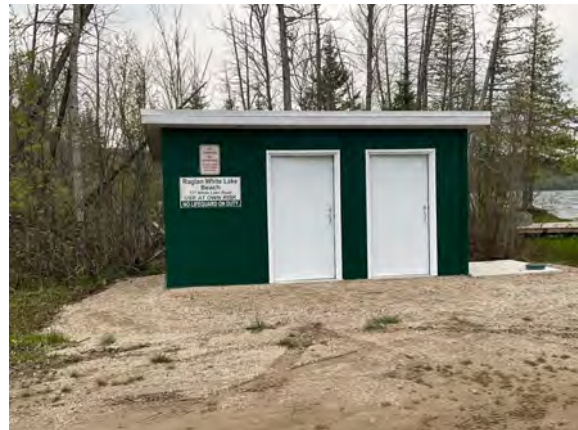
Raglan White Lake Beach - B301028

No significant deficiencies were observed or reported. Replacement is not anticipated in the short term.

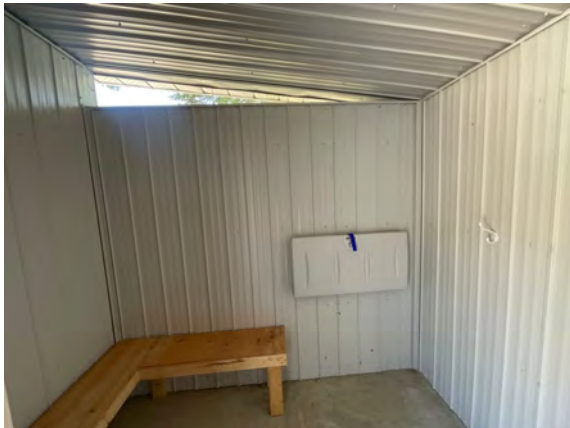
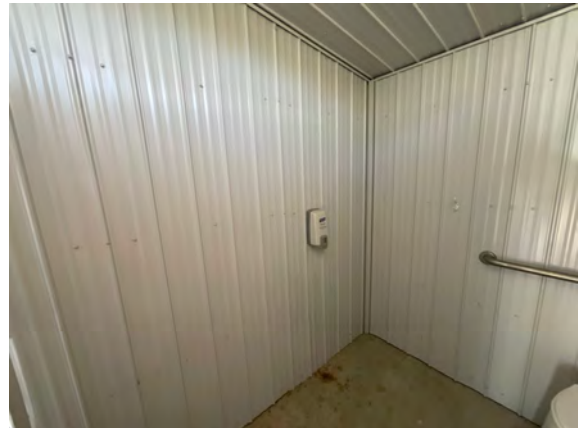
Raglan White Lake Beach - C301099

No significant deficiencies were observed or reported. Replacement is not anticipated in the short term.

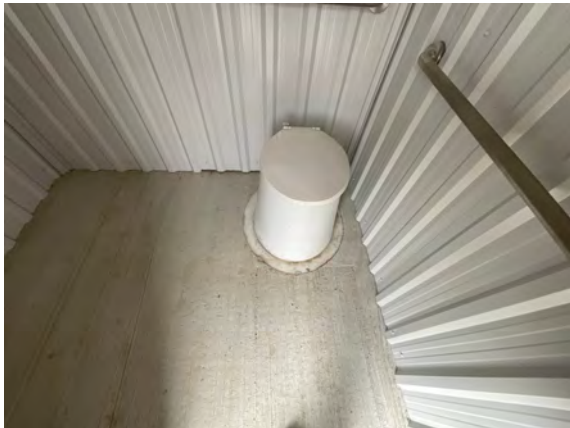
Raglan White Lake Beach - D201001

No significant deficiencies were observed or reported. Replacement is not anticipated in the short term.

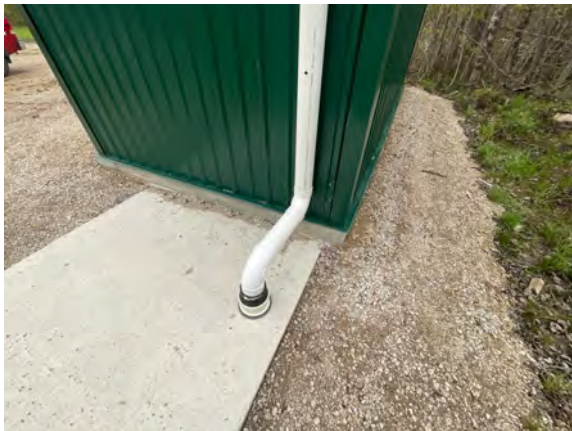
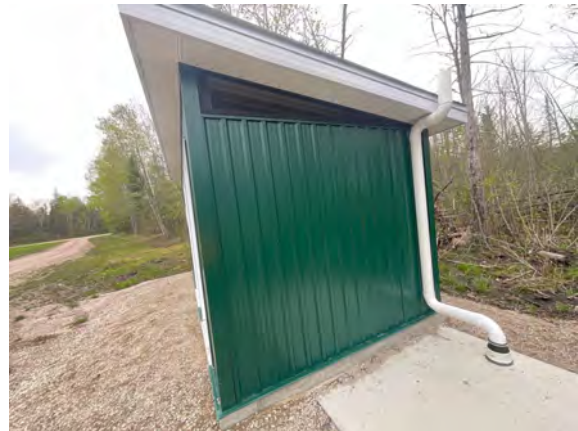
Raglan White Lake Beach - D203001

Element Description	
Name	D203001 - Sanitary Waste and Vent Piping and Fittings - Washroom/Changeroom
Installation Year	2022
Condition	2 - Good
Expected Useful Life	50 Years
Remaining Useful Life	48 Years
Renewal Year	2072
Quantity / Unit of Measure	12 / SM Building
Unit Cost	\$60.00
Difficulty / Regional / Soft Cost / Replacement	1.00 / 1.04689 / 1.30000 / 1.0000
Element Cost	\$979.89

No significant deficiencies or leaks were observed or reported. Replacement is not anticipated in the short term.

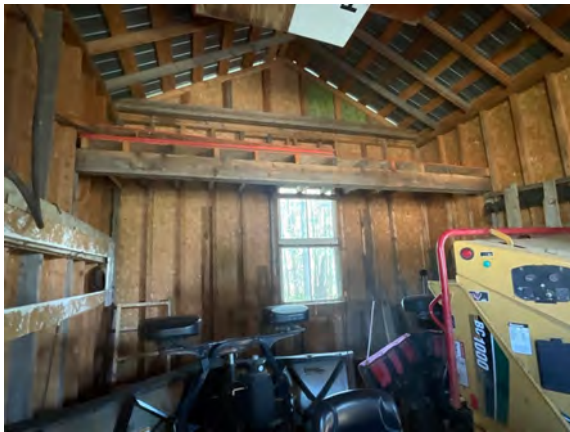
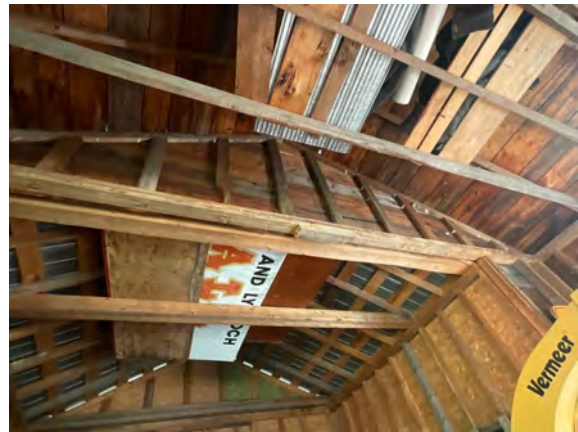
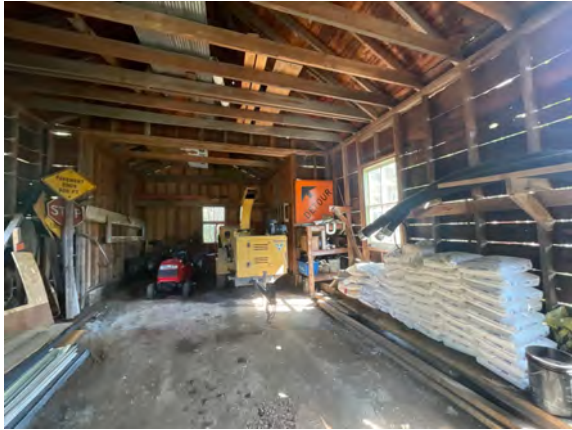
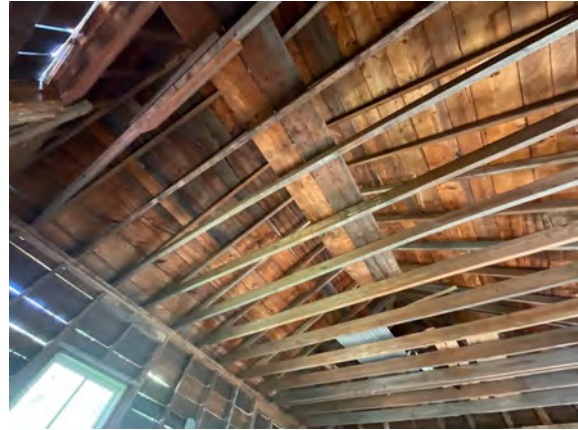
Storage Building - Quadeville - B103001

No significant deficiencies were observed or reported. Replacement is not anticipated in the short term.

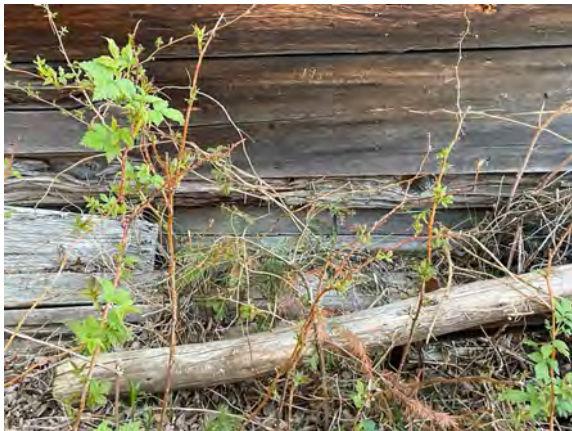
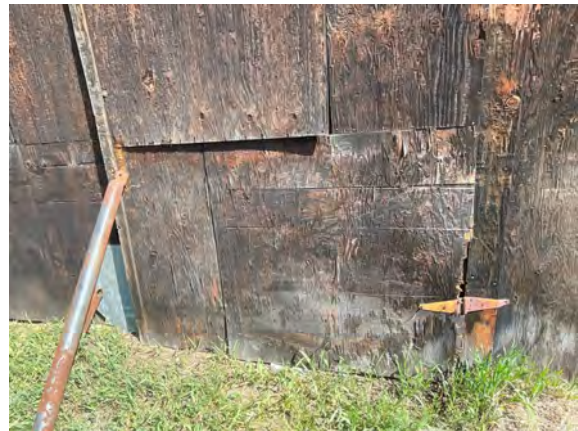
Storage Building - Quadeville - B201026

Deficiencies observed or reported during the assessment include damaged surfaces, rot, deformation, loose connections, loose components, staining, fading, and gaps in material coverage. The deterioration is anticipated to progress. Replacement is recommended in the short term.

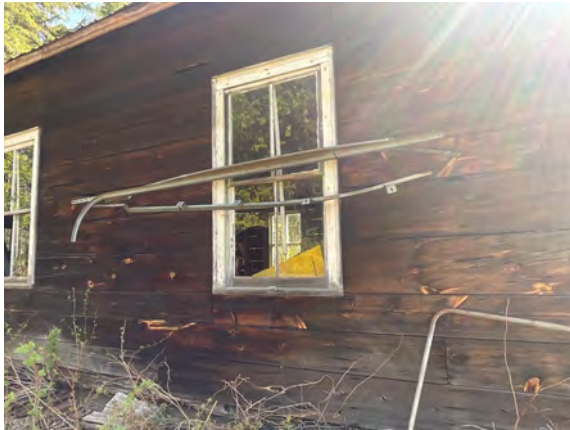
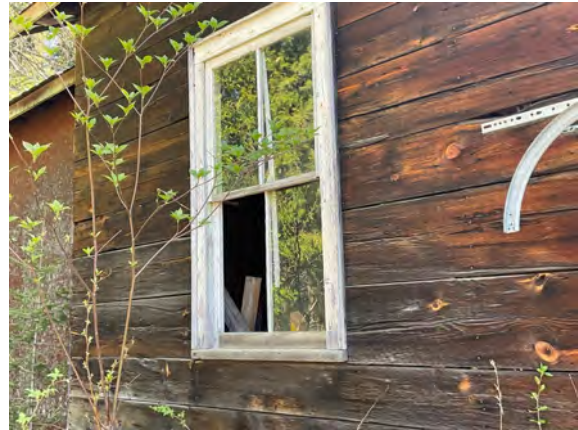
Storage Building - Quadeville - B202001

Element Description	
Name	B202001 - Windows - Storage Building
Installation Year	1974
Condition	4 - Poor
Expected Useful Life	35 Years
Remaining Useful Life	0 Years
Renewal Year	2024
Quantity / Unit of Measure	5 / SM
Unit Cost	\$1,200.00
Difficulty / Regional / Soft Cost / Replacement	1.00 / 1.04689 / 1.30000 / 1.0000
Element Cost	\$8,165.74

Deficiencies observed or reported during the assessment include damaged glazing, degraded sealant and worn framework and trim. The deterioration is anticipated to progress. Replacement is recommended in the short term.

Recommendations #1 - Windows	
Type	Life Cycle Replacement
Year	2024
Cost	\$8,165.74

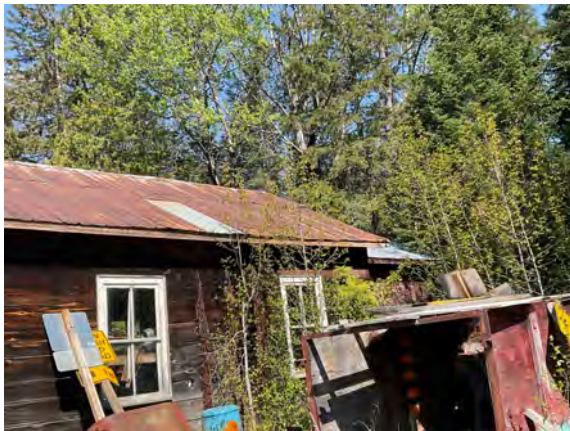
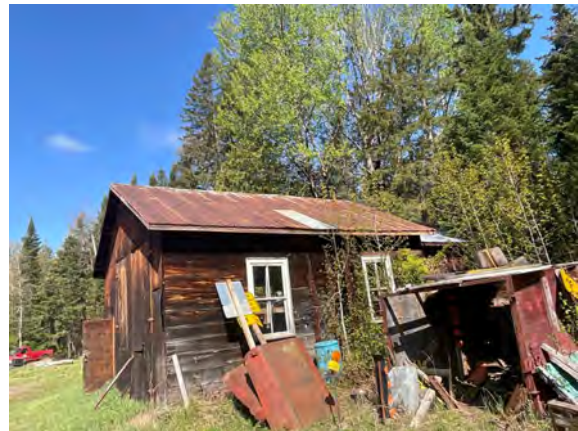
Storage Building - Quadeville - B301028

Element Description	
Name	B301028 - Metal Roofing - Storage Building
Installation Year	1974
Condition	4 - Poor
Expected Useful Life	40 Years
Remaining Useful Life	0 Years
Renewal Year	2024
Quantity / Unit of Measure	91 / SM
Unit Cost	\$398.00
Difficulty / Regional / Soft Cost / Replacement	1.00 / 1.04689 / 1.30000 / 1.0000
Element Cost	\$49,291.14

Deficiencies observed or reported during the assessment include evidence of moisture infiltration and corroded panels as well as fasteners. The deterioration is anticipated to progress. Replacement is recommended in the short term.

Recommendations #1 - Metal Roofing	
Type	Life Cycle Replacement
Year	2024
Cost	\$49,291.14

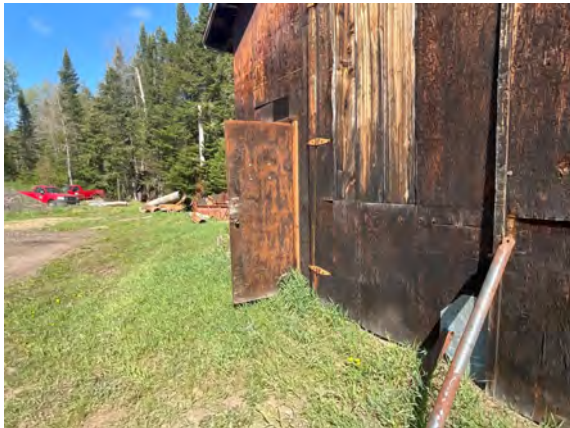
Storage Building - Quadeville - C102022

Element Description	
Name	C102022 - Single Door - Wood - Storage Building
Installation Year	1974
Condition	4 - Poor
Expected Useful Life	40 Years
Remaining Useful Life	0 Years
Renewal Year	2024
Quantity / Unit of Measure	1 / Each
Unit Cost	\$2,520.00
Difficulty / Regional / Soft Cost / Replacement	1.00 / 1.04689 / 1.30000 / 1.0000
Element Cost	\$3,429.61

Deficiencies observed or reported during the assessment include damaged surfaces, wood rot and worn hardware. The deterioration is anticipated to progress. Replacement is recommended in the short term.

Recommendations #1 - Single Door - Wood	
Type	Life Cycle Replacement
Year	2024
Cost	\$3,429.61

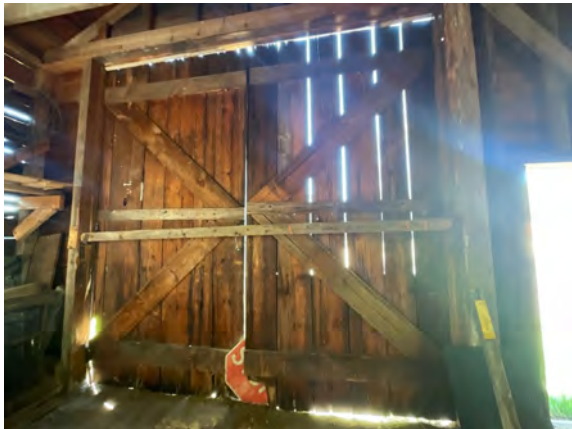
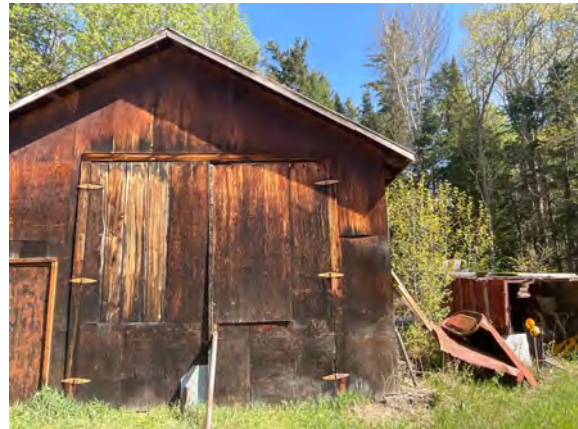
Storage Building - Quadeville - C102025

<b>Element Description</b>	
Name	C102025 - Double Door - Wood - Storage Building
Installation Year	1974
Condition	4 - Poor
Expected Useful Life	40 Years
Remaining Useful Life	0 Years
Renewal Year	2024
Quantity / Unit of Measure	1 / Each
Unit Cost	\$4,400.00
Difficulty / Regional / Soft Cost / Replacement	1.00 / 1.04689 / 1.30000 / 1.0000
Element Cost	\$5,988.21

Deficiencies observed or reported during the assessment include damaged surfaces, wood rot and worn hardware. The deterioration is anticipated to progress. Replacement is recommended in the short term.

<b>Recommendations #1 - Double Door - Wood</b>	
Type	Life Cycle Replacement
Year	2024
Cost	\$5,988.21

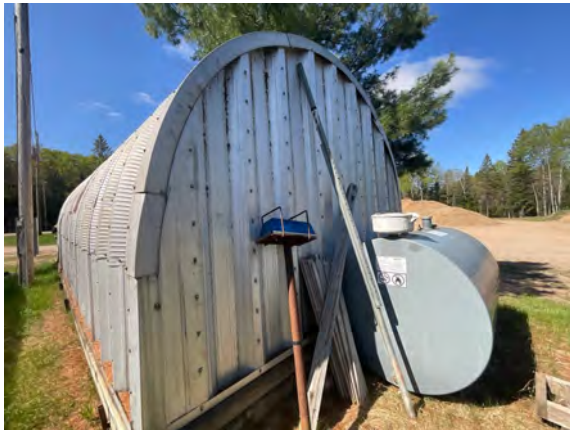
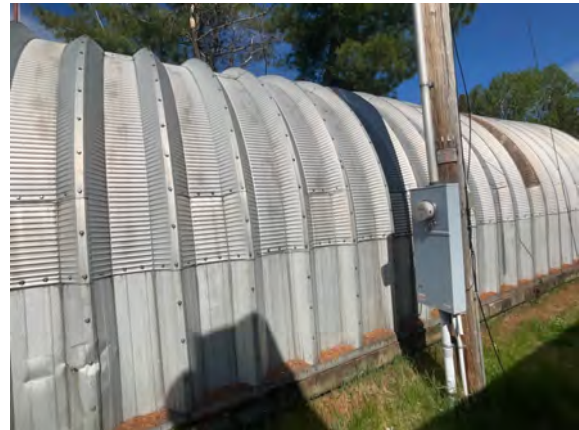
Storage Shed 2 - Quadeville - B301028

No significant deficiencies were observed or reported. Replacement is not anticipated in the short term.

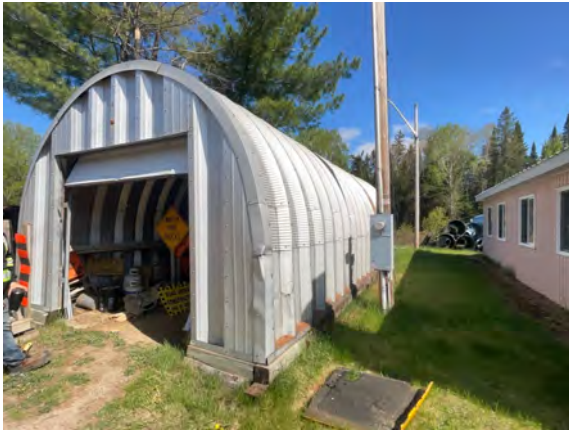
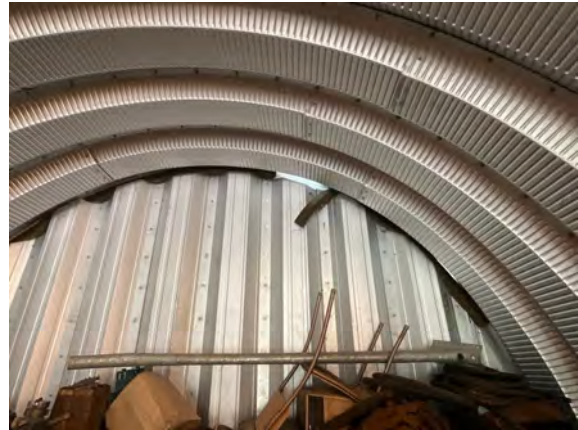
Storage Shed 2 - Quadeville - B201024

No significant deficiencies were observed or reported. Replacement is not anticipated in the short term.

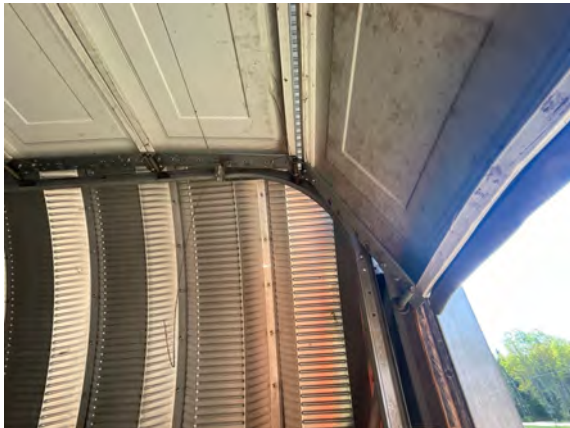
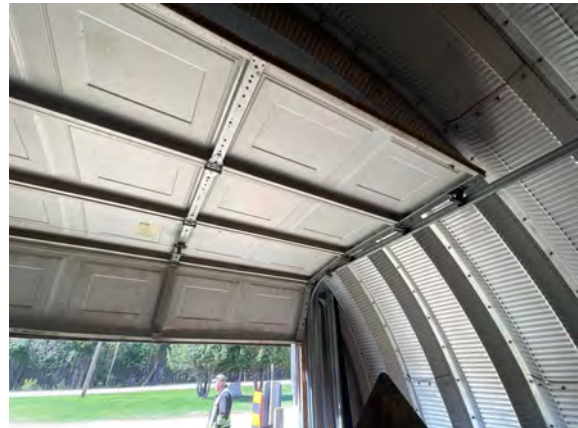
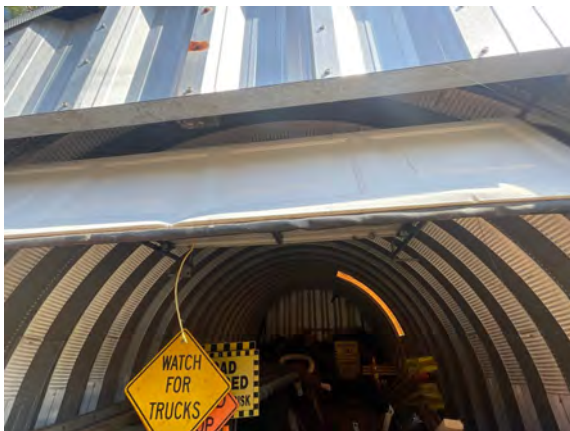
Storage Shed 2 - Quadeville - C102005

No significant deficiencies were observed or reported. Replacement is not anticipated in the short term.

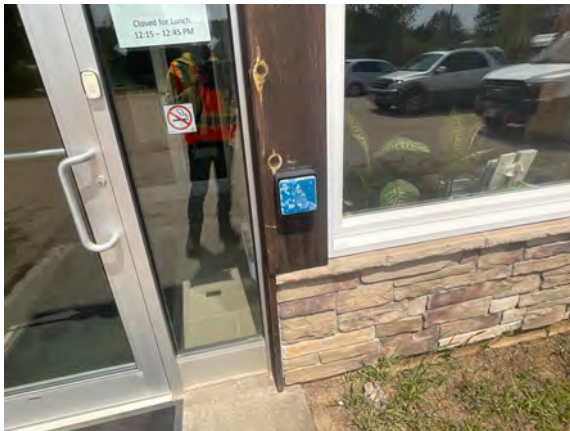
Township Office - B203008

Deficiencies observed or reported during the assessment include worn controls and hardware. Replacement is recommended in the short term.

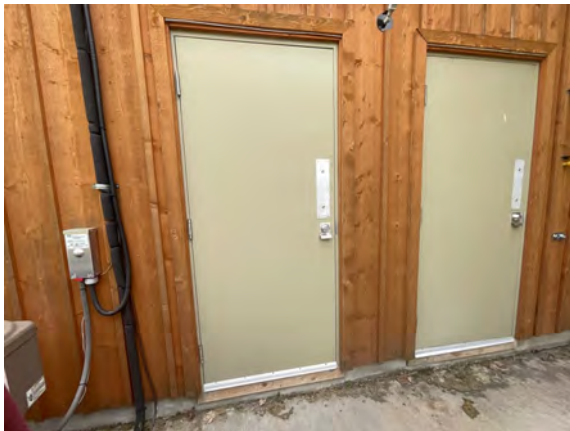
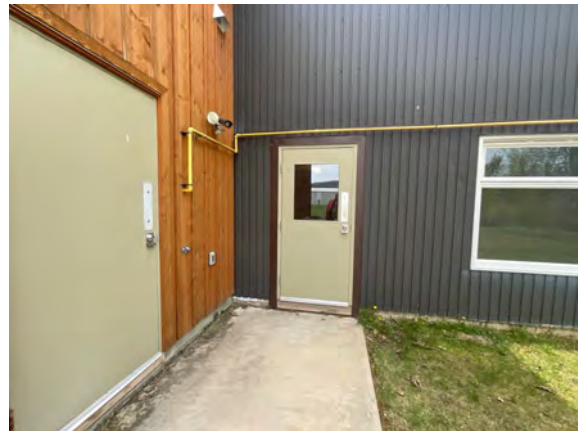
Township Office - B203023

No significant deficiencies were observed or reported. Replacement is not anticipated in the short term.

Recommendations #1 - Single Door - Hollow Metal	
Type	Life Cycle Replacement
Year	2043
Cost	\$16,412.98

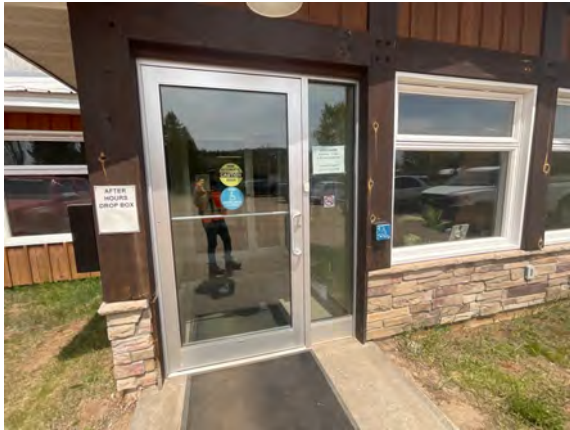
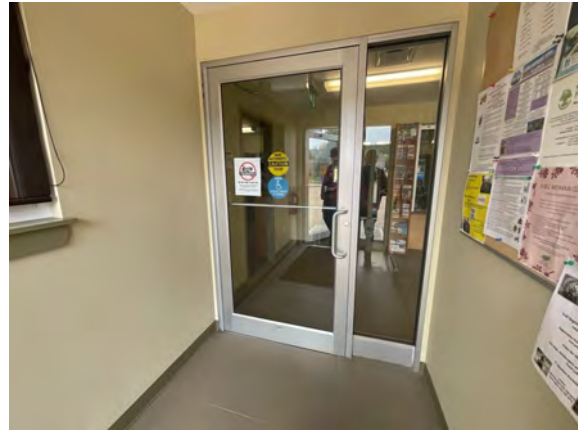
Township Office - B203025

No significant deficiencies were observed or reported. Replacement is not anticipated in the short term.

<b>Recommendations #1 - Single Door - Aluminum and Glass</b>	
Type	Life Cycle Replacement
Year	2048
Cost	\$17,093.46

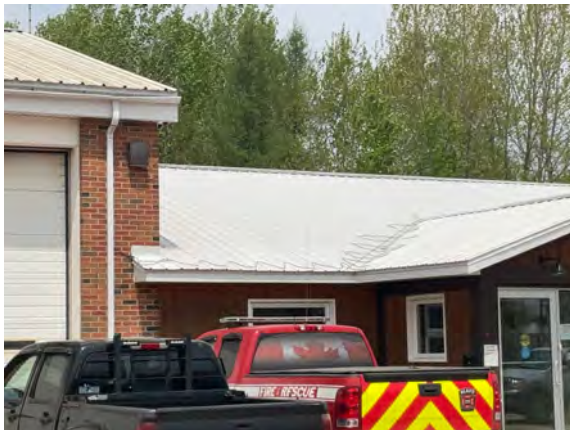
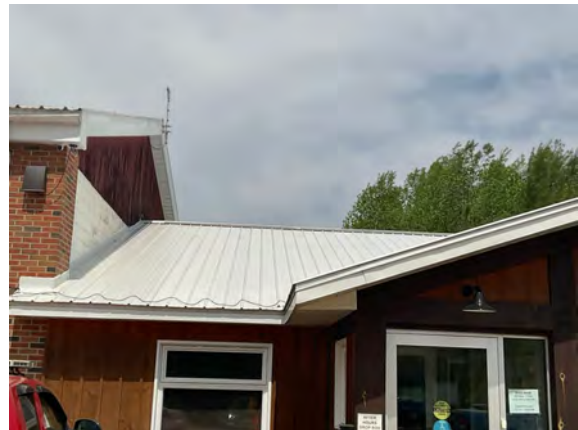
Township Office - D502002

No significant deficiencies were observed or reported. Replacement is not anticipated in the short term.

Recommendations #1 - Metal Roofing	
Type	Life Cycle Replacement
Year	2053
Cost	\$137,038.90

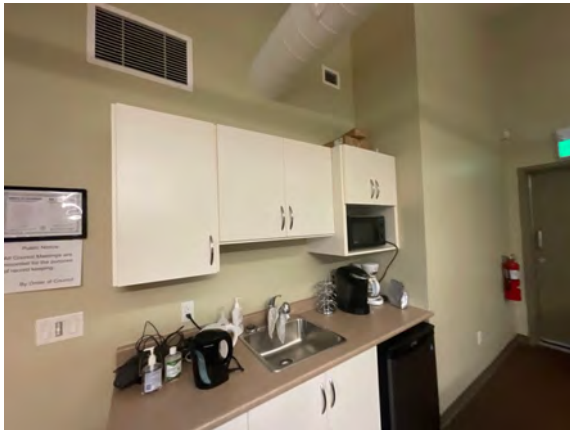
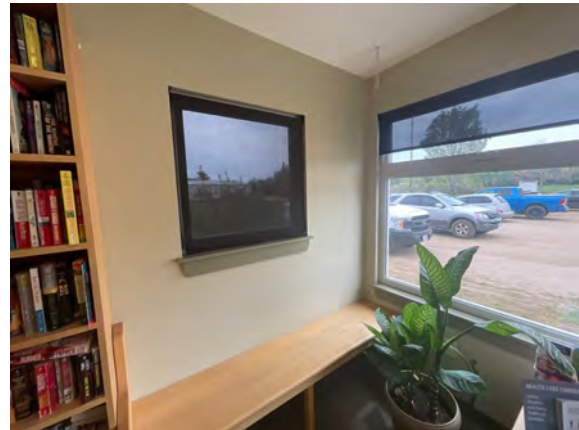
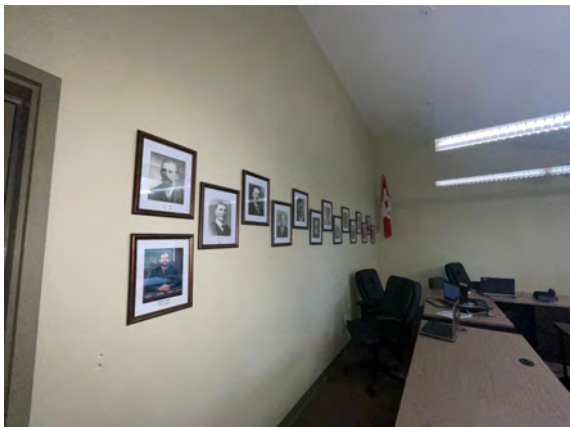
Township Office - C101001

No significant deficiencies were observed or reported. Replacement is not anticipated in the short term.

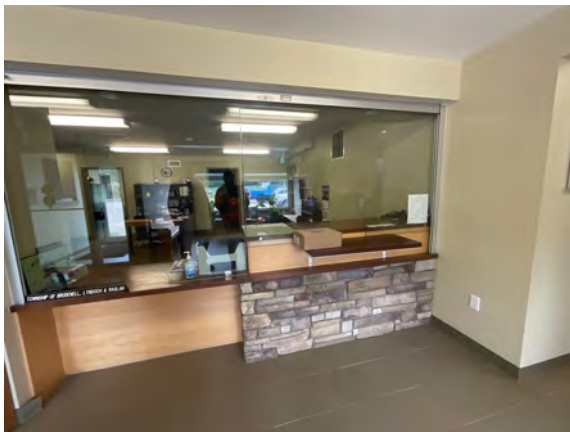
Township Office - C101005

No significant deficiencies were observed or reported. Replacement is not anticipated in the short term.

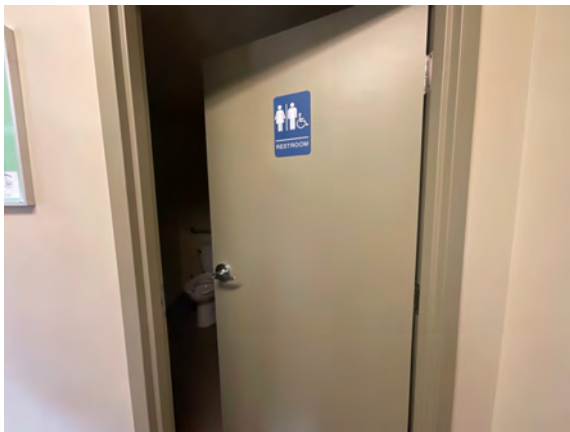
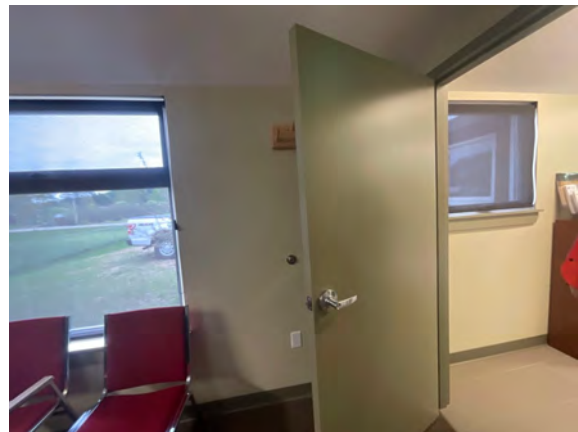
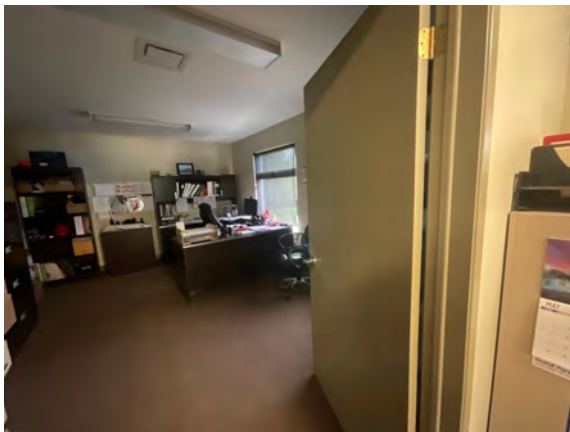
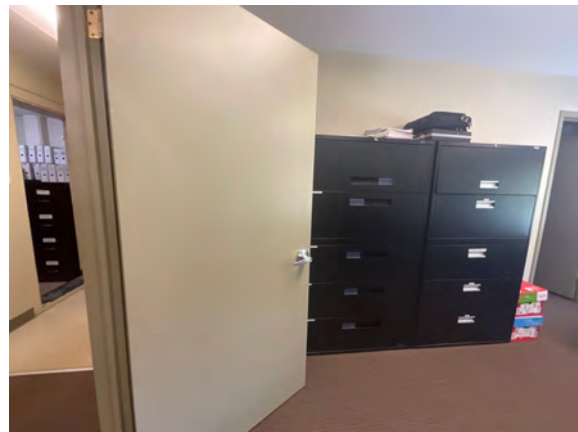
Township Office - C102022

No significant deficiencies were observed or reported. Replacement is not anticipated in the short term.

<b>Recommendations #1 - Single Door - Wood</b>	
Type	Life Cycle Replacement
Year	2053
Cost	\$27,436.63

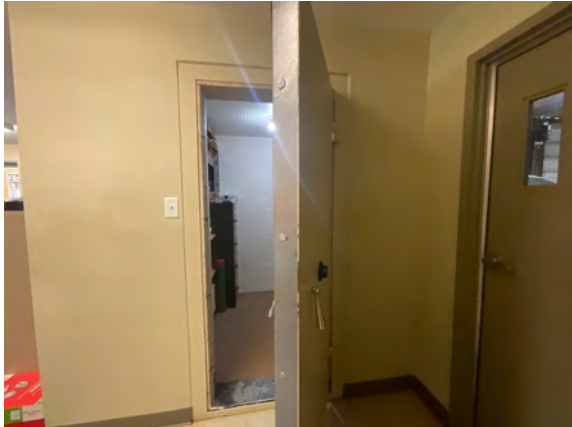
Township Office - C102099

No significant deficiencies were observed or reported. The vault door appears to be original from a another building. Replacement is not anticipated in the short term.

<b>Recommendations #1 - Other Interior Doors</b>	
Type	Life Cycle Replacement
Year	2029
Cost	\$14,861.51

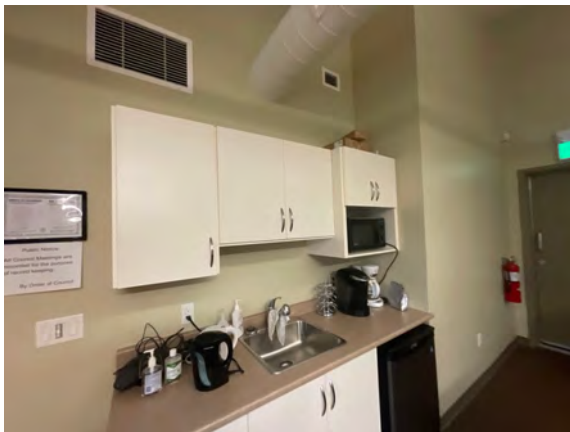
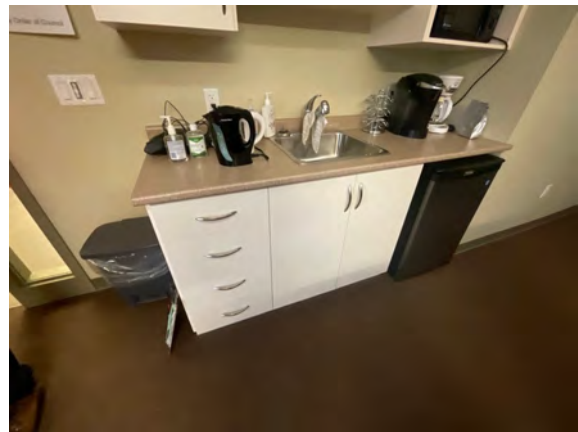
Township Office - C103009

No significant deficiencies were observed or reported. Replacement is not anticipated in the short term.

<b>Recommendations #1 - Fixed Casework</b>	
Type	Life Cycle Replacement
Year	2048
Cost	\$15,433.10

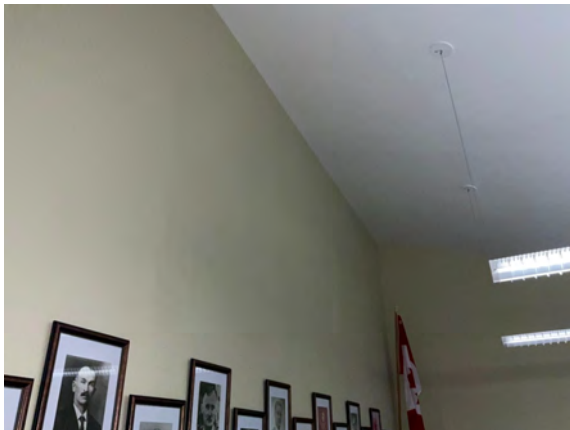
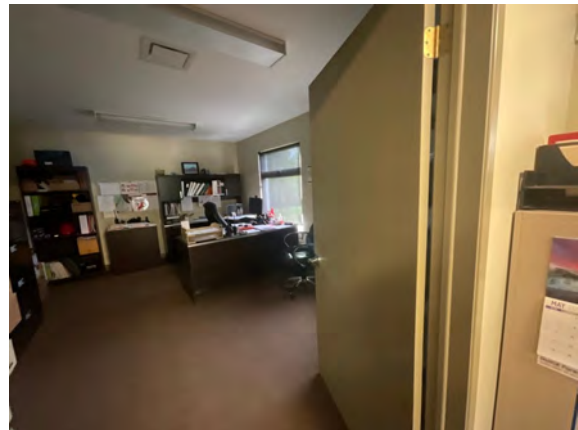
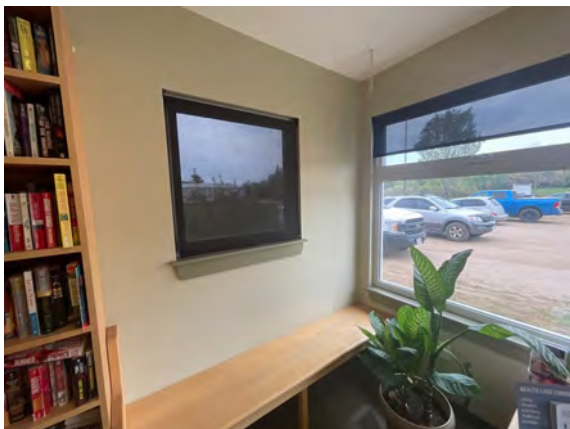
Township Office - C301005

No significant deficiencies were observed or reported. Lifecycle replacement may be deferred.

<b>Recommendations #1 - Paint Wall Covering</b>	
Type	Life Cycle Replacement
Year	2029
Cost	\$15,219.44

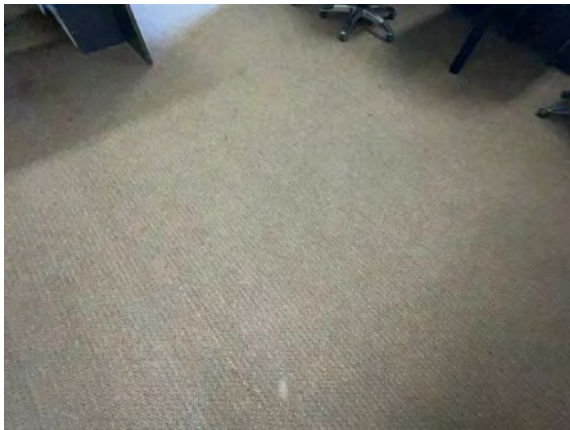
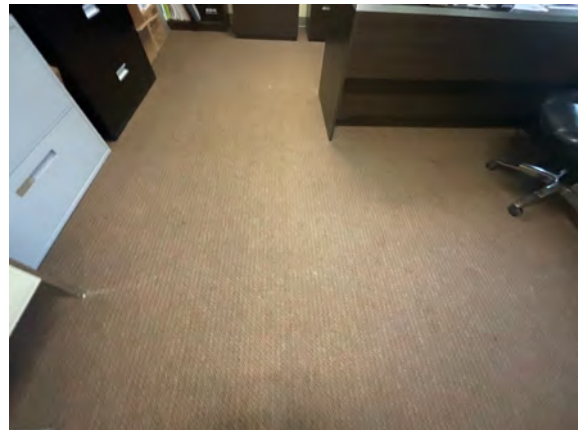
Township Office - C302005

<b>Element Description</b>	
Name	C302005 - Carpet Floor - Administration
Installation Year	2013
Condition	3 - Fair
Expected Useful Life	10 Years
Remaining Useful Life	2 Years
Renewal Year	2026
Quantity / Unit of Measure	50 / SM
Unit Cost	\$114.00
Difficulty / Regional / Soft Cost / Replacement	1.00 / 1.04688 / 1.30000 / 1.0000
Element Cost	\$7,757.38

Deficiencies observed or reported during the assessment include damaged and frayed surfaces and wear and deterioration. The deterioration is anticipated to progress due to age and ongoing building activities. Replacement is recommended in the short term.

<b>Recommendations #1 - Carpet Floor</b>	
Type	Life Cycle Replacement
Year	2026
Cost	\$7,757.38

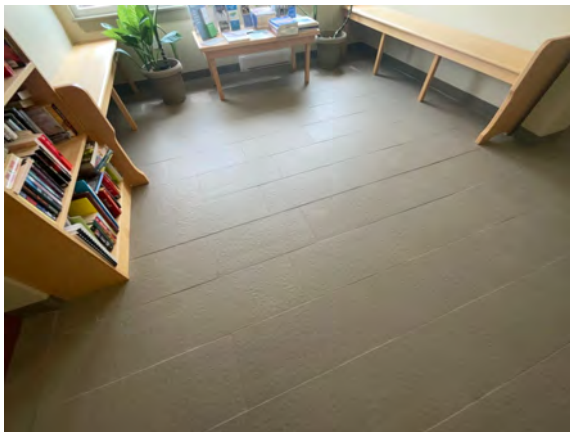
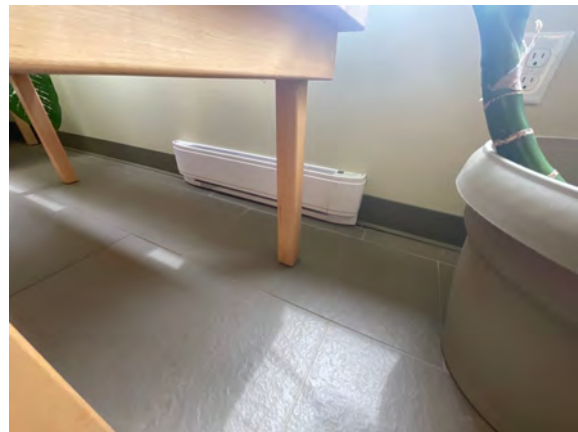
Township Office - C302023

No significant deficiencies were observed or reported. Lifecycle replacement may be deferred.

<b>Recommendations #1 - Vinyl Sheet Floor</b>	
Type	Life Cycle Replacement
Year	2029
Cost	\$10,751.46

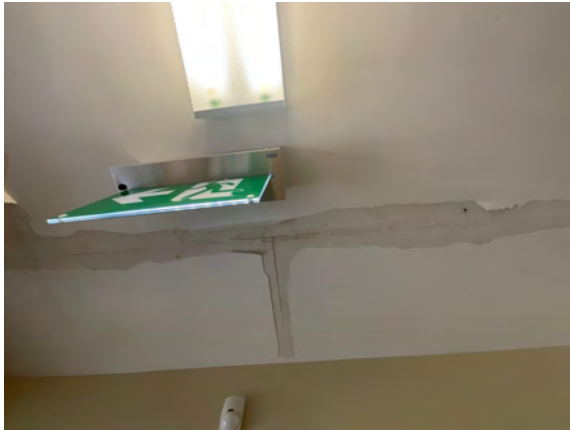
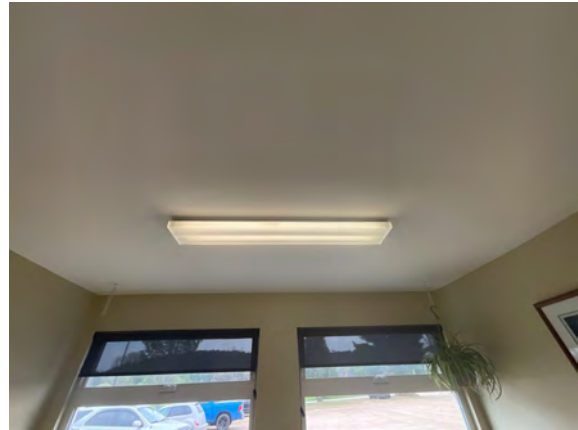
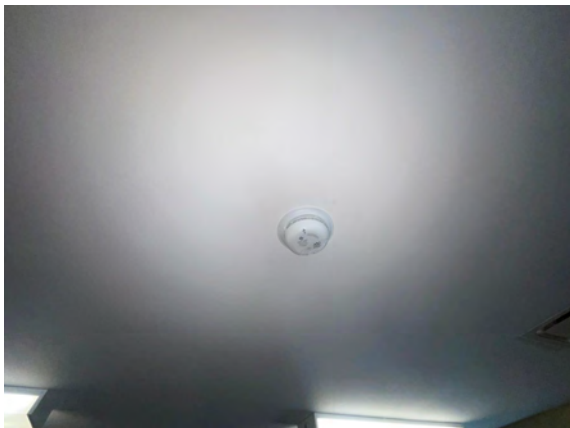
Township Office - C303006

No significant deficiencies were observed or reported. Lifecycle replacement may be deferred. However minor peeling was noted, and repair is recommended as a part of ongoing maintenance.

<b>Recommendations #1 - Painted Ceiling Structures</b>	
Type	Life Cycle Replacement
Year	2029
Cost	\$10,601.75

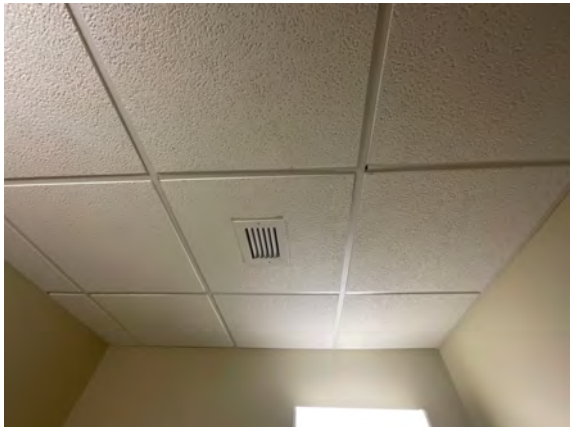
Township Office - C303007

No significant deficiencies were observed or reported. Replacement is not anticipated in the short term.

<b>Recommendations #1 - Suspended Acoustic Ceiling Panels</b>	
Type	Life Cycle Replacement
Year	2038
Cost	\$930.89

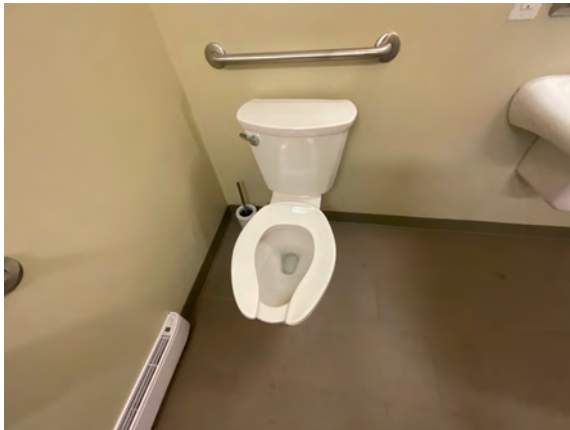
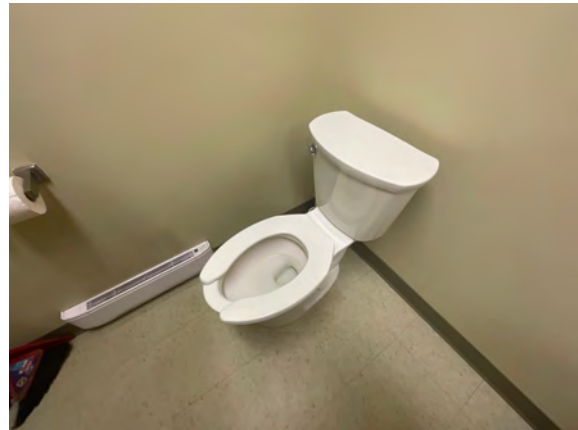
Township Office - D201001

No significant deficiencies were observed or reported. Replacement is not anticipated in the short term.

Recommendations #1 - Water Closets	
Type	Life Cycle Replacement
Year	2048
Cost	\$3,266.27

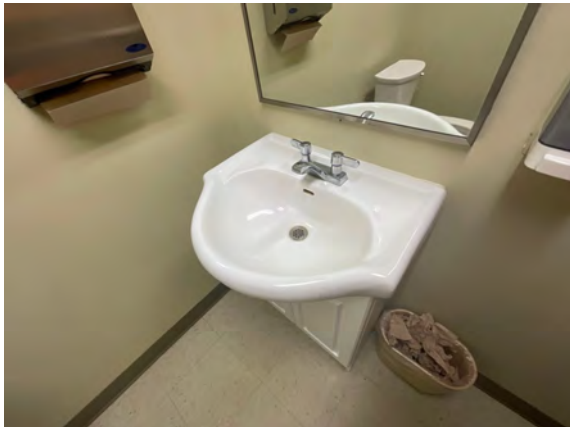
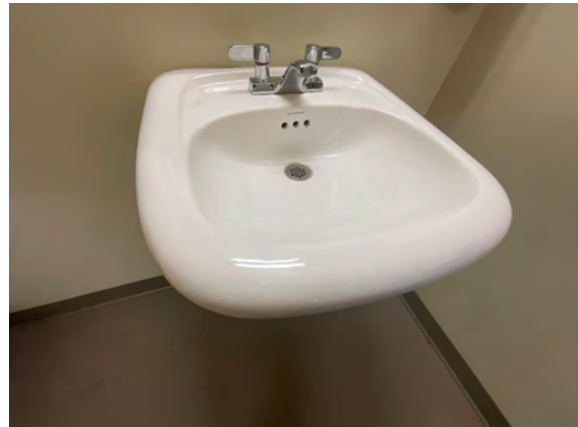
Township Office - D201003

No significant deficiencies were observed or reported. Replacement is not anticipated in the short term.

<b>Recommendations #1 - Lavatories</b>	
Type	Life Cycle Replacement
Year	2048
Cost	\$3,266.27

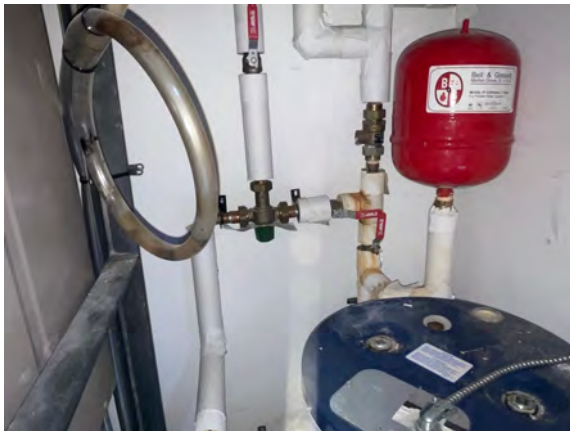
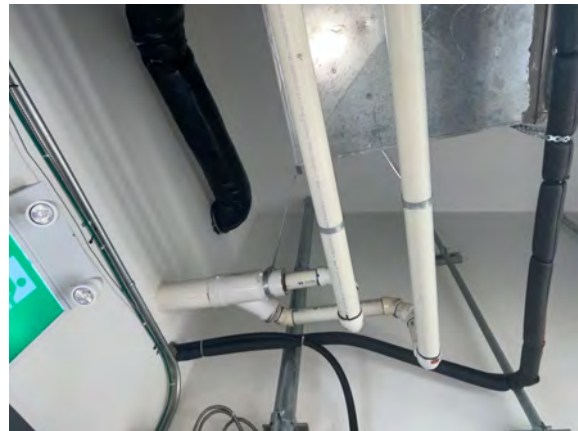
Township Office - D202001

No significant deficiencies were observed or reported. Replacement is not anticipated in the short term.

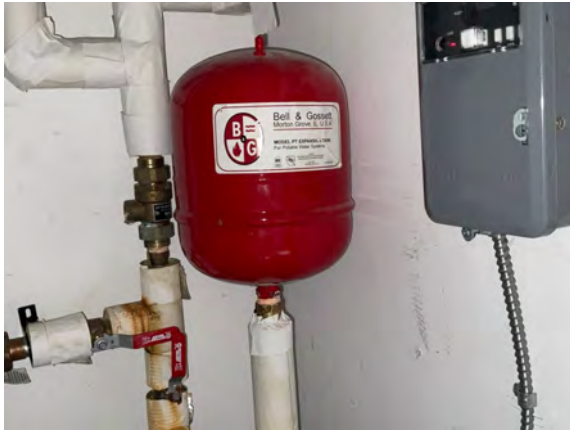
Township Office - D202008

No significant deficiencies were observed or reported. Replacement is not anticipated in the short term.

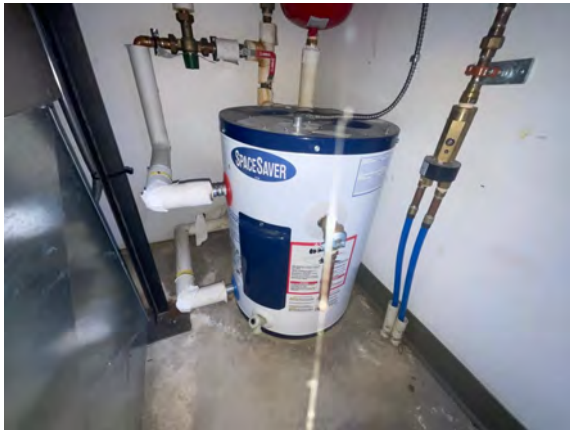
Township Office - D202034

No significant deficiencies were observed or reported. However, the system, based on age, is approaching its expected useful life with performance and reliability likely diminishing over time. Replacement is recommended in the short term.

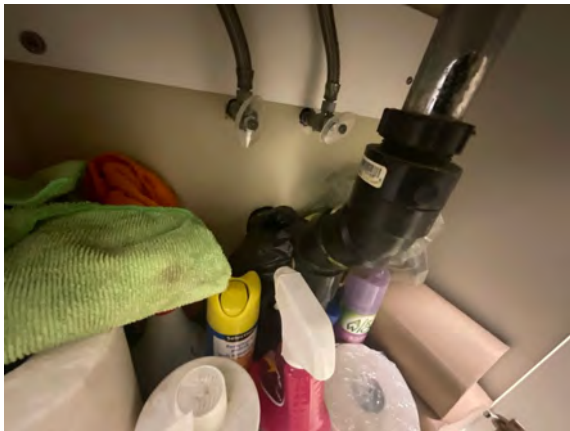
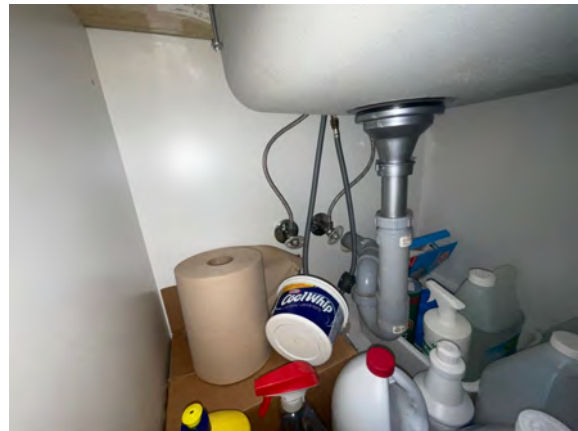
Township Office - D203001

No significant deficiencies were observed or reported. Replacement is not anticipated in the short term.

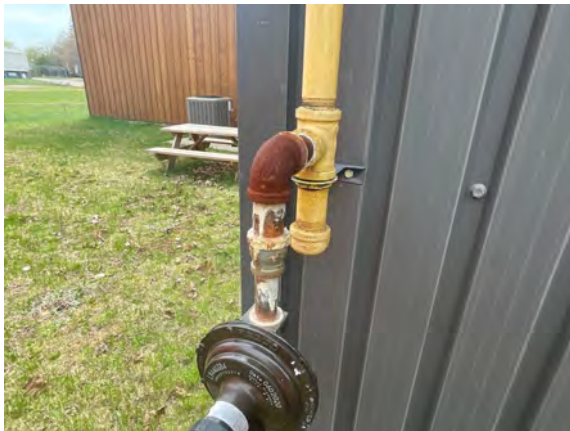
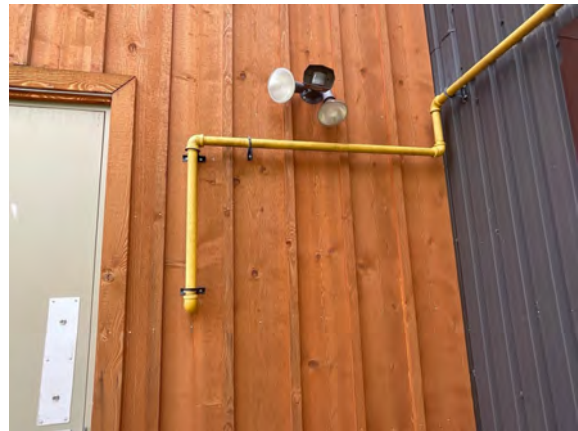
Township Office - D301002

No significant deficiencies were observed or reported. Replacement is not anticipated in the short term.

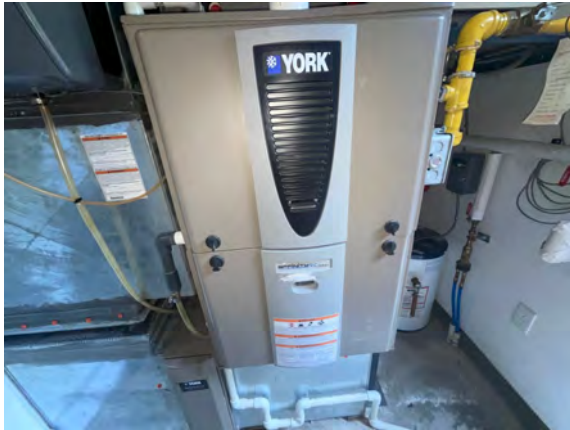
Township Office - D302003

No significant deficiencies were observed or reported. Replacement is not anticipated in the short term.

<b>Recommendations #1 - Fuel Fired Forced Air Furnaces</b>	
Type	Life Cycle Replacement
Year	2031
Cost	\$8,982.23

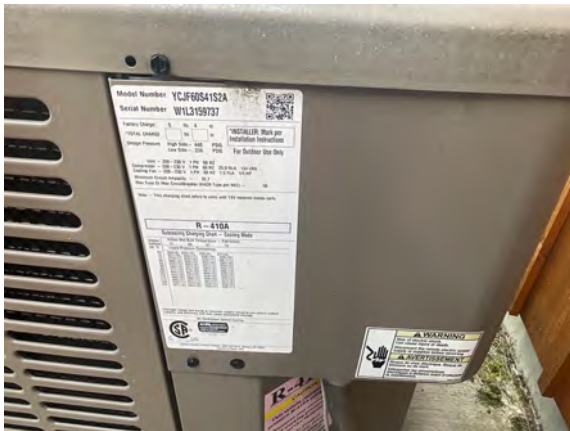
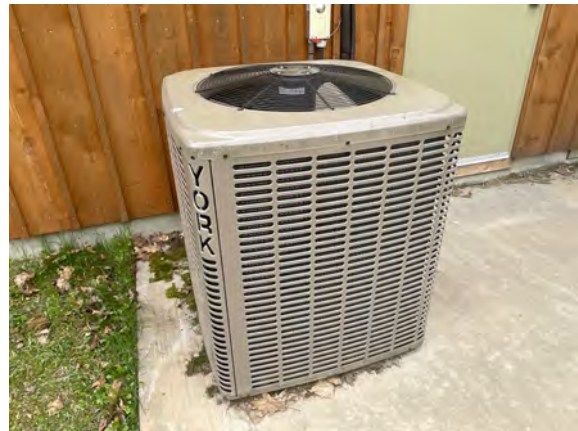
Township Office - D303041

Building cooling includes an air-cooled condensing unit identified as a split system air conditioning system. The condensing unit is manufactured by York model YCJF60S41S2A, serial number W1L159737, and has a cooling capacity of 3 tons. The unit is charged with refrigerant R-410a and is located on grade.

No significant deficiencies were observed or reported. Replacement is not anticipated in the short term.

Recommendations #1 - Refrigerant DX Condensing Units - 1 to 5 Tons	
Type	Life Cycle Replacement
Year	2031
Cost	\$6,845.55

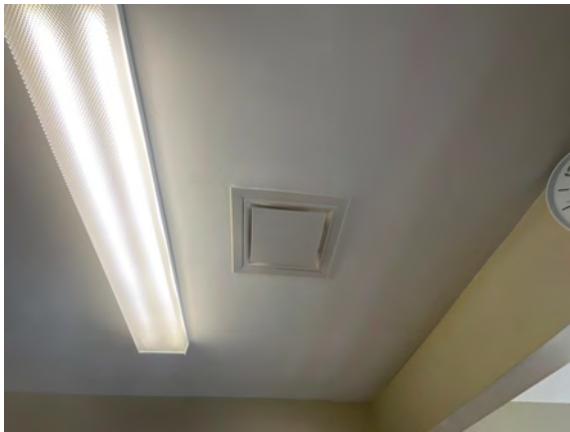
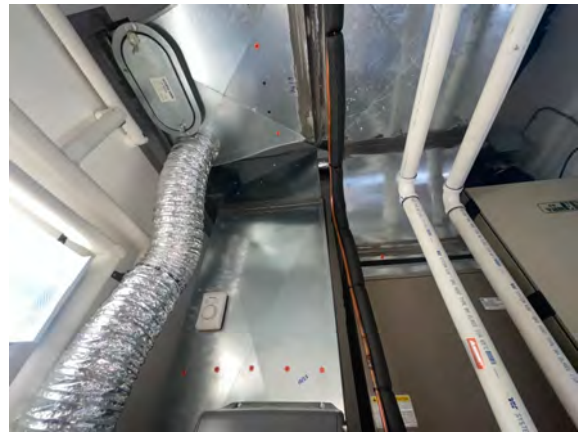
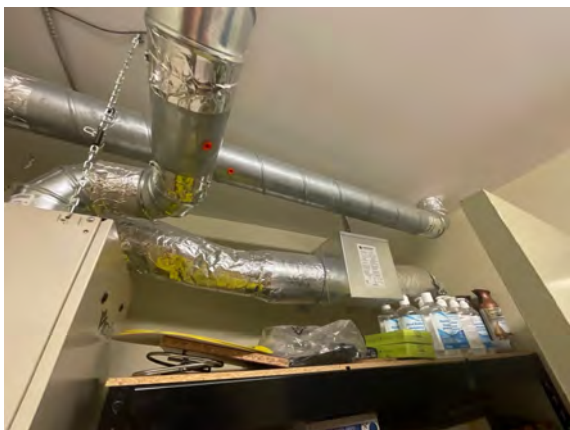
Township Office - D304001

No significant deficiencies were observed or reported. Replacement is not anticipated in the short term.

<b>Recommendations #1 - Air Distribution Systems</b>	
Type	Life Cycle Replacement
Year	2067
Cost	\$51,114.33
