# Brudenell Lyndoch and Raglan

Submission to Township of Brudenell, Lyndoch, and Raglan

Roth IAMS Ltd.  
207-1075 North Service Rd W, Oakville ON, L6M 2G2  
[www.rothiams.com](http://www.rothiams.com)  
Project No. 23502

**Facility Condition Assessment Report**  
**Brudenell Fire Hall #4**

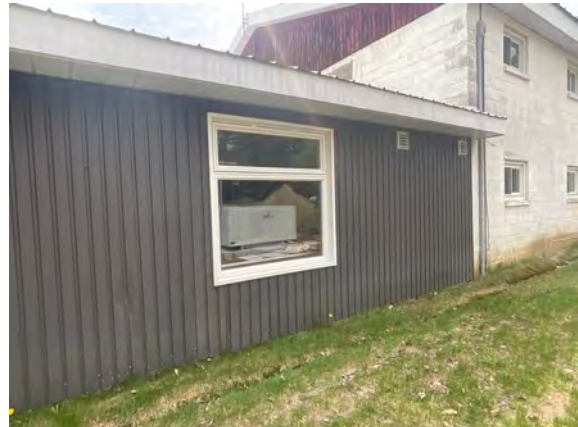
Township Office - D304033

No significant deficiencies were observed or reported. Replacement is not anticipated in the short term.

<b>Recommendations #1 - Exhaust Fans - Residential</b>	
Type	Life Cycle Replacement
Year	2038
Cost	\$4,695.26

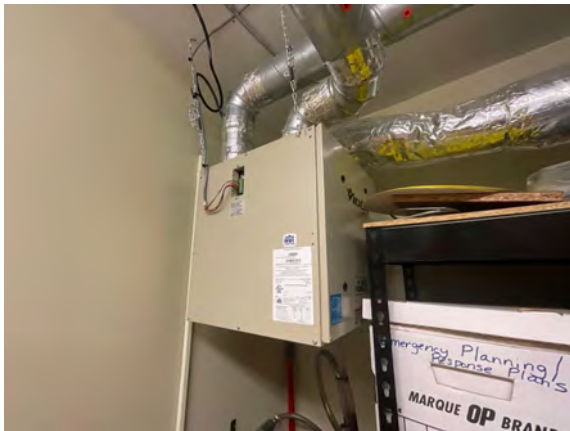
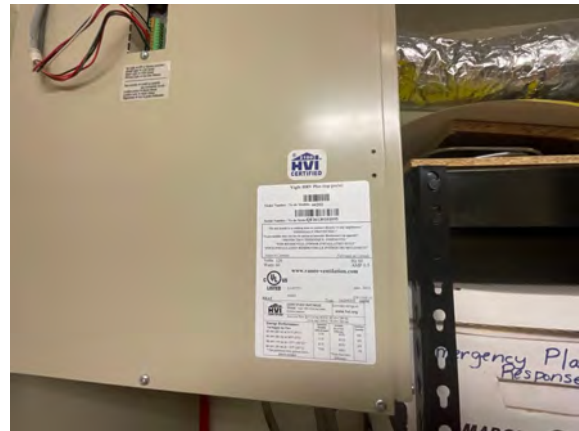
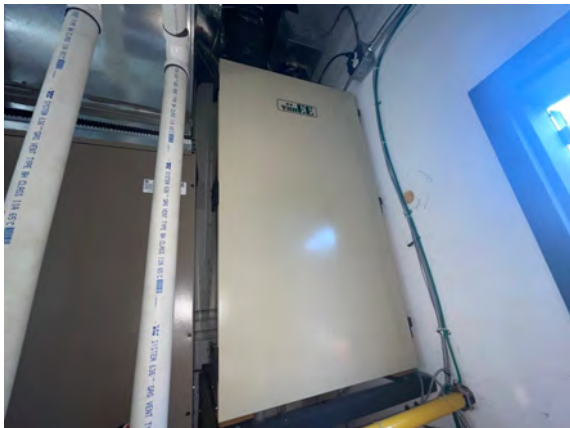
Township Office - D304053

No significant deficiencies were observed or reported. Replacement is not anticipated in the short term.

<b>Recommendations #1 - Heat Recovery Ventilators (Residential)</b>	
Type	Life Cycle Replacement
Year	2033
Cost	\$9,363.29

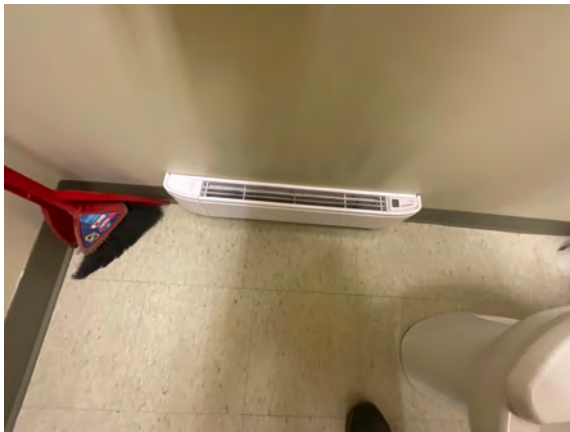
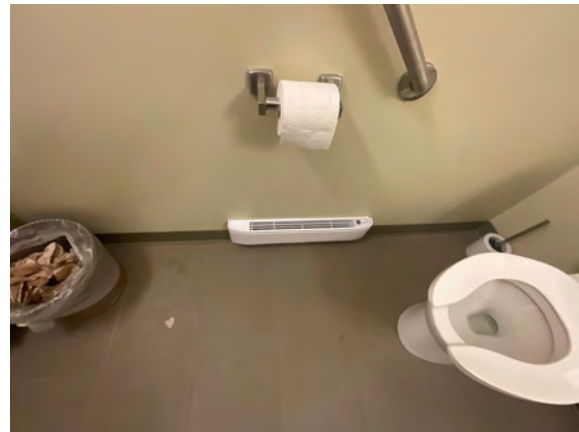
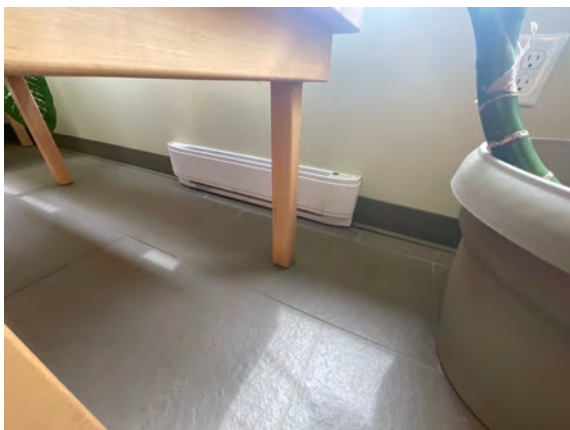
Township Office - D305010

No significant deficiencies were observed or reported. Replacement is not anticipated in the short term.

<b>Recommendations #1 - Electric Baseboard Heaters</b>	
Type	Life Cycle Replacement
Year	2031
Cost	\$2,939.64

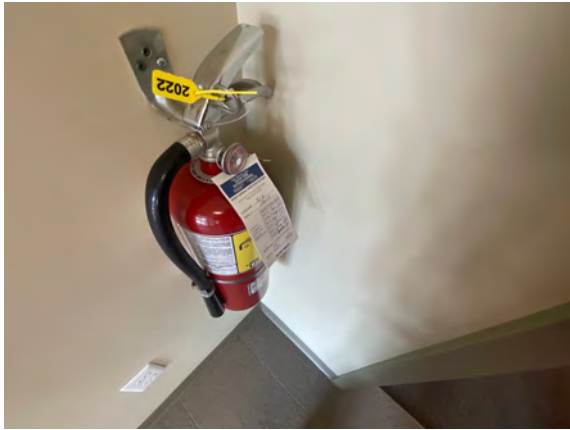
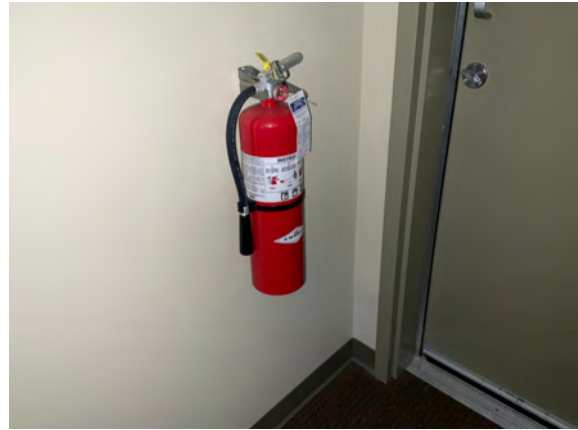
Township Office - D403002

No significant deficiencies were observed or reported. Replacement is not anticipated in the short term.

Recommendations #1 - Individual Fire Extinguishers	
Type	Life Cycle Replacement
Year	2029
Cost	\$702.25

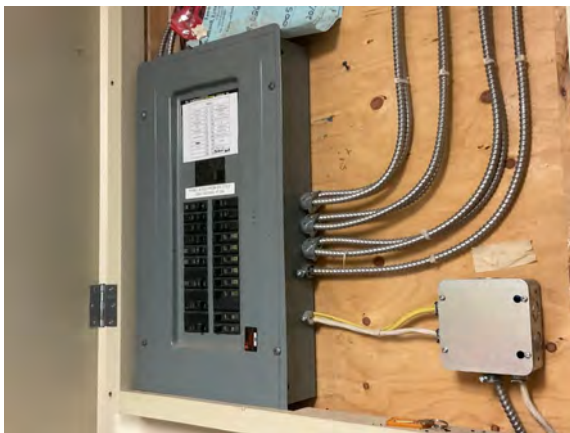
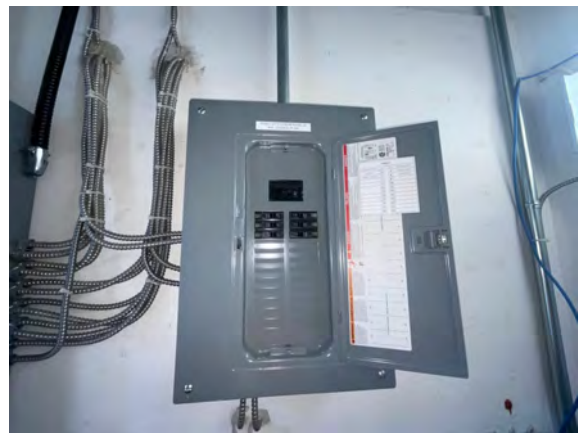
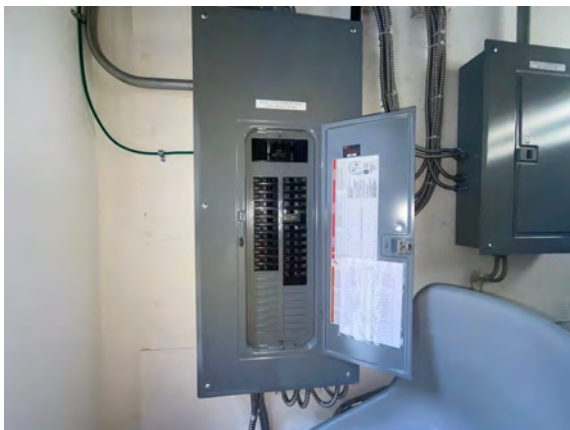
Township Office - D501031

No significant deficiencies were observed or reported. Replacement is not anticipated in the short term.

<b>Recommendations #1 - Electrical Distribution</b>	
Type	Life Cycle Replacement
Year	2053
Cost	\$22,685.58

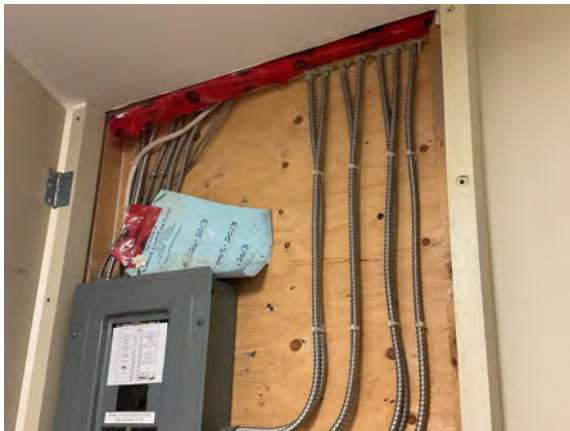
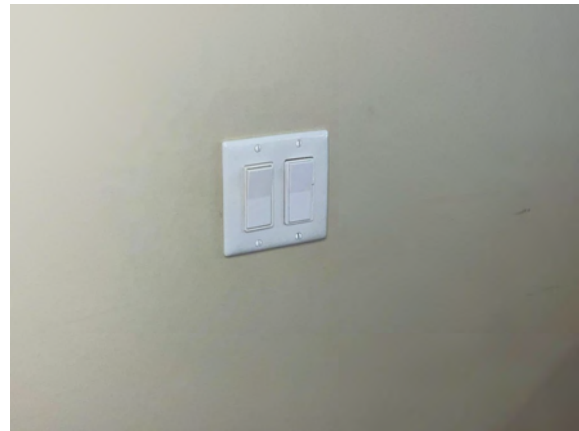
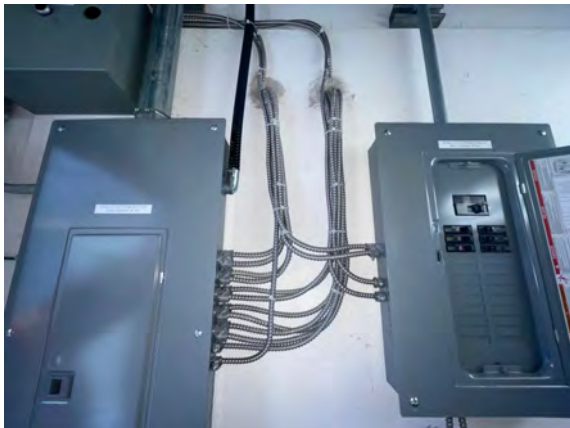
Township Office - D502001

No significant deficiencies were observed or reported. Wiring was added for the 2013 addition. Replacement is not anticipated in the short term.

<b>Recommendations #1 - Branch Wiring and Devices</b>	
Type	Life Cycle Replacement
Year	2063
Cost	\$40,489.44

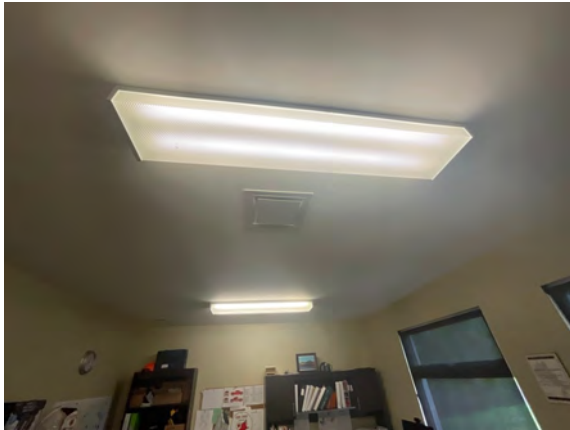
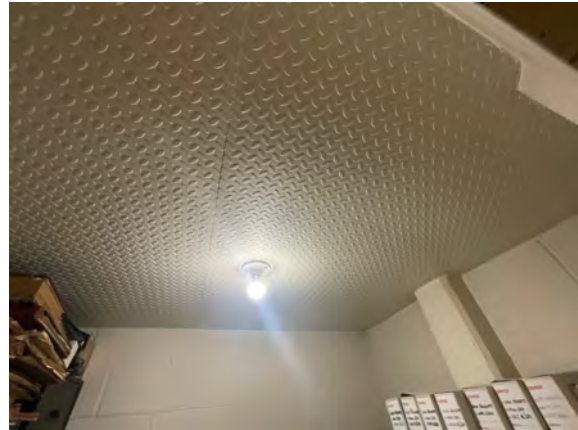
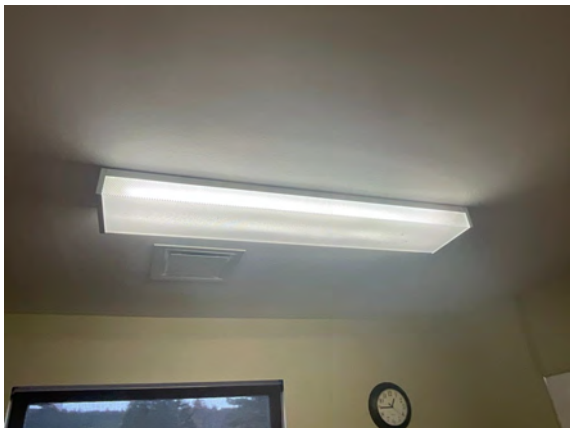
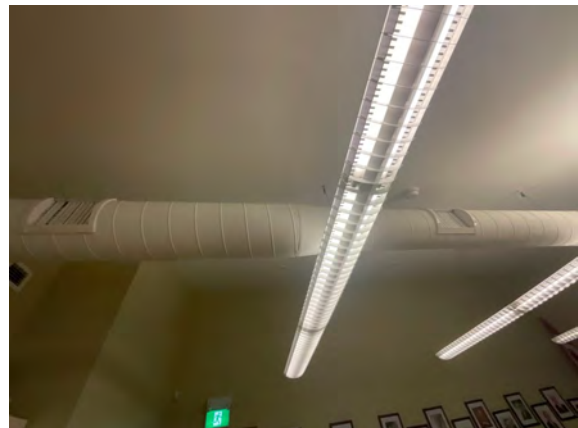
Township Office - D502002

No significant deficiencies were observed or reported. Replacement is not anticipated in the short term. Upgrade to LED should be considered.

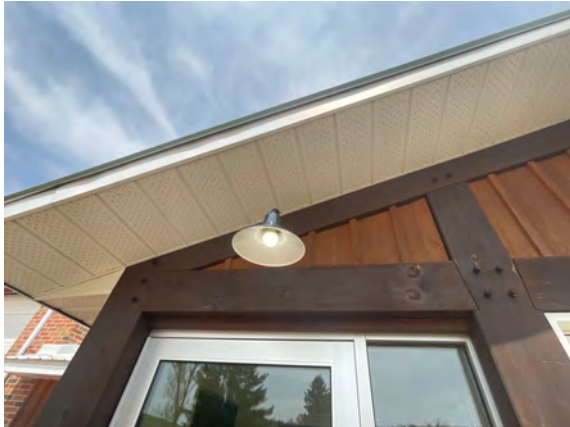
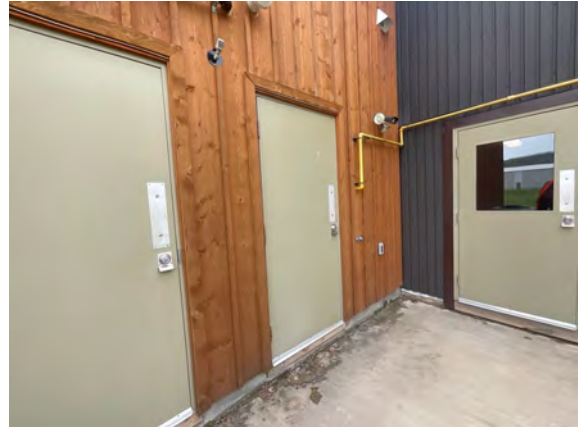
Township Office - D502041

No significant deficiencies were observed or reported. Replacement is not anticipated in the short term.

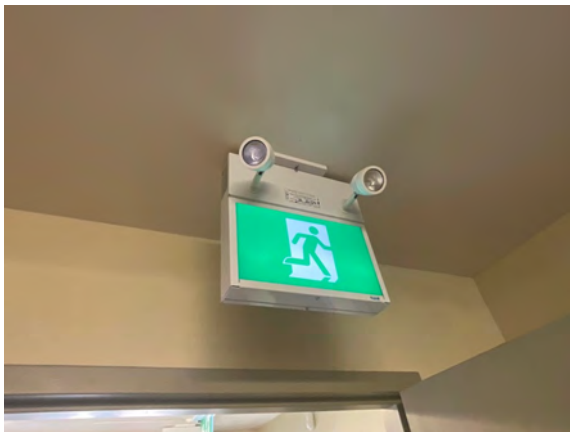
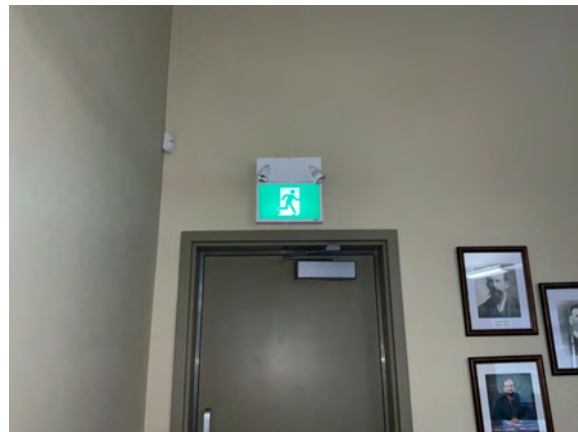
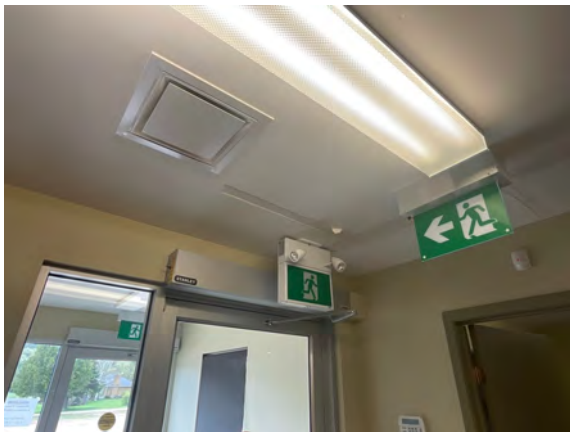
Township Office - D502051

No significant deficiencies were observed or reported. Replacement is not anticipated in the short term.

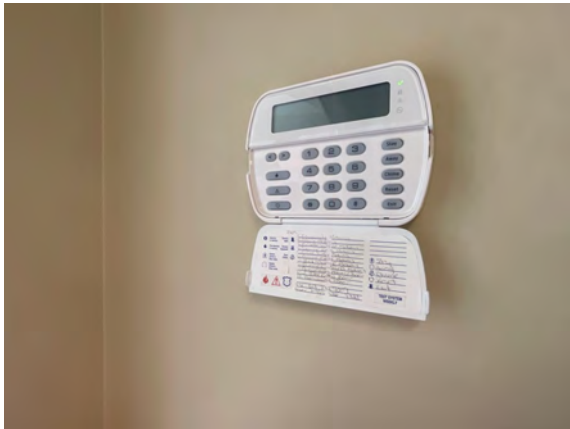
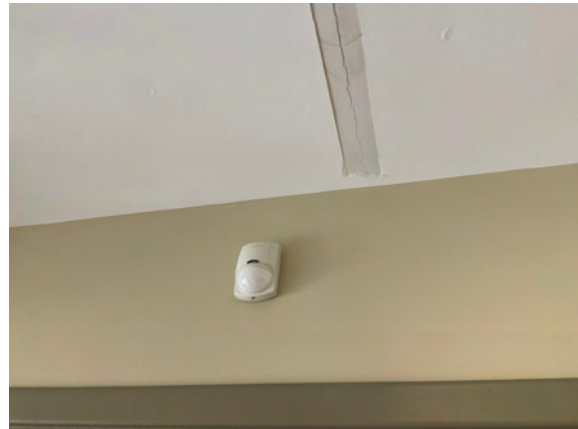
Township Office - D503008

No significant deficiencies were observed or reported. Replacement is not anticipated in the short term. Upgrade to LED should be considered.

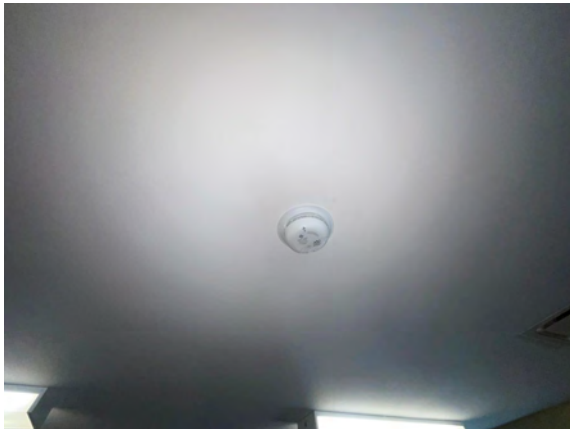
Township Office - D503015

No significant deficiencies were observed or reported. Replacement is not anticipated in the short term.

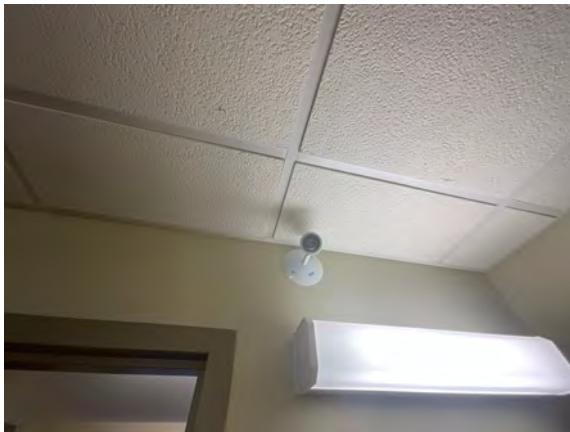
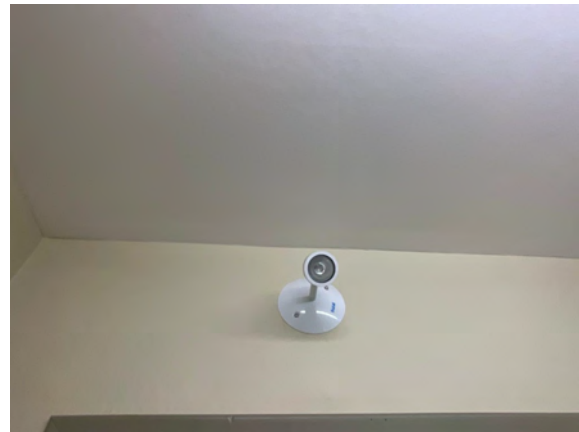
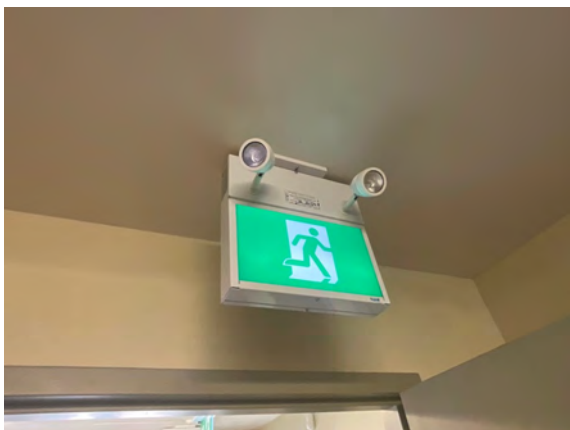
Township Office - D509003

No significant deficiencies were observed or reported. Replacement is not anticipated in the short term. Upgrade to LED should be considered.

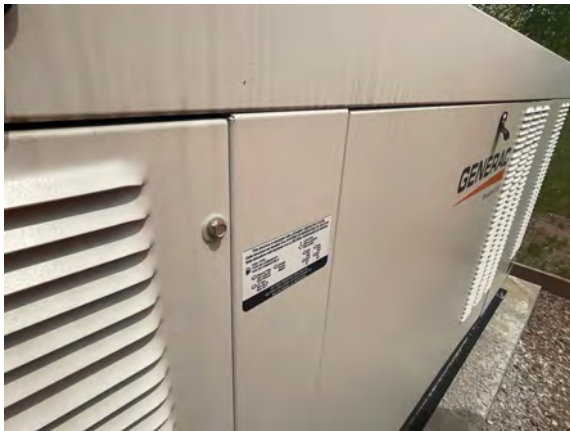
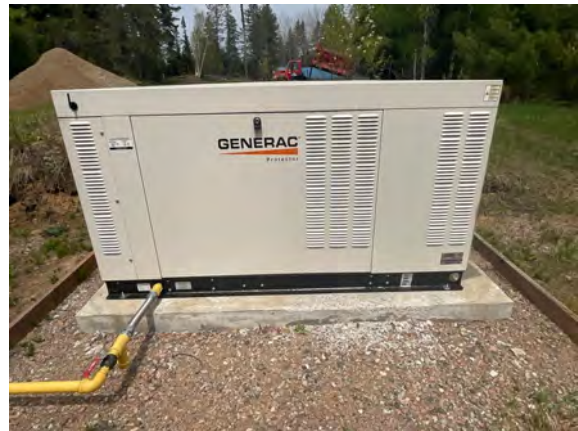
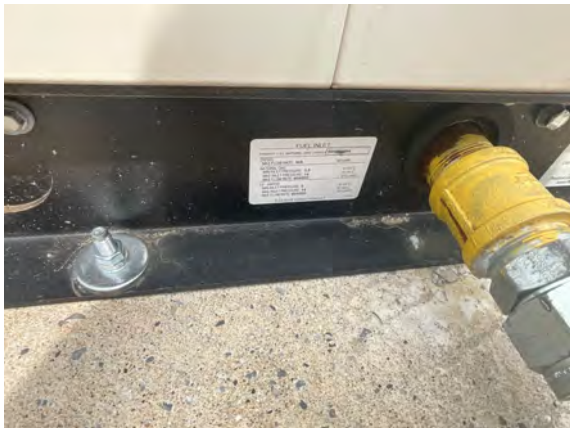
Township Office - D509012

No significant deficiencies were observed or reported. Replacement is not anticipated in the short term.

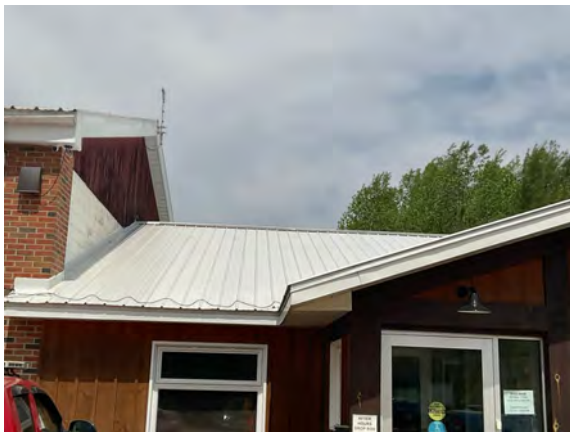
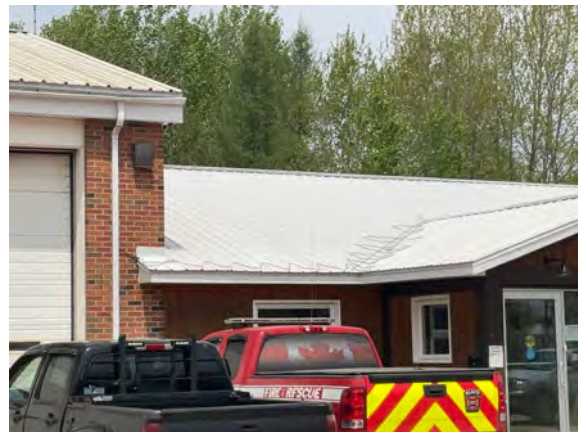
Township Office - D509051

<b>Element Description</b>	
Name	D509051 - Heat Trace Systems - Administration
Installation Year	2021
Condition	2 - Good
Expected Useful Life	20 Years
Remaining Useful Life	17 Years
Renewal Year	2041
Quantity / Unit of Measure	20 / LM
Unit Cost	\$58.00
Difficulty / Regional / Soft Cost / Replacement	1.00 / 1.04688 / 1.30000 / 1.0000
Element Cost	\$1,578.70

No significant deficiencies were observed or reported. Replacement is not anticipated in the short term.

<b>Recommendations #1 - Heat Trace Systems</b>	
Type	Life Cycle Replacement
Year	2041
Cost	\$1,578.70

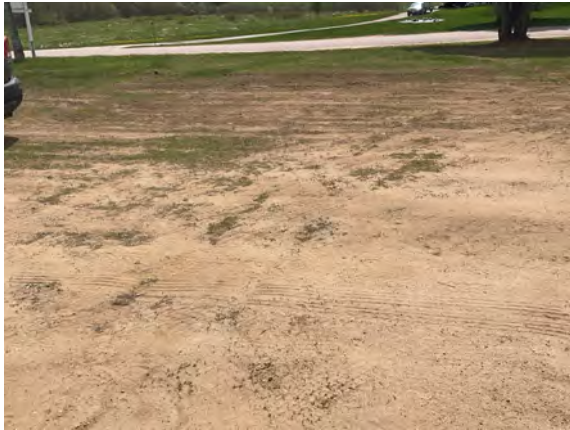
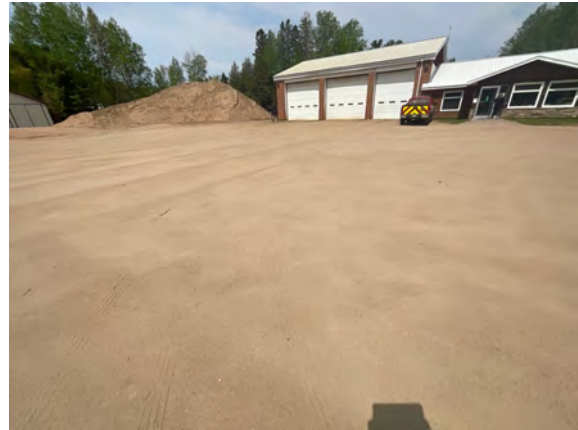
Township Office - G202024

<b>Element Description</b>	
Name	G202024 - Gravel Paved Surface - Parking Area - Administration
Installation Year	2013
Condition	2 - Good
Expected Useful Life	15 Years
Remaining Useful Life	5 Years
Renewal Year	2029
Quantity / Unit of Measure	400 / SM
Unit Cost	\$32.00
Difficulty / Regional / Soft Cost / Replacement	1.00 / 1.04688 / 1.30000 / 1.0000
Element Cost	\$17,420.08

No significant deficiencies were observed or reported. Minor washboarding at isolated sections of the gravel paved surface should be repair as part of maintenance.

<b>Recommendations #1 - Gravel Paved Surface - Parking Area</b>	
Type	Life Cycle Replacement
Year	2029
Cost	\$17,420.08

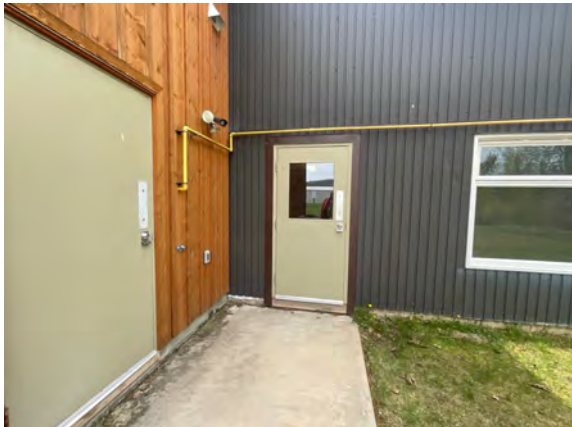
Township Office - G203022

<b>Element Description</b>	
Name	G203022 - Concrete Paved Surfaces - Administration
Installation Year	2013
Condition	2 - Good
Expected Useful Life	30 Years
Remaining Useful Life	19 Years
Renewal Year	2043
Quantity / Unit of Measure	6 / SM
Unit Cost	\$208.00
Difficulty / Regional / Soft Cost / Replacement	1.00 / 1.04688 / 1.30000 / 1.0000
Element Cost	\$1,698.46

No significant deficiencies were observed or reported.

<b>Recommendations #1 - Concrete Paved Surfaces</b>	
Type	Life Cycle Replacement
Year	2043
Cost	\$1,698.46

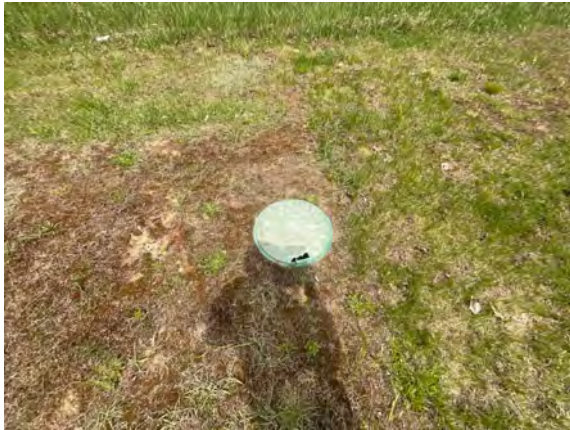
Township Office - G302016

Element Description	
Name	G302016 - Septic Tank - 4000 Gallons - Administration
Installation Year	2013
Condition	2 - Good
Expected Useful Life	50 Years
Remaining Useful Life	39 Years
Renewal Year	2063
Quantity / Unit of Measure	1 / Each
Unit Cost	\$37,620.00
Difficulty / Regional / Soft Cost / Replacement	1.00 / 1.04688 / 1.30000 / 1.0000
Element Cost	\$51,198.71

No significant deficiencies were observed or reported. Replacement is not anticipated in the short term.
